Operation of PAL-XFEL LLRF

J. Hu[†], J. Hong, K.H. Kim, S. Jung, D. Na, Y. J. Park, S.-H. Kim, S. Park, C.-K. Min, H.-S. Kang, H.-S. Lee, PAL, POSTECH, Pohang, South Korea

Abstract

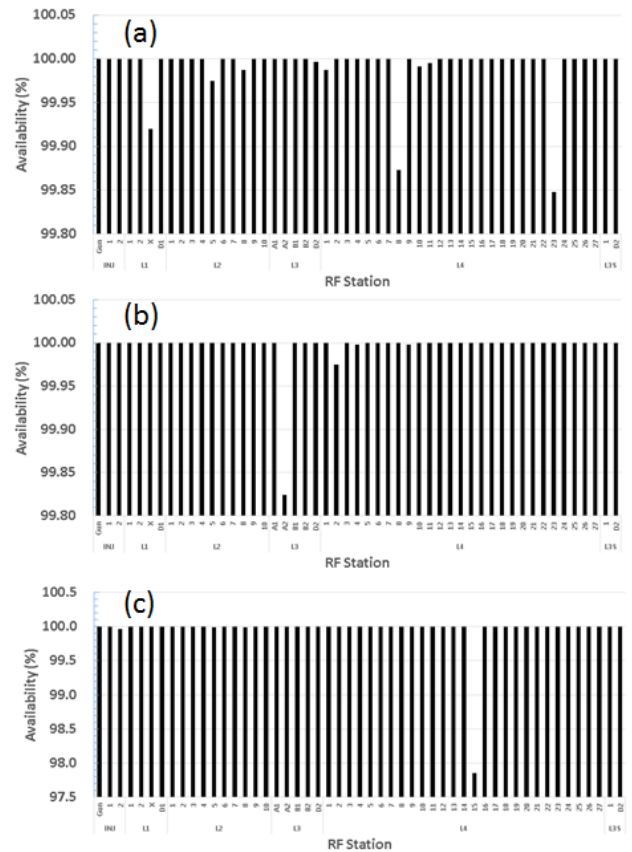
With the definition of availability, the availability of PAL-XFEL LLRF, SSA, and TC rack is shown in table 3 and figure 4. From table 3, the system availability of LLRF and SSA exceeds 99% this year and that for TC rack is 97.8% this year. From figure 4, there have been no problems except some stations this year.

Figure 4: Station availability of LLRF (a), SSA (b) and TC rack (c)

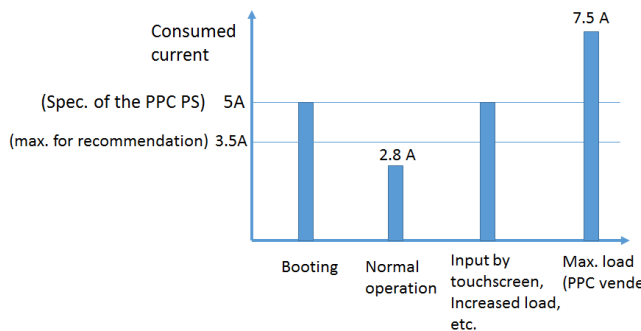
With some investigation it was identified that the problems came from the degradation of power supplies of the PPCs. To see why the PSs were degraded, a simple current analysis was done as shown in figure 6. It was judged from the analysis that the occasional use of the power supplies higher than the recommended value (3.5A, 70% of the indicated specification) caused the reduction of the lifetime of the power supplies.

Figure 6: A simple current analysis of a PPC of a PAL-XFEL LLRF set.

All the PPCs' PSs were upgraded Feb. 2019. After the upgrade, the problematic sets were recovered but some sets which had not shown the problems newly showed the symptoms (table 4). Therefore, we will be conducting further investigation.

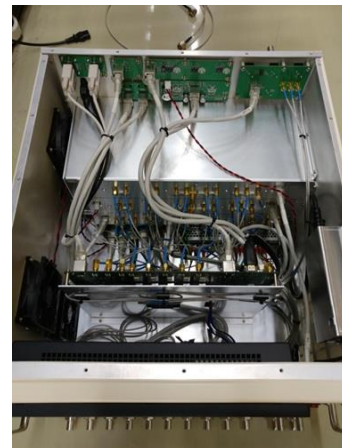
Symptoms that seem to be irrelevant were due to incomplete connection of connectors. Figure 7 shows the internal picture of a PAL-XFEL LLRF unit. As one can see from the figure, many RJ45 connectors and 2 HDMI connectors are used.

Figure 7: Internal view of a PAL-XFEL LLRF set.

Figure 8 shows a block diagram of the connection of cables between a digital board and a RF module illustratively. This configuration enables the internal connection simple, very efficient and high-speed operation but not perfect. Through reconnection of the cables, all the sets were recovered. We will search for better solutions such as new venders or new types of connections.

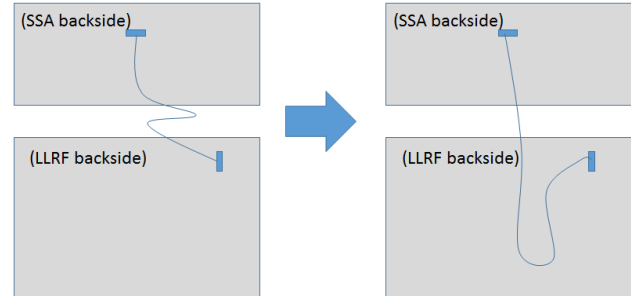
Another hint was found at L4-2 SSA, which occurred “over repetition” interlock several times suddenly right after winter maintenance. The job in the period was reinstallation of LLRF and reconnection of cables at the site. Therefore, the cable rerouting as shown in figure 9 has been applied and no problem has occurred so far.

It is inferred from these hints that the strong electrical noise from the HV modulator affected RS-232 communication. For L4-2 SSA case, the abnormal interlock was disappeared in the change as shown in figure 9 but for some

Figure 9 : Rerouting cable between LLRF and SSA pair

other stations, the reverse showed positive effects. As long-lasting solutions, noise countermeasures will be in place or more noise-resistant communications will be applied in the next version.

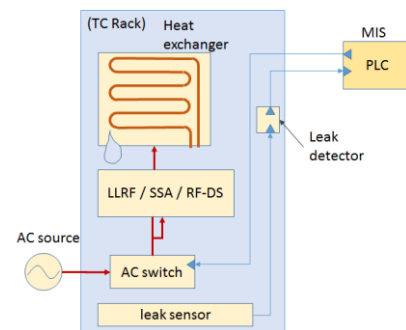
TC rack (Temperature-Controlled Rack) for PAL-XFEL is shown in figure 10. The TC rack regulates temperature inside the rack with cooling water and has a leakage detector to cut electricity when leak events occur. The leak detection system worked properly and helped to detect leakage remotely early.

Figure 10: Block diagram of PAL-XFEL TC rack

As shown in table 5 leak events increased seriously this year. Whenever cooling water leak, the leak exchangers are replaced with spare exchangers. The working time required for each replacement is about 1~2 hours and spare exchangers are only two not enough to manage the events.

Therefore, we proceed in three ways; preparing more spare exchangers, redesigning heat exchangers and developing a rack easier to replace heat exchanger.
