Computer Vision-Based Health Monitoring of Mecklenburg Bridge Using 3D Digital Image Correlation

A collaborative investigation between the University of Virginia (UVA) and the Virginia Transportation Research Council was performed on the Mecklenburg Bridge (I-85 over Route 1 in Mecklenburg County). The research team aided the Virginia Department of Transportation - Richmond District in the characterization of the bridge behavior of one of the bridge beams that had been repaired due to a previous web buckling and crippling failure. The investigation focused on collecting full-field three-dimensional digital image correlation (3D-DIC) deformation measurements during the dropping sequence (removal of jacking to support beam on bearing/pier). Additionally, measurements were taken of the section prior to and after dropping using a handheld laser scanner to assess the potential of lateral deformation or out-of-plane buckling. Results from the study demonstrated that buckling of the tested beam did not occur, but did provide a series of approaches that can be used to evaluate the effectiveness of repaired steel beam ends. Specifically, the results provided an approach that could estimate

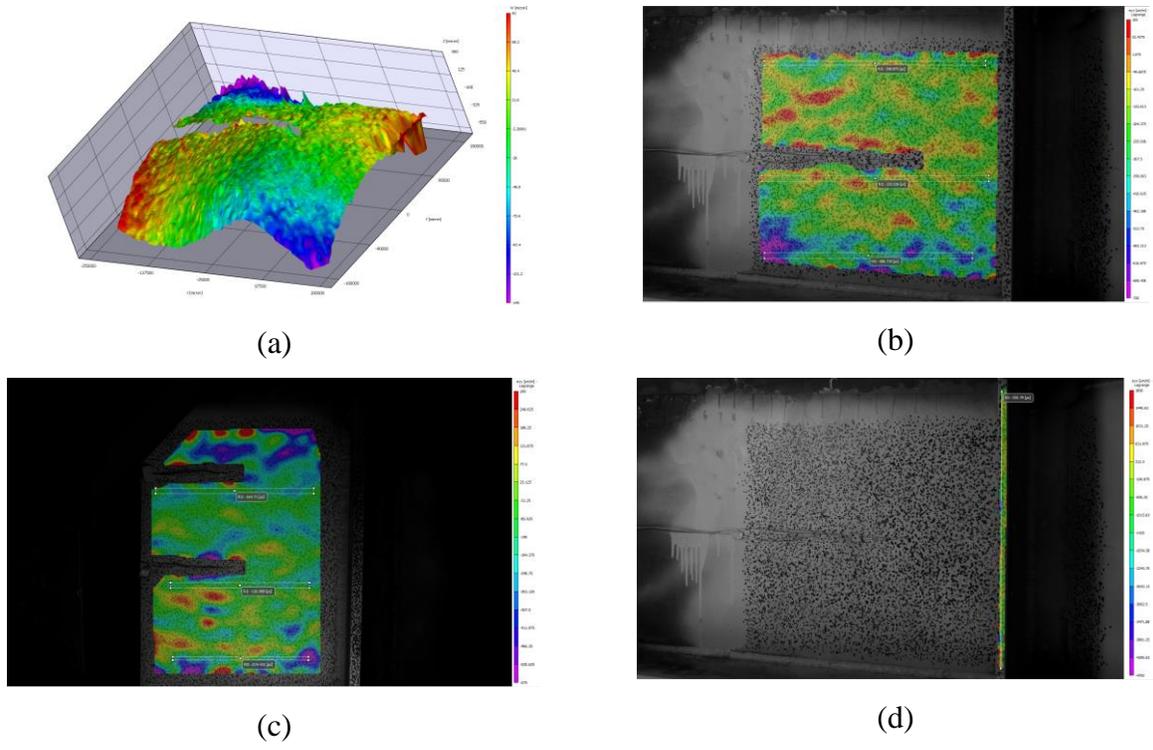
Measurements derived from DIC were able to describe the full-field 3D deformation response over the loading. Figure 3a illustrates the full-field response of Regions 0 at the end of the drop sequence. With the foil strain gauge mounted on the observed surface, measurements were not available within these regions; however, the full-field measurement allows for evaluation of global and local responses that cannot be realized with a strain gauge. For example, Figure 3a represents the out-of-plane deformation of Region 0, which exhibits positive curvature with an amplitude on the order of approximately 0.00197 in. (~50 microns) along the diagonal. A similar observation can be made for the tail of the beam (Region 1) which exhibits a similar contour change along the diagonal; however, the magnitude of the deformation is significantly lower, on the order of 3-5 microns, suggesting no significant out-of-plane deformation in this region.

Figure 3. (a) 3D Out-of-plane deflection (w) at $t = 100s$ (Note 3 regions of interest) for Region 0. (b) Vertical strain measurements on the Region 0 (c) Vertical strain measurements on the Region 1, (d) Vertical strain measurements on the Connection Plate

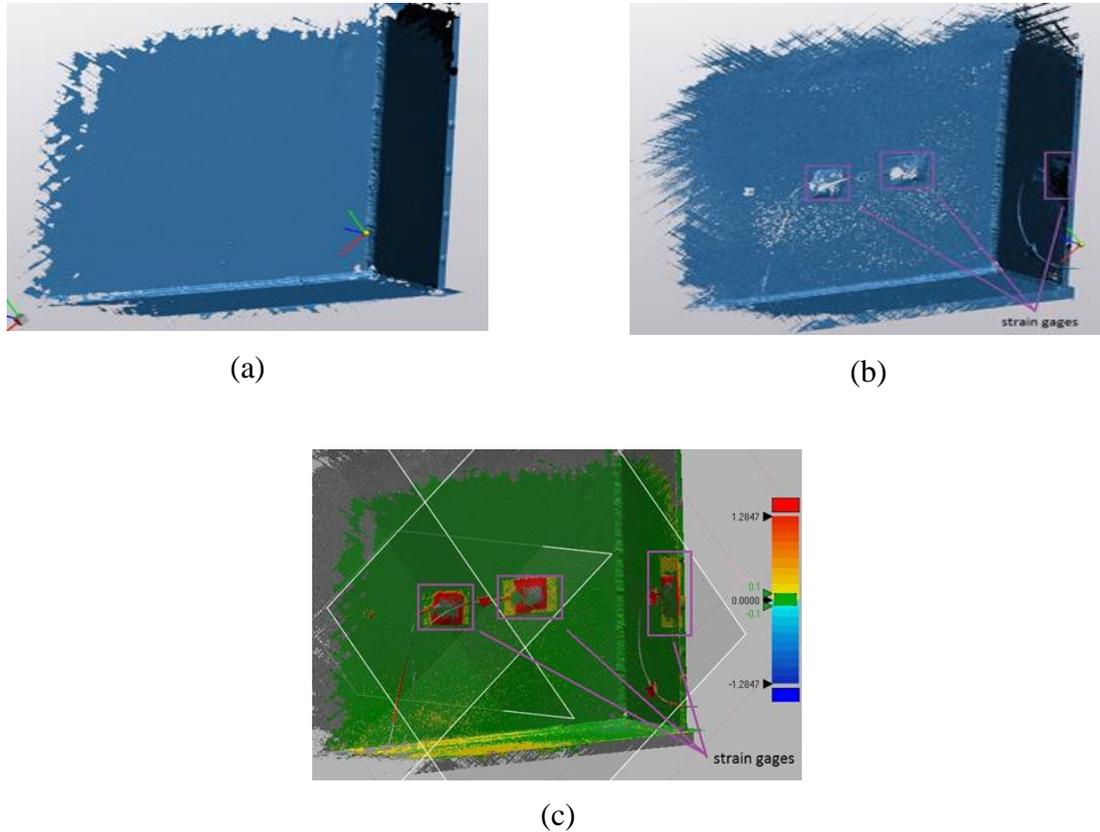
Similar to the 3D-DIC results, measurements derived from the 3DS were able to illustrate the full three-dimensional surface geometry of the beam end for Region 0, with the 3D shape reconstruction for each of the scans collected shown in Figure 6. In Figure 6b, it becomes apparent that deviations associated with the strain gauge weatherproofing and wires are captured within the second scan; however, no additional deformations are obvious to the naked eye. Following the surface reconstruction, the geometry of the two surface scans was aligned using common reference points between each scan and a deviation analysis was performed. The deviation analysis was performed using the Cloud Compare software package, which is an open source 3D point cloud and mesh processing software designed for direct comparison of 3D point clouds or 3D entities [31]. The deviation analysis confirmed the subjective observations from the 3D shape reconstructions, with only the deviations from the strain gauge systems highlighted in Figure 6c.

Figure 6. 3DS of Region 0 (a) scan 1 prior to dropping the beam, (b) scan 2 two weeks after dropping the beam, (c) deviation analysis results between Scan 1 and Scan 2 (units in mm)
