Visual investigation of possible degradation in GEM foil under test

S. Chatterjee*, A. Sen, S. Das, S. Biswas

^aDepartment of Physics, Bose Institute, EN-80, Sector V, Kolkata-700091, India

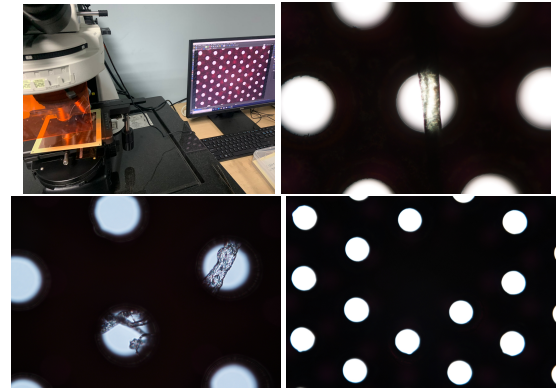
Visual investigation of a Single Mask (SM) Gas Electron Multiplier (GEM) foil, showing small resistance ($\sim 40 \text{ k}\Omega$), is performed manually using an optical microscope. The GEM foil is scanned and the different imperfections in the foil are identified. Different techniques are used to clean the GEM foil to remove the short paths created between the GEM electrodes. The details of the method used for cleaning the GEM foil and the result of leakage current measurement after the cleaning of the foil are discussed in this article.

Figure 1: Microscope setup for scanning the GEM foil (top left). Imperfections in the GEM foil at different magnifications (40X: top right, bottom left; 20X: bottom right)

under scanning. The visual inspection revealed several imperfections in the foil and they are shown in Fig. 1. The pitch and diameter of the GEM holes are also measured using the microscope and their distributions are shown in Fig. 2. The average hole diameter is found to be $69.57 \pm 0.09 \mu\text{m}$ and the average pitch is found to be $140.20 \pm 0.80 \mu\text{m}$.

After doing the visual scanning, the GEM foil is cleaned using millipore water and also using an ultrasonic ($\sim 20 \text{ kHz}$) bath with millipore water as the medium.

First, the GEM foil is immersed in the millipore water bath for ~ 60 minutes and then the foil is removed and kept for drying under continuous hot air flow for ~ 30 minutes. After that, the foil resistance is measured and still, it is found that the resistance of the foil is low ($\sim 1 \text{ M}\Omega$). The foil is kept for another 24 hours in a closed box and then again the foil resistance is measured but still, the resistance is found to be $\sim 1 \text{ M}\Omega$. Fig. 3 shows the GEM foil in the millipore water bath.

After the water bath, the foil is put in the ultrasonic ($\sim 20 \text{ kHz}$) bath with millipore water as the medium. The foil is kept in the ultrasonic bath for ~ 5 minutes. After removing the foil from the ultrasonic bath, the foil is dried for ~ 30

minutes under continuous hot air flow. After that, the foil resistance is measured and it is found to be very high, which implies that the short paths are removed. Fig. 4 shows the GEM foil in the ultrasonic bath with millipore water as the medium.

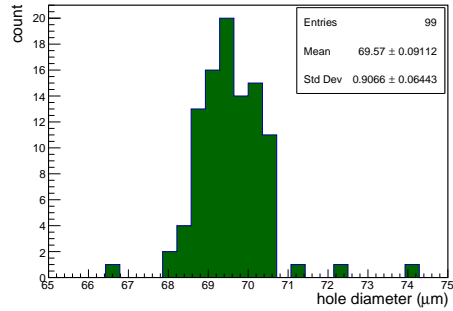
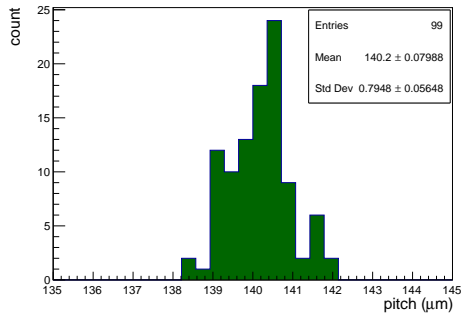
Figure 2: Distribution of GEM hole diameter (top) and pitch (bottom).

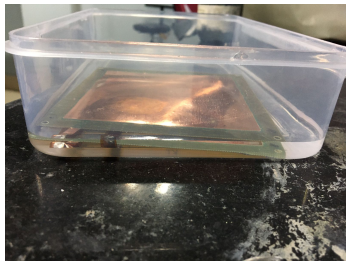
Figure 3: Millipore water bath of the GEM foil.

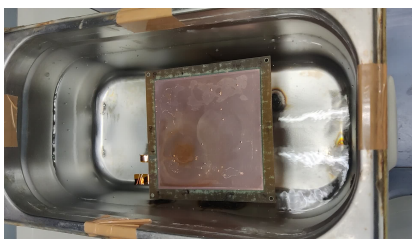
Figure 4: Ultrasonic bath of the GEM foil with millipore water as the medium.

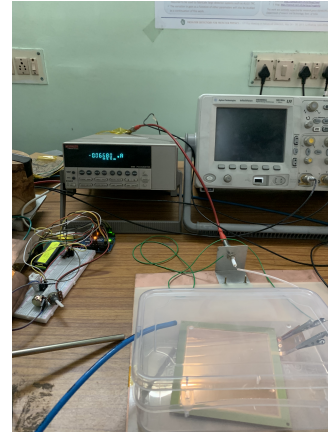
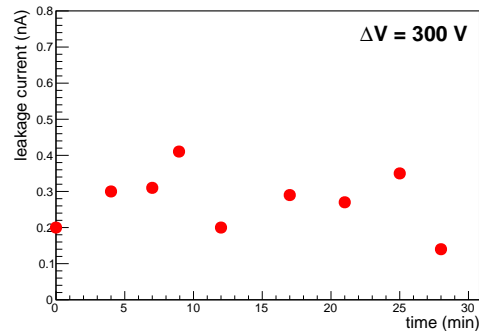
After cleaning with the ultrasonic bath, the leakage current of the foil is measured under a continuous flow of Ar/CO₂ gas mixture. The voltage is applied across the GEM foil by connecting the two leads of the foil to the external High Voltage module. The current is measured using a Keithley picoammeter (Mod No.: 6485). The setup of the leakage current measurement is shown in Fig. 5 (top). The voltage across the GEM foil is kept at $\Delta V \sim 300$ V and the leakage current of the foil is measured for 30 minutes. The leakage current is found to be ~ 0.3 nA at a relative humidity (RH) of ~ 50 %. The measured

Figure 5: Setup for leakage current measurement of the GEM foil (top). Leakage current as a function of time (bottom).

leakage current as a function of time is shown in Fig. 5 (bottom).
