# **An Endangered National Heritage Site - The Cape Observatory**

*IS Glass (SAAO)*

The SAAO Cape Town campus was declared a National Heritage Site in December 2018, just short of its 200<sup>th</sup> anniversary, but is now in a run-down condition. As the former Royal Observatory, it is the oldest scientific institution in South Africa and probably in all Africa. It has a fascinating and well-documented history and surely deserves better. For many years maintenance has been neglected and many of the old telescopes and buildings are in a poor state. They are beginning to show signs of serious decay. Some examples are given.

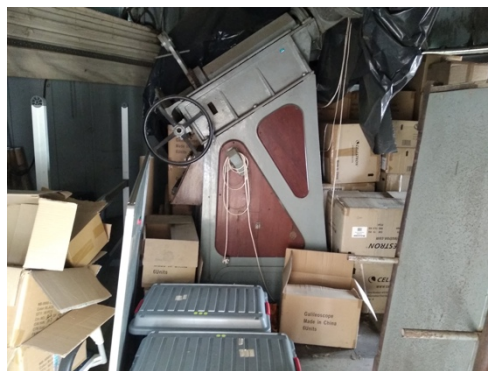
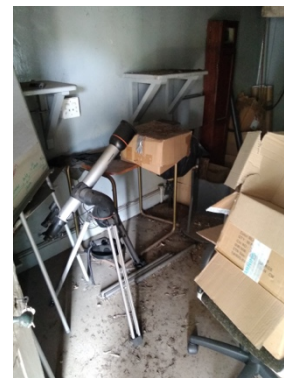
*Fig 1 (a,b): The Astrographic dome is currently used as a junk room, containing many boxes of unused equipment. These are gathering dust and dirt.*

- Astrographic: The building should be cleaned up and the original telescopes replaced on the mount. The screws and fittings are probably all still there.

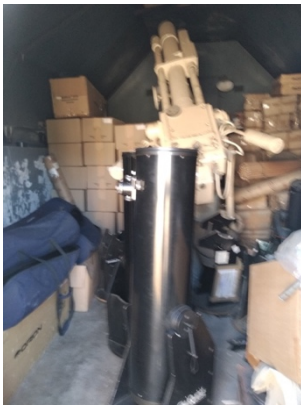
*Fig 5: The Lyot is used as storage for telescopes used in outreach and today also contains many boxes of unused material*

- Lyot: Clean up.
- 6-inch: replace/repair roof
- 1849 dome/Photo heliograph: Repair woodwork.
- All: clean regularly. Paint as necessary.

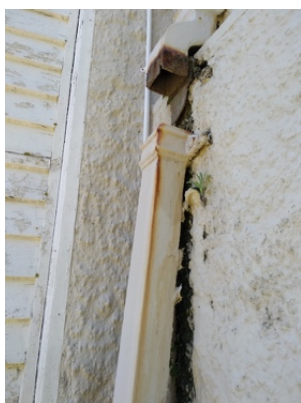
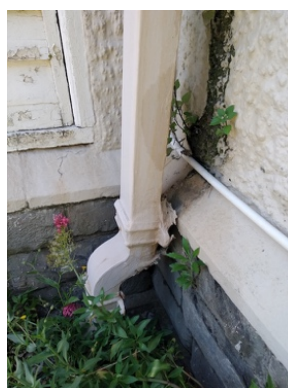
*Figs 8, 9: (left and centre) Original cast iron drain pipes becoming detached from wall. Mould growing on wall and weeds rooting in wall.*

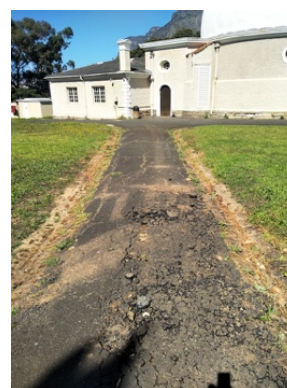
*Fig 10: (right) path to dome broken up by recent truck traffic.*

- Broken up pavements could be repaired, especially the old brick gutters that must have looked attractive before a century or more of general neglect, natural decay, damage by trucks, excavations for cables, weed encrustation etc.

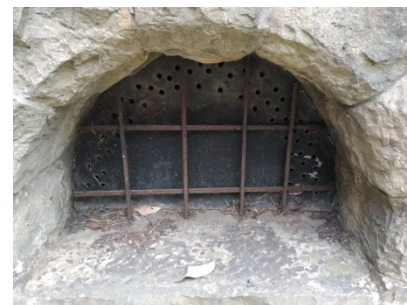
The security of the building is a constant concern.

*Fig 11: The grills over the basement windows are loose and will not deter any determined intruder.*

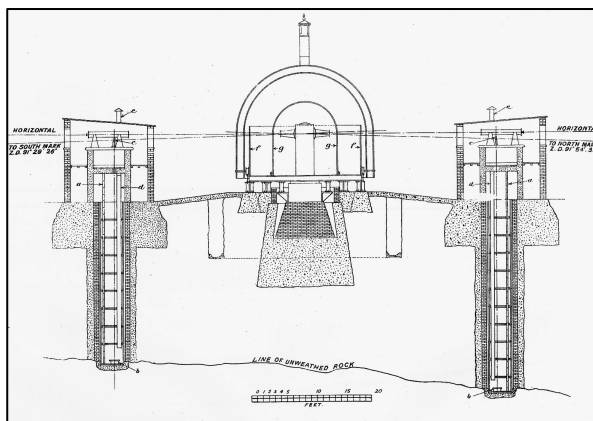
The building is of steel and is rusting away, particularly since **the ventilators on top are broken and admit** rain to the space between the inner and outer shell of the building. The door is jammed shut (2023) but is perhaps openable with a crowbar.

*Fig 15: The building is mostly made of sheet steel and consists of two layers. Thanks to the missing ventilator top on the West side, rain is getting in between the two layers. The remains of the missing ventilator are inside the building.*

I believe the building could be preserved with minimal expense – the first item being to prevent the ingress of rain

- 18-inch: Re-seal the dome, fix roof leak (s), re-tile floor and set up as a display of photometry.
- RTC: Repair vents, treat rust, consider making housing opening mechanism operable. Set up a display of astrometry.

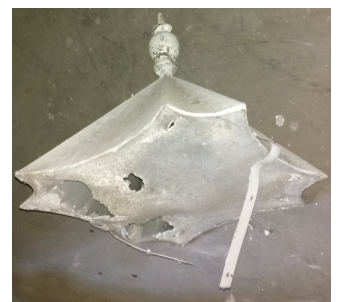
*Fig 17: Typical examples of rust on the outside of the building.*

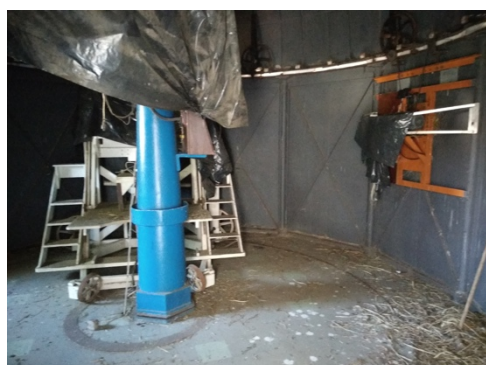
*Figs 18 & 19: The interior of the building, showing the result of bird invasion and leaks.*

Though an attempt was made to seal it off, this was not successful. No cleaning has been performed for at least 2 years. There is a **water leak** and this also causes wetness in the archives overflow storeroom below, some of whose shelves can no longer be used. Just outside this part of the dome is a narrow downpipe whose purpose is not clear and it may be part of the problem. A large downpipe to the NW is in danger of falling off.

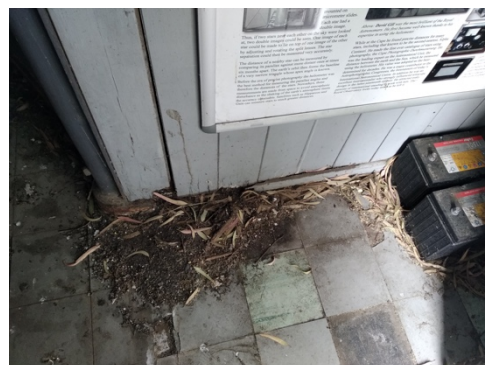
*Fig 20: The building has been invaded by starlings and the floor is covered by straw and bird droppings.*

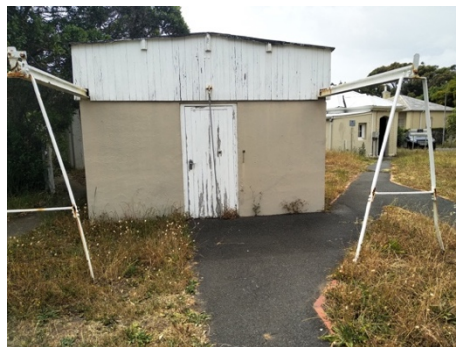
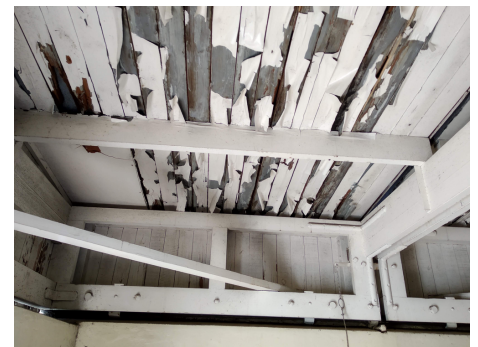
*Figs 22 & 23: It has not been cleaned recently. The woodwork of the sliding-roof building, which dates from 1935, is rotting away and has not been painted in recent years.*

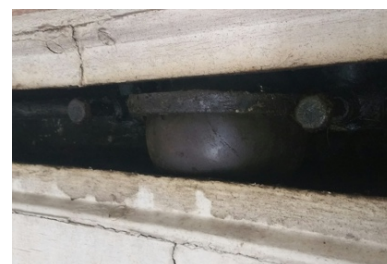
The telescope is in working condition for solar spot viewing though not kept clean. The woodwork of the dome is in need of repair in various places. The paint is peeling. The telescope itself was cleaned and overhauled in 2009.

*Fig 25: One of the cannon ball “bearings” of the dome.*
