# Defect detection in III-V multijunction solar cells using reverse-bias stress tests

## Abstract:

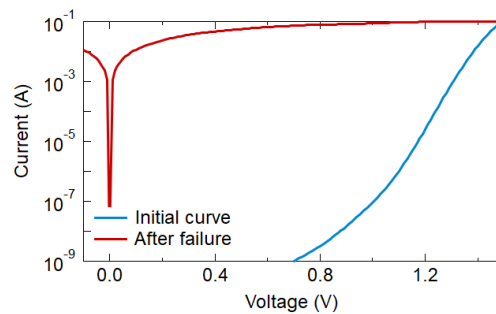
Most devices with a leaky initial I-V curve, i.e. with a low shunt resistance, show changes in the I-V curve after applying reverse voltages lower than required for failure, making it predictable. However, for some devices, especially those with a good initial I-V curve, no change is detected in the I-V curve until it catastrophically fails, and when failure occurs, the current increases abruptly. In the forward dark I-V curve measured afterwards, it can be seen how the shunt resistance also decreases abruptly, so much so that it could be considered that the device is practically short-circuited (see Fig. 5).

Fig. 5. Forward dark I-V curve measured before starting the reverse bias stress test and after the catastrophic failure of the device.

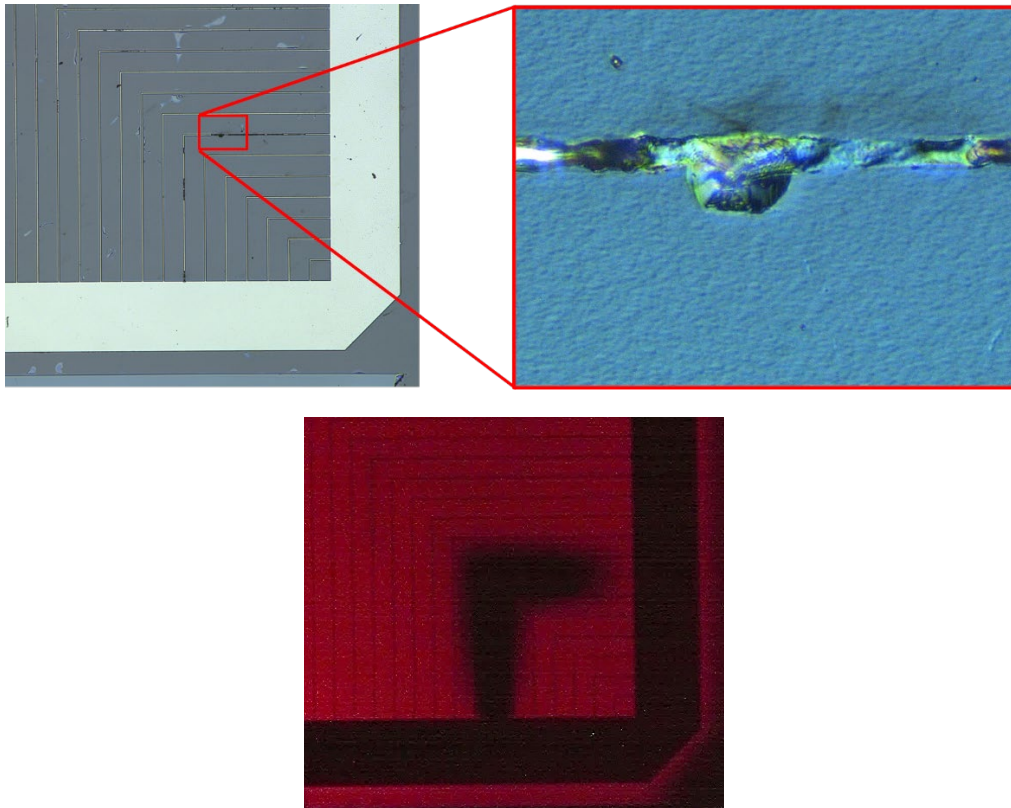
However, irrespective of the reverse voltage level at which the devices fail, after the failure, burnt and melted regions are observed right where a metal-covered defect is located. These burnt regions look different depending on whether the defect is located under a grid finger or a busbar. First, when the defect is under a finger, these regions appear along the entire finger (see Fig. 6), and not only on the defect. Thus, the failure of the device can be confirmed not only by measuring the forward I-V curve but also by doing EL mapping, in which the entire finger appears darkened (see Fig. 6), or by analysing it under the microscope.

Fig. 6. Appearance of burnt and melted metal regions in a finger after the catastrophic failure where there is a defect covered with metal (top image). The same finger completely shadowed in EL mapping (bottom image).

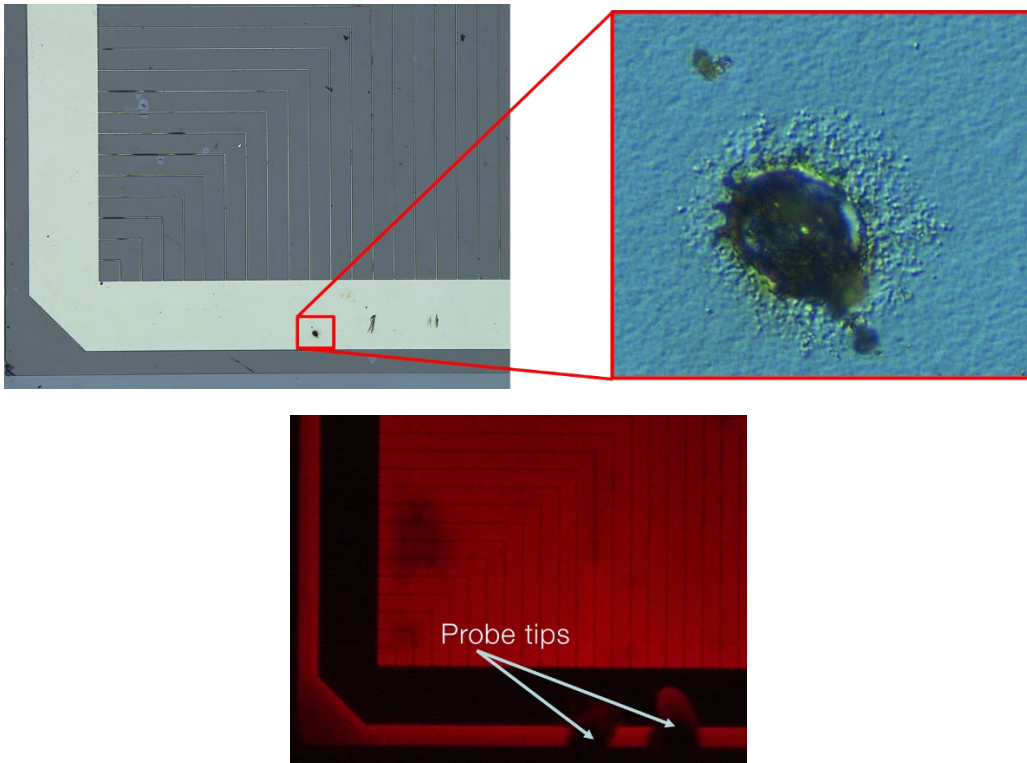
As shown in Fig. 7, if the defect is under the bus the failure mechanism is basically the same: when examined under the microscope, burnt and melted metal regions appear where there was a metal-covered hillock and, again, a forward dark I-V curve reveals a device which is almost short-circuited. However, in this case, as the bus covers and masks the defect, the failure cannot be detected by EL mapping (see Fig. 7).

Fig. 7. Appearance of burnt and melted metal regions in the bus after the catastrophic failure where there is a defect covered with metal (top image). No change can be observed by doing EL mapping as the bus is completely shadowing the defect (bottom image).

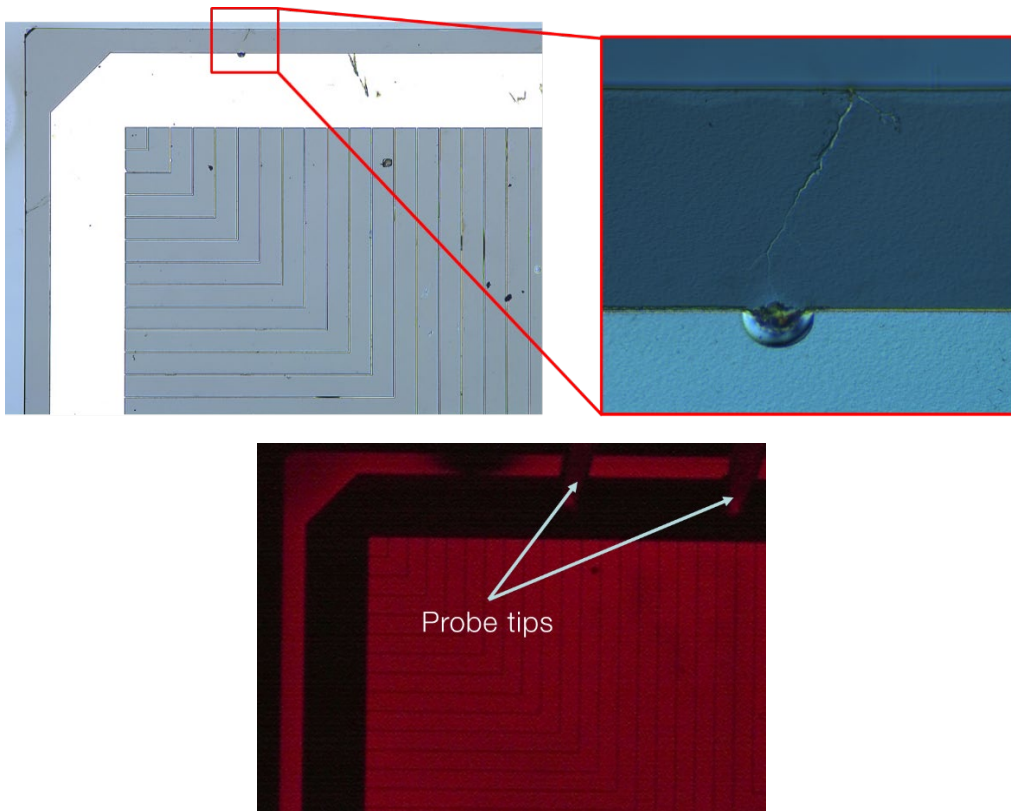
The devices that do not have growth defects covered with metal withstand reverse voltages up to the maximum -20 V tested, even those showing the same kind of hillock defects but located in the semiconductor area. These devices were subjected to higher reverse voltages up to -30 V. Eventually, these devices fail but the failure mechanism is not reverse breakdown, despite the reverse voltage used is close to or even higher than the theoretical breakdown voltage. Instead, dielectric breakdown is observed at some point of the edge of the device. An arc seems to appear between the bus and the edge of the devices causing a crack in the semiconductor and a burnt area in the bus (see Fig. 8). In this case, the failure can be located by looking at the EL measurement, where a black spot appears at the edge of the device in the vicinity of where the arc was formed (see Fig. 8). As in the previous cases, the electrical consequences of such failure are a sudden decrease of the shunt resistance, and therefore an almost short-circuited device.

Fig. 8. Appearance of burnt and melted metal regions in the bus and cracks in the semiconductor due to a dielectric breakdown (top image). Black spot observed in the edge of the device by doing EL mapping (bottom image).

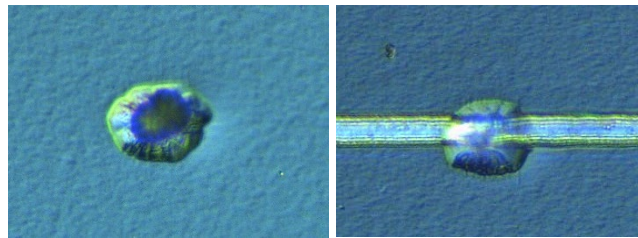
Fig. 9. Image under Nomarski microscope of a hillock without metal (left image) and partially covered with a metal grid finger (right image).

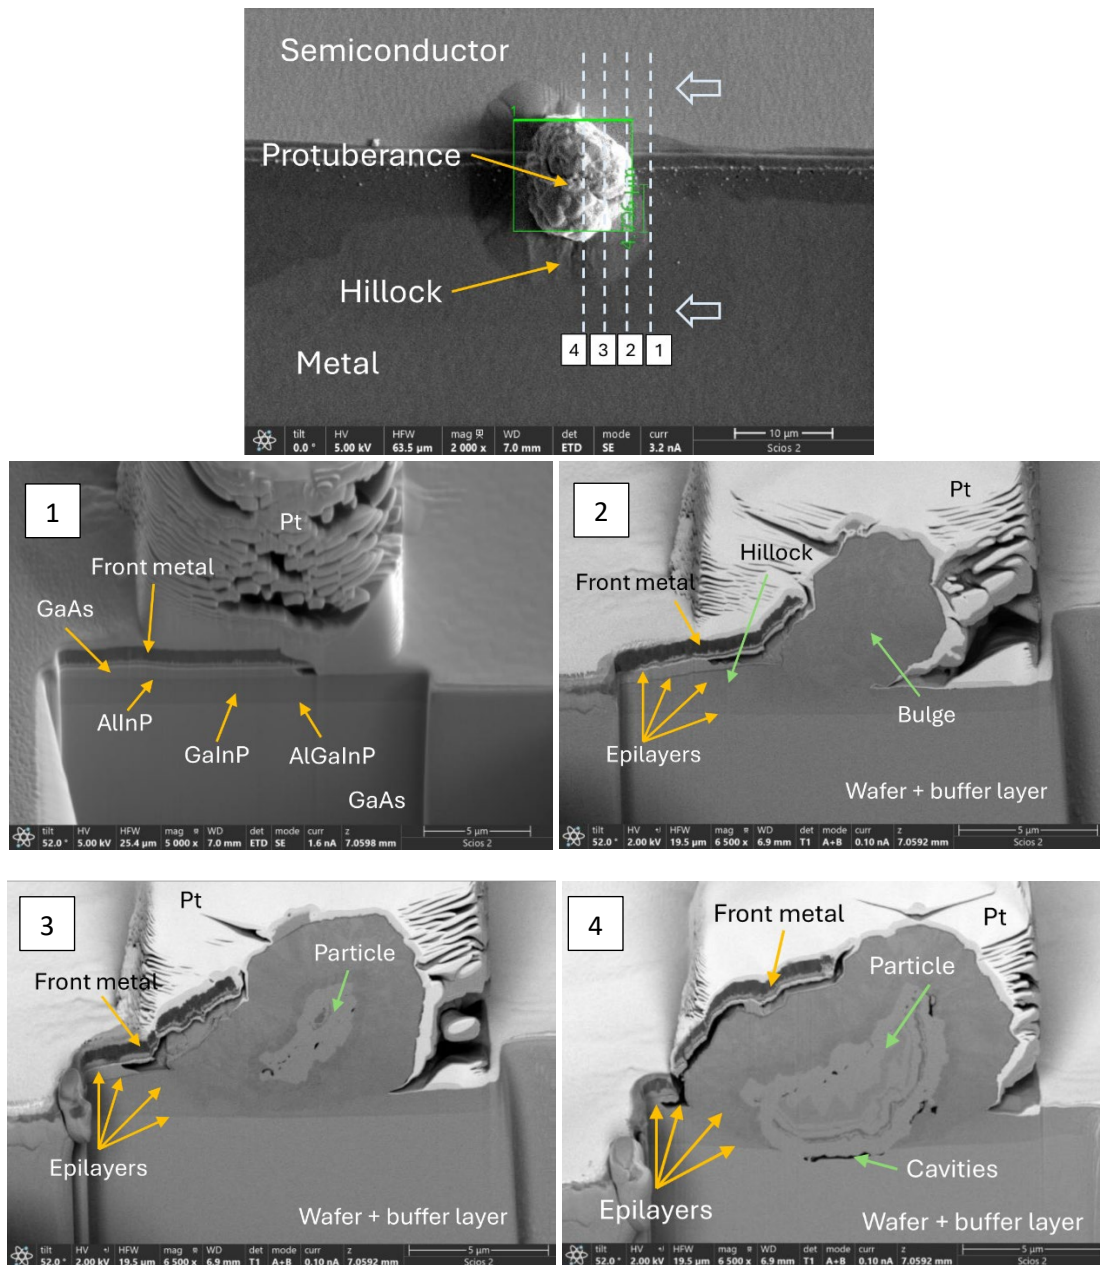
The first image in Fig. 10 shows how the semiconductor structure is not affected in the vicinity of the defect. As we get closer to the centre of the defect, a bulge, mainly composed of GaInP, appears, as it is depicted in the second image. The existence of the protrusion also affects the semiconductor structure in its vicinity, where a hillock is formed. Finally, in third and fourth images, a particle appears in the core of the defect. It can be seen that the bulge is formed by growth of material on the surface of this particle, and under the particle there are voids as the deposited material does not reach these areas. Moreover, the colours of the particle clearly reveal that its composition is mainly GaAs with traces of other materials. The composition of the particle has been studied by EDX analysis and is available in the supplemental “SEM and EDX study performed”. They show that the particle comprises the typical materials of a GaInP structure, indicating that it is originated by the formation of particles from the remaining of previous runs in the MOVPE reactor, as represented and detailed in Fig. 11. After detaching from somewhere in the reactor chamber and depositing in the GaAs wafer, the particle causes the formation of a cavities in the GaAs buffer layer and modifies the growth direction of the upper layers. This reveals higher index planes producing higher growth rates, which create a hillock in the surroundings of the particle. Moreover, the material being deposited also grows at the surface of the particle, with high growth rates, creating a bulge on it with a large thickness, compared to the thickness of the layers deposited on the wafer surface.

Fig. 10. SEM images of a defect partially covered with metal. Top and general view of the defect without platinum indicating the cutting planes of the cross-section images. (top image). Cross-section images from the outside to the inside of the defect (images numbered 1 to 4).

The morphology of the defects shown in Fig. 10 suggest the presence of leakage paths. The particle itself has p- and n-type layers, since it comes from previous depositions of materials with some doping. Also, during the growth of the semiconductor structure, as the upper layers adapt to the particle shape, areas with high mechanical stress and dislocations are formed. In addition, due to the non-uniformity of the GaInP layer thickness, there may be areas where the n-p junction is closer to the metal, and therefore more likely to cause a shunt as the applied reverse voltage increases.

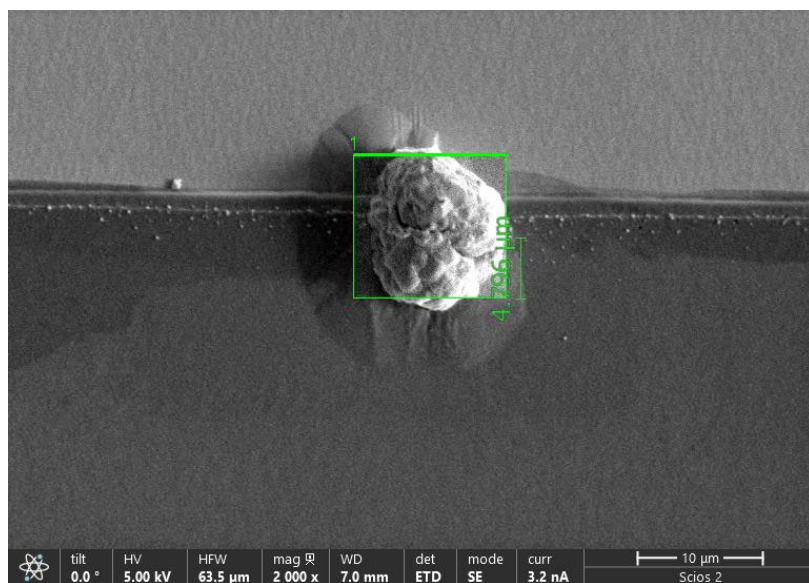
First, in Fig. 1 you can see a general top-view image of the analysed hillock growth defect. The defect is partially covered with metal (Pd/Ge/Ti/Pd/Al front metal grid). Then, in Fig. 2, the same defect is shown, but with platinum deposited to prevent the particle from detaching during the study.

Fig. 1. Top-view of the defect under study.

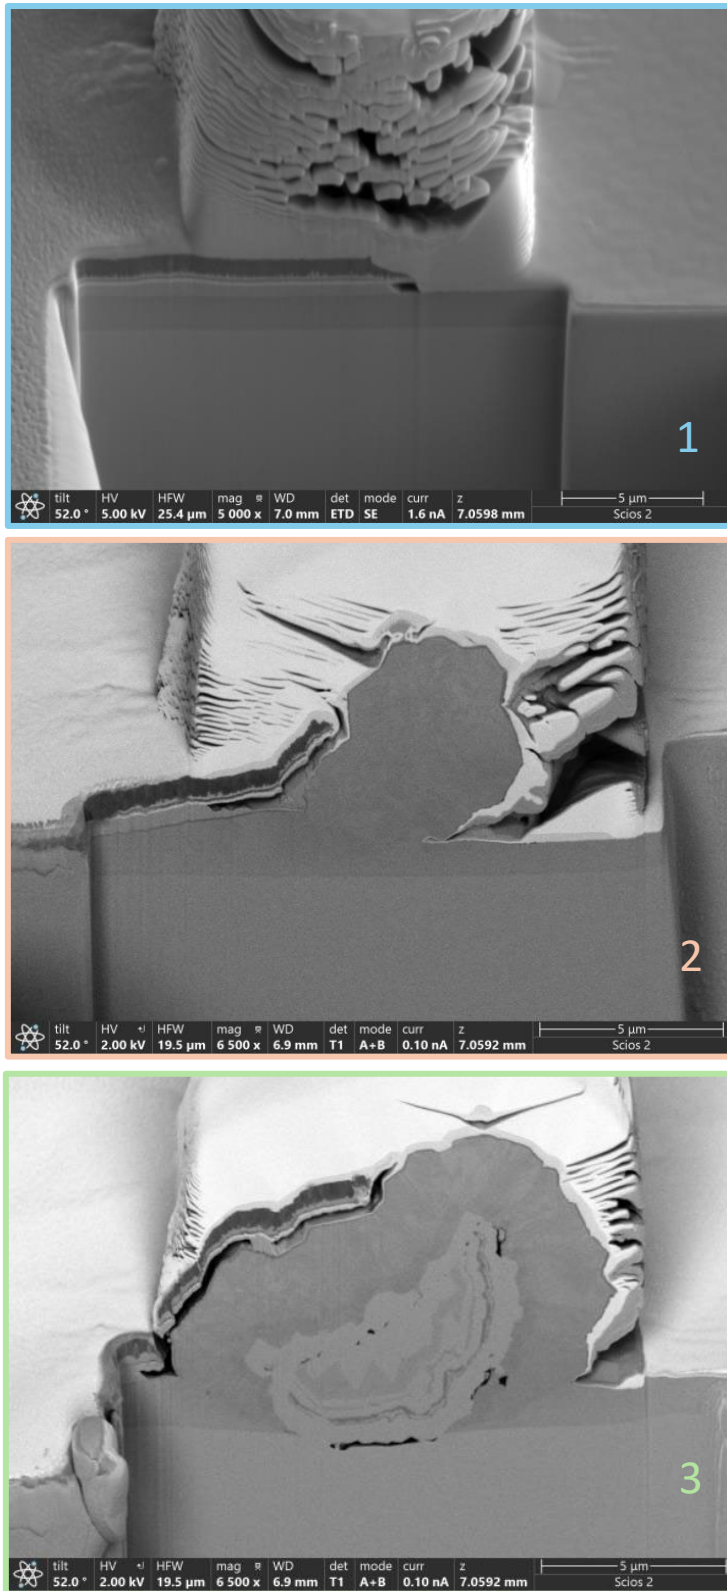
Fig. 4. SEM cross-section images from the edge towards the centre of the defect.

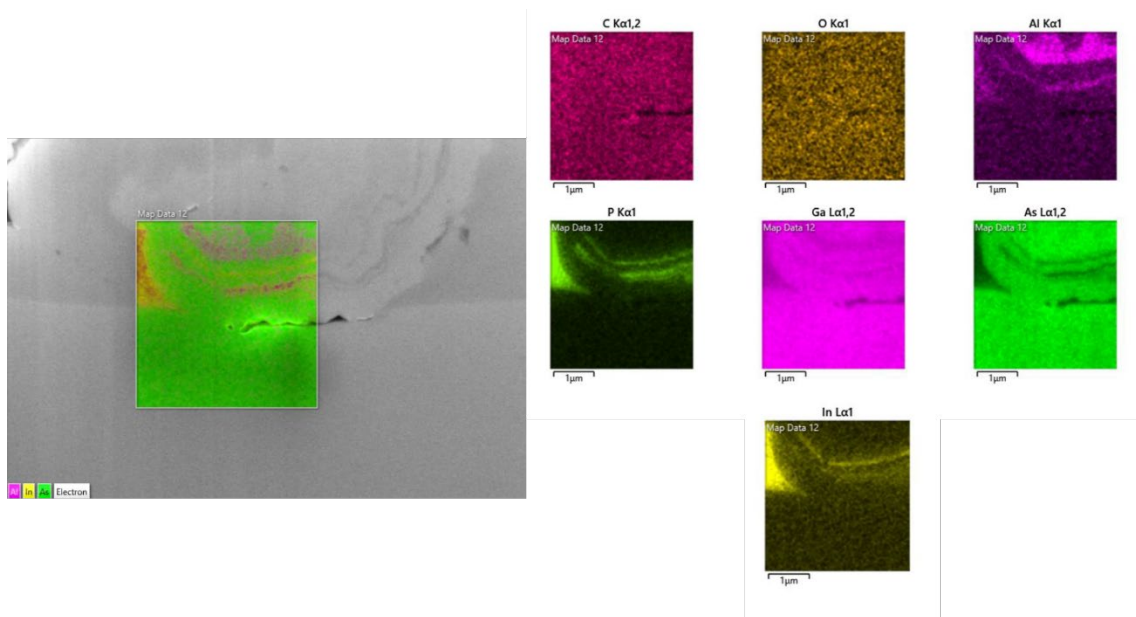
Finally, in Fig. 7, we can see that the particle causing the defect formation is composed mainly of gallium and arsenic. However, as can be seen in the SEM image, there are layers inside the particle of other materials, whose composition cannot be detected with EDX. That is why, new images are taken by zooming in on the particle, which are included in Fig. 8. As can be seen, the layers inside the particle present gallium, aluminium, phosphorus and indium signals. These materials correspond to the ones used in the GaInP, GaAs, AlGaInP and AlInP typical layers deposited during the growth of triple-junction solar cell structures in the reactor used.

Fig. 8. EDX maps taken to see the composition of the particle.
