Setups for eliminating static charge of the ATLAS18 strip sensors

KEYWORDS: Silicon strip sensors, Electrostatic charge, Recovery techniques

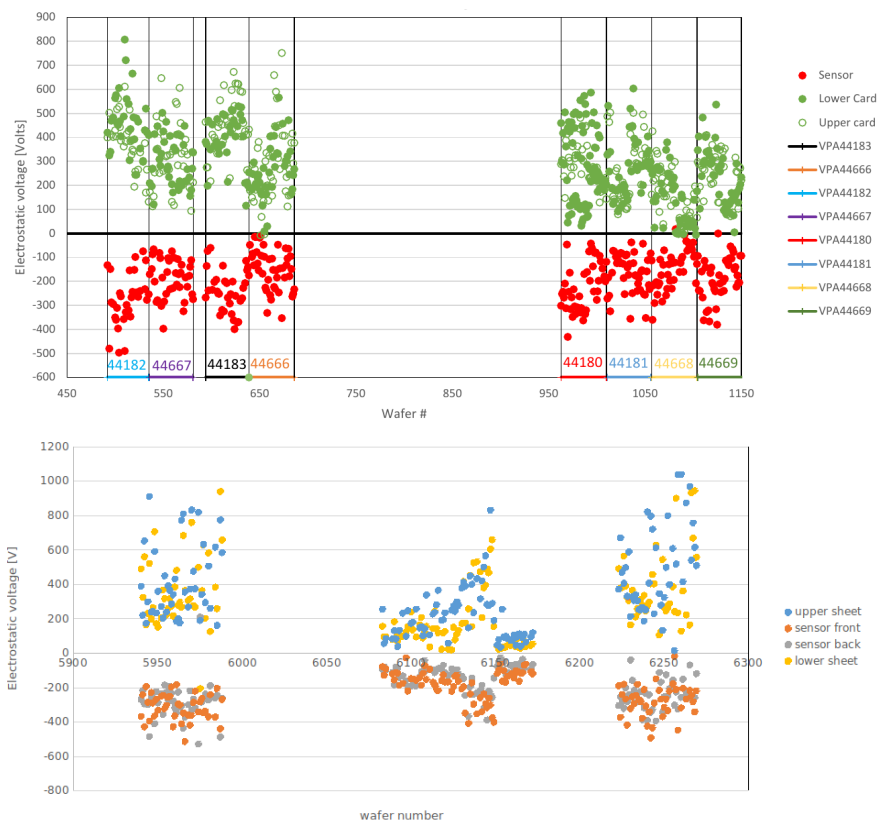
The QC sites have measured a significant electrostatic charge present on the surface of a considerable number of sensors and their plastic sheets, see Figure 1 for measurement in FZU. The plastic sheets are used to provide mechanical protection for the sensors within paper envelopes. The sensors themselves have a negative static charge, while the plastic sheets carry a positive charge. In both cases, the electrostatic charge can reach the values of several hundreds of volts per inch, see Figure 2.

The electrostatic charge, generated by various means, including the rubbing of plastic sheets against sensors within paper envelopes, facilitates the occurrence of "Local trapped charge" events. These events subsequently lead to failures in electrical QC tests at several QC sites.

Figure 2. Electrostatic charge measured on the surface of sensors and their sheets in FZU (top) and in QMUL (bottom).

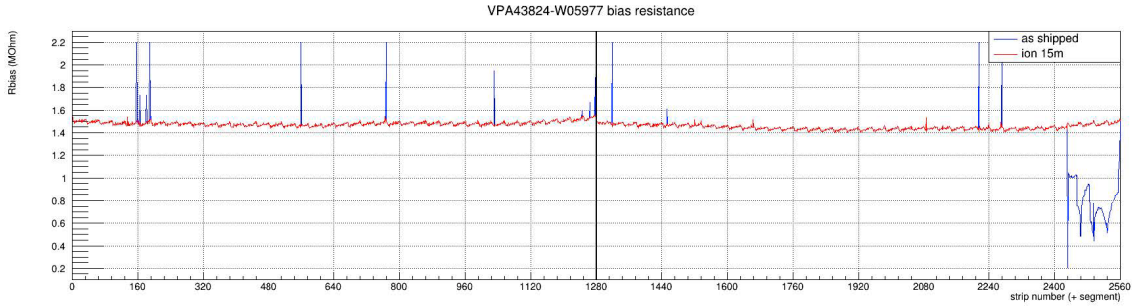
1. **IV measurements indicating early breakdown:** Sensors experience breakdown at low applied bias voltages, well below the required 500 V.
2. **Low interstrip isolation** in neighboring strips: Low interstrip isolation between neighboring strips: Areas of tens or hundreds of neighboring strips with a low resistance of polysilicon bias resistors were revealed by the Full strip tests, indicating low interstrip isolation in these regions [4].

Figure 5. The Full strip test performed on the sensor before and after the ion-blower treatment in QMUL. The resistance of the polysilicon bias resistor was measured on all strips of the sensor VPA43824-W05977. The area of 160 neighboring strips (around strip 2500) with low interstrip isolation was recovered by the ion blower treatment.

Application of the implemented recovery methods on the sensors affected by the "Local trapped charge" events is typically very effective. In some cases, several iterations are needed to fully recover the electrical characteristics of these sensors. The recovery of the low interstrip isolation by the intensive flow of ionized air is shown in Figure 5, while the application of the UV-A irradiation is illustrated in Figure 6. A significant increase in the breakdown voltage by the UV-A irradiation is represented by Figure 7.

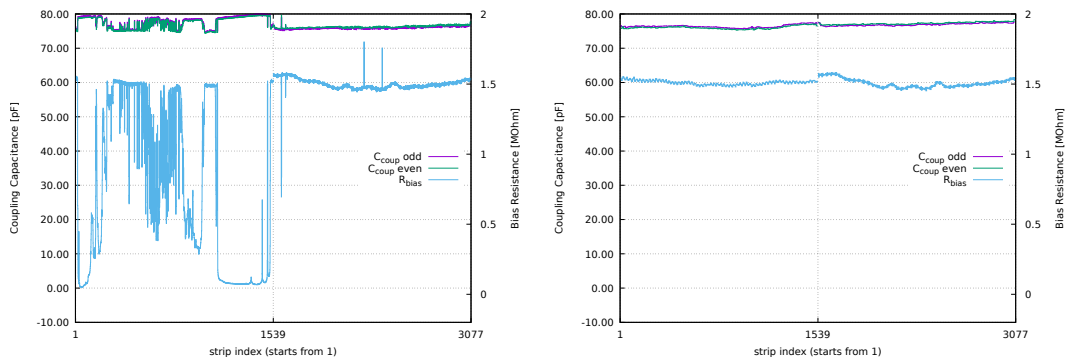
Figure 6. The Full strip test performed before (left) and after the UV-A treatment (right) in FZU. The resistance of the polysilicon bias resistor and coupling capacitance was measured on all strips of the sensor VPA38205-W00189. The area of ~ 1500 strips with low interstrip isolation was recovered.

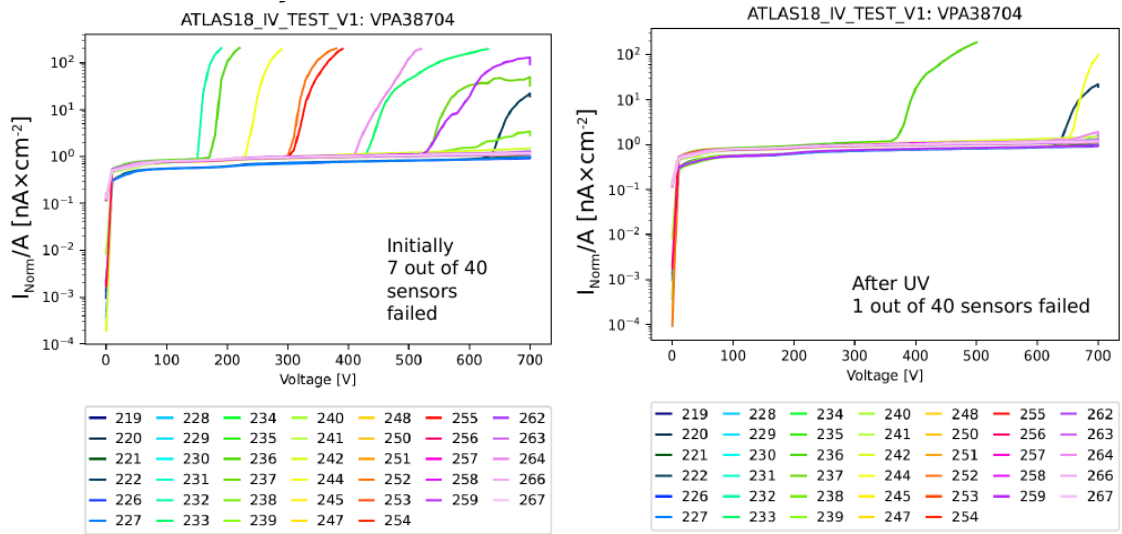
Figure 7. The IV measurements for the batch VPA38704 before and after the UV-A treatment in FZU. The current normalized to the surface of a sensor in the dependence of high voltage was measured for all sensors in the aforementioned batch. The majority of sensors with lower breakdown voltage were fully recovered.
