20th Anniversary "Trento" Workshop on Advanced Silicon Radiation Detectors 4–6 February 2025 FBK, Trento, Italy

Pixel column issue in the ATLAS Inner Tracker modules

ABSTRACT: Pixel modules are currently being built for the ATLAS ITk Pixel detector upgrade. During the preproduction phase, recurring chip malfunctioning was observed during electrical testing. It was possible to bypass this issue by disabling some pixel core columns in the ITkPix readout chip. Therefore the issue is called "core column issue" which is a direct disqualifier for a pixel module. A concerning number of cases has been observed in pixel modules with ITkPix v1.1 as well as v2 chips which significantly impacts the module yield. However, the behaviour is erratic and there is not any evidence hinting at the origin of this issue. These proceedings outline the investigations of the issue, highlighting the electrical behaviour during testing, present findings from the data collected via our production database and through visual inspection, and point towards possible causes of the issue.

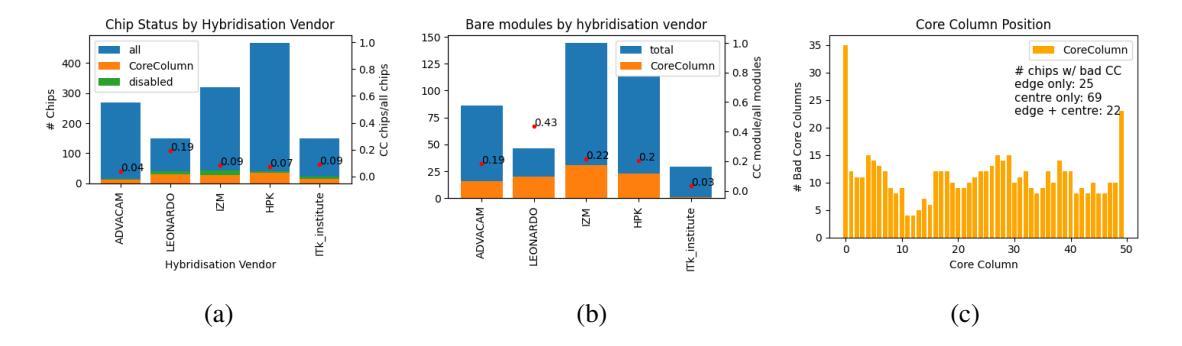
The largest amount of the data are from warm tests on v1.1 chips assembled in both quad and triplet modules, therefore they are used in the following investigations. Figure 3 shows fractions of chips (3a) or modules (3b) with CC issues, which are similar across all hybridisation vendors, showing that the issues are not associated with one vendor. The number of FE chips that are disabled in software during testing is also indicated in figure 3a. This could be due to either the user not associating errors with the core column issue, or other issues such as the chip is not wirebonded due to damage of the wirebond pads or wirebonding failure. Therefore, disabled chips are not included in the number of FE chips with CC.

Figure 3c shows the distribution of all disabled CCs for all hybridisation vendors. The distribution is uniform across FE chip except for the edges where an increase is seen. The increase in

Figure 3: Fraction of chips (a) and modules (b) with disabled core columns per hybridisation vendor. (c) positions of disabled CCs on all problematic chips.

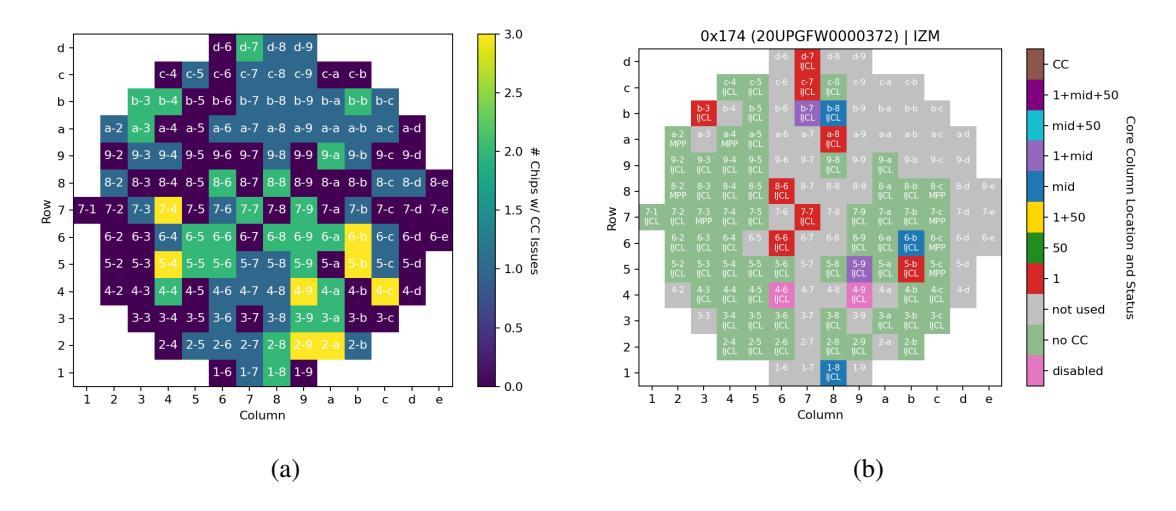
disabled edge columns is associated with one vendor. The position of chips on wafers were studied as shown in figure 4. While the cumulative map (figure 4a) does not show any preferencial position for CC chips, looking at individual wafer maps reveals that CC chips often cluster together in a row or in a column which could indicate problems with dicing or picking, like shown in figure 4b.

Figure 4: (a) Cumulative wafer map with occurence of CC chip position. (b) example wafer map where CC chips often appear in consecutive oder in a row or column. The z-scale indicate the location of disabled core columns on that chip.

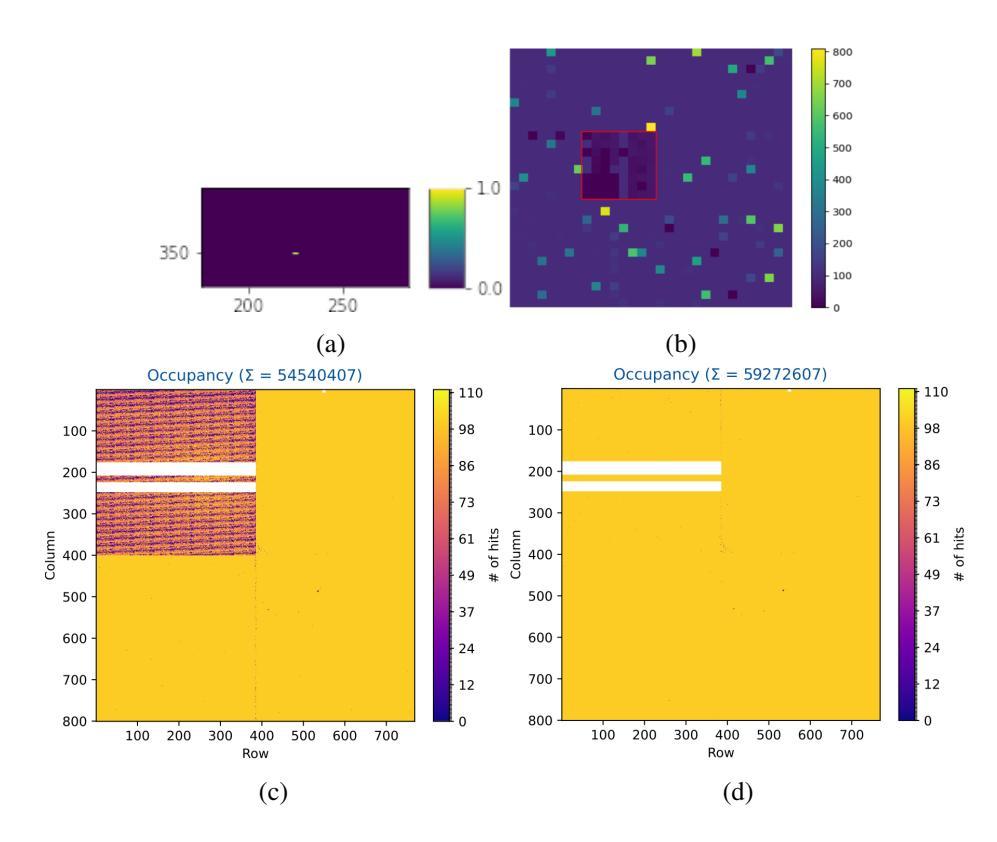
Very few CC cases can be potentially narrowed down to bad pixel regions $(4 \times 1 \text{ pixels})$ as shown in figure 5a or bad pixel cores $(8 \times 8 \text{ pixels})$ as shown in figure 5b. Once these smaller areas are disabled, the chip can function normally without disabling the CCs. This would drastically reduce the number of bad pixels overall on a chip compared to disabling entire core columns.

CC issue often shows inconsistent symptoms even within the same chip. One example is figure 5b, where the bad pixel core was hard to find. While the software diagnostics tool cannot find any bad CCs in this chip, the analog scan often fails, indicating CC issues. Only when sometimes an analog scan runs successfully, this bad pixel core can be seen in the occupancy map.

CC symptoms sometimes show dependencies on the analog settings, for example threshold or injection charge. Figure 5c shows a bad occupancy map of the chip with CC issue when the injected charge is 1650 e. The same chip behaves normally when the injected charge is 2600 e as shown in figure 5d.

Figure 5: (a) Map from a pixel test highlighting a bad 4×1 pixel region. (b) Occupancy map from an analog scan with a bad 8×8 pixel core with mostly 0 hits. (c) Occupancy map of a module at 1650 e injection charge. (d) Occupancy map of the same module at 2600 e injection charge.

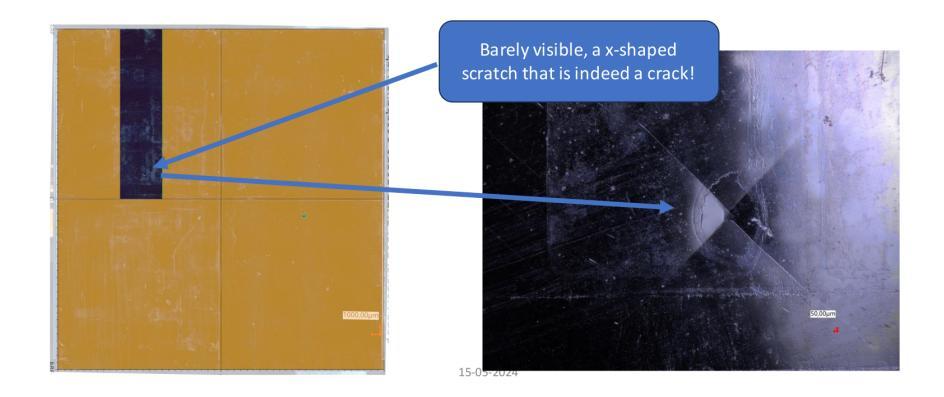
First hint The first confirmation of mechanical damage causing the CC issue was an accident in which two previously functional modules developed CC issues. On one module the CC issue was reproduced in a different chip by rotating the module by 180° in the same setup. Only under certain angle and with the correct lighting conditions, some cross or pyramid pattern was found on the back side of the FE chips, which could be a crack in the silicon as can be seen in figure 6. The location of this crack lies in the area of the disabled CCs on the chip. Investigations found the cause to be a bump from a solder splash of about 100 μ m size on the vacuum chuck used in that particular setup.

Figure 6: A quad module has developed core column issue. Careful visual inspection revealed a crack within the area of disabled core columns which came from a solder splash on the vacuum chuck.

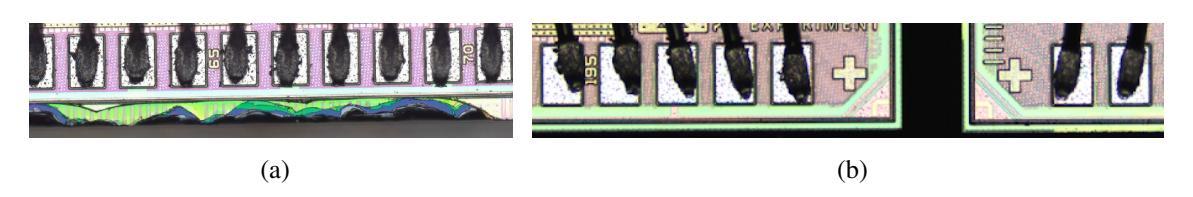
Visual inspection Visual inspection of many affected modules were done. While a few known chips with bad dicing edges, as shown in figure 7a, had core column issues, most CC modules collected for this campaign did not show any visible bad dicing as shown in figure 7b, or any damage on accessible part of the chip, e.g. the backside or around the wirebond pads. There was no clear correlation between modules with CC issue due to bad dicing. Bad CC issues can be associated with poor dicing, but poor dicing does not necessarily imply CC issue.

Figure 7: Different quality of dicing edges in v1.1 and v2 chips. Core column issues have been observed both on chips with bad (a) and good (b) dicing edges.

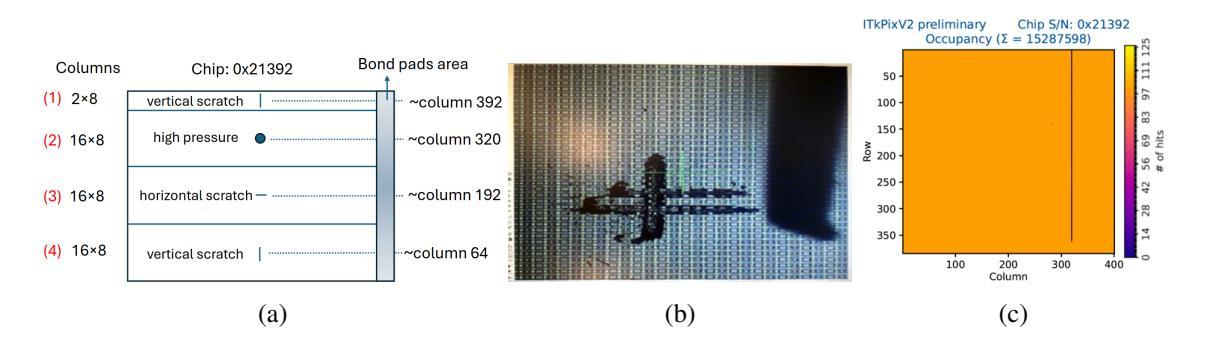
Induce surface damage From the diced single ITkPix v2 chips in section 3.1, mechanical damage was induced trying to provoke core column issue. Each chip is divided into several sections as shown in figure 8a. In each of the sections, a different scratch pattern with varying strength was induced via probe needles. An example of a scratch is shown in figure 8b. The chips were then

Figure 8: Destructive test on diced v2 chips by inducing different scratch patterns in different regions of a chip (a) and (b). The result was a chip with partially damaged double-column analog bias that is visible in an analog scan (c).

probed again to test for any induced damage. From the two scratched chips, one ended up dead, the other one suffered a damaged double-column analog bias from one of the scratches, as can be seen in an analog scan in figure 8c. This agrees with expectations as the power distribution of the chip happens in the top metal layers. However, core column issues were not induced by this scratching test.

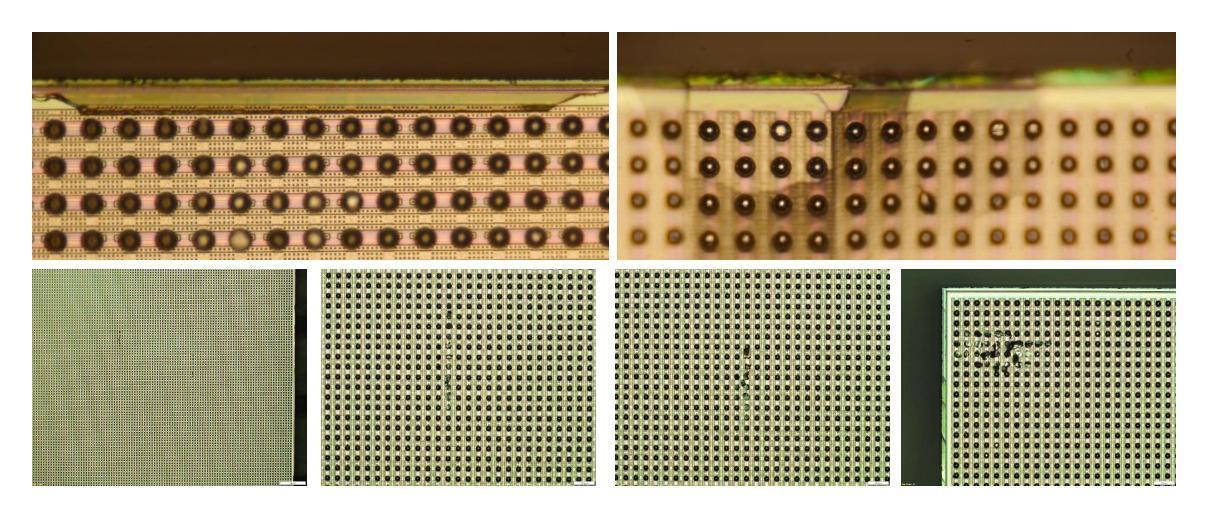
Figure 9: Top: damages of two vendor-rejected chips which exhibit core column issue. Bottom: defects of four vendor-rejected chips without core column issue.

magnification and tested on a probe station. Using the same software to test all these chips, the two chips with what looks like chipped edges as shown in the top row in figure 9 had CC issues while no core column issues were found on the other four chips with bump defects as shown in the bottom row in figure 9.

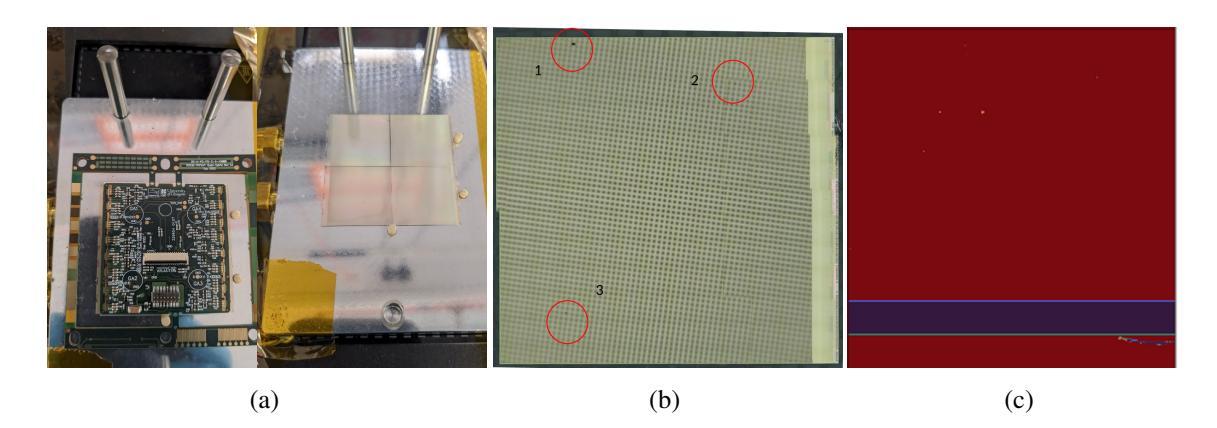
Destructive tests Two modules with CC issues from the same vendor were disassembled by heating up on a hotplate, shown in figure 10a, and using vacuum tools to pull apart the chips at the melted solder bumps. Three defects were found on one of the chips, shown as an example in figure 10b, where defect 1 and 3 are similar as can be seen in figure 11. The location of disabled CCs agrees with the location of defect 3. The appearence of the defect correlated with the CC issue on the second module is the same as defect 3. An energy-dispersive x-ray (EDX) measurement revealed that the extra material consists mostly of silicon, which may be due to some debris from dicing that got between the FE chip and the sensor during hybridisation.

Figure 10: (a) A module on a hotplate (left). After successful disassembly, four chips can be seen on the hotplate (right). (b) Defects found on one disassembled chip. Out of the three defects, the location of defect 3 agrees with the location of the disabled CCs in a scan (c).

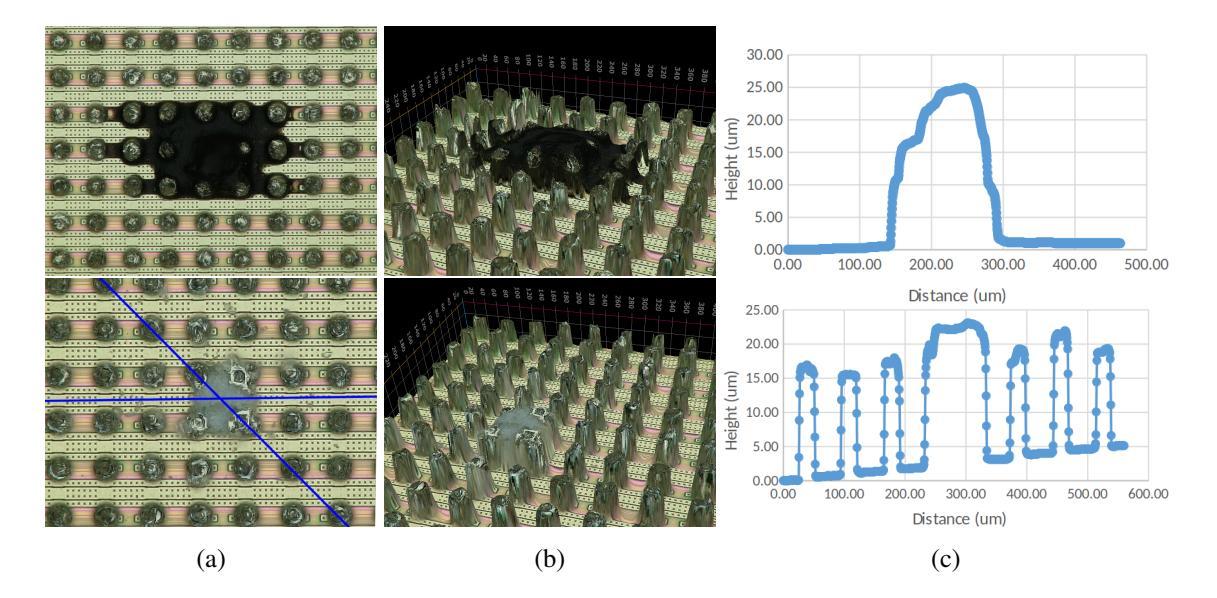
Figure 11: Top: defect 1 does not correspond to a disabled CC. Bottom: defect 3 is associated with a disabled CC (same appearance as on the second disassembled CC module). (a) birds-eye view of the defect. (b) 3D view of the defect. (c) measured dimensions of the defect.
