# EXPERIENCES WITH THE FERMILAB HINS 325 MHZ RFQ

R. C. Webber#, T. Khabiboulline, R. Madrak, G. Romanov, V. Scarpine, J. Steimel, D. Wildman  
FNAL\*, Batavia, IL 60510, U.S.A.

The Fermilab High Intensity Neutrino Source program has built and commissioned a pulsed 325 MHz RFQ. The RFQ has successfully accelerated a proton beam at the design RF power. Experiences encountered during RFQ conditioning, including the symptoms and cause of a run-away detuning problem, and the first beam results are reported.

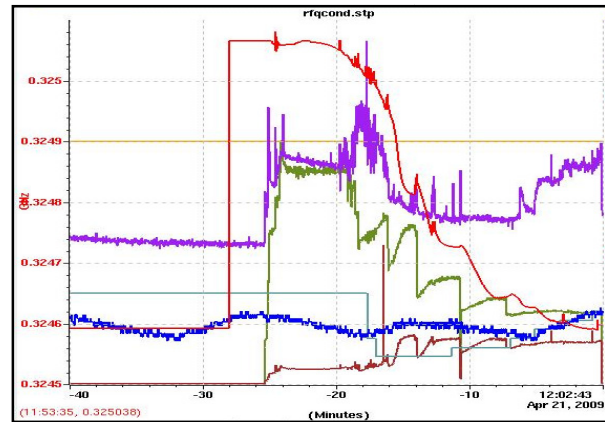
Figure 1 shows the course of a detuning cycle. The detuning could exceed several hundred kilohertz if RF power was reduced sufficiently to prevent vacuum

interlock trips. Once the severely detuned state was established, only tens of watts average RF power was necessary to maintain it. The effect was completely reversible; after twenty minutes without RF power, the RFQ returned to ‘normal’. The time-to-onset of the run-away condition correlated strongly with the average applied RF power.

Figure 1. RFQ frequency (red, 600 kHz span), peak power (green, 600 kW span), and pulse width (cyan, 4 ms span) vs. time (40 min span) at constant 2 Hz pulse rate

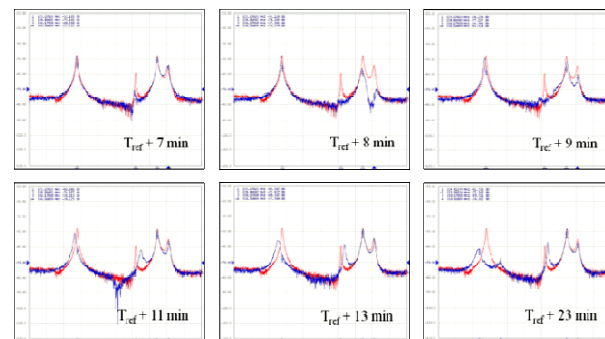
Figure 2 shows the mode spectrum of the RFQ changing dynamically during run-away. A parasitic mode moves lower in frequency over time, eventually splitting the desired 325 MHz accelerating mode (leftmost peak).

Figure 2. Network analyzer plot of ‘normal’ RFQ mode spectrum (red) and mode spectra (blue) as RFQ slips into run-away state. Scale is 10 dB/div and 11 MHz full span. T<sub>ref</sub> is time from RF turn-on at ambient temperature.

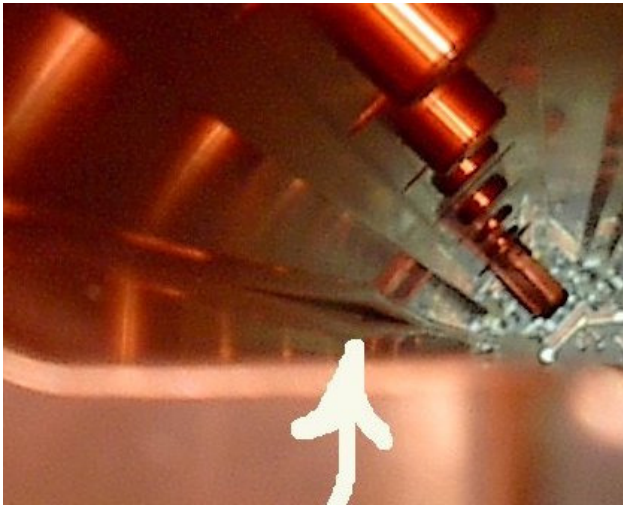
Figure 3. RFQ End-view and bulging RF c-seal responsible for run-away detuning

When the RFQ was opened for inspection, a C-seal, designed to serve as an RF current by-pass across the longitudinal joint between quadrants, was found dislocated from its groove. A 12-18 in. section at one joint, about 18 in. from the RFQ high-energy end, was bulging into the RF volume. It was discoloured from heat and sparking. Figure 3 shows the bad C-seal.

ACCSYS replaced both C-seals in the affected quadrant at their facility. Subsequently, the RFQ has been powered to well beyond the level previously sufficient to cause the run-away and the problem appears to be solved.

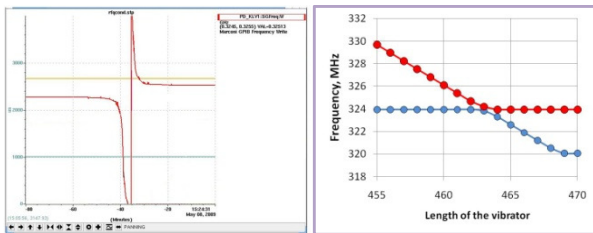
The bulging seal was added to the CST MicroWave Studio solid model of RFQ. Simulations indicated a parasitic mode corresponding to a resonator almost exactly  $\lambda/2$  at the RFQ operating frequency and strongly coupled to the desired quadrupole field. As the C-seal heats and bulges farther from the groove, the parasitic frequency moves ultimately crossing the quadrupole mode. The well-known mode-mixing picture in Figure 4 is the result.

Figure 4. Mode mixing in RFQ, experiment (left) and simulation (right)

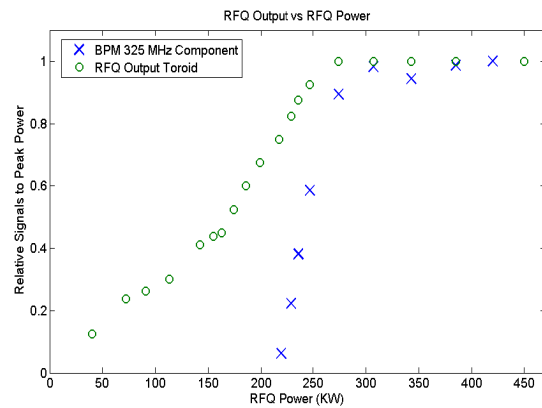
Figure 5. Relative transmission of total beam current (green circle) and bunched, accelerated beam current (blue x) through RFQ as function of RF power

The relative beam transmission through the RFQ was measured as a function of RF power. Downstream of the RFQ, signals were taken from the beam current transformer for a measure of total beam and from a BPM through a 325 MHz bandpass filter for a measure of the bunched, presumably accelerated, beam. Figure 5 shows the results. The acceleration knee is found to be just below 300 kW, near the 350 kW level expected from the design. Below that power level, the accelerated beam drops quickly to nothing at 210 kW. The total transmitted beam drops slowly and disappears only as the RF power approaches zero. This indicates that the RFQ serves as a

viable focusing and transport channel for non-accelerated particles.

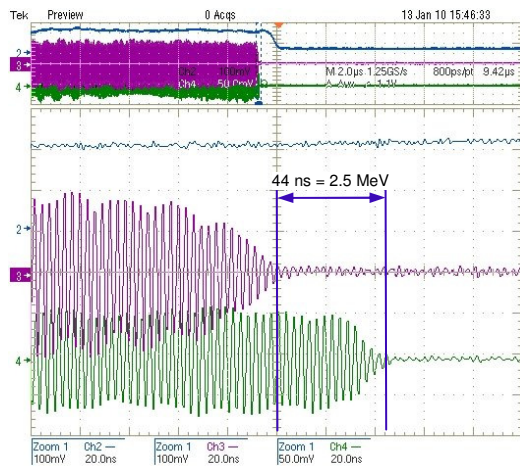
Two BPM pick-ups in the diagnostic line provided signals for a time-of-flight energy measurement. Figure 6 shows these signals. The BPMs are separated by 0.96 m. The corresponding transit time delay for 2.50 MeV protons is 43.96 ns with a sensitivity of 8.7 ps/keV or  $1^\circ/\text{keV}$  (325 MHz phase). The phase between the two signals could be determined with great accuracy; however, the integer number of RF cycles in the delay can be ambiguous without a sharp temporal edge on the beam. The most likely delay was determined to be 14 RF cycles + 940ps = 44.012 ns. This indicates the beam energy  $\sim 7$  keV less than the 2.50 MeV design.

Figure 6. Time of flight energy measurement (20 ns/div)
