PICO- AND NANOSECOND LASER ABLATION OF MIXED TUNGSTEN / ALUMINIUM FILMS

Keywords: ITER; First mirrors; Laser cleaning

Abstract

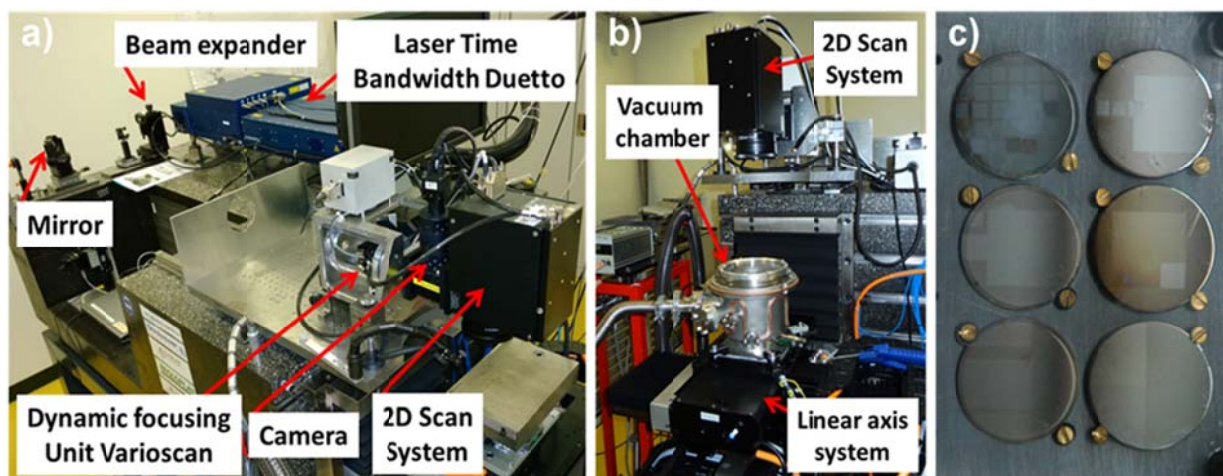
Fig. 1 (a, b) The setup, showing the vacuum chamber in position. Note that the exposures took place with the samples lying horizontally. (c) View of the samples inside the vacuum chamber through the quartz window, after the cleaning experiments. The cleaned patches are clearly visible on the mirrors.

Finally, two patches on the last sample were cleaned using nanosecond system at 532 and 350 nm,³ in order to make a comparison with those areas exposed using the picosecond system. The exposures using the picosecond system were done with the samples lying horizontally, while the exposures using the nanosecond system were done with the samples mounted vertically.

Fig. 1 (a, b) The setup, showing the vacuum chamber in position. Note that the exposures took place with the samples lying horizontally. (c) View of the samples inside the vacuum chamber through the quartz window, after the cleaning experiments. The cleaned patches are clearly visible on the mirrors.

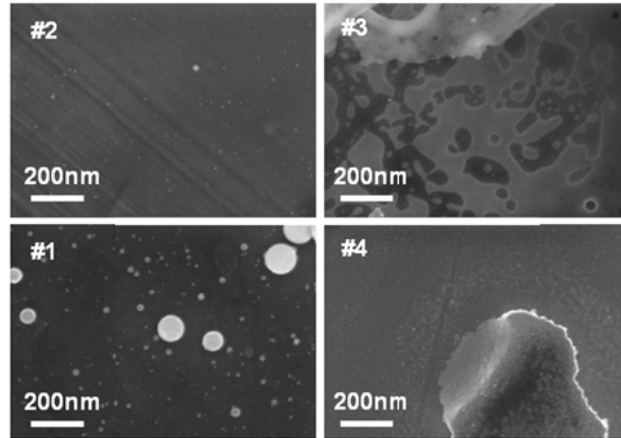
Fig. 2. Polycrystalline molybdenum mirror, the two patches on the right were cleaned using a nanosecond system. The patches on the left, the bottom one of which is particularly difficult to make out, were cleaned using the picosecond system. For each patches 10^3 pulses were used.

The results for all samples used in the experiment were very similar and to illustrate the results we will consider a polycrystalline molybdenum sample coated with aluminium and aluminium oxide, of which one half was cleaned with the picosecond and the other half with the nanosecond laser, see Fig. 2. Figure 3 shows SEM images corresponding to Fig. 2. The left two areas were cleaned using the picosecond laser. Area #2 was exposed to $0.13 \mu\text{J}/\text{pulse}$ and area #1 to $0.07 \mu\text{J}/\text{pulse}$ for 10^3 pulses. Dust may be seen in particular in area #1. The two images on the right are of areas that were cleaned using the nanosecond laser, area #3 being exposed at 532 nm and #4 at 350 nm. Most

Fig. 2. Polycrystalline molybdenum mirror, the two patches on the right were cleaned using the nanosecond system. The patches on the left, the bottom one of which is particularly difficult to make out, were cleaned using the picosecond system. For each patches 10^3 pulses were used.

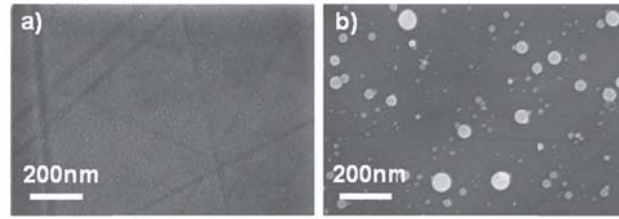
Fig. 3. Surface view SEM images, the numbers correspond to Fig. 2. Images were taken in the middle of each cleaned area.

Fig. 4. SEM images correspond to location #5 in Fig. 2. Area adjacent to a cleaned area, before (a) and after (b) cleaning with the picosecond laser, showing dust has spread from the cleaned area during the cleaning process.

of the film has disappeared from #4, though some patches are still left. The structure of the film remnant and the absence of small dust particles suggest that buckling was the removal mechanism. The SEM images in Fig. 4 correspond to location #5 in Fig. 2. They show an area adjacent to a cleaned area, before (a) and after (b) cleaning with the picosecond laser, showing dust has spread from the cleaned area during the cleaning process. X-ray energy dispersive spectrometry (EDS) measurements (not shown here) revealed that the dust consists mainly of aluminium, as might be expected. XPS measurements also show that the molybdenum core level was detected on the two patches cleaned with the nanosecond system, but not on two patches cleaned with the picosecond system. Also, the dust was firmly attached to the surface, remaining in place while handling the samples after the experiment. The reflectivity of each of the four patches before and after cleaning is compared to the reflectivity before coating in Fig. 5. The procedure that was used for measuring the reflectivity is described in detail in Ref. 16. Both patches cleaned with the picosecond system show a decrease of the reflectivity, attributable to dust formation, while those cleaned with the nanosecond laser both show a near complete recovery. Finally, Table I lists the atomic concentrations before and after cleaning as determined by XPS. The molybdenum core level was measured in the areas cleaned with the nanosecond system, showing the removal of the coating. Note that although no tungsten was measured by XPS on the surface after coating, it is found deeper inside the coating even if both magnetrons were used during the deposition. Another sample nicely illustrates the increasing oxidation of tungsten with an increasing number of exposures. Fig. 6 shows four XPS measurements of the W4f core level, taken after different numbers of exposures using the picosecond laser. Each spectrum has been normalized to one. It is quite likely that each laser pulse produced a

Fig. 3. Surface view SEM images, the numbers correspond to Fig. 2. Images were taken in the middle of each cleaned area.

Fig. 4. SEM images correspond to location #5 in Fig. 2. Area adjacent to a cleaned area, before (a) and after (b) cleaning with the picosecond laser, showing dust has spread from the cleaned area during the cleaning process.

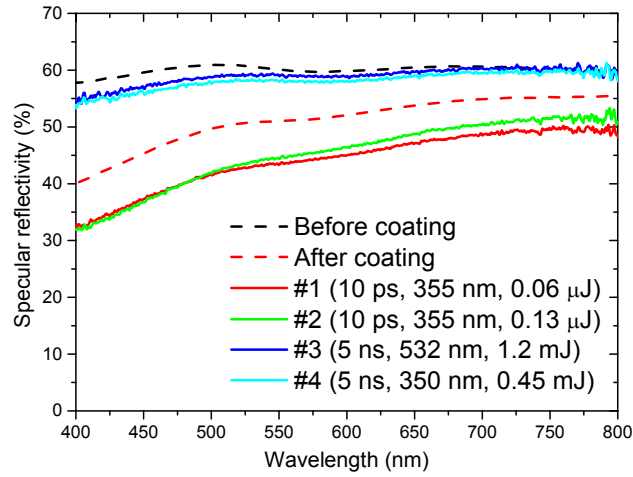
Fig. 5. Specular reflectivity of each patch before and after coating, and after cleaning. The two patches cleaned with the picosecond system show a reflectivity lower than that of the coating due to the dust remaining on the surface. The two patches cleaned using the nanosecond system show an improved reflectivity (colour online).

Fig. 5. Specular reflectivity of each patch before and after coating, and after cleaning. The two patches cleaned with the picosecond system show a reflectivity lower than that of the coating due to the dust remaining on the surface. The two patches cleaned using the nanosecond system show an improved reflectivity (colour online).

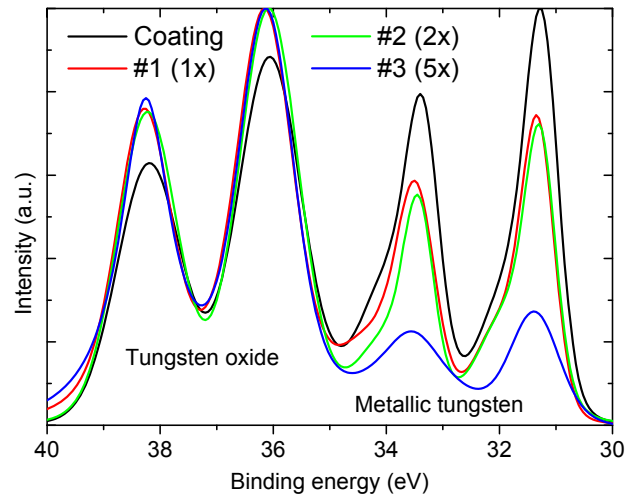
Fig. 6. W4f core level XPS spectrum, measured on the coating and three cleaned areas with an increasing number of exposures with the picosecond system. The increase of the oxidized component relative to the metallic component is evident (colour online).

short temperature rise and hence the oxidation process. The concentration of tungsten oxide relative to metallic tungsten increased with the number of exposures.

Fig. 6. W4f core level XPS spectrum, measured on the coating and three cleaned areas with an increasing number of exposures with the picosecond system. The increase of the oxidized component relative to the metallic component is evident (colour online).

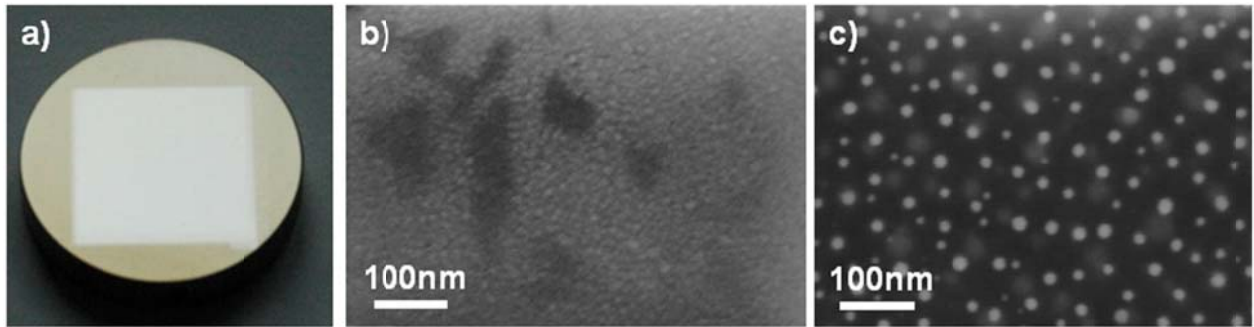
Fig. 7. a) PcMo mirror that was coated and cleaned twice. The two SEM images are of the coating (b) and the cleaned area (c).

As a final example of nanosecond cleaning we shall briefly consider a polycrystalline molybdenum mirror that was coated and cleaned using successive exposures at 532 and 230 nm, a technique that was shown to enhance dust removal in Ref. 3. The pulse

Fig. 7. (a) PcMo mirror that was coated and cleaned twice. The two SEM images are of the coating (b) and the cleaned area (c).

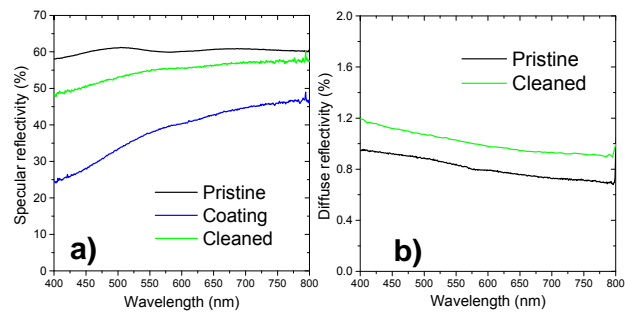
Fig. 8. Specular (a) and diffuse (b) reflectivity after two coating/cleaning cycles.

energy was 1 mJ/pulse for 1000 pulses. The speed depends on the spot size of the beam and the desired overlap between consecutive pulses, taking into account that the laser fires at 20 Hz. The spot size of the beam chosen was 300 μm , with an overlap of 250 μm , meaning that the sample travelled 50 μm every 50 ms, i.e. with 1 mm per second. The overlap exists for both the x- and y-direction, so that in this case the sample moved by 50 μm in the y-direction after each scan line in the x-direction. The dimension of the cleaned area was 17 \times 17 mm, resulting in a total time of about 1.5 h per cleaning cycle. After the second cleaning the complete process was repeated to simulate cycles of coating and cleaning. The applied coating consisted of an Al/Al oxide/W mixture with an Al/W ratio of 9:1 and an estimated total thickness of the order of 30 nm. The sample is shown in Fig. 7. The specular and diffuse reflectivities are shown in Fig. 8, showing a substantial recovery of the reflectivity (a) and a negligible increase of the diffuse reflectivity (b).

Fig. 8. Specular (a) and diffuse (b) reflectivity after two coating/cleaning cycles.
