# Multiaxial Fatigue Behaviour of A356-T6

M. Roy<sup>a,\*</sup>, Y. Nadot<sup>b</sup>, D. M. Maijer<sup>a</sup>, G. Benoit<sup>b</sup>

Aluminum alloy A356-T6 was subjected to fully reversed cyclic loading under tension, torsion and combined loading. Results indicate that endurance limits are governed by maximum principal stress. Fractography demonstrates long shear mode III propagation with multiple initiation sites under torsion. Under other loadings, fracture surfaces show unique initiation sites coincidental to defects and mode I crack propagation. Using the replica technique, it has been shown that the initiation life is negligible for fatigue lives close to  $10^6$  cycles for combined loading. The natural crack growth rate has also been shown to be comparable to long cracks in similar materials.

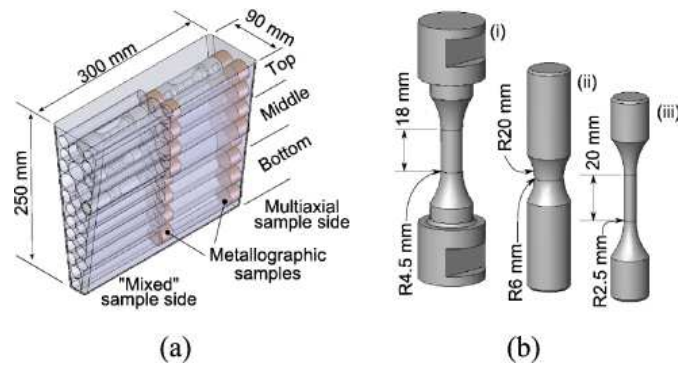
Figure 1: Wedge casting dimensions and specimen locations (a) and (b) the different types of fatigue specimens employed: tension-torsion (i), torsion (ii) and tension (iii) type.

The motivation for using a wedge-shaped casting (Fig 1a) was to create a cooling rate gradient during solidification that varied with height in the casting. A more refined microstructure was expected at the base of the casting where the cooling rate was the highest and a coarser microstructure occurred at the top where the cooling rate was the lowest. One half of the wedge was sectioned to produce tension-torsion fatigue specimens, while the other half was used to produce a mixture of solid tension, torsion and tension-torsion fatigue specimens (Fig 1b). Solid specimens were employed as opposed to tubular specimens in order to retain sampling within specific microstructural regions of the wedge. Metallographic specimens were taken such that there was at least two samples per height where fatigue specimens were cut in the wedge (Fig 1a). Additional tension-torsion fatigue and metallographic specimens were sectioned from the spokes of a Low Pressure Die Cast (LPDC) automotive wheel. All specimens were subjected to a T6 heat treatment: solutionized at 538°C for 3 hours, quenched in

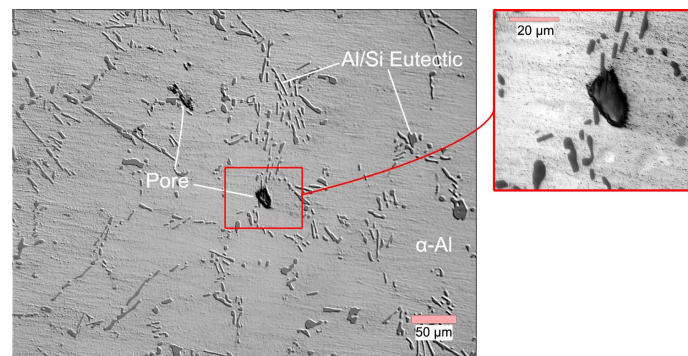
Figure 2: Typical A356-T6 microstructure showing  $\alpha$ -Al, Al-Si eutectic phases and porosity.

Aluminum alloy A356 has an as-cast microstructure consisting of a primary dendritic structure,  $\alpha$ -Al, filled with Al-Si eutectic phases. As the cooling rates decrease and solidification time increases, the dendritic structure coarsens resulting in larger secondary dendrite arm spacings. The T6 heat treatment serves to modify and refine the Al-Si eutectic structure. Depending on the casting conditions, the as-cast material may contain a variety of defects include gas and shrinkage porosity, and/or oxides which remain after heat treatment. Fig 2 shows optical micrographs of the typical microstructure. Metallographic analysis did not present any evidence of Fe-rich intermetallic phases known to affect fatigue properties.

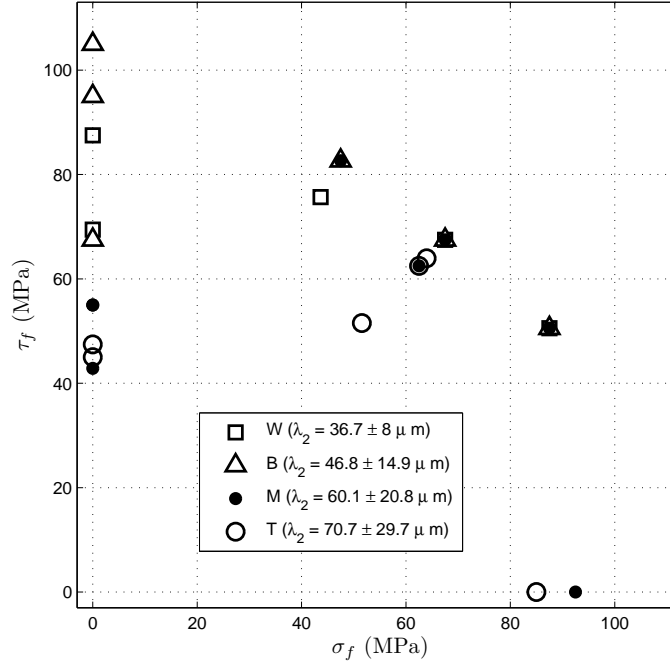
Figure 3: Fatigue limit grouped by material family type.

Grouped according to family, Fig 3 depicts  $\sigma_f$  versus  $\tau_f$  for each specimen. Following the trend of

decreasing  $\lambda_2$  from top to bottom of the wedge, the general trend is that specimens with the largest  $\lambda_2$  exhibit the lowest fatigue limit. The exception was specimens extracted from the wheel, which showed a lower fatigue limit than the wedge material at a tension/torsion ratio slightly below pure torsion. However, this difference is less than the range of results shown by the pure torsion testing of the wheel specimens. Fig 4 depicts  $\sigma_a$  versus  $\tau_a$  for all of the loading scenarios (Table 3) independent of family type. Considering the maximum fatigue limit for the entire experimental data set independent of specimen type and microstructure,  $\sigma_f$  and  $\tau_f$  for  $R = -1$  are approximately equidistant from the

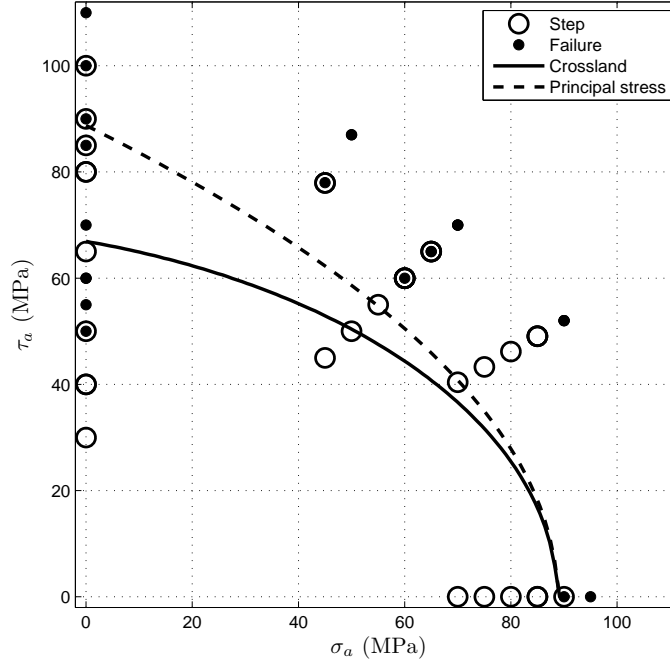
Figure 4: Fatigue test points compared to Crossland and Maximum Principal Stress criteria.

These two criteria are plotted versus  $\sigma_a$  and  $\tau_a$  in Fig 4. Both the Crossland and the MPS criteria underestimate the measured fatigue limit for combined loading. It should be noted that the Crossland criteria approaches the MPS criteria under tension. As a result, the variance in the pure torsion results may show that the Crossland criteria applied to these results is overly conservative. Since the Crossland criterion is reliant on the determination of an accurate fatigue limit under pure torsion, the MPS criteria is the most conservative criteria to describe these results [1, 15].

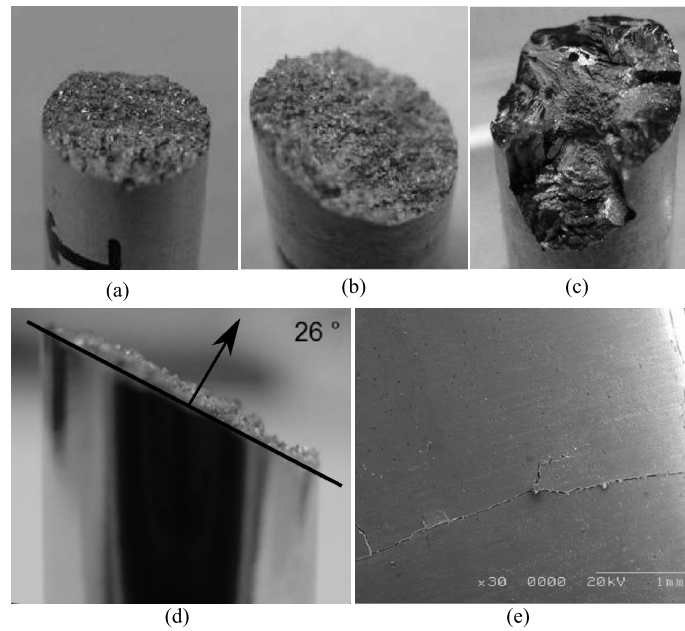
Figure 5: Failure types: (a) pure tension (b) combined tension-torsion ( $\sigma_a = \tau_a$ ) (c) pure torsion (d) Macroscopic crack plane orientation combined tension-torsion ( $\sigma_a = \tau_a$ ) (e) shear crack on the gauge section of the torsion sample far from the fracture surface.

A representative summary of the fracture surfaces formed for each type of loading is presented in Fig 5. Under pure tension (Fig 5a), the fracture plane was found to be always normal to the direction of applied stress and thus, coincident with the maximum principal stress ( $\sigma_{1_{\max}}$ ) plane. Specimens from both the wheel and wedge casting exhibited this behaviour indicating that this observation is

Under combined tension-torsion loading, the fracture surface features are similar to pure tension including regular fracture planes with no bifurcation (Fig 5b) regardless of the sample location. SEM observation of the gage section far from the fracture surface reveals only small secondary cracks less than 50  $\mu\text{m}$  long. The orientation of the fracture surface in Fig 5d is shown by the fracture surface normal. In this combined loading case where  $\sigma_a = \tau_a$ , the fracture surface normal is oriented  $26^\circ$  from the axis of the specimen. With the maximum principal stress acting at  $31^\circ$  from the specimen axis, the fracture surface normal is close to being parallel. This difference of  $5^\circ$  is the largest discrepancy observed over the 18 multiaxial specimens tested. Thus, the orientation of the macroscopic fracture plane under combined loading conditions correlates to the loading condition and more specifically, to the direction of the maximum principal stress ( $\sigma_{1\text{max}}$ ). Therefore, the tension component of the loading must play a major role in deciding the path of crack propagation.

that of pure tension and combined tension-torsion loading. Fig 5c is an example of the fracture surfaces observed. The tortuous fracture surface has two major crack planes activated: one aligned with the axis of the specimen and the other one perpendicular to this axis. This highlights the difficulty in finding a unique initiation site on the fracture surface. Macroscopic observations confirmed by SEM analysis indicate that there are many different initiation sites over the periphery of the gage section and that different crack planes link together to form the final fracture surface.

The fracture surfaces of the samples tested in pure torsion were much more difficult to analyze than the pure tension samples. As shown in Fig 5c, the macroscopic topology of the surface is very complex with two perpendicular mode III cracks activated and multiple initiation sites. Initiation is spatially distributed and as a result, the fracture surface is a combination of different cracks that have coalesced to cause final failure of the sample. Thus, it was difficult to identify a single initiating feature. However, when the fracture surface was less tortuous, there were features that could be analyzed (Fig 6f). For these samples, it was non-trivial to separate the fatigue zone from final failure zone. Fig 6f shows two features that are presumed fatigue initiation sites. The feature closest to the center of the specimen is clearly shrinkage porosity with an equivalent diameter of 265  $\mu\text{m}$ , located well away from the surface. The second feature is possibly an oxide film, but the features have been

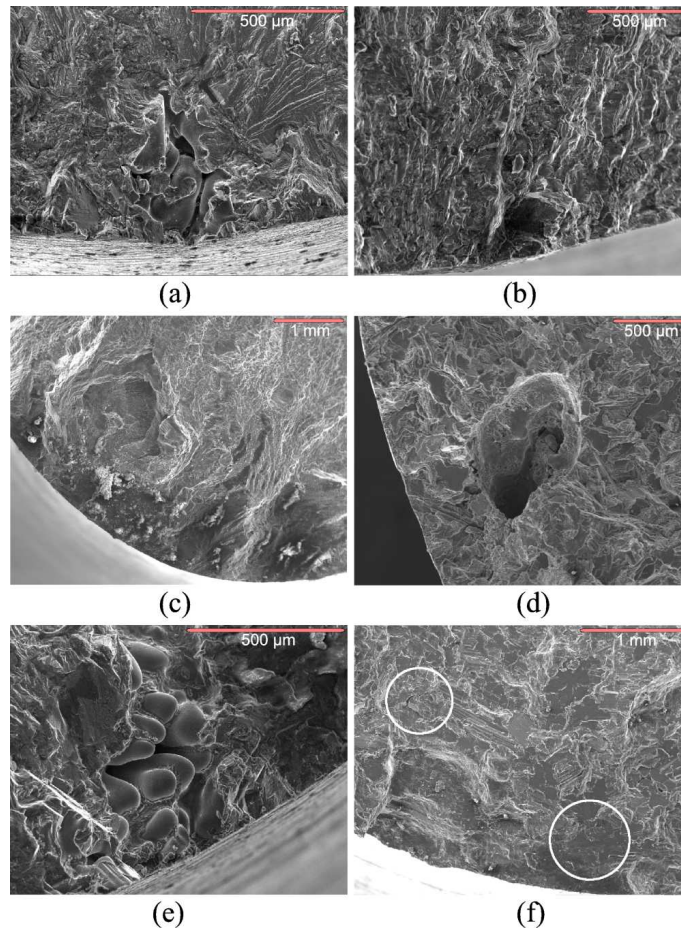
Figure 6: Fracture surfaces: (a) specimen T5,  $\sigma_f = 85$  MPa (b) specimen B3,  $\sigma_f = \tau_f = 68$  MPa (c) specimen W5,  $\sigma_f = \tau_f = 68$  MPa (d) specimen M4,  $\sigma_f = \tau_f = 63$  MPa (e) specimen T4,  $\sigma_f = \tau_f = 51$  MPa (f) specimen T7,  $\tau_f = 45$  MPa.

Due to the readily available tensile fatigue data for A356-T6, only two specimens were tested under these conditions. Each of these specimens exhibited a gas or shrinkage pore as the initiation site for the fatal crack. The first, M3 (Table 3), had a fatigue limit of 90 MPa and contained a gas pore with an equivalent diameter of 88  $\mu\text{m}$  at the initiation site. The other specimen, T5, had a shrinkage pore with an equivalent diameter of 370  $\mu\text{m}$  (Fig 6a) at the initiation site and exhibited a fatigue limit of 85 MPa.

Similar to pure tension, the combined tension-torsion samples exhibited fracture surfaces that were easily characterized. Figs 6b-e are examples of typical defects that initiated the fatal crack. Fig

6b shows the fracture surface of sample B3 that had a  $\sigma_f$  of 68 MPa. The initiation area on this specimen was readily identified, but a root initiating defect could not be found. Fig 6c is the fracture surface for sample W5, which had the same fatigue limit as B3. The fracture surface is less clear but it was possible to identify the initiation area where no clear defects were observed. The fracture surface instead shows friction-generated oxide associated with crack propagation. Fig 6d reveals a 500  $\mu\text{m}$  subsurface pore just below the surface of specimen M4. Remarkably, the fatigue limit for M5 was 63 MPa, which is close to the highest value observed. This may be caused by the root defect location relative to the surface of the sample. When a propagating crack does not intersect the sample surface, it is not under ambient environmental conditions, but under vacuum instead. This effect has been investigated in a cast Al-Si-Cu alloy [19] where the fatigue life under vacuum when a surface defect is present is the same as when failure initiates from an internal defect of the same size. These observations have also been confirmed with nodular cast iron [20]. Therefore, a fatigue assessment of cast A356 should account for the position of the defect with respect to the free surface as there is different damage accumulation dependant on whether the defect lies on the surface or within the bulk. Fig 6e shows a typical shrinkage pore at the surface of specimen T4. In this case, a 500  $\mu\text{m}$  pore decreased the  $\sigma_f$  to 51 MPa. This result suggests that the surface shrinkage pore is more detrimental to the fatigue life than the previous subsurface pore of the same size. However, the environmental effect is not the only factor in this case because the morphology of the defects are different.

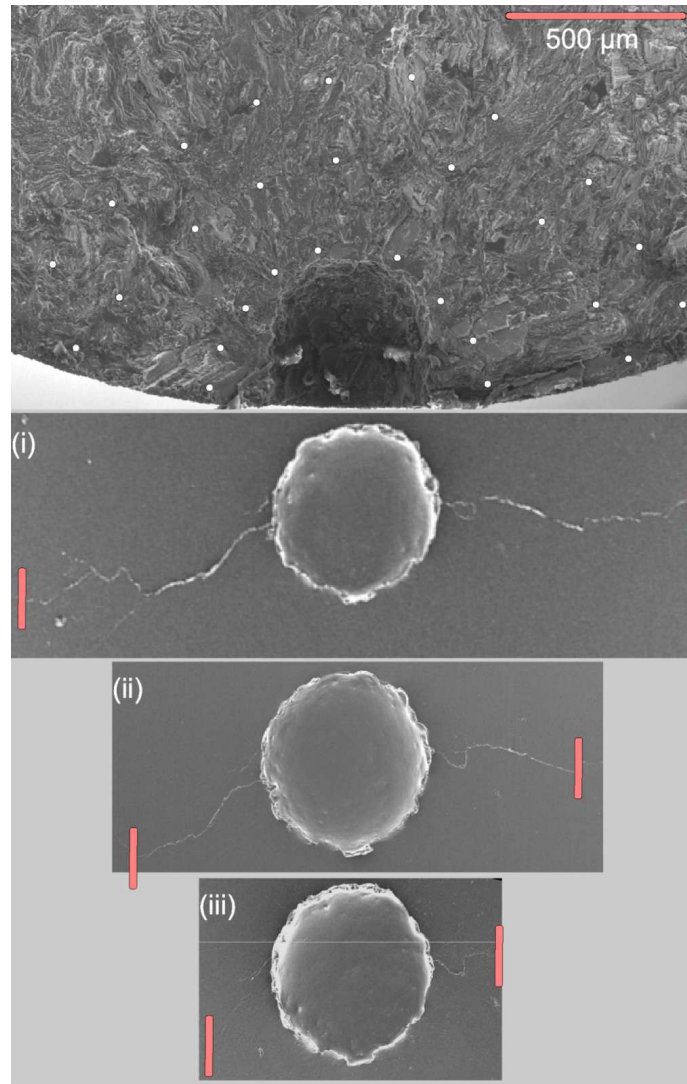
Figure 7: Tensile specimen with a 416  $\mu\text{m}$  artificial defect,  $\sigma_a = 90$  MPa and  $N_f = 6.73 \times 10^5$  cycles. The top image is the fracture surface with crack front marking compared to surface replica at (i)  $N = 3 \times 10^5$ , (ii)  $N = 2.25 \times 10^5$  and (iii)  $N = 1.50 \times 10^5$  cycles. Replicas are oriented normal to the loading direction.

The resulting fatigue life of this sample, 673 000 cycles, indicates that the defect had an influence on the fatigue limit. The artificial defect is easily identifiable as the origin of failure on the fracture surface shown in Fig 7. The replica results in Fig 7 show the crack along the surface of the sample at 150 000, 224 000, and 300 000 cycles. Indicators identifying the extent of the crack have been added to the replica images. Through the superposition of the fracture surface and the replicas, it is possible to correlate the crack extent indicators with the fracture surface. The exact configuration of the crack with both the surface and inner shape of the crack front is tractable. As shown by the markers on Fig 7, cracking occurs on either side of the defect and the crack front passes through the defect early in crack propagation.

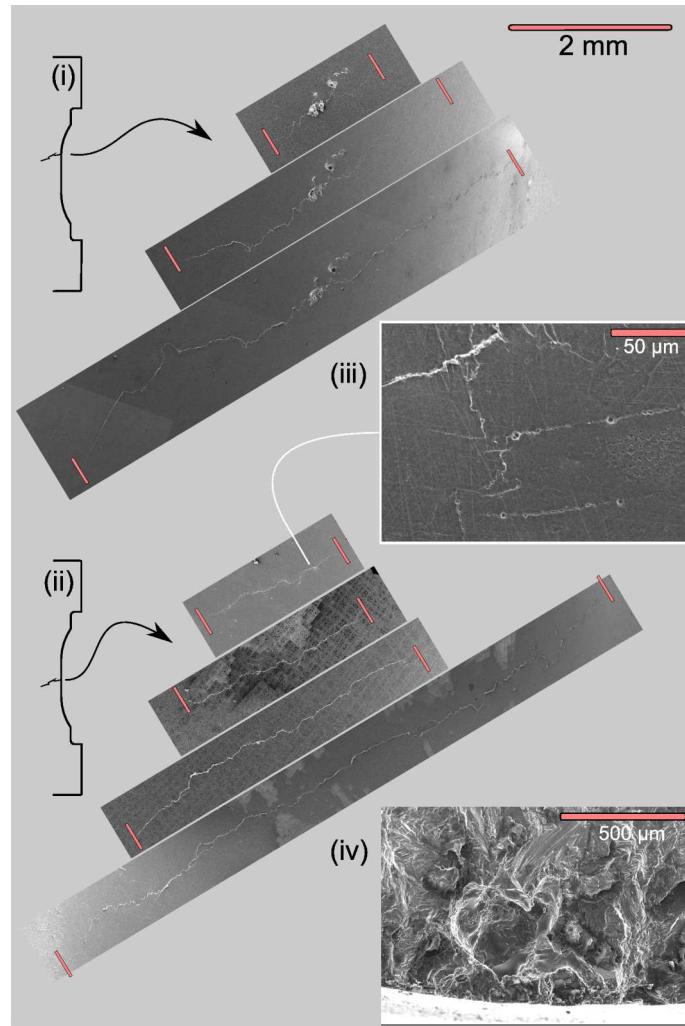
Figure 8: Multi-axial specimen T3,  $\sigma_a, \tau_a = 65$  MPa and  $N_f = 9.07 \times 10^5$  cycles with the secondary crack (i) at  $N = 2.25 \times 10^5$ ,  $N = 6.75 \times 10^5$  and  $N = 8.75 \times 10^5$ . The primary crack (ii) is shown at  $N = 2.25 \times 10^5$ ,  $N = 3.75 \times 10^5$ ,  $N = 6.75 \times 10^5$  and  $N = 8.75 \times 10^5$ . Damage accumulation (iii) was found to occur at the initiation zone and a 300  $\mu\text{m}$  defect (iv) was found on the fracture surface.

Sample T3 was cycled at  $\sigma_a = \tau_a = 65$  MPa until failure at  $N_f = 907$  000 cycles. The entire gauge surface of the sample was captured via replicas throughout the test. The replicas revealed that two cracks were present on the gage section at failure. It was also noted that this sample lacked the multiple initiations observed optically on samples following pure torsion loading. The critical crack was located in the middle of the gage section and the secondary crack was at the edge of the gage section. The replica results, showing the evolution of both the primary and secondary cracks, are

presented in Fig 8. The crack path is regular and the propagation plane normal of both cracks is oriented at  $31^\circ$  from the central axis of the specimen. This is consistent with other tests of the same type (Section 4). Fracture surface analysis revealed a gas pore with an equivalent diameter of 300  $\mu\text{m}$  just below the gage surface. Since this specimen had the same fatigue limit (68 MPa) as a specimen where a defect could not be identified, it is assumed that this pore had minimal effect on the fatigue limit. The secondary crack observed on this sample initiated at a gas pore, visible on the surface of the specimen, near the beginning of loading and grew in the same orientation as the main crack.

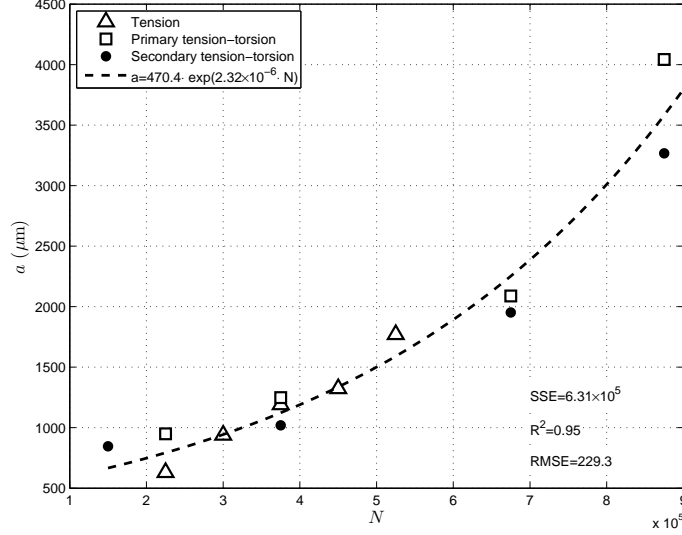
Figure 9: Crack growth law under tension and tension-torsion.

Fig 9 shows the evolution of the crack length  $a$  versus the number of loading cycles, where  $a$  is half of the crack length measured from the replica. The estimated accuracy of these crack length measurements is  $\pm 5 \mu\text{m}$ . While the crack length data in pure tension is for a test with  $\sigma_1 = 90 \text{ MPa}$ , the multiaxial test data is for  $\sigma_1 = 105 \text{ MPa}$ . Assuming that  $\sigma_1$  is the governing parameter for crack growth, these two tests are not strictly comparable as the stress state for each is different. However, this difference is relatively minor and the natural crack growth behaviour exhibits a very small difference in crack growth versus cycle count despite the different stress states. Therefore, the crack growth data in Fig 9 demonstrates the intrinsic short crack growth behaviour of this alloy. Consequently, the aggregate crack growth data has been used to fit an exponential relationship according to:

where  $2a$  is the surface crack length,  $N$  the number of cycles with  $\alpha$  and  $\beta$  fitting coefficients. As the short crack growth behaviour shows inherent variations, this exponential fit characterizes the average short crack growth curve with  $\alpha = 470.4$  and  $\beta = 2.32 \times 10^{-6}$  (Fig 9). The crack evolution described by Eq. 3 lacks the non-linear behaviour associated with initiation. However, based on the degree this equation represents the crack growth data, it is apparent that propagation dominates the fatigue life for A356-T6. The investigation of precise correlations for the initiation stage of the fatigue life of A356-T6 has demonstrated that fatigue initiation can be neglected for pure tension[4]. For fatigue lives close to 1 million cycles, the present findings assert that fatigue initiation may be considered negligible regardless of loading condition.

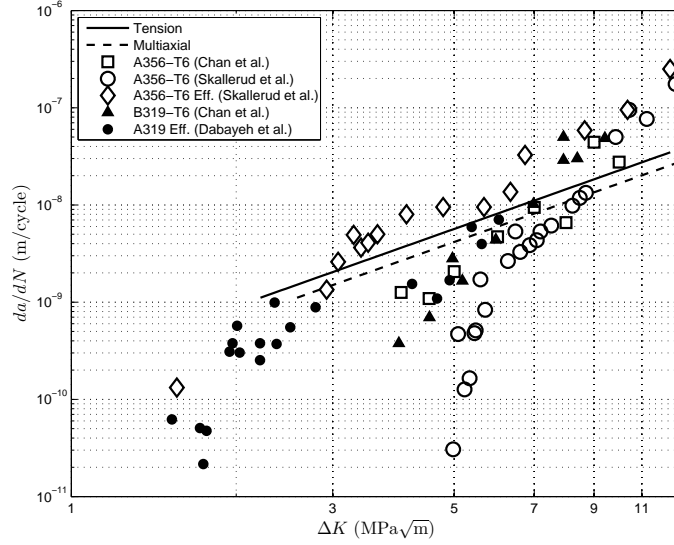
Figure 10: Comparison between effective long crack growth behaviour and natural crack growth behaviour.

The crack growth rates are plotted against the amplitude of the stress intensity factor in Fig. 10. The crack growth rates for each stress state were determined from the fitted data (Eq. 3). The stress intensity factor was computed assuming a semi-circular crack front, where  $K = \phi\sigma_1\sqrt{\pi a}$  with  $\phi = 0.643$  [22, 33]. The results for the two stress states are compared against studies performed on A319 [28] by Dabayeh et al., B319-T6 and unmodified A356-T6[29] by Chan et al., and peak-aged A356-T6 [2] by Skallerud et al. [2]. These four data sets for similar materials with different load ratios are plotted to provide references for short, long, and unstable crack growth behaviours.

difference between  $\Delta K$  and  $\Delta K_{\text{eff}}$  for A356-T6. The tensile and multiaxial crack growth rates from the current study are approximately the same as that of  $\Delta K_{\text{eff}}$  Skallerud et al., which reinforces the short crack categorization microstructure, as it has been found appropriate to employ a closure-free  $K$  value to describe short crack behaviour [34, 35].

where  $da/dN$  is the crack growth rate in meters per cycle and  $\Delta K$  is the positive component of the load cycle in MPa  $\sqrt{\text{m}}$ . As  $da/dN$  versus  $\Delta K$  for both natural cracks analyzed via the replica technique (Fig 10) show good agreement with aggregate long crack data for similar alloys, the MPS assertion is further validated.
