Some Experiences on BEPCII SRF System Operation

Abstract The Superconducting Radio Frequency (SRF) system of the upgrade project of Beijing Electron Positron Collider (BEPCII) has been in operation for almost 8 years. The SRF system has accelerated both electron and positron at the design beam current of 910 mA successfully, and a high beam intensity colliding of 860 mA (electron)*910 mA (positron) has been achieved in April 2014. Many problems were encountered during the operation, among which some were solved and some remain unsolved. This paper will describe some experiences on BEPCII SRF system operation, including the symptoms, causes and solutions.

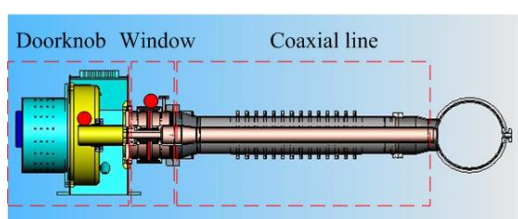
Fig.1. The 3D model of the power coupler: the area noted with red point is overheating.

During the annual operation from 2010 to 2011, the doorknob temperature noted with red point as shown in Fig.1 increased above 46 °C at the power level of 100 kW. Power leak was suspected at the beginning. So a reinstallation of the doorknob was implemented. However, the temperature was still too high. Finally, two big air conditioners were added for the doorknob air cooling. The temperature of the inlet cooling air reduced more than 10 °C and the doorknob temperature decreased accordingly [4]. Based on some experiments, the temperature of the doorknob cooling air should be below 20 °C for safety operation.

In Nov. 2013, the temperature of the window for the BPR power coupler was found excessively high, which became a big potential danger for the BPR SCC. In the worst case, the window temperature noted with red point as shown in Fig.1 increased to 50 °C in 5 minutes at the power level of 3 kW. Based on a series of experiments, the following characteristics were found: 1) the

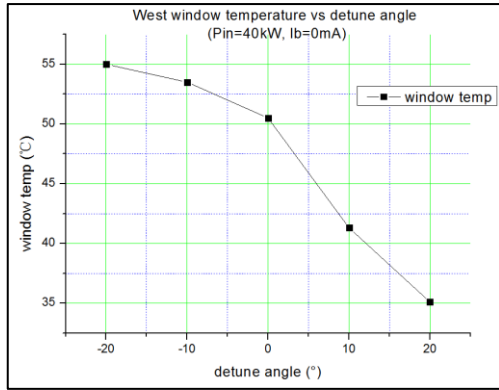
Fig.2. The window temperature is sensitive to the detune angle.

heating was very sensitive to the detune angle. As shown in Fig.2, at the power level of 40 kW, the temperature increased from 35 °C to 54 °C when the detune angle changed from 20 degree to -20 degree; 2) the heating is not uniform. The temperature of one side was 10 °C higher than the opposite side at the same power level of 80 kW. Since the window structure is axis-symmetric, we can deduce that the abnormal heating source is located around one side of the planar ceramic; 3) after three times 150 °C baking, the temperature increasing slope reduced obviously, as can be seen from Fig.3, which proved that the heating source isn't stable; 4) the heating usually became more serious if some big outgassing happened; 5) the vacuum of the overheating window has always been half order worse compared with the BER Ring normal window, which is more likely to occur discharging. So we speculated the possible overheating reason as follows: First, some serious discharging produced a large number of ions, then these ions bombarded the copper surface, and then the sputtered copper reacted with the residual gas of CO, CO₂, H₂ or H₂O, formed some kind of copper compounds of CuC₂ or CuH. Finally, the copper compounds deposited on the ceramic surface, which resulted in the ceramic overheating. If the above guess is reasonable, it tells us that keeping a good vacuum is very important for power coupler safety. Up to now, the problem is just alleviated instead of eliminated. A close monitoring of the window temperature has been done during current beam operation.

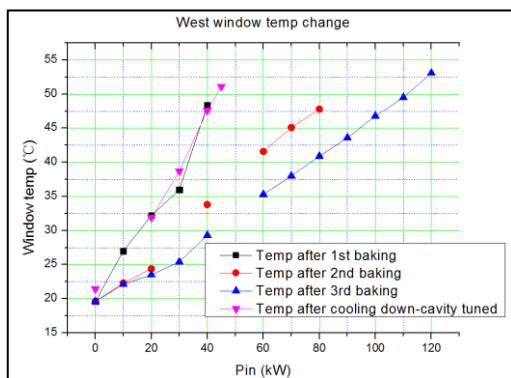
Fig.3. 150 °C baking is effective to alleviate the window overheating problem.

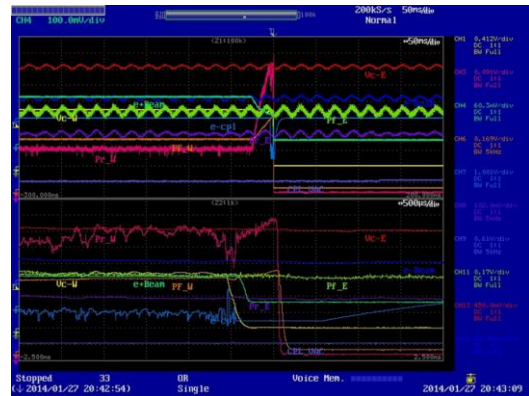
Fig.4. The signals variation during tripping, which recorded by the multi-channels oscilloscope.

Frequent tripping during high beam intensity colliding, resulted in single beam or two-beam lost, has always been a stubborn problem. Sometimes the tripping happens at the beginning, sometimes in the medium and the latter of colliding. The tripping significantly limits the current intensity and the efficiency of colliding. A multi-channels oscilloscope is used to record the signals of beam, accelerating voltage, RF power, vacuum pressure, RF phase, tuner and LLRF control loop. With the trigger function, the signals changing within micro-seconds of tripping can be recorded, saved with data and shown with picture (Fig.4). Then, a preliminary tripping reason analysis can be done by distinguishing the time sequences and variation tendencies of the signals. A bunch by

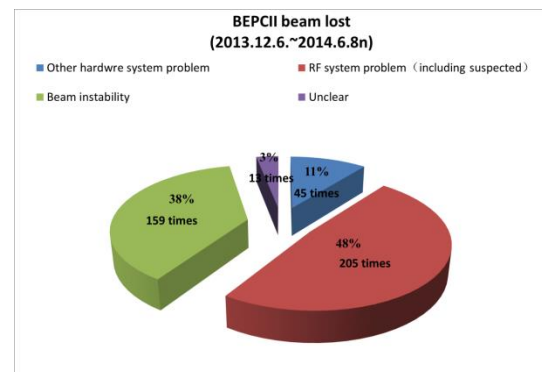
Fig.5. The categorized pie chart of tripping rate during 2013 to 2014 annual operation.

bunch beam diagnostic system has also been built to analyze the tripping reason by monitoring the variation of the beam itself [5]. The analysis results of the two methods can be compared and always agree with each other well. Up to now, almost all the tripping can be easily distinguished as beam instability, RF tripping, magnet and other system breakdown such as power supply and cryogenic, which is very helpful to reduce the tripping rate. Fig.5 shows the categorized pie chart of tripping rate during 2013 to 2014 annual operation based on the above tripping diagnostic methods.

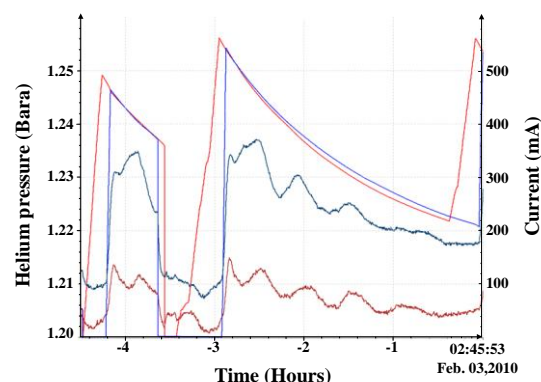
Fig.6. The helium pressure of the BER SCC increases quickly as the electron injecting (red: positron current; blue: electron current; indigo: BER SCC helium pressure; brown: BPR SCC helium pressure).

The excessive helium pressure of the BER SCC began in 2008, which has the following characteristics: 1) the helium pressure increasing only happens in the BER SCC and in collision mode, i.e. never happens in BPR SCC and SR mode; 2) the helium pressure increases quickly during the electron injecting, as shown in Fig.6; 3) the vertical orbit has an impact on the helium pressure; 4) the helium pressure just increases with the beam intensity, has nothing to do with the beam bunches; 5) the temperatures around the taper of both upstream and downstream increases accordingly; 6) the unknown heat source is about 80 W at the electron current of 750 mA [6]. By adjusting vertical orbit and increasing the helium pressure up-limit value, the problem has been alleviated to a certain extent now. However, it still exists; and more
