Radiation Hardness Test of Eljen EJ-500 Optical Cement

We present a comprehensive account of the proton radiation hardness of Eljen Technology's EJ-500 optical cement used in the construction of experiment detectors. The cement was embedded into five plastic scintillator tiles which were each exposed to one of five different levels of radiation by a 50 MeV proton beam produced at the 88-Inch Cyclotron at Lawrence Berkeley National Laboratory. A cosmic ray telescope setup was used to measure signal amplitudes before and after irradiation. Another post-radiation measurement was taken four months after the experiment to investigate whether the radiation damage to the cement recovers after a short amount of time. We verified that the radiation damage to the tiles increased with increasing dose but showed significant improvement after the four months time interval.

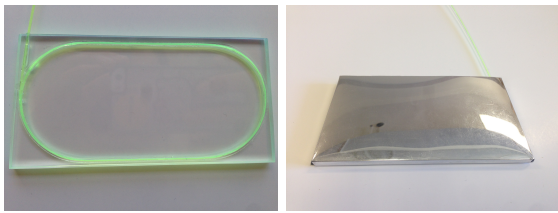
Figure 1: 12cm×5.5cm×0.5cm EJ-200 scintillator with a triple layer of Kuraray Y-11 WLS fibers glued with EJ-500 optical cement. This was one of the tiles used in the radiation hardness experiment. The right picture shows the same tile wrapped in aluminum mylar.

Scintillator Tiles. The design of the test tiles was directly taken from that of a midrange tile in the EPD. The tiles were machined from EJ-200 plastic scintillator sheets into 12 cm×5.5 cm×0.5 cm trapezoids. Sigma-shaped grooves 0.16 cm wide were machined into the tile to a depth of 0.36 cm in order to hold three layers of a single WLS fiber for each tile (See below section on Optical Fibers for more information). An assembled test tile is shown in Figure 1.

Once the edges were sufficiently polished, each tile was cleaned and the optical fibers were glued into the sigma grooves (see below section on Epoxy Preparation). After the epoxy hardened the tiles were cleaned again before being wrapped in aluminum mylar to contain the signal photons inside the scintillator. We found that simply hand-wrapping a piece of mylar around the tiles was insufficient because the result was not tight enough. Instead, we drew a template cut for the mylar that would minimize the total surface area of the mylar while completely covering all faces of the tile. The mylar was then laid over the template and cut out with a box cutter for each tile. Any piece of the mylar that would be a fold on the tile was also perforated somewhat so as to ensure sharp edges all around. A wrapped test tile is shown in Figure 1 (right). This mylar wrapping was used during the pre- and post-radiation measurements but was not

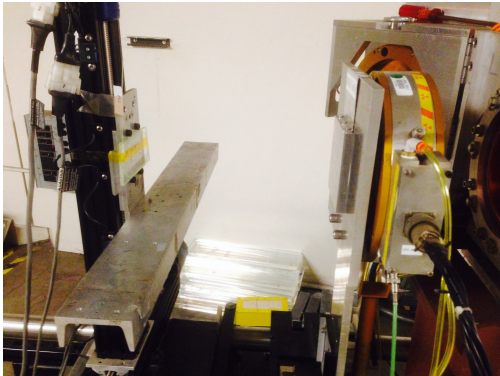
Figure 2: Test tile attached to a vertical support post (left) in the direct path of the beamline, positioned about 25 cm away from the beam window (right).

The radiation experiment was conducted at Lawrence Berkeley National Lab’s 88-Inch Cyclotron with a 50 MeV proton beam. The tiles were positioned in a way that about 90% of the surface was uniformly irradiated. A camera was set up inside the experiment vault so that we could monitor the tiles by live video feed as they were being irradiated. No bubbling or melting of any component was seen throughout the entire experiment. The tiles were attached one at a time to a vertical bar

directly in the path of the beam. This setup is pictured in Figure 2. Once the experiment finished all tiles were left in the experiment vault for two to four days to allow time for the activation levels in the tiles to decrease so that they could be safely handled and tested.

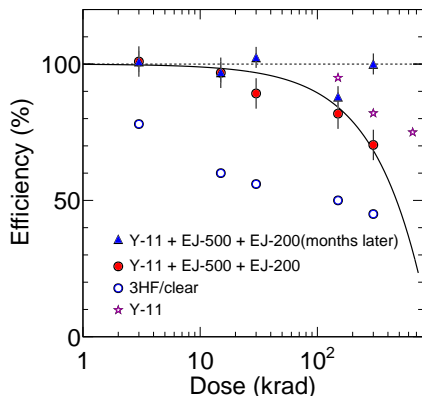
Figure 3: Measurement of the efficiency rate per dose of the assembled detector tiles compared with the reported efficiency rates of the Kuraray Y-11 WLS and 3HF clear optical fibers. EJ-500 is the optical cement while EJ-200 represents the plastic scintillator.

To be conscientious of the fact that there are multiple components to our test tiles we researched radiation tests on the optical fibers that were used in their construction. There have been studies conducted on the radiation hardness of Kuraray WLS fibers that show agreement with our result of a 30% loss in detector efficiency. One such study found that after a dose of 650 kRad the fibers had an efficiency of 70% [3]. For our experiment, we had 1.0×10^{12} protons/cm² in our maximum irradiated tile, while the average energy deposited in the fibers

during the experiment is calculated to be $19 \text{ MeV} \cdot \text{cm}^2/\text{g}$. This equates to a maximum dosage of 300 kRad in our WLS fibers, a factor of two less than the aforementioned study. A second study measured the attenuation length of Kuraray 3HF clear optical fibers to decrease by about 50% after an irradiation dosage of 300 kRad [4]. The results of both studies are compared to our experiment results in Figure 3. Both studies report that while a small percentage of the radiation damage to the fibers is permanent, the fibers are able to partially recover from the damage after a rest time on the order of one to two months. From the comparison of our 30% loss in efficiency with the aforementioned studies we conclude that our result is in agreement with the reduction in efficiency of WLS fibers that have been exposed to high dosages of radiation. This indicates that the WLS fibers account for the majority of the radiation damage to the tiles. With the efficiency back to normal after about four months we consider the whole detector setup to be safe for BESII.
