Rapid Assessment of Damaged Homes in the Florida Keys after Hurricane Irma

Abstract

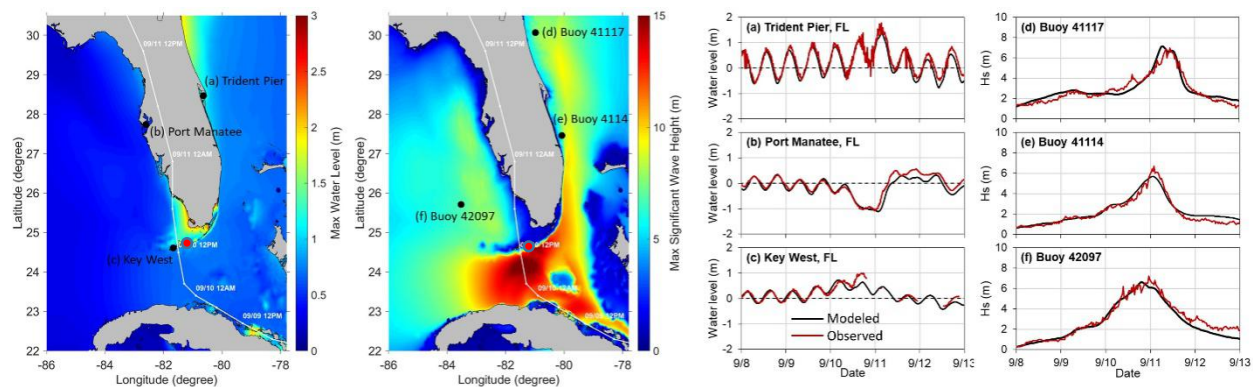
Figure 1. Hydrodynamic modeling of water level and wave height for Hurricane Irma. Left two panels show spatial distribution of modeled maximum water level and significant wave height, respectively. White curve represents storm track. Black points show locations of available tidal gauge and buoy stations. Red point indicates approximate location of study area. Right two panels compare observed and modeled time series of water level and significant wave height (H_s), respectively.

To understand the hazard and inform the field survey, we first use the coupled hydrodynamic and wave model ADCIRC+SWAN (Dietrich et al. 2012, Marsooli and Lin 2017) to simulate the storm tide (i.e., water level) and wave height for Hurricane Irma. To simulate Irma's storm tide and wave (Figure 1), we apply the surface wind (at 10-m) and sea-level pressure fields from National Center for Environmental Prediction Final (NCEP FNL) operational global analysis data (0.25° x 0.25° x 6 hours). The model results, e.g., time series in Figure 1, indicate that the model satisfactorily captures the temporal evolution and the peak values of the water levels and wave heights induced by Hurricane Irma. The model results show that the highest water levels, between 2 and 2.5 m, occurred in South/Southwest Florida. However, coastal zones in this region are predominantly uninhabited and covered by wetlands, so little loss of life or property is expected. High water levels are also estimated for the Florida Keys, especially islands located on the right side of the storm track. For example, the peak storm tide in Big Pine Key and Marathon reaches up to 2 m. The

model results also show that large waves with a significant wave height of about 14 m reached a few kilometers off the Florida Keys. In contrast, wave heights off the southern and southwestern coasts of Florida were small (< 2 m).

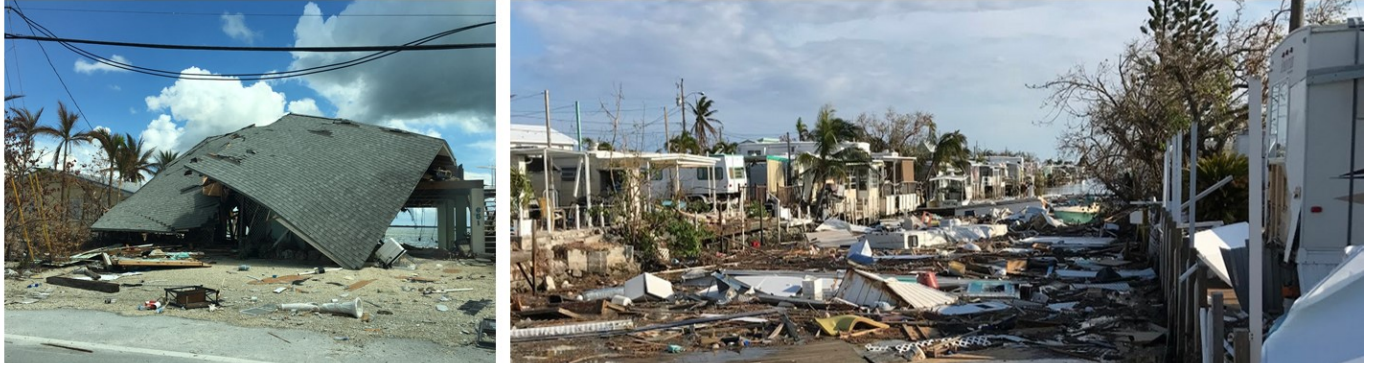
We found that the destroyed and severely damaged buildings were caused largely by hydrodynamic forces induced by storm surge/waves. For example, Fig. 2a shows that storm surge/waves completely crashed the lower part of a building in Big Pine Key. Fig. 2b shows debris from damaged trailers floating in the water in a trailer community in Marathon. The observed storm surge damage is consistent with the high surge and wave heights estimated for the two sites (Figs. 3a and 3b). The assessed damage state for each house appears in Figs. 3c and 3d. The slightly and moderately damaged buildings are 72.7% and 75% of the total surveyed building for the assessed areas in Big Pine Key and Marathon, respectively. The percentages of the destroyed buildings are 13.9% and 16.9%, respectively. In both areas, the destroyed buildings are clustered. The destroyed buildings in Big Pine Key are near the coastline and narrow waterways, a strong indication that the damage was caused mainly by hydrodynamic forces. The completely destroyed buildings in Marathon cluster in the north and middle parts of the study area. The majority of those buildings are mobile homes.

Figure 2. Photos of damage in (a) Big Pine Key: storm surge damage besides waterway (left side of building) and (b) Marathon: trailer community with house debris filling waterway

Possible measures to reduce flood vulnerability in the study areas include elevating and strengthening the buildings (especially mobile homes) and relocating homeowners living near the

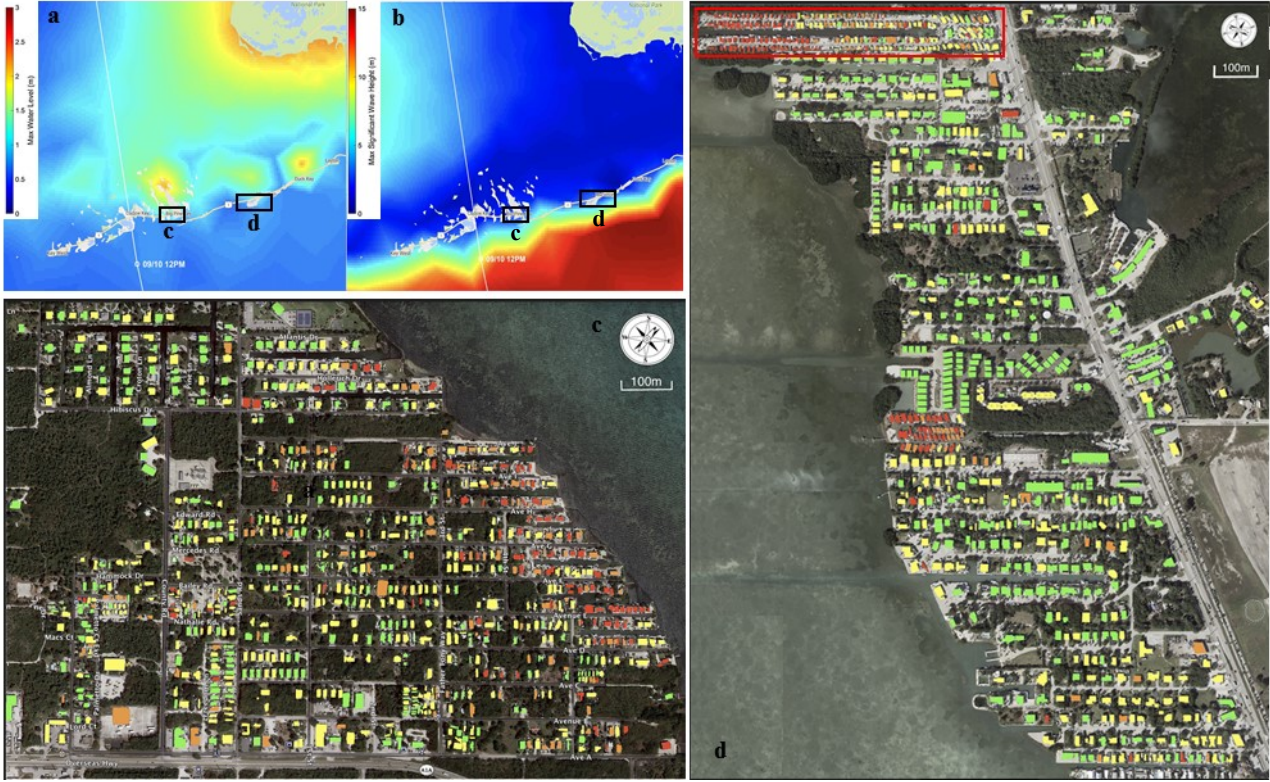
Figure 3. Spatial distribution of estimated hazards and damage states in study areas. (a) and (b) show simulated maximum total water level and significant wave height, respectively; (c) and (d) show assessed damage state (none: green; minor: yellow; major: orange; destroyed: red) for residential buildings in Big Pine Key and Marathon, respectively.

coastline (and narrow waterways) further inland. However, potential financial challenges exist, especially for Marathon, where the median annual income is \$50,976 vs. \$63,716 for Big Pine Key. Some local homeowners in a destroyed trailer community in Marathon (indicated by the red rectangle in Fig. 3d) with whom we talked had lived in trailers as their primary homes for decades without flood insurance. Financial constraints may hinder their rebuilding or relocating to somewhere safer. As low-income people living in mobile homes suffered most, natural hazards worsen economic inequality in this case. In contrast, discussion with local residents in Big Pine Key indicated that many structures there were second homes and, furthermore, were designed to withstand hurricane hazards (e.g., key assets were raised above the ground floor). These observations raise again issues of affordability and equity (Montgomery and Chakraborty, 2015). Policies relevant to hurricane damage recovery and rebuilding must address these issues.
