Influence of KCl and HCl on a Laser Clad FeCrAl Alloy: In-Situ SEM and Controlled Environment High Temperature Corrosion

Keywords: In-Situ SEM, FeCrAl, APMT, High Temperature Corrosion, Chlorine

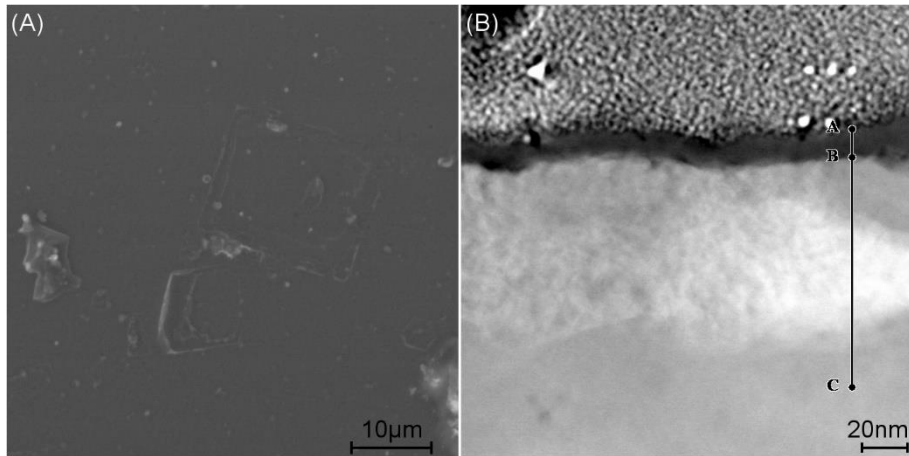
Figure 1 (A) shows the exposed top surface of the APMT coating deposited with KCl. Figure 1 (B) shows a TEM section through a KCl crystal at a point where the obvious corrosion deposits resulting from the KCl crystal are not present. Two layers of protective platinum can be seen on top of the oxide. As oxygen has been excluded from the EDX measurements, all percentages represent cation percentage. At regions where the influence of the KCl crystal is not immediately obvious, a dual layer oxide can be seen to have formed on the surface. Moving from point A inwards, the chromium increases, from a minimum value at A of 9.9 % to a maximum of 43.1 %, well above the bulk composition. This is matched by a decrease in iron concentration over the same distance from its maximum at A of 82.6 % to a minimum of 43.9 %. This region represents an iron oxide with a thickness of approximately 10 nm, giving a total oxide thickness of 16 nm. In Figure 2, A high concentration of aluminium can be seen at the oxide coating interface, suggesting the presence of aluminium oxide. Beyond this region, across the boundary at B, there is a very rapid chromium depletion over a distance of approximately 6 nm. Here chromium concentration reaches 13.8 %. This is again matched by a change in iron as its concentration raises back to 74.5 % over the same region. As oxygen has been excluded from the EDX measurements, this transition region most probably represents the iron-chromium spinel. Moving inwards from point B we see a small region in Figure 2 below the boundary at B, approximately 15 nm thick where chromium returns to its nominal bulk value of 21.6 ± 0.1 %. Iron also returns to its bulk value over this region of 67.7 ± 0.1 %.

Figure 1: (A) SE micrograph of top surface and (B) STEM-HAADF image of a FIB lift out cross section of the surface of the APMT coating exposed in laboratory air at 1 Torr at 450 °C. The section is taken through the site of a crystal shown in (A).

In the TEM cross-sections of the APMT clad exposed for 1 h in air, in a region where the influence of KCl is not obvious, there were three major phases identified at the coating-environment interface; an iron rich oxide, an iron-chromium mixed oxide and an aluminium enriched layer. In regions free from the presence of any KCl crystal on the top surface of the APMT clad, there was a chromium depletion zone observed within the coating inward of the innermost mixed iron-chromium oxide layer. This outward movement of chromium is what causes the observed relative decrease in iron. The formation of mixed iron and chromium oxides in stainless steel alloys is expected and well documented in the literature [17]. A relatively thin region of aluminium enrichment is observed suggesting that the formation of the iron and chromium oxides is rapid. The phase diagram of the iron-chromium-oxygen system shows that a continuous series of solid solutions of Fe_2O_3 and Cr_2O_3 form [17]. These can then form into spinels in solid solution with Fe_3O_4 .

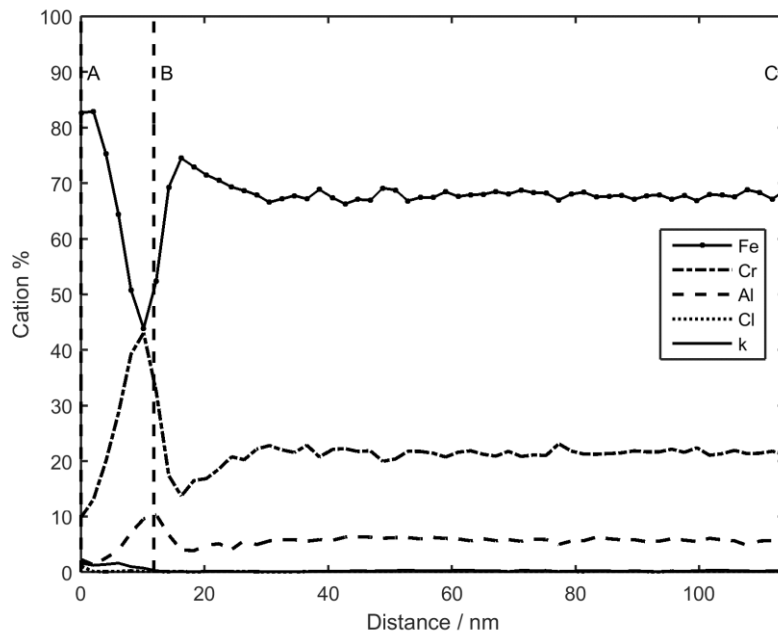
Figure 2: Elemental distribution along the line shown in Figure 1. There is an outer iron oxide which decreases as an iron-chromium oxide grows between points A and B. An aluminium rich region can also be seen at the interface denoted by the line B.

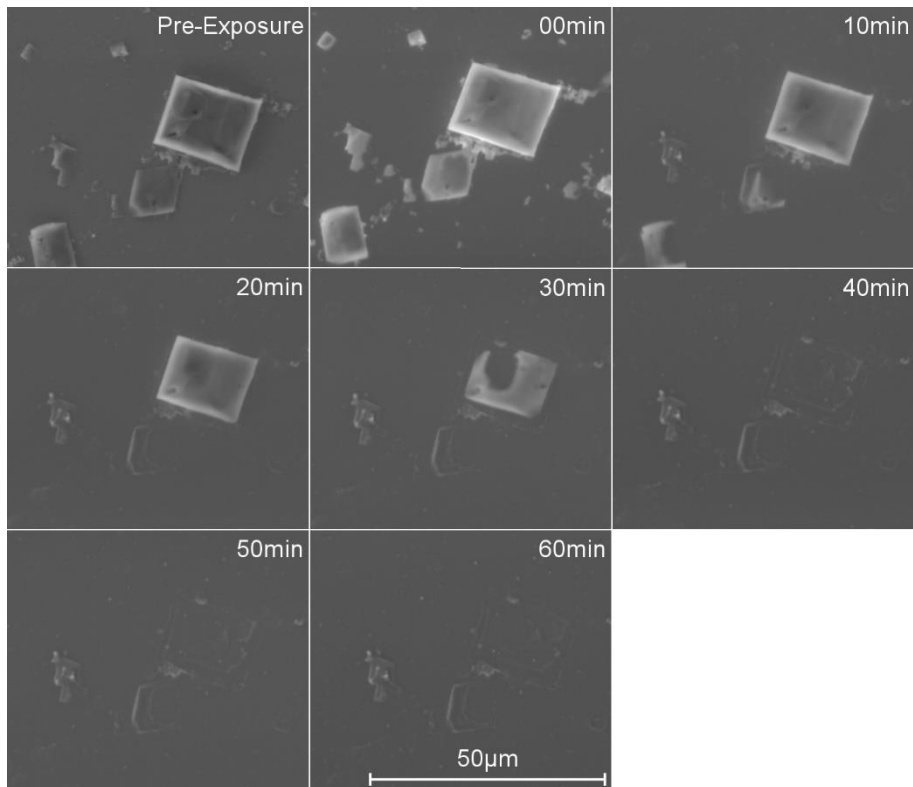
Figure 3 shows the evolution of a potassium chloride crystal during heating at 450 °C over the course of 1 h in the in-situ SEM setup. It can be seen that in the case of this crystal, the KCl is evaporated during the heating, beginning at around 30 mins. Regions of corrosion product can be seen beginning to form around the edge of the crystal as the KCl is consumed, and become especially evident after 40 min when the remaining KCl crystal has

Figure 3: Time evolution of a KCl crystal on the surface of APMT coating exposed in-situ in laboratory air at 1 Torr at 450 °C over a 1h timescale. The KCl crystal is consumed, however a thin deposit can be seen around its perimeter. All micrographs have the same scale.

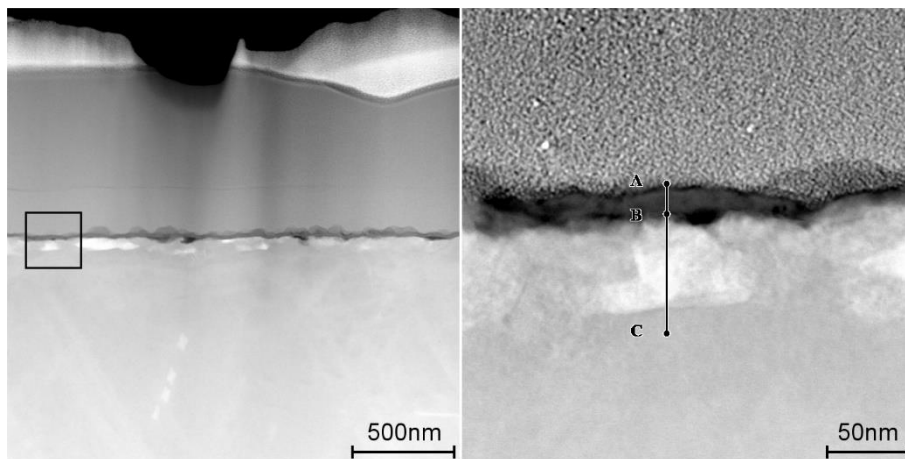
completely evaporated. Cross-section of this evaporated crystal can be seen in Figure 4. A thin layer of oxide can be seen above the surface of the coating between points A and B. This is shown to be more separated from the underlying coating than that of the sample taken far from the evaporated crystal shown in Figure 1. From Figure 5, it can be seen that a double layered oxide has again formed, similar to that seen in the sample where the influence of the KCl is not obvious. In the outermost region, at point A, an iron oxide forms with the chromium concentration dropping to 8.3 % and the iron content increasing to 83.6 %. Moving inwards, towards the coating oxide interface, most likely an iron-chromium spinel forms approximately 6 nm thick. This contains 46.6 % chromium and 30.3 % iron.

In the bulk material there is a depletion of both iron and chromium close to the coating oxide interface at B. In the approximately 4 nm before the boundary, iron is depleted from the bulk level to 61.0 %. The chromium depletes to a lesser extent but over a greater distance, dropping to 14.9 % over a distance of approximately 22 nm. The region between points B and C again represent the bulk material and have a composition of 68.4 ± 0.2 % iron and 21.6 ± 0.2 % chromium. Figure 5 also shows an aluminium enrichment at the coating oxide interface where the concentration is 10.0 % compared to its measured bulk value between 5.0 % and 6.1 %. Finally, the presence of the KCl crystal can be evidenced, in the peaking of chlorine and potassium in the iron-chromium spinel layer with concentrations of 10.0 % and 3.3 % respectively.

Figure 4: STEM-HAADF images of a section of APMT coating exposed in laboratory air at 1 Torr at 450 °C. The section is taken close to the edge of a KCl crystal. In the left hand micrograph, platinum can be seen in the bright contrast and dark contrast region above the thin dark band of oxide. The micrograph on the right is a high magnification of the area marked by the box.

Looking at the same TEM cross sections (Figure 4) of the APMT after 1 h exposure in-situ, but in close vicinity to a KCl crystal, the same three major components are spotted as in the regions far from the KCl crystal: an iron rich oxide, an iron-chromium mixed oxide and an aluminium enriched layer. Additionally, a potassium chloride enrichment was observed at the original coating-environment interface. A chromium depletion zone was again observed within the coating after the innermost mixed oxide layer. When comparing the depth of this chromium depletion zone in the presence of KCl as opposed to areas far from the KCl crystals, it can be seen that both the depth of the depletion zone, and the overall thickness of the reaction products are increased in the presence of the KCl. This increased thickness is especially true of the iron oxide that has grown outermost. It is well established that the presence of chlorine can inhibit the growth of chromium oxides and as such could explain the increased thickness of the iron based outer oxide [3]. It can also be seen in Figure 4 (B) that there are voids that have formed along the oxide-coating interface. It is possible that these voids may have been formed by the removal of chromium in the form of chromium chlorides as has been seen in other work with iron-chromium-aluminium alloys [11]. This removal of chromium in the form of chlorides could also explain the increased depth of the chromium depletion zone despite the inhibited chromium oxide growth.

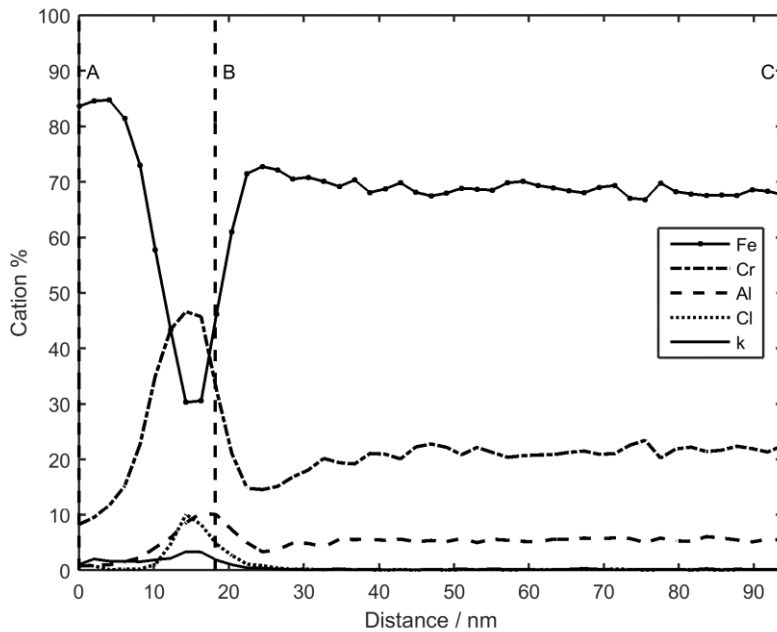
Figure 5: Elemental distribution along the line shown in Figure 4. A double layered oxide is seen in the dark region with an outer iron rich oxide, and an inner mixed chromium iron oxide. A rise in chlorine can be seen matching with the increase in chromium in the same region.

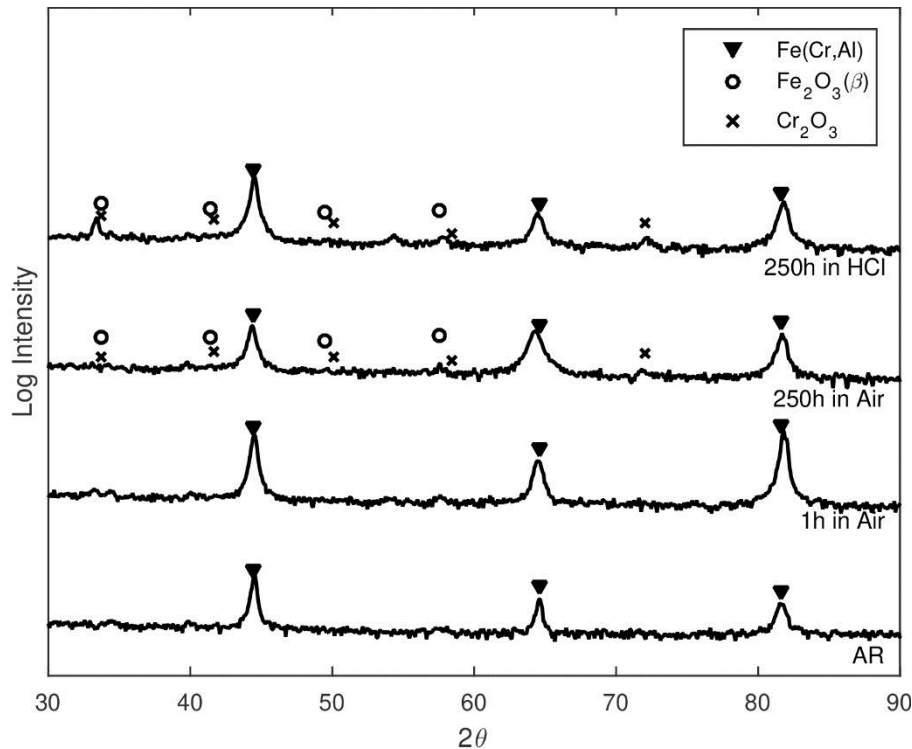
Figure 6 shows XRD scans of the coatings exposed in air and HCl for varying times without the presence of KCl. It can be seen in the spectra for the as-clad APMT where the peaks for the substrate lie. Whilst this phase could not be indexed accurately, it closely matches a number of iron-chromium and iron-aluminium mixed phases (PDF 03-065-4664, PDF 00-045-1203 respectively) with peak positions at 44.4° , 64.6° and 81.7° and associated d-spacing of 2.04 \AA , 1.44 \AA and 1.18 \AA respectively. As such it is suggested that this is an iron solid solution containing chromium and aluminium, as would be expected from APMT. After 1 h there were no oxide peaks found within the detection limit of the XRD. After 250 h in both air and HCl, peaks can be identified matching the crystal structure of haematite and chromia. It can also be seen that the presence of HCl increases the intensity of these peaks. Aside from these peaks there are no other phases visible from the XRD scans and as such, any other phases present under these conditions are expected to be very thin.

Figure 6: XRD of APMT coating, as-coated and after 1 h and 250 h exposure at 450 °C in air and HCl. There are no obvious oxide phases present when compared with a pre-exposure sample after 1 h; however, very low intensity peaks occurring most notably at 58 ° and 72 ° appeared after 250 h, corresponding the presence of Fe_2O_3 and Cr_2O_3 which may be see in 3.1.1.

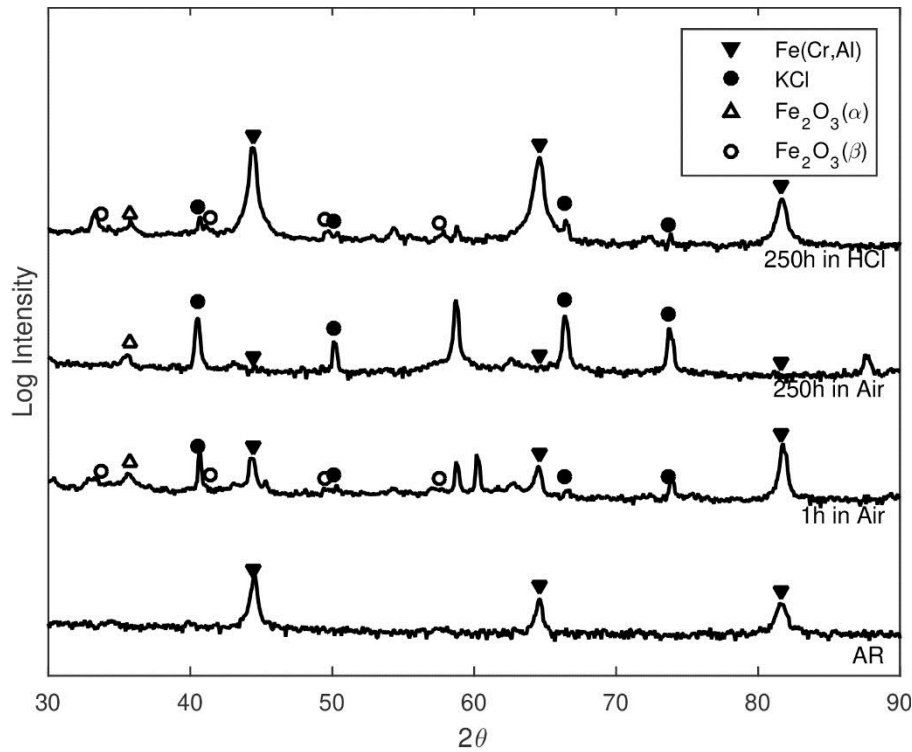
Figure 7 shows XRD scans of the coating exposed in air and HCl for varying times with KCl. As observed in the samples exposed without the presence of KCl (as was observed in Figure 6), the same iron solid solution phase can be seen in all four scans. After 1 h in air in the presence of KCl, the β -hematite that was observed without KCl can be seen. This is accompanied by α -hematite which can be seen at all times and atmospheres when KCl is present. The other major phase noticed is potassium chloride. This can be seen in all of the samples with potassium chloride deposits and is never fully consumed. After 250 h in the presence of HCl the intensity of KCl in comparison to the other samples is lower, suggesting more of the KCl has been consumed. In the presence of air, the coating peaks cannot be observed. This could be due to a thick layer of KCl covering the surface and obscuring the substrate. There is an unindexed peak centred at a 2θ of 58 °. This peak appears in all samples in the presence of KCl, however a match could not be found.

Figure 7: XRD of APMT coating, as coated and after 1 h and 250 h exposure at 450 °C in air and HCl, with a KCl deposit. The APMT peaks are visible at all times except 250h, where the APMT is not visible.

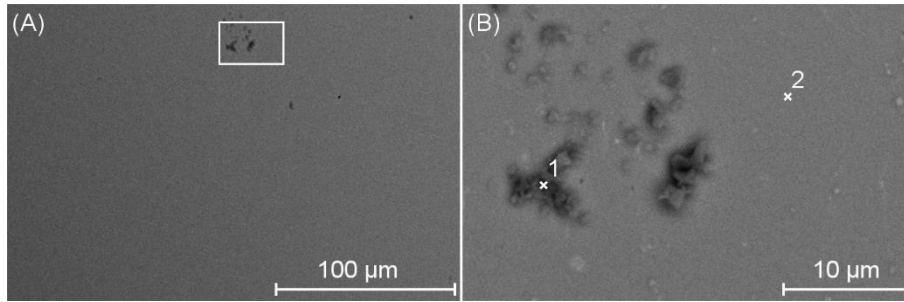
After completing exposures in air for 1 h, long term exposures were carried out for 250 h. The top surface of the sample exposed without a KCl deposit can be seen in Figure 8. Figure 8 (A) shows a low magnification image of the top surface. Much like the surface of the sample exposed for 1 h, there are very few features that can be seen on the surface of the sample. The features that can be seen are shown in higher magnification in Figure 8 (B). Table 1 provides information on the composition of these phases. Whilst point 1 is iron and chromium deficient compared to the substrate measured at point 2, it is enriched in manganese suggesting a manganese oxide on the surface. This was not picked up in the XRD shown in Figure 6 however these oxides are very small.

Figure 8: BSE Micrograph of the oxides that have grown on the surface of APMT after exposure in air atmosphere for 250h at 450 °C. In (A), isolated deposits of oxide can be seen on the surface. A high magnification of the area marked in (A) is shown in (B). All of the oxides in this field of view have a similar morphology.

Fe	Cr	Al	Si	Ni	Mo	Mg
2	57.3	18.1	4.2	3.4	2.9	2.9	11.3
4	69.0	21.0	3.2	0.4	3.3	3.2

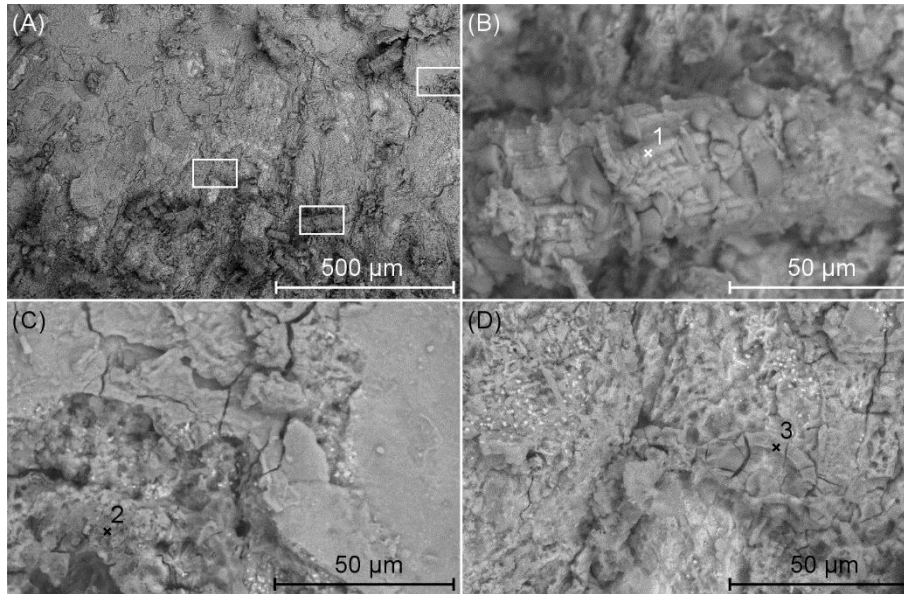
When exposed for 250 h in the presence of KCl, the deposits which grow on the surface of the APMT, seen in Figure 9 are very different to those that are observed at shorter duration and without KCl. Figure 9 (A) shows a low magnification image of the surface. It can be seen that there is a continuous and varying covering over the entire surface of the coating. Higher magnification images show some of the complex phases present in higher magnification. Figure 9 (B) shows a thick, extruded tube like structure. These structures have a cracked layered surface and can be seen from Table 2 to be rich in chlorine and chromium. The point 1 is the underlying iron oxide layer, however it can be seen that this has been penetrated by chlorine in Table 2. The majority of the surface is covered with the oxide under point 2, another iron rich oxide again permeated with chlorine and potassium. Finally, point 3 shows the presence of potassium chromate.

Figure 9: BSE Micrograph of the oxides that have grown on the surface of APMT after exposure in air atmosphere for 250h at 450 °C in the presence of KCl. In (A), the continuous deposit across the surface can be seen. A high magnification of the areas marked in (A) are shown in (B), (C) and (D).

Fe	Cr	Al	Cl	Si	Ni	Mo	K
1	14.3	33.7	12.0	25.5		1.9	3.7	9
2	65.9	11.0	2.1	6.5	0.7	4.6	3.3	5.8
3	23.0	32.9	5.1	11.8	0.8	2.8	7.5	16.2

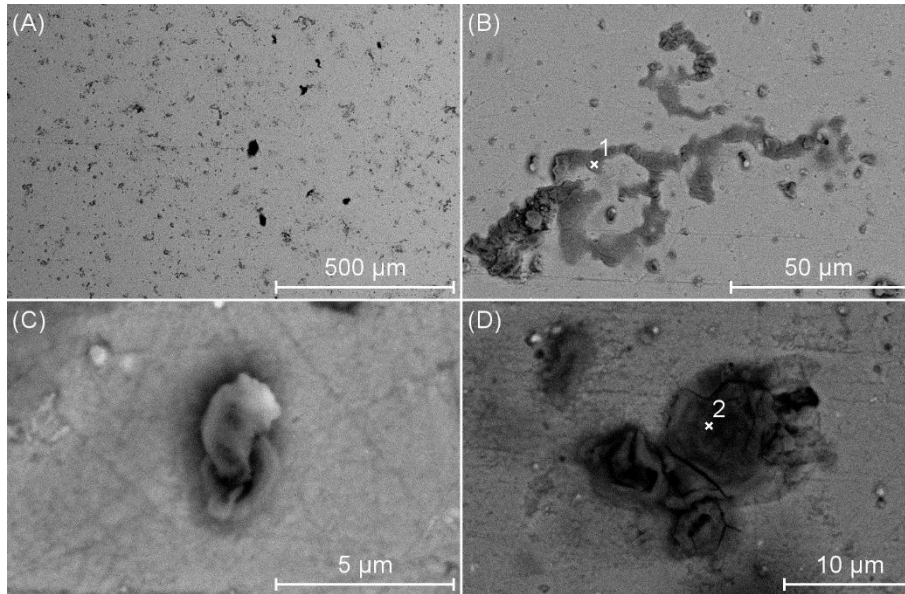
After investigating the behaviour of the coating for different exposure lengths in air, a synthetic flue gas rich in HCl was used for a 250 h test. This can be seen in Figure 10. At low magnification as seen in Figure 10 (A) a fairly regular deposit can be seen the entire surface, although it is not continuous. Figure 10 (B) shows a typical structure that makes up the majority of the deposits seen on the surface. This deposit is covered by point 1 in Table 3. It is very thin so shows mostly the underlying APMT coating however there is also chlorine present. Figure 10 (C) shows a plume like structure. These appear across the surface and look to originate from pores. These pores are not observed in the as-clad coating, nor after any of the other coated condition except when HCl is present. Figure 10 (D) shows another chlorine rich deposit on the surface, showing that the gaseous HCl can interact with the surface.

Figure 10: BSE Micrograph of the oxides that have grown on the surface of APMT after exposure in HCl atmosphere for 250h at 450 °C. A thin, non-continuous oxide can be seen across the surface in (A). One region of oxide that have grown on the surface of APMT can be seen in (B). A plume like structure is shown in (C) which has grown out of the surface, seeming to originate from pores despite these not being visible on the unexposed surface. The other morphology of surface deposit not seen in (B) is shown in (D).

Fe	Cr	Al	Cl	Si	Ni	Mo
1	64.6	20.7	6.8	2.8	0.9	2.6	1.7
2	63.3	22.0	6.6	2.5	1.0	3.0	1.5

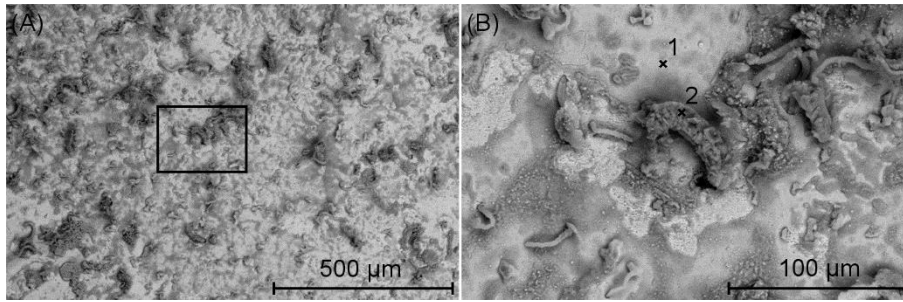
The final sample analysed was in a combination of both HCl gas and a KCl deposit. It can be seen in Figure 11 (A) that there is a complete covering of the sample with deposit. Figure 11 (B) shows the two components that make this up. There is a thin, continuous oxide that covers the entire surface. This is very thin and as such, is difficult to detect with EDX. The other feature on the surface is the chlorine rich tubes similar to those seen in Figure 9 (B). Finally, the plume like structures originating from pores that were seen in Figure 10 (C) are longer and better defined under these conditions.

Figure 11: BSE micrograph of the oxides that have grown on the surface of APMT after exposure in HCl atmosphere for 250h at 450 °C with a KCl deposit. A more comprehensive, continuous oxide than without the presence of KCl can be seen across the surface in (A). All of the phases present in the box in (A) can be seen in (B). They are all larger than those seen without the presence of KCl. In the presence of KCl the plumes that are shown in Figure 10 have grown larger and longer, however are still rooted in the pore like structures.

Fe	Cr	Al	Cl	Si	Ni	Mo	K
1	63.0	21.0	6.6	3.1	1.2	2.9	1.7	0.6
2	61.1	21.7	2.9	9.4	0.7	2.5	1.2	0.4

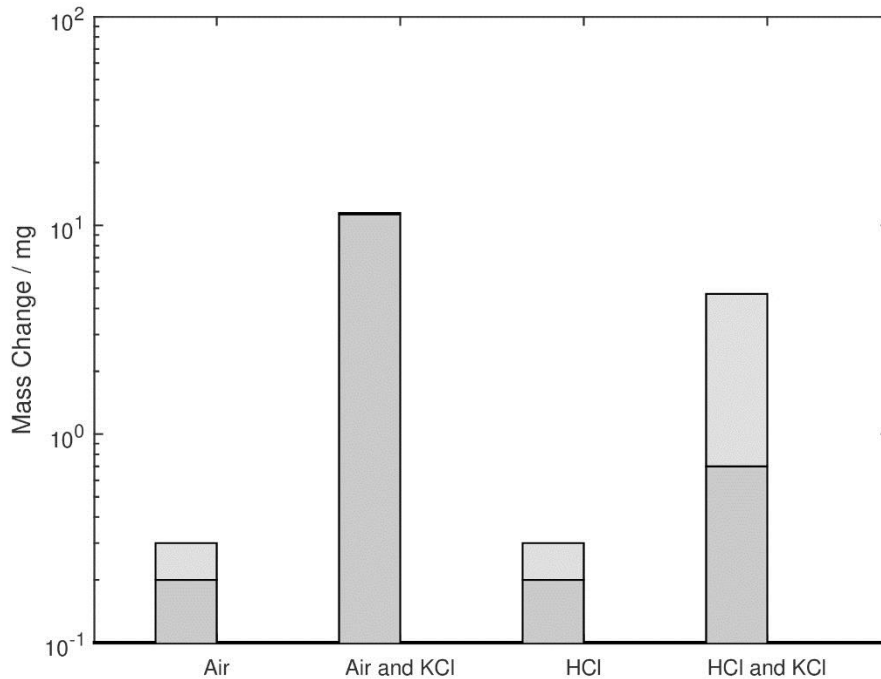
Mass change was taken from the coated to the post exposure samples. The greatest mass gain arises when KCl is present in both air and HCl environments. The addition of HCl seems to have little effect without the presence of KCl, however, when KCl is present, it is observed to have a protective effect. Whilst HCl and KCl individually exhibit corrosive effects on the coatings, combined, their effect is reduced in comparison to KCl alone.

Figure 12: Mass Change information for APMT coated samples in a range of environments and deposits. The light grey region represents the error in the measurement. In all environments, the presence of a KCl deposit increases mass gain. At 450 °C an HCl+KCl environment reduces the mass gain relative to a similar coating in air+KCl.

With the presence of HCl instead of air, the most notable result is the reduced mass gain in the coating with KCl as can be seen in Figure 12. Whilst it can be seen that the mass gain is greater in both air and HCl when KCl is present, the mass gain in HCl with KCl is significantly lower than that observed in air with KCl. In an air environment, the only source of chlorine is from the dissociation of potassium and chlorine. The presence of HCl causes an increase in chlorine partial pressure which could slow the dissociation of potassium from chlorine and therefore cause the observed mass gain differences. It has been proposed that HCl can produce chlorine through the reaction shown in Equation 1 [19].
