APPLICATION OF DINSAR TECHNIQUE TO HIGH COHERENCE SATELLITE IMAGES FOR STRATEGIC INFRASTRUCTURE MONITORING

In this paper the authors present and validate a procedure, which intends to combine the latest state of the art models in bridge monitoring with freely available satellite data. Through the Differential SAR interferometry (DInSAR) technique, a dataset of displacements for the Morandi bridge in Genoa (Italy), before its collapse, has been created, by using images downloaded by the Copernicus Open-Access Hub and the ASFVertex Hub. The data have been processed through the ESA SNAP software to identify the rate of displacements in the parts of the bridge where collapse occurred. Results demonstrate that the adopted procedure has great potentiality in the application field, as it represents a simple and inexpensive method to monitor large structures in a continuous way, by helping to better quantify risks and guide effective mitigation countermeasures. Moreover, the same procedure, once properly validated, could be effectively extended to the current and future performance estimation of civil infrastructures.

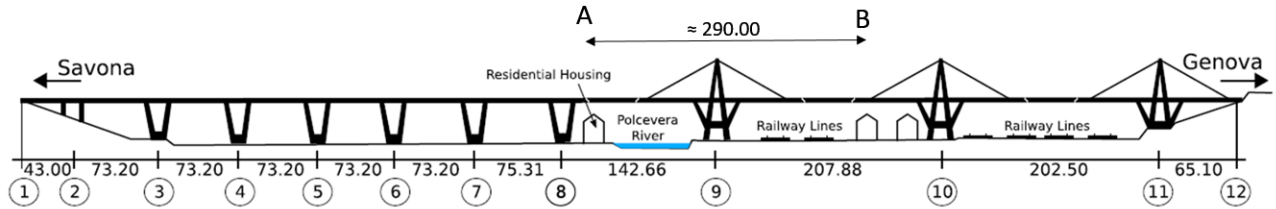
Fig. 1: Two-dimensional structural scheme of the bridge, from West (1) to East (12). Dimensions in meters [6].

stressed concrete stays [9]. This bridge connected the motorways Milan-Genoa and Genoa-Savona, crossing a heavily urbanized area and rising above civil and industrial buildings. The bridge was a prestressed concrete cable-stayed bridge composed of 11 spans, for a total length of about 1102 meters, supported by two single piers (1 to 2), six V-shaped piers (3 to 8) consisting of two reinforced concrete inclined piers, and A-shaped frames consisting of three independent balanced systems (see Figure 1). The three-span continuous deck were supported by stay cables, made of steel and concrete shells casted around the cables [8]. The function of these shells, besides protecting the steel cables, was to reduce the cable elongation during the passage of traffic loads because of prestressing of the shells themselves. The deck was entirely made of reinforced concrete.

On August 14, 2018, one of the three balanced system (the number 9 in the Figure 1) collapsed, causing the death of 43 people. The collapsed balanced system is highlighted in red in the Figure 2.

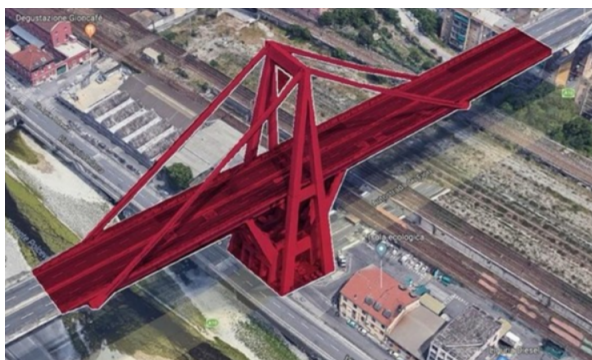
Fig. 2: Collapsed stack 9 balanced system highlighted in red [10]

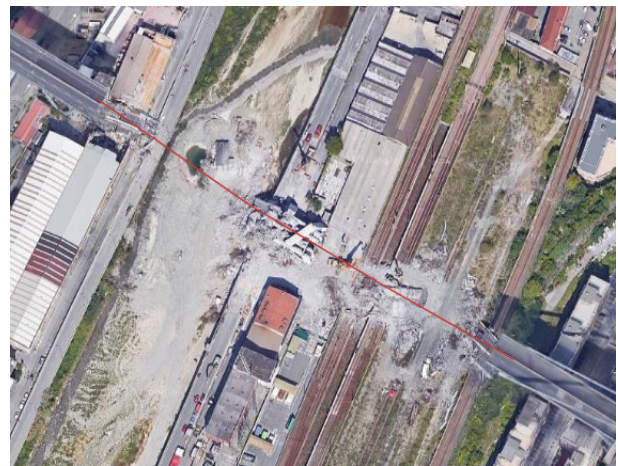
Fig. 3: The single line covering the stack 9 balanced system: only measures on this line have been considered.

Analysis has been carried out from August 2017 to August 2018, until a few days before the bridge collapsed. In particular, a single line covering the stack 9 balanced system (see Figure 3) has been considered, along which the time-series displacement map for a certain number of selected pixels was built.

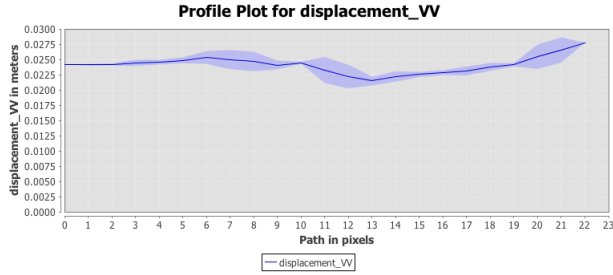
Fig. 4: Displacements along the bridge from 08-08-2017 to 08-20-2017

For the pair of images 08/08/2017 – 08/20/2017, in the Figure 4 the displacements are shown once the Profile Plot tool of SNAP has been applied. This information has then been acquired for the whole sequence of master-slave pairs of images, over the one-year monitoring period, by obtaining a set of vectors describ-

ing how the points on the bridge were moving overtime, as shown in the Figure 5. For the sake of clarity, it is worth to clarify that geographical coordinates have been converted into distances between pixels, therefore the two Figures 4 and 5 display number of pixels in one case, and meters in the other. Moreover, in the Figure 6 a different perspective of the previous results is shown. This work is in progress and detailed description of the methodology and discussion of results will be presented in the final paper. Yet, it is already possible to highlight how the portion was subjected to stress over the one-year period. It is worth to say that the difference of displacements of a point of the deck near the antenna, during the observed period, was in agreement with the results reported in [11]. This corroborates the reliability of the proposed methodology.

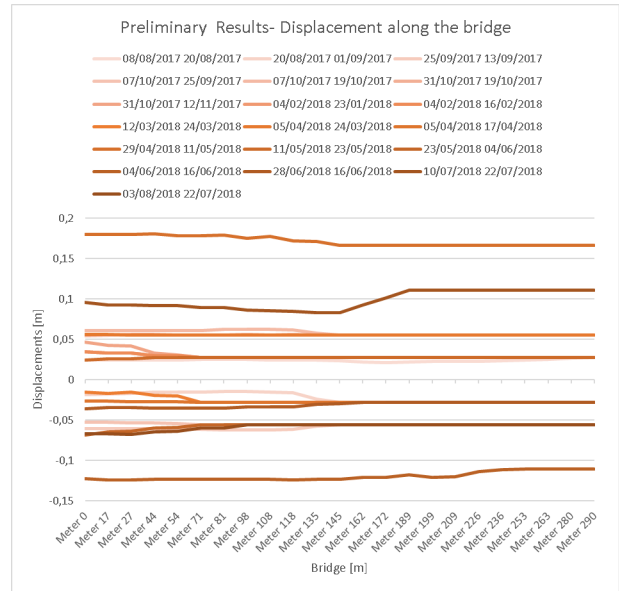
Fig. 5: Preliminary results - Detected displacements along the bridge

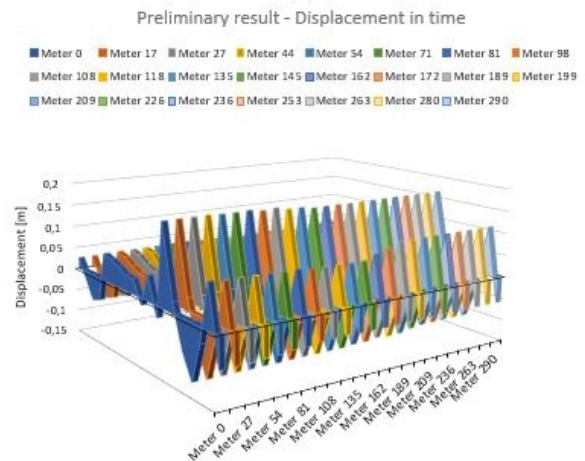
Fig. 6: Preliminary results - Detected displacements in time
