INTERNATIONAL CONFERENCE INSTRUMENTATION FOR COLLIDING BEAM PHYSICS  
24-28 FEBRUARY 2020

## Investigation and improvements of the mechanical structure of Cylindrical GEMs for the BESIII experiment

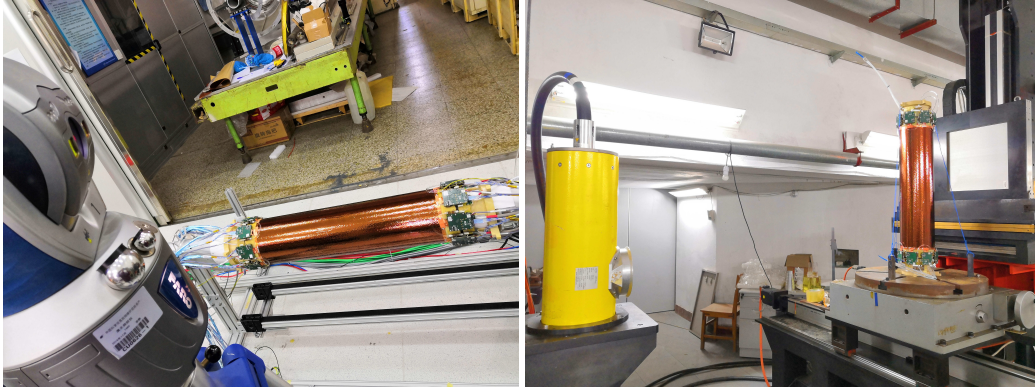
- Laser Surface Measurement. The external structure of all the detectors shipped to Beijing has been measured with a laser machine. The goal was to bring to light any defect caused by inappropriate torsion, stretch or compression during the handling or the assembling of the layer together. The measurements were performed with a laser tracker (figure 1) acquiring as many points as possible of the surface to reach the highest precision. The test was performed by measuring the circumference in different points along the length of the detector on the part facing the laser pointer. To increase the precision, the same measurements were performed multiple times.

**Figure 1:** Laser Measurements setup    **Figure 2:** Computed Tomography setup

The results, obtained with a precision of few hundreds  $\mu\text{m}$ , did not point out any major issue of the outermost part of the detector.

- Computed Tomography Scan. It has been decided to try to have a look inside the detector thanks to a industrial scan (450 keV) available in the same institute of our laboratory. Since it was the first time for such detectors to perform this kind of measurement, it has been decided to test both working and problematic detectors. This could help to run a comparative analysis of any possible issue that we could have found.

The operation started performing few X-ray scans of the detector in the horizontal position to adjust the right intensity of the beam in order to properly distinguish gaps and foils inside the detector. Then, the detector was placed in vertical position on a rotating platform and properly secured mechanically as presented in figure 2. With the detector in vertical position, a scan along its length has been performed by extracting different slices of the detector in different measurement points. An example of the resulting images is reported in figure 3.

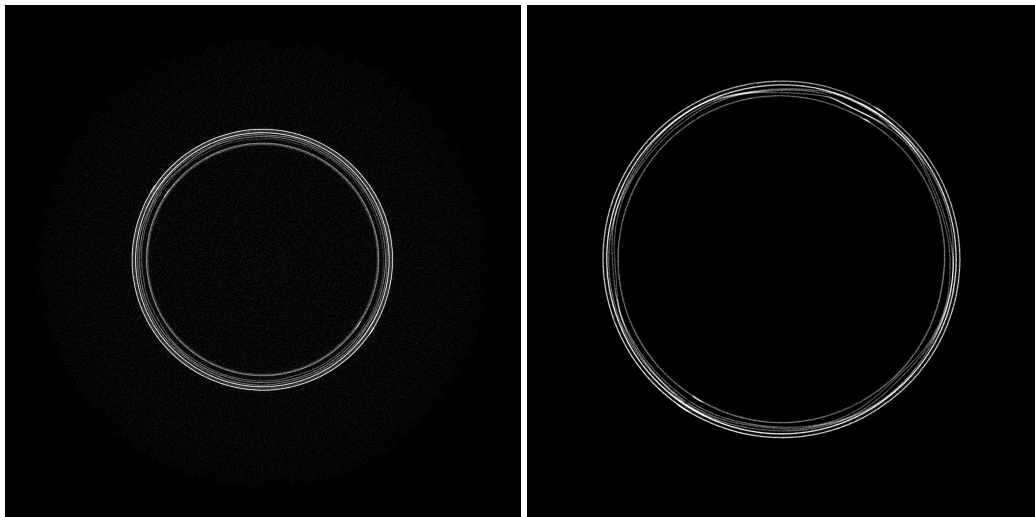
**Figure 3:** CT result of a bad detector

In both figures it is possible to distinguish, from inside to outside, the cathode with the Rohacell-Kapton sandwich, the three GEMs, the Anode, the sandwich of Rohacell-Kapton and the ground plane as most external circle. The resolution of the machine does not allow to picture the exact sizes of the foils and the gap but the important thing is to be able to see any distortion. The difference between the figures is given by the fact that in figure 3a a 'good detector' is presented, where all the foils are almost equally separated along the circumference, while figure 3b is a 'bad detector', where it is possible to notice that the GEM foils are touching in more than one point.

The results of such innovative test brought light to what we already found with the measurements of resistance and capacitance: where a shortcut was found, it is possible to see that the foils are touching.

(a) Working detector - middle layer

(b) Prolematic detector - outer layer

to open two of the non-working layers and check them inside. This operation was performed foil by foil, starting from the ground plane, scratching out the Rohacell to remove the mechanical structure, and checking the GEM foils and understand how the defects underlined by the CT presents themselves. By opening the detector, it was also possible to control if issues emerged with the mechanical structure composed by permaglass ring and two sandwiches of Rohacell and Rohacell. No major issues were found but some fragilities were pointed out. The chosen mechanics was enough for this kind of detector and its usual handling and operations. Its fragilities come out under a higher mechanic stress like the one produced by the shipping.

The outcome of these investigations brought us to understanding that the mechanical structure chosen for these detectors (Rohacell-Kapton sandwiches) was good for the material budget and for the normal operations, but it is critical for the internal structure of the detector in situations with an excess of vibration or in unexpected events like a turbulence during the shipping from Italy to China. It has been decided to proceed for the final detectors with an improved mechanical robustness.

The final detectors present the same design as the prototypes but they will differ for the mechanical support of cathode and anode. Instead of a sandwich of Rohacell-Kapton, a combination of carbon fiber and honeycomb will be used. Simulations calculated that the new structure will sustain a maximum deformation of  $15\ \mu\text{m}$  if one end of the cylinder
