Structural study of the Notre-Dame ancient *charpente*

P. Vannucci

The timber roofing structure (*charpente* or *combles*, in French) of the cathedral Notre-Dame, destroyed by the fire of April 15th, 2019, is studied. The aim is twofold: on the one hand, it is interesting to evaluate the structural behavior of the original wooden structure in view of the reconstruction of the cathedral's roof. On the other hand, its structural analysis, never done before, can help to shed a light on the design process used by the masterbuilders of the XIIIth century, and to reconstruct, at least in part, the structural thought and knowledge of the ancient builders.

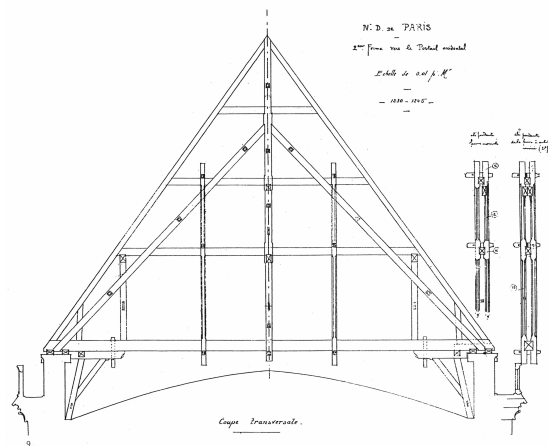
Figure 3: The survey of the second *ferme*, FN2, of the nave, according to Deneux [1927]; the *suspente* on the right side was not present, in reality.

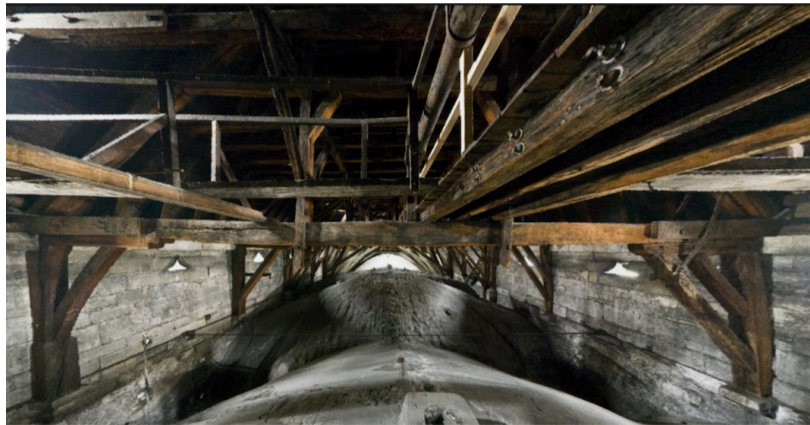
Figure 5: The *charpente* of the choir; the top of the guttering wall was, before ~ 1220 , at the level of the corbels supporting the wall pieces and braces beneath the *fermes*.

We have already mentioned that during the modifications started around 1220, the guttering wall was raised of ~ 2.70 m above the keystone of the high vault, see Fig. 5, where it is apparent that the *entrains* of the *fermes* can now well pass above the vault, while this was impossible for the *charpente* of ~ 1170 , as the top of the guttering wall was at that time at the level of the stone corbels well visible in the picture and serving as support for the lower part of the *fermes*.

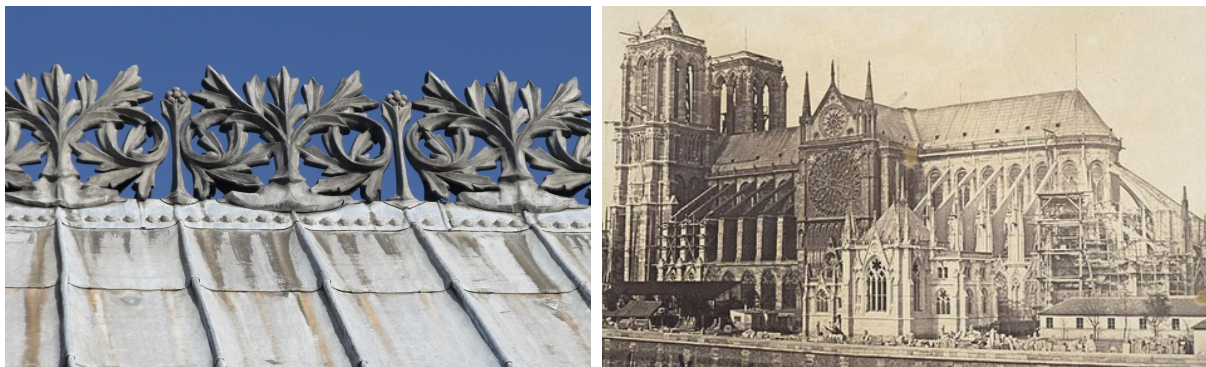
Figure 6: The lead frieze at the roof top and Notre-Dame before the restoration of Lassus and Viollet-le-Duc, without the frieze.

Originally, according to [Dubu \[1854\]](#), who wrote a history of Notre-Dame during the restoration works of Lassus and Viollet-le-Duc, the covering of the roof was made by 1236 lead plates, each one of the dimensions 0.975×3.248 m and 5 mm thick, for a mass of 120 kg each, which gives a total mass of the lead covering of ~ 2060 tons. This calculation is manifestly false: if the dimensions of a tile are correct, its mass should be of ~ 180 kg, and the total mass of the covering of 221.15 tons, not far from the value normally given of 210 tons. However, this was not the lead covering melt by the fire of April 15th, 2019. In fact, in [Lassus and Viollet-le-Duc \[1843\]](#) it is specified that the Cardinal of Noailles proceeded to the restoration of the roof in 1726 and that the new mass of the lead covering was of 220240 pounds, i.e. about 99.9 tons. Evidently, the new lead tiles had a less thickness, presumably of ~ 2.25 mm. Successively, during the restoration of Lassus and Viollet-le-Duc, the covering was made again, still with lead tiles, but now with a thickness of 2.82 mm, [Laboulaye \[1873\]](#); the tiles were welded together and fixed to the *charpente* with staples, Fig. 4 b). This was the lead covering melt by the fire of 2019. Its total mass can be estimated to ~ 135 tons. Also, a lead frieze was put on the top of the roof, that did not exist before, Fig. 6.

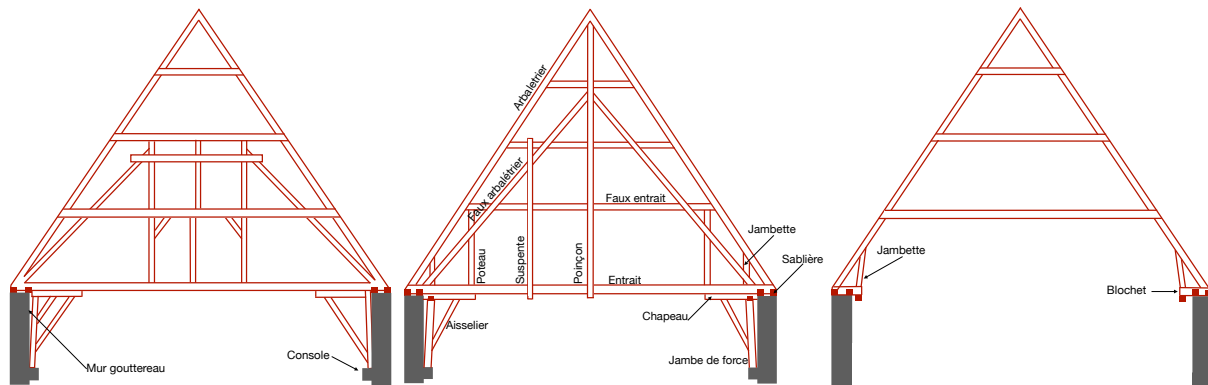
Figure 7: From left to right, scheme of a *chevron maître* of the choir, of the nave and of a *fermette*.

The *chevrons maîtres* of the choir and nave of Notre-Dame, as well as the model of a *fermette*, are shown in Fig. 7. In the same figure, the French names for the different pieces of the structure are also indicated, they will be used in the remainder of this paper. These schemes have been reconstructed using mainly Chevrier [1995] and Fromont and Trentesaux [2016]. These documents give a lot of valuable information about the structure of the *combles*, namely on the dimensions of the wood pieces.

Another point of debate is the presence of the *suspentes* on the North side of the nave's *charpente*. As apparent from Figs. 7 and 12 c), this was a clear element of dissymmetry for the frame. In [Fromont and Trentesaux \[2016\]](#) a plausible hypothesis for this dissymmetric solution is given: the *suspente* was used to support the *entrait* where a catwalk, running all along the *combles*,

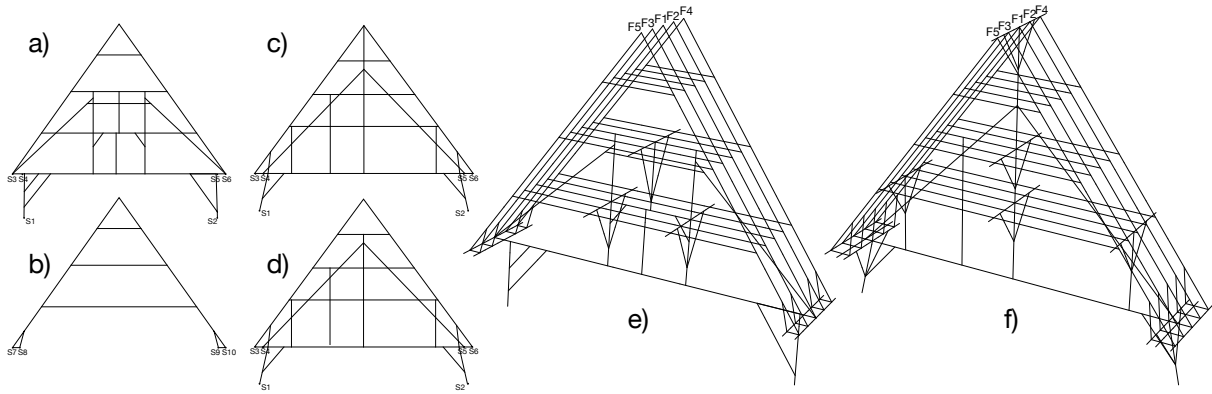
Figure 12: Schemes of the *combles*'s structure: a) *ferme principale* of the choir; b) a *fermette*; c) *fermes principales* FN1-FN2 and FN5-FN11 of the nave; d) *fermes principales* FN3-FN4 of the nave; e) the structural unit of the choir's *charpente*; f) the structural unit of the nave's *charpente*.

In the case of the nave, two different calculations are performed: one for the structural unit in Fig: 12 f), valid for FN1 to FN2 and for FN5 to FN11. The other one, for the structural units of FN3 and FN4, for which the model is slightly modified to account for some peculiarities, described above: the *suspente* is not linked to the *entrait*, the *pointon* is interrupted at the level of the third *faux entrait* and the tie connecting together the *consoles* is not linked to the *jambettes*, Fig. 12 d).

The distribution of the reaction forces for each support point, S1 to S6 for the main frame F1, S7 to S10 for the secondary frames F2, F3 and F4, F5, cf. Fig. 12, is detailed in Tab. 5 for all the *charpentés* and loading conditions (R_x : horizontal reaction; R_y : vertical reaction). The distribution of the reactions is almost symmetric between the South and North sides, though not exactly, due to the small asymmetries in the main frames structure. It is interesting to notice that not all the supports are active for the vertical load (condition OW): for the choir, the supports S7 and S10 of the *fermettes* are inactive, as well as S9 for F2 and F3 of the nave's *charpente* exception made for the part between FN3 to FN4. We can also observe that the vertical reactions in S1 and S2, i.e. at the level of the corbels supporting the *jambes*, is far less than that absorbed by nodes S3 to S6, on the guttering wall's top, for the choir's *charpente*, while it is higher in the nave, due to the different arrangement of the structure. This confirms that the system of wooden *consoles* is not determining in supporting the vertical loads, as already commented. For the loading condition OW+W, the situation is different: the presence of the *jambes* strongly affects the distribution of the reactions. The set of supporting nodes changes: in the choir, nodes S3 on the North side (the wind is simulated to blow from the South, where the cathedral is more exposed to the wind) are heavily charged, while nodes S4, S5, S8 and S10 are inactive. Nodes S6, S7 and S9 are also active, but with a reaction force far below that of S3. The node S1 is charged only horizontally, to entirely absorb the wind thrust, while S2 is charged in the vertical direction, as an effect of the roof's slope, see below. In the nave, due to the different scheme, S2, S4, S6, S8 and S10 are inactive, while S1, S3, S5, S7 and S9 active. It is interesting to notice the high reaction at node S5, consequence of the structural scheme. The distribution of the reaction forces is depicted in Fig. 15, for the original state. Better than the data in Tab. 5, this two figures let see how the distribution of the reactions on the top of the guttering walls was far from being uniform. The main part of the load is transmitted by the *chevrons maîtres*, that play a fundamental role in the structural functioning of the *combles*.

The number of the frames and nodes is indicated in Fig. 12

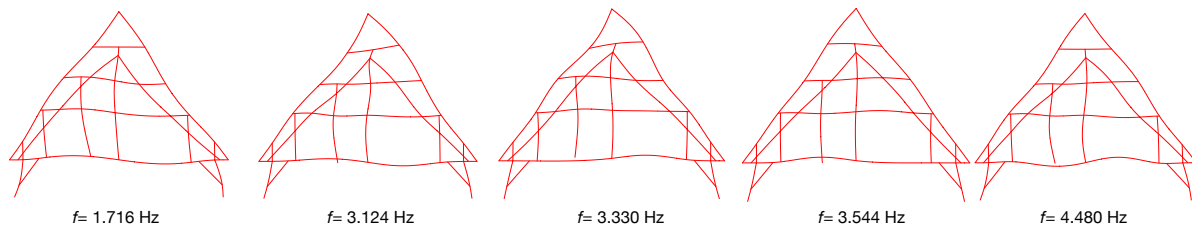
Figure 14: From left to right: the first five modal forms of FN3, CAST3M simulation.

Mode	Frequencies of vibration [Hz]	
	SAP	CAST3M
1	1.749	1.716
2	3.138	3.124
3	3.462	3.330
4	4.945	3.544
5	6.181	4.480

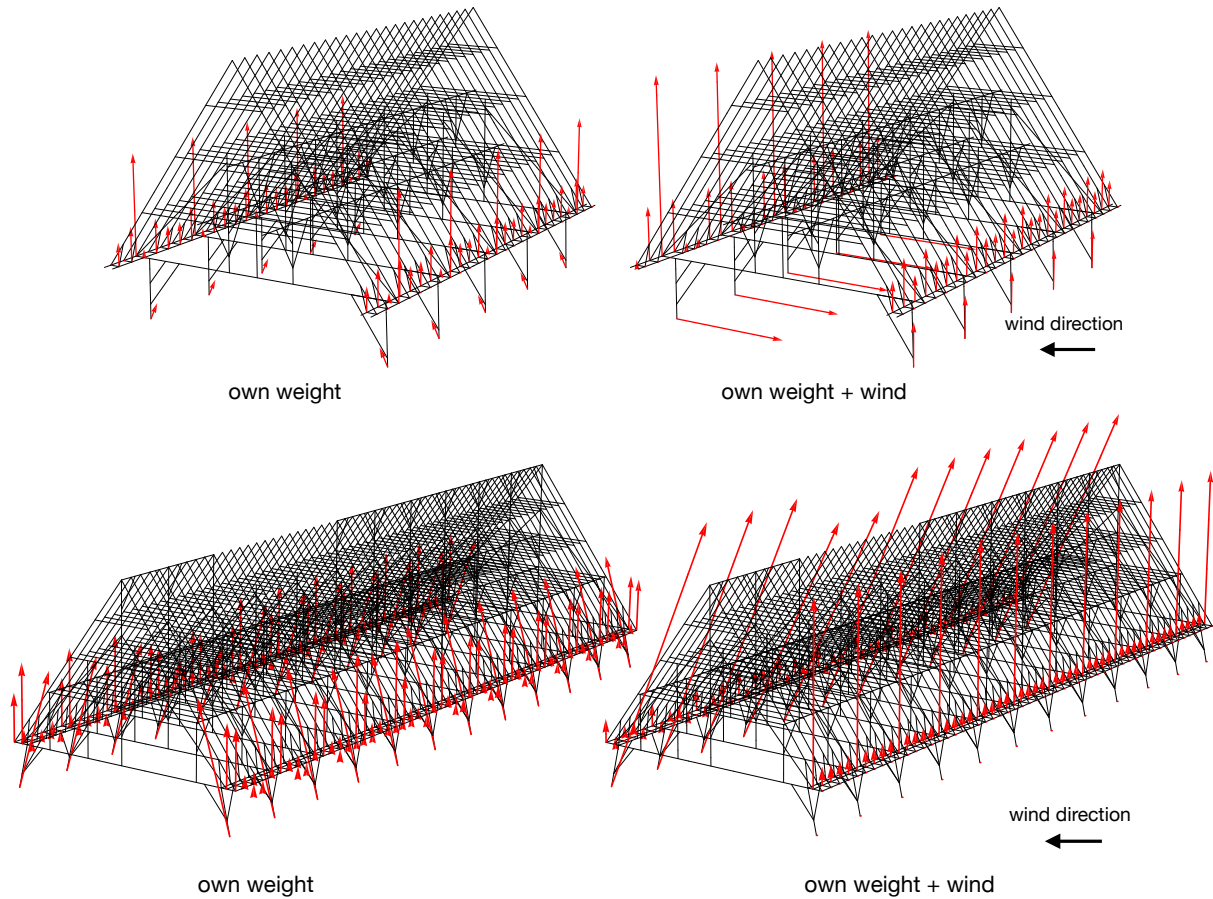
Figure 15: Distribution of the reaction forces in the original state; top, the choir's *charpente*, bottom the nave's one.

distribution w_1 on the windward side, Fig. 13, which explains the positive reaction in nodes S2, S6 and S9 of the choir and the high reaction at node S5 of the nave's *charpente*. Of course, we cannot affirm with certitude that the Goths were conscious of this fact (the moment of w_1 becomes an overturning one at a slope of 60°), though the concept of moment of a force and its role in the equilibrium of a mechanical system was already roughly grasped in the Middle Ages, see Benvenuto [1981]. Nevertheless, the slope of the *combles* has at the same time a stabilizing effect for the wind actions and allows to decrease the bending of the *chevrons*, two real structural advantages. In Tab. 5 the resultant of the reactions is also indicated. This gives also an estimation of the global loads and weights; they are summarized in Tab. 6.

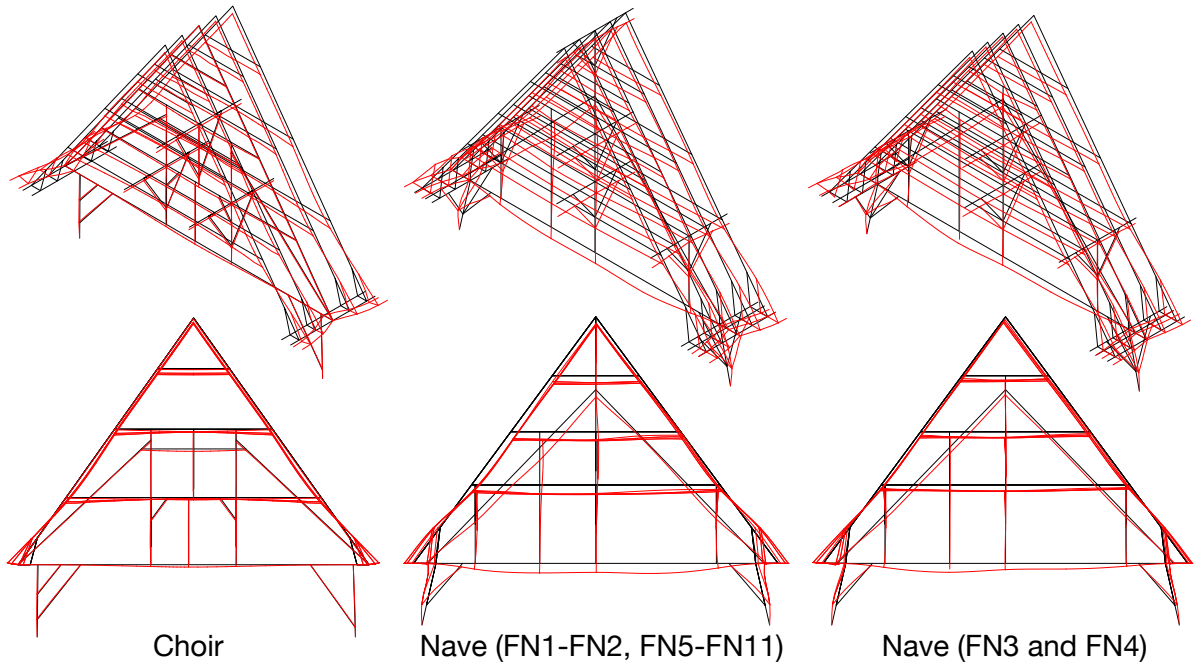
Figure 16: Deformation of the structural units of the *charpente*, in the original state, for the own weight (displacements magnified).

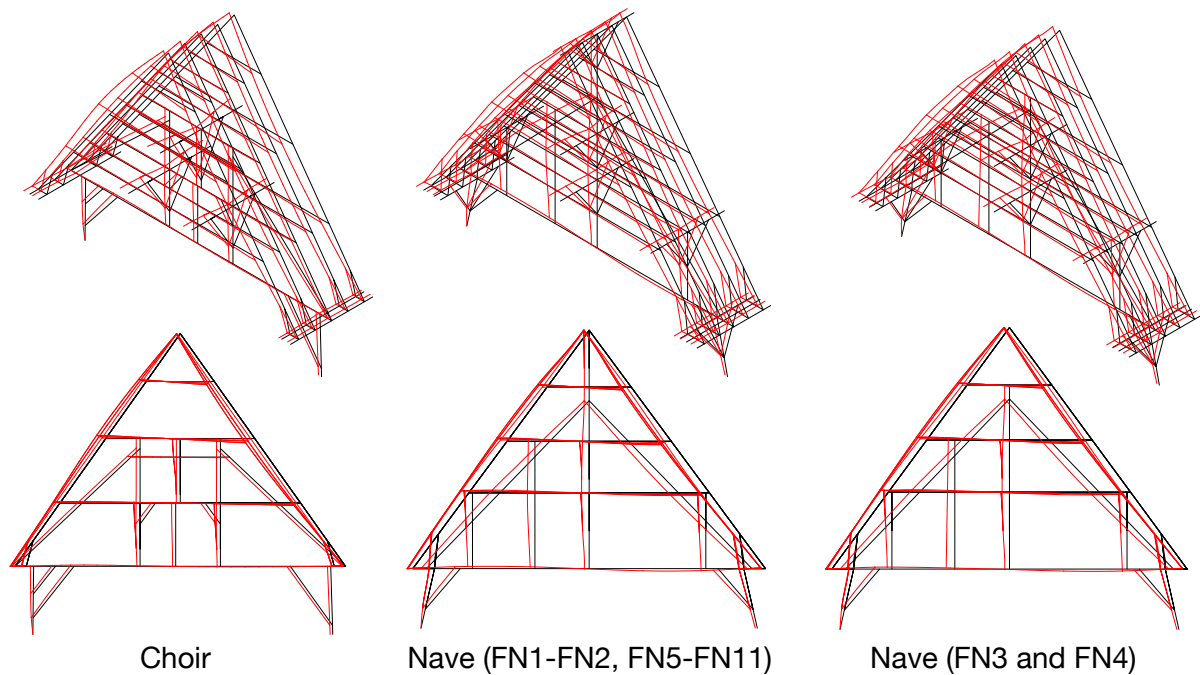
Figure 17: Deformation of the structural units of the *charpente*, in the original state, for the own weight and wind (displacements magnified).

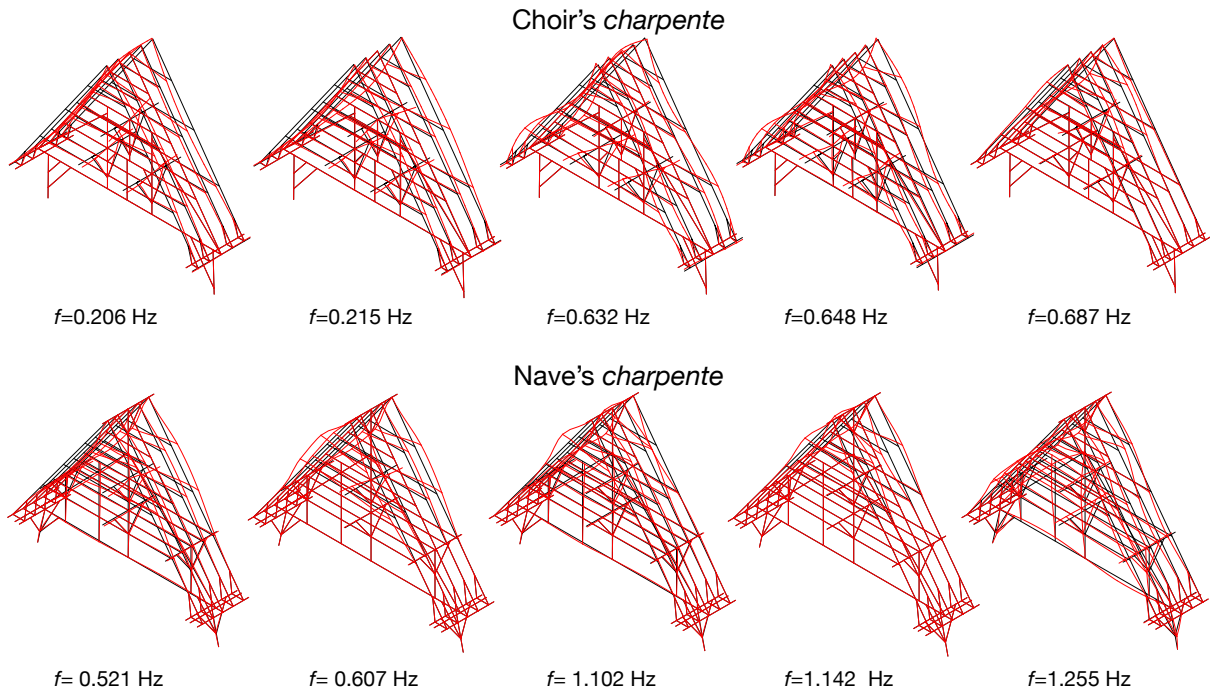
Figure 18: First five normal modes and corresponding vibration frequencies, original state.

A comparison of the frequencies of the first five fundamental modes is presented in Tab. 13. The evaluation has been done with the same assumptions used for the check of the friction mechanism, in the previous Section: all the nodes from S1 to S10 are fixed bilateral supports. Actually, to perform a nonlinear dynamical simulation with unilateral contacts is out of the scope of this study while a simulation done with fixed supports remains sufficient to compare the two structures to have an assessment of their respective stiffnesses.

What is apparent from the results shown in Tab. 13 is that the nave's structural unit has a stiffness sensibly greater than that of the choir's one. Comparing the fundamental frequencies, mode 1, we can see that the frequency of the nave's structural unit is ~ 2.5 times that of the choir's one. This is a clear, tangible sign of the better structural conception of the nave's *charpente* with respect to that of the choir. The frequencies of the structural units of FN3 and FN4 are slightly lower than those of the other parts of the nave's *charpente* for the differences between these structural units of the nave's *combles*, already described in Sect. 4.1, differences
