# Neutron emission from fracturing of granite blocks: An experimental revisitation

A series of experimental tests, such as those of Carpinteri et al. (2013), have been performed. The aim was to check the emission of neutrons in the fracture of Luserna granite blocks under mechanical loading, as reported by the above mentioned authors. No neutrons have been detected and some doubts have emerged on the soundness of the previous measurements.

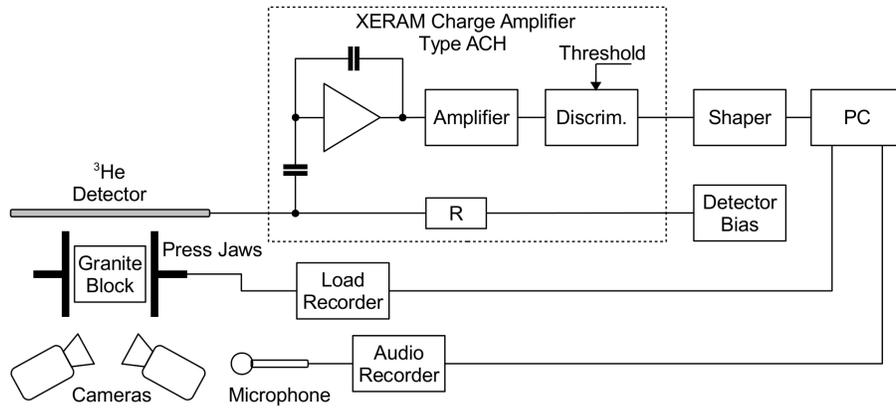
Figure 1: Schematics of the experimental set-up used in the compression tests.

Our experimental set-up is sketched in Fig. 1. The cubic specimens were Luserna granite, the same material used by Carpinteri et al. in their tests, having dimensions either  $10 \times 10 \times 10 \text{ cm}^3$  or  $10 \times 10 \times 8 \text{ cm}^3$ . No differences were observed between them, except the collapsing load. The neutron detector used in the compression tests is a  $^3\text{He}$  type 65-NH-45 manufactured by Xeram, (France) with its standard electronics [6, 7]. The detector (25 mm diameter, 450 mm long) is exactly of the same model of that used in [1]. Its thermal neutron sensitivity is 65 cps for a thermal neutron flux of  $1 \text{ neutron s}^{-1} \text{ cm}^{-2}$ . During the tests the detector was powered at 1.4 kV by means of a high voltage CAEN N126 power supply. The electronics performs an integral-differentiation of the  $^3\text{He}$  signal ( $1 \mu\text{s}$  integration,  $4 \mu\text{s}$  differentiation) followed by a discrimination which supplies output TTL pulses ( $10 \mu\text{s}$  width). The time width of these pulses was stretched to 1 ms by means of a Gate Generator (CAEN 2255B), the output of which was directly connected to the input of a PC sound card board used as data-acquisition card allowing the sampling of the input pulses at 10 kSa/s and giving the time of occurrence of each  $^3\text{He}$  count with a precision of 0.1 ms. The sensitivity of the  $^3\text{He}$  detector was checked before the measurements against a known neutron flux [8]. The press employed is a servo-hydraulic “200 Mp Compression Testing Machine model 200 D 76”, manufactured by Amsler (Switzerland) [9]. The maximum value of the applied loading force is 2000 kN. The adopted instrumentation was integrated with two video cameras and an audio recorder. The acquisition of  $^3\text{He}$  pulses, mechanical load, video and audio signals was synchronized at the beginning of each run.

The minimal possible distance between the center of the rock sample and the detector was 26 cm. In comparison with [1], there is a reduction of a factor six in the collected solid angle, nevertheless, according to the data in Table 2 of the same reference, more than one neutron should still be detected in the crash.

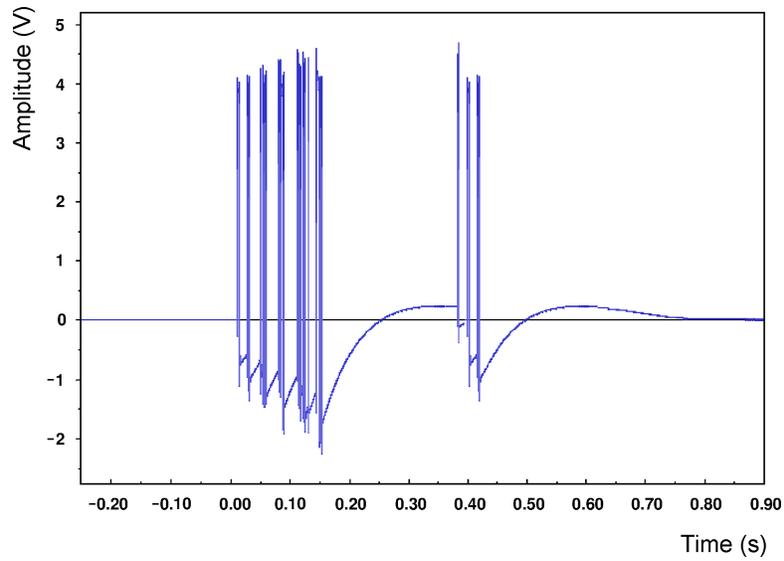
Figure 2: Acquired  $^3\text{He}$  signals showing many TTL pulses surfing over a strongly perturbed baseline.

In one of the earliest test, the  $^3\text{He}$  detector was accidentally hit by a mechanical component of the hydraulic press. The acquired signal, shown in Fig. 2, presented a complex waveform in which many TTL signals were surfing over a strongly perturbed baseline. The corresponding  $^3\text{He}$  counts are shown as black dots in Fig. 3, together with the loading force exerted by the press on the specimen (red line). The vertical blue dashed line in the plots indicates the crashing time. At first glance these signals should have been associated to neutrons detection but, because of the mentioned shock accident and the high number of associated pulses, it was impossible to rule out a mechanical effect on electronics. Furthermore, even an acoustic effect was eligible, as supposed in [3].

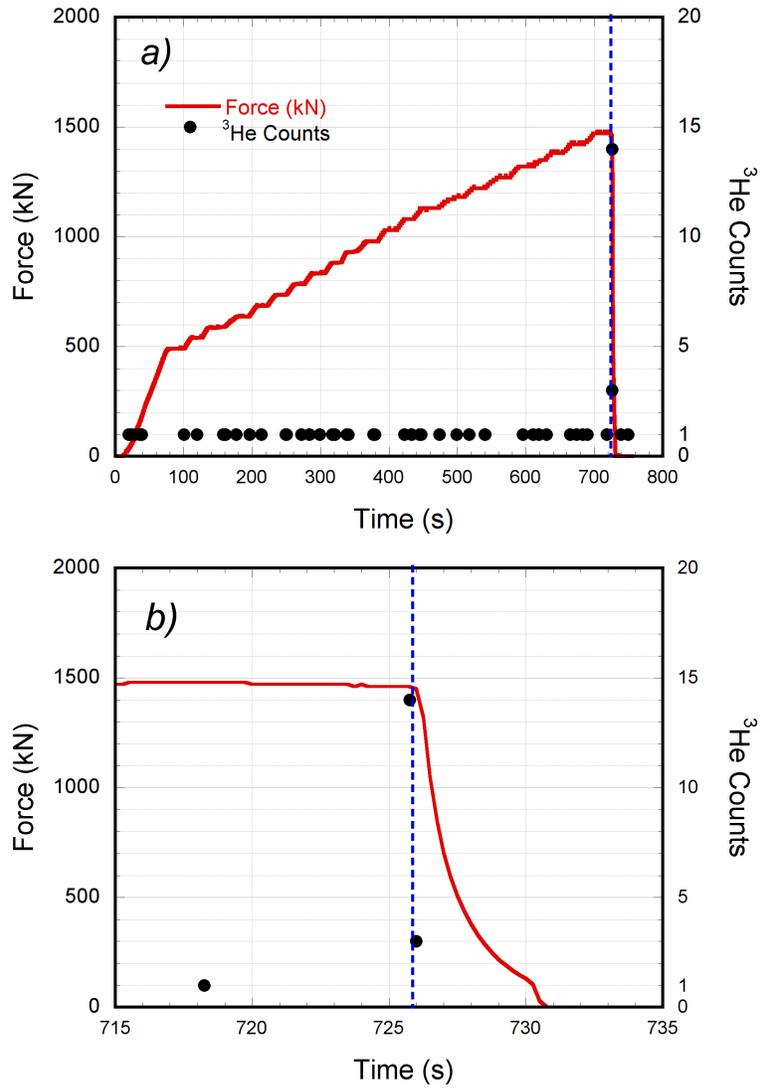
Figure 3:  $^3\text{He}$  counts (black dots) together with the loading force on the specimen (red line) in one early test with the unshielded neutron detector. In a) the whole experimental test time is plotted whereas in b) a zoom around the crashing moment is represented. The vertical blue dashed line, in the plots, indicates the crashing time.

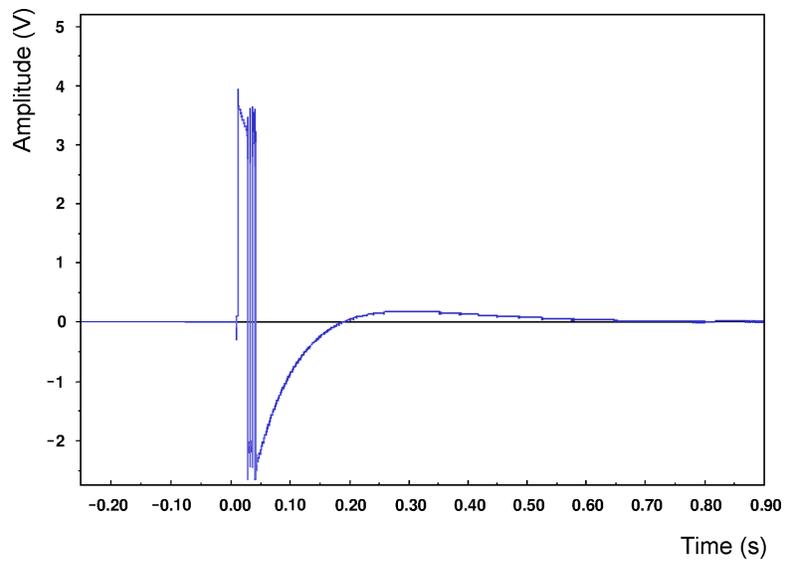
Figure 4: TTL signals acquired when a blank gun was fired near the  $^3\text{He}$  detector.

This last hypothesis found a proof when we intentionally fired a blank gun near the  $^3\text{He}$  detector: TTL signals were recorded, exactly as in the case of neutron occurrence, as shown in Fig. 4. Following this finding, we started a systematic investigation of this artifact in the detection unit. To this purpose, we repeated the test with the blank gun mentioned above by installing an increasing amount of acoustical shielding material, until we found no additional pulses above the background single ones at all.

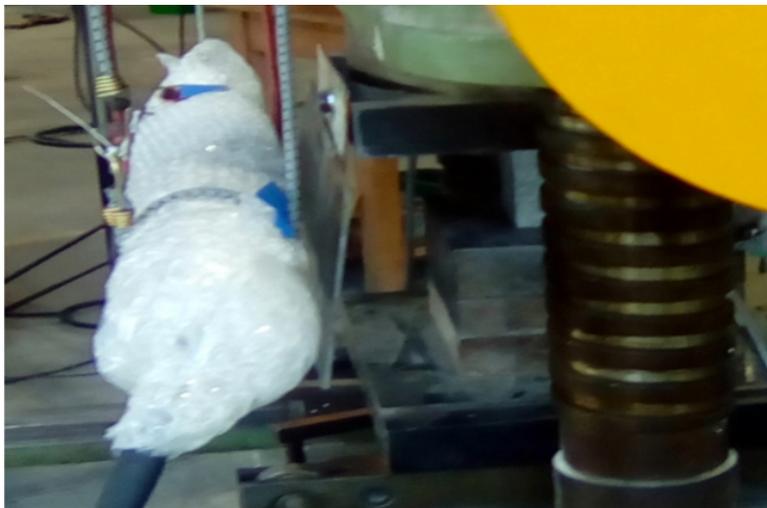
Figure 5: The mechanical press, the granite block inside its jaws and the detector, suspended and wrapped in a white protective plastics. The  $^3\text{He}$  detection system was recalibrated against thermal neutrons with this protection in place.

Eventually a suitable protection was achieved, i.e. no pulses observed above the background ones, and test on granite restarted. This protection, as shown

in Fig. 5, was made of tubular foam covering the  $^3\text{He}$  tube, its cable and the preamplifier. Furthermore, the detector was wrapped with a pluriball foil. Of course we were aware that the gun shot wasn't necessarily equivalent to that generated in the collapse of the granite specimen, but we considered a success to have at least eliminated this kind of perturbation. As matter of facts, after then we never observed a neutron signal in conjunction with the collapse of granite blocks, except the single pulse background. A record of a typical test is reported in Fig. 6.

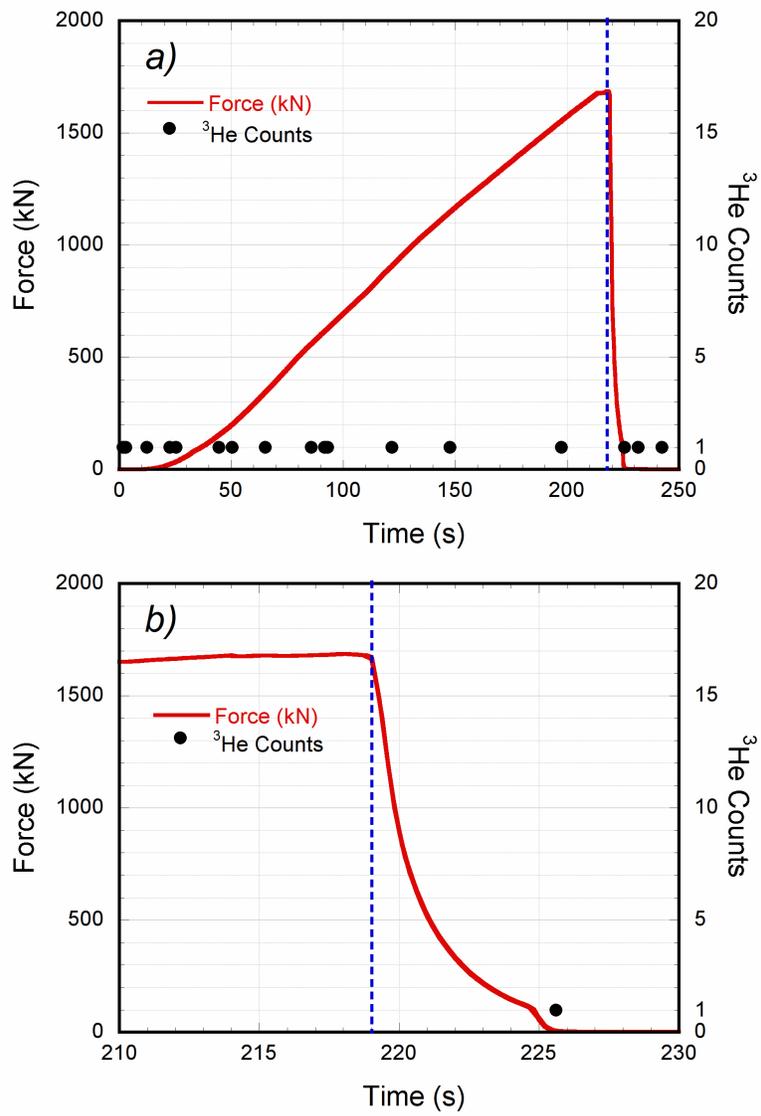
Figure 6:  $^3\text{He}$  counts (black dots) together with the loading force on the specimen (red line) for the test with the whole neutron detector protected against acoustic effects. In a) the whole experimental test time is plotted; in b) a zoom around the crashing time is represented. The vertical blue dashed line, in the plots, indicates the crashing time.

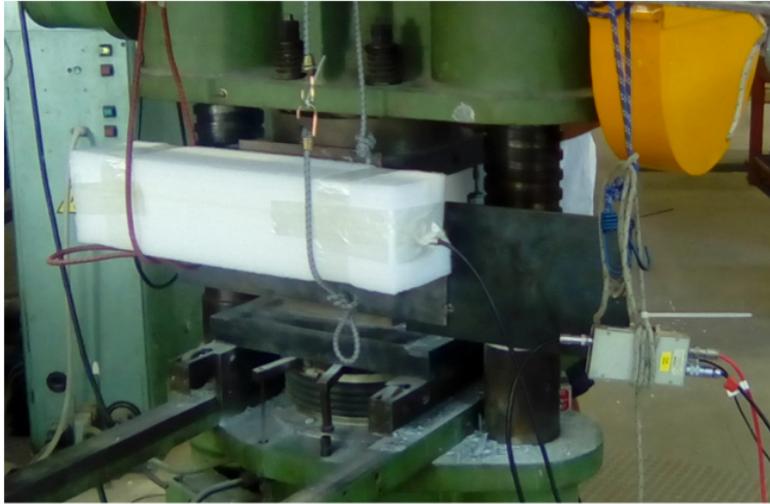
Figure 7: The suspended detector, embedded in polystyrene protection and the preamplifier, now unsheltered.

Once ascertained that with a suitable protection of the detector, at the time of the collapsing of the Luserna granite, no signal occurred, neither from detected neutrons nor from acoustical effects, it was decided to repeat tests without acoustic protection, except for the  $^3\text{He}$  tube, where the protection was replaced with a polystyrene shield, as shown in Fig. 7. Apparently this last configuration had also been adopted in the work of Carpinteri et al. [1].

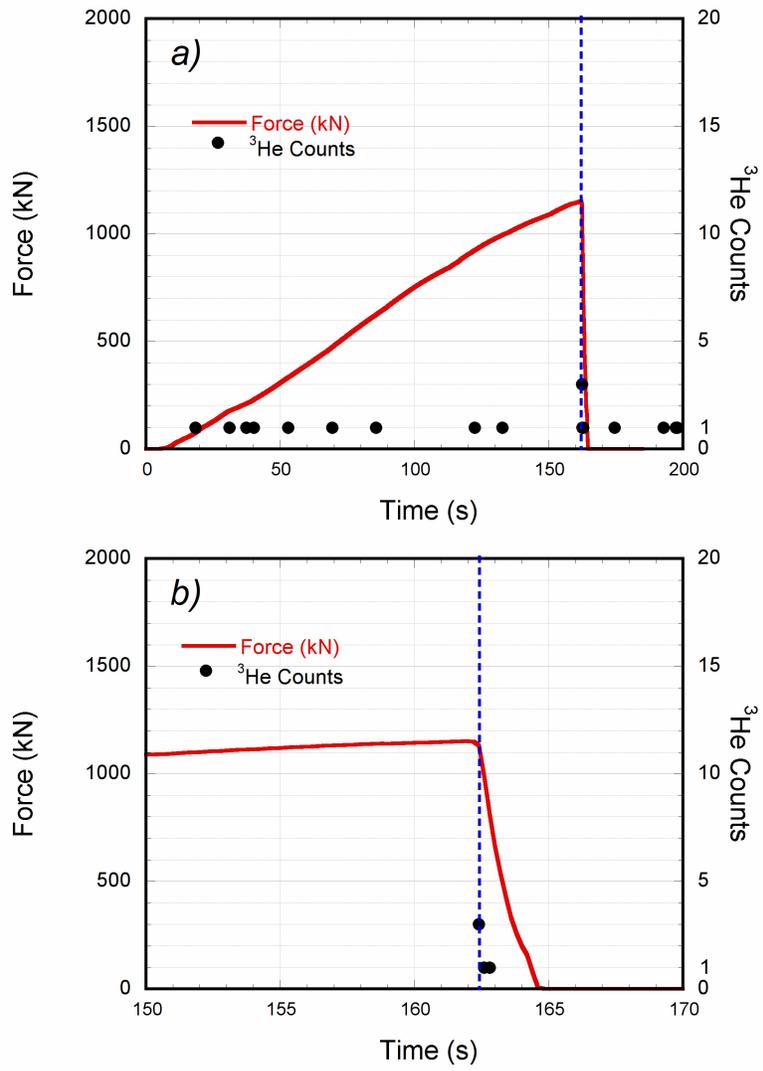
Figure 8:  $^3\text{He}$  counts (black dots) together with the loading force on the specimen (red line) when only the  $^3\text{He}$  detector is protected by a polystyrene shield, as by a way in [1]. In a) the whole experimental test time is plotted whereas in b) a zoom around the crashing moment is represented. The vertical blue dashed line, in the plots, indicates the crashing time.

Not only the system was now sensitive again to the blank gun but also at the crashing time of a granite block the TTL signals appeared again (Fig. 8) confirming that even the preamplifier/cable are sensitive to the acoustic noise.
