Improving fretting corrosion resistance of CoCrMo alloy with TiSiN and ZrN coatings for orthopedic applications

Abstract

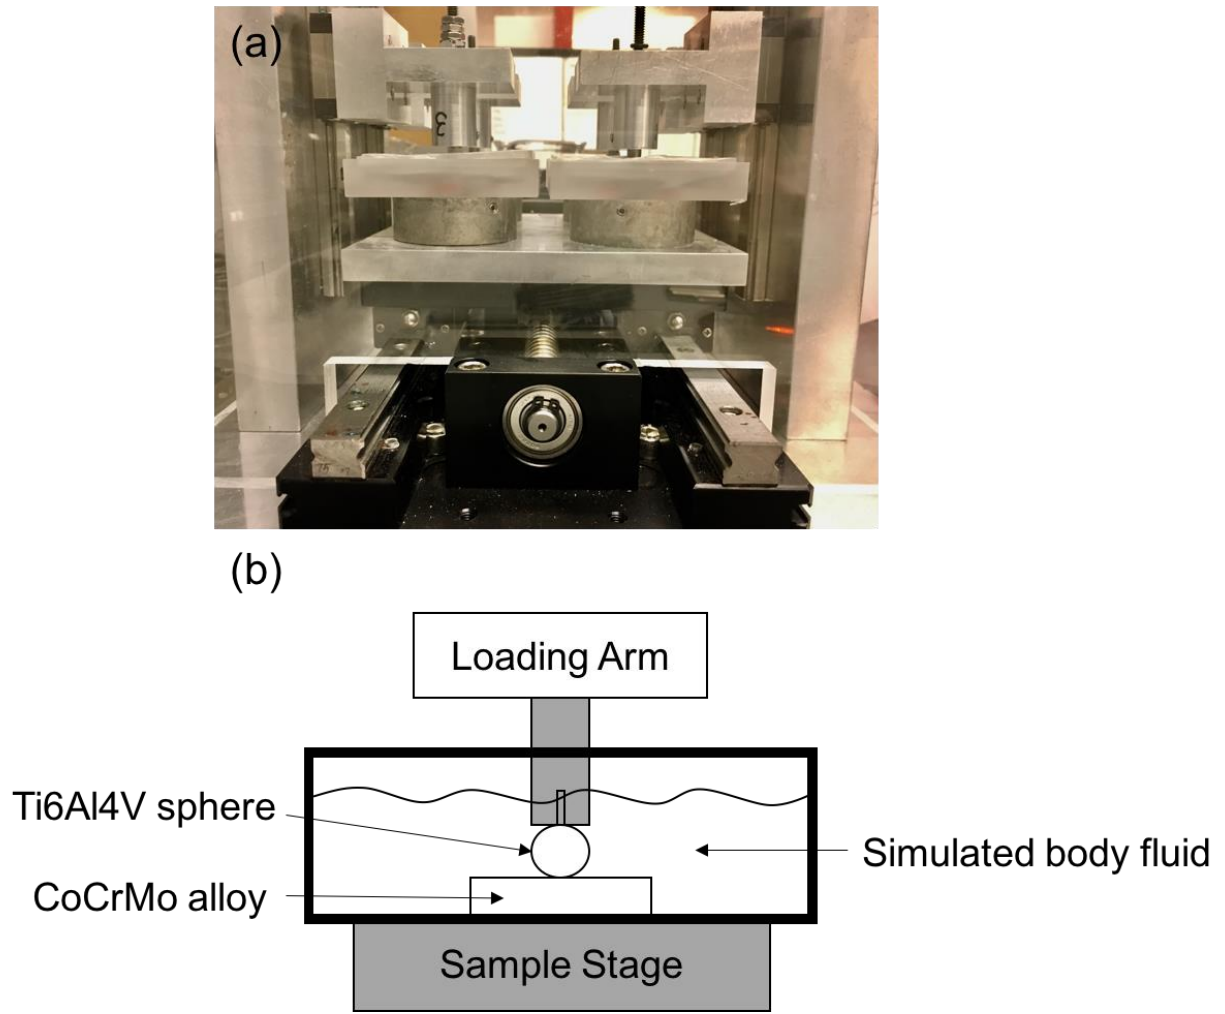
Figure 1. (a) Side view of four-station fretting apparatus. (b) Illustration of the setup of each station.

Fretting corrosion tests on Ti6Al4V-CoCrMo (coated and uncoated) couples were conducted using a four-station fretting apparatus based on linear reciprocating action similar to a previously used machine [39] (Figure 1). An environmental chamber enclosed each individual sample test station, and the fretting tests were carried out in simulated body fluid (SBF). SBF was prepared according to the literature [58] and kept at pH = 7.40. Ti6Al4V spheres (ASTM F136, Dongguan Tengyue, Guangdong, China) 5 mm in diameter were used to wear against both the uncoated and the arc-PVD coated CoCrMo specimens. Nine samples in total were used in fretting corrosion tests (three on the CoCrMo substrate and three on each of the two coated Co alloy groups). The tests were carried out with a normal load of 2.3 N creating maximum Hertzian contact stress of around 744.8 MPa calculated from the equations in the literature [59]. The frequency was set at 1 Hz with a sinusoidal motion of ± 25 μ m in amplitude generating a total linear fretting amplitude of 50 μ m for 1 million cycles. After the tests, the wear scars were examined with SEM and wear products were collected with acetate cellulose replicating film (Ted Pella) and analyzed with EDS. The film was first softened with acetone and then placed on the surface of the fretted CoCrMo specimens. After acetone volatilization, the film was stripped off the specimen so that the wear particles were transferred onto the film. An optical profilometer (Filmetrics Profilm 3D, KLA) was used to measure the wear track after collection of the wear particles and the wear volume was estimated.

One aim of this study is to simulate fretting corrosion that would occur *in-vivo*. Therefore, a homemade fretting apparatus re-designed from a previous report [39] was used instead of commonly used pin-on-disk tribometer. This device enabled us to perform tests on four samples simultaneously in a simulated physiological environment with a small sliding amplitude. We also specifically chose simulated body fluid in this study to ensure a similar environment to that experienced *in-vivo*. A maximum Hertzian contact stress of around 745 MPa was applied in fretting tests, which is much higher than that experienced in implants [62]. This higher contact stress, however, was proven to be effective in examining not only the two coatings but also CoCrMo substrate in laboratory settings. With the apparatus, we were able to reproduce similar fretting corrosion results (both ion release and particle formation) that were observed from retrieved implants in a clinical study [10,63]. The contact stress applied in our fretting tests is well below the hardness of unmodified and modified CoCrMo. However, severe plastic deformation was observed. This could be due to the multi-asperity contact between the two surfaces [64,65]. Fretting wear was started by the rough surface contact between CoCrMo and Ti alloy at a nanoscale. In an ideal situation, the whole contact area should be in contact. However, the rough nanoparticles on the surfaces were the ones to initiate contact against their counterpart. The nanoscale contact area gave rise to high local contact stress causing local plastic deformation. When plastic deformation happened, more particles were generated and thus leading to the spread of plastic deformation over time.

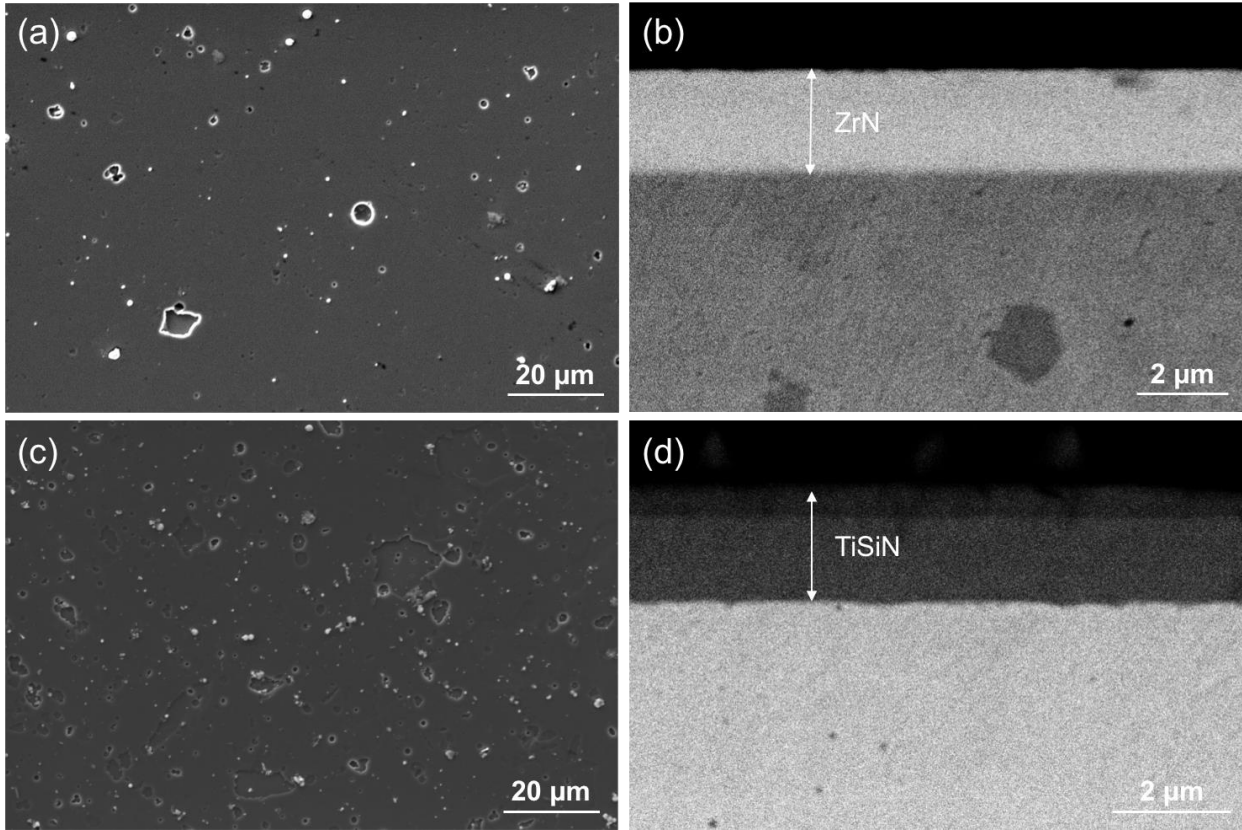
Figure 2. SEM surface morphology of (a) ZrN and (c) TiSiN coatings. Cross-sectional backscattered electron (BSE) images of (b) ZrN and (d) TiSiN coatings.

Figure 2a, 2c are SEM secondary electron images showing surface morphologies for ZrN and TiSiN coatings. The ZrN coating shows a substantially denser surface than the TiSiN coating. This can also be observed in the surface roughness values (Sq) in Table 1 measured using optical profilometer. Both coatings show increased surface roughness compared to uncoated CoCrMo substrates. Figure 3 shows EDS spectra used to determine the surface chemistry of the CoCrMo substrate and the two coatings. ZrN coatings showed strong peaks at their major components Zr and N with similar relative atomic concentrations. The signals of the substrate materials (Co, Cr, Mo) were not observed since the coating thickness is larger than sampling depth of EDS (~1 μm). For TiSiN, strong peaks can be seen at Ti and N with around 7 at% Si. The Cr signal from the interlayer was also recorded. SEM on cross-sections (Figure 2b, 2d) revealed the thickness of the coatings, which are 2.37 μm for ZrN and 1.89 μm for TiSiN.

are substantially higher than ZrN. Therefore, better fretting resistance exhibited by TiSiN is not unexpected. For surface morphology of both coatings processed by arc-PVD, SEM images show that TiSiN has substantially higher surface roughness compared to ZrN (Table 1). That could be partially due to the addition of Si into TiN that affects the grain growth during deposition process resulting in more defects on the surface [74].

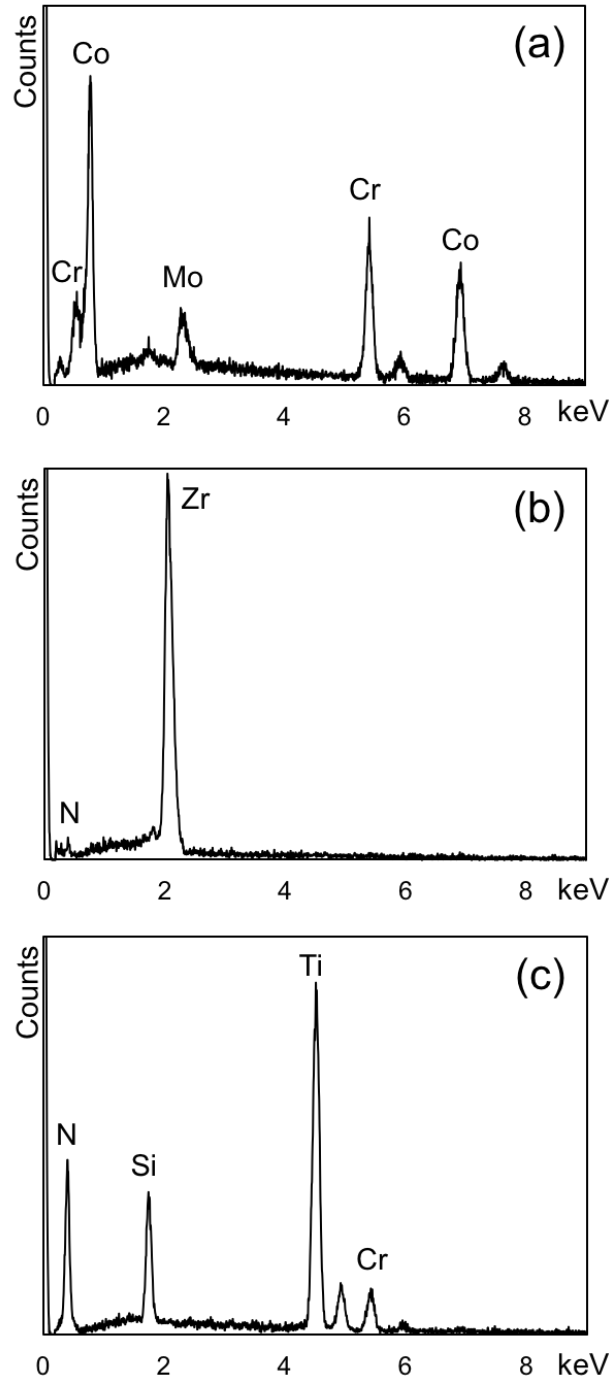
Figure 3. EDS spectra of (a) CoCrMo substrate, (b) ZrN and (c) TiSiN coatings deposited on CoCrMo.

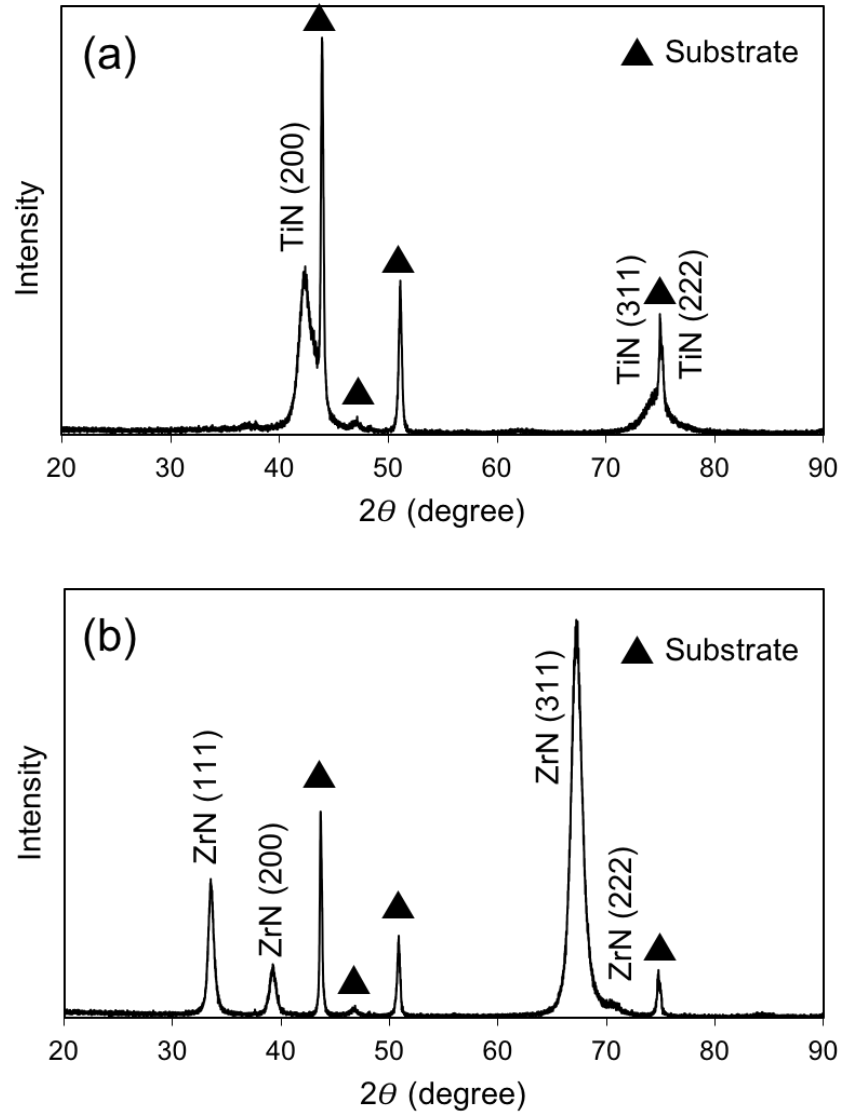
Figure 4. XRD spectra of (a) ZrN and (b) TiSiN coatings deposited on CoCrMo. Substrate peaks are labelled with triangles.

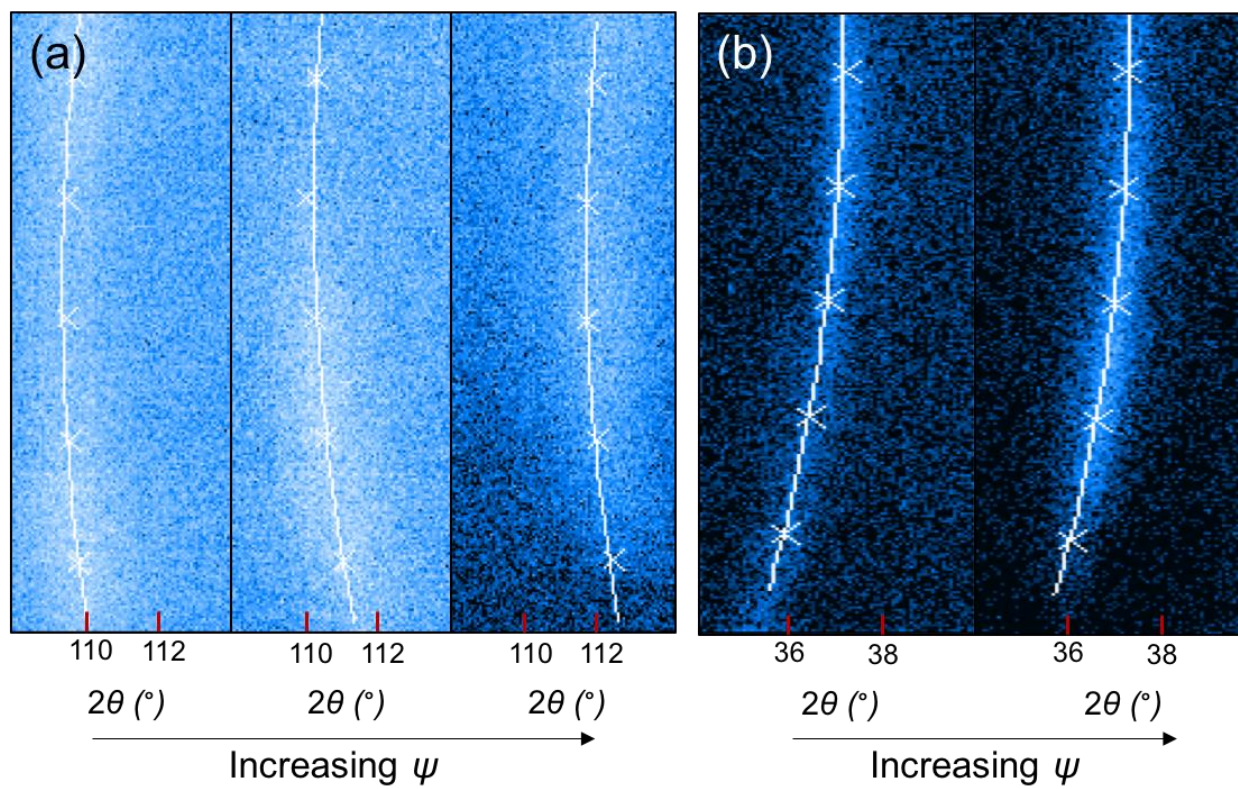
Figure 5. XRD² images of (a) ZrN in the gamma range of $-76^\circ \sim -102^\circ$ and (b) TiSiN in the gamma range of $-66^\circ \sim -91^\circ$ at different ψ angles.

Residual stress of the coatings was measured with Two-dimensional X-ray diffraction (XRD²) technique using a Bruker D8 discover diffractometer equipped with a Pilatus (2D) detector, following a protocol reported in the literature [55]. Briefly, the measurements were performed in the 2θ range of the selected peaks and samples were tilted 3 steps in the ψ -range with ϕ -angle at 0° , 120° , 240° . As the samples were tilted at different ψ angles, diffraction peaks (2θ) would be observed shifting due to the d-spacing changes caused by residual stress. Residual stress values can then be calculated through Hooke's Law. Quantitative XRD data analysis was performed using the LEPTOS software (Bruker). The peaks were integrated and fitted with Pearson VII function. A biaxial and shear model was used due to the chosen data collection scheme. The stress values were calculated using equations connecting stress tensor components to diffraction cone distortion.

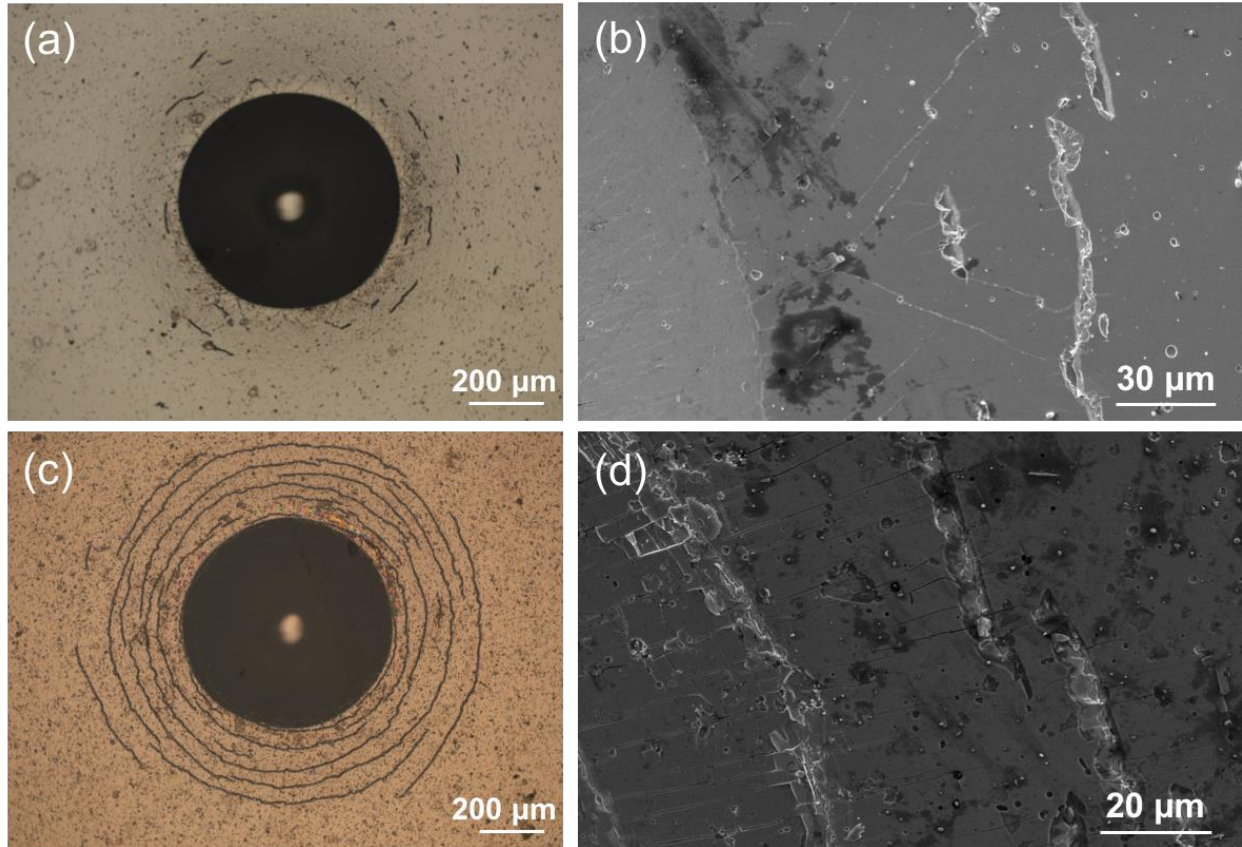
Figure 6. OM images of Rockwell indents of (a) ZrN and (c) TiSiN. SEM images of cracks and delamination spots surrounding Rockwell indents of (b) ZrN and (d) TiSiN.

Rockwell C test was conducted as a quick assessment of the adhesion of the coatings. The coatings were indented with a cone-shaped diamond tip under a load of 150 kg causing an area of coating damage. The indentation scars were then evaluated with OM and SEM. The damage was classified according to VDI3198 standard from HF1 to HF6, where HF1 demonstrates great adhesion with mild cracking and HF6 indicates unacceptable adhesion with severe delamination around the indentation scar [56]. The image of ZrN coating (Figure 6a, 6b) shows a number of radial cracks at the boundary of indentation scars as well as a few regions in which delamination has occurred. The adhesion strength of this coating can be classified as HF3 suggesting acceptable adhesion according to VDI3198 standard. The TiSiN indentation scar also shows radial cracks surrounding the indentation scar in Figure 6c, 6d. Moreover, ring cracks and several regions of delamination were observed surrounding the indent. Therefore, adhesion strength of TiSiN should also be classified as HF3.

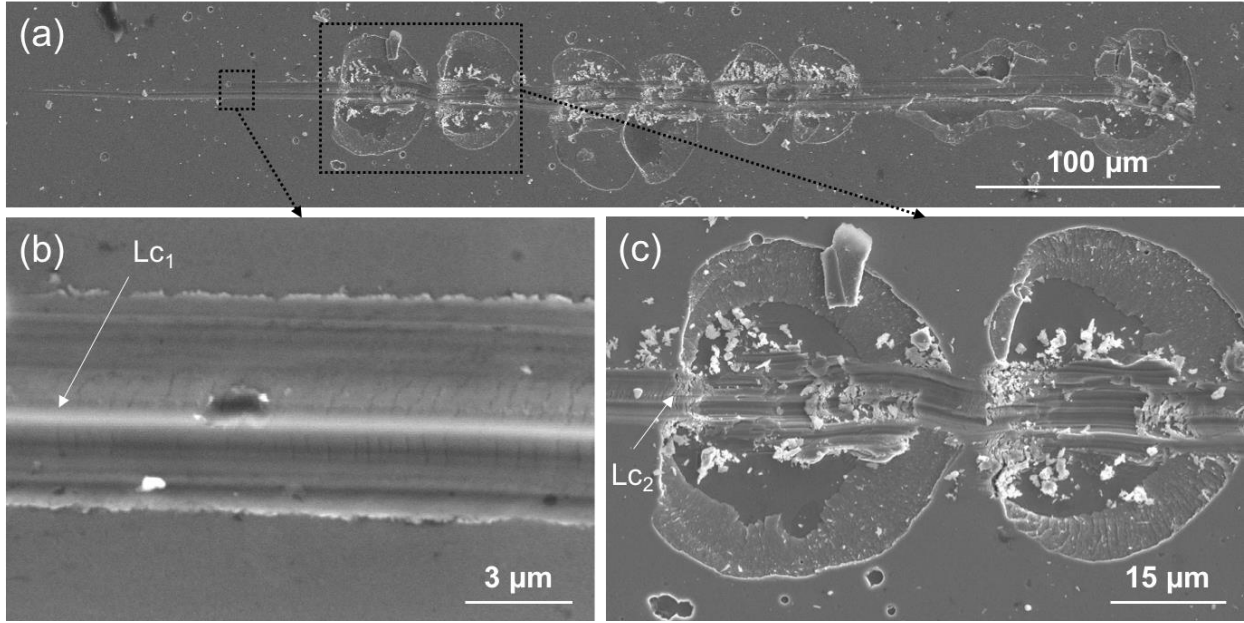
Figure 7. SEM images of (a) a typical nano-scratch track of ZrN with (b) tensile cracks at Lc_1 and (c) compressive delamination at Lc_2 .

Nano-scratch testing was used to further understand the failure mechanisms and critical load values for both coatings. The typical scratch track of ZrN is shown in Figure 7. Figure 7b shows the starting point of tensile crack propagation, which is identified as Lc_1 . As load progresses, large areas of compressive delamination, where the substrate is exposed, start to develop. The start of this type of failure corresponds to Lc_2 (Figure 7c). For TiSiN, tensile cracks are also presented at Lc_1 (Figure 8b). However, a different failure mode is observed at Lc_2 . Chipping can be seen in figure 8c. No apparent delamination can be observed even though substrate material is exposed. Table 2 summarizes the failure modes and critical load values of TiSiN and ZrN. Critical loads of TiSiN are larger than ZrN for both Lc_1 and Lc_2 . Two coatings display the same mechanism at crack propagation. Severe large area delamination is observed in ZrN as opposed to chipping in TiSiN coating.

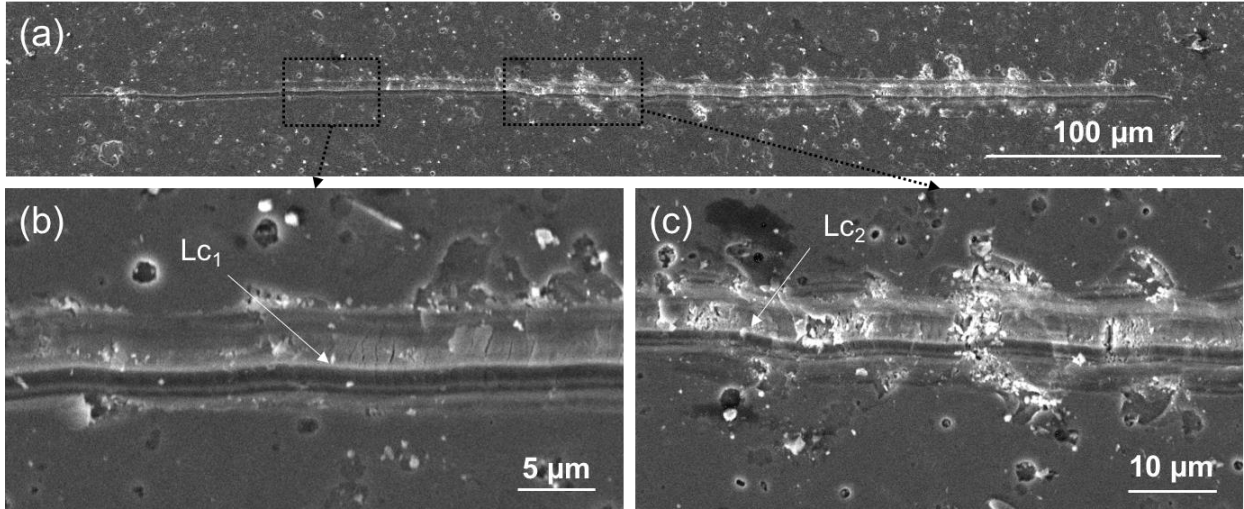
Figure 8. SEM images of (a) a typical nano-scratch track of TiSiN with (b) tensile cracks at Lc_1 and (c) chipping and buckling at Lc_2 .

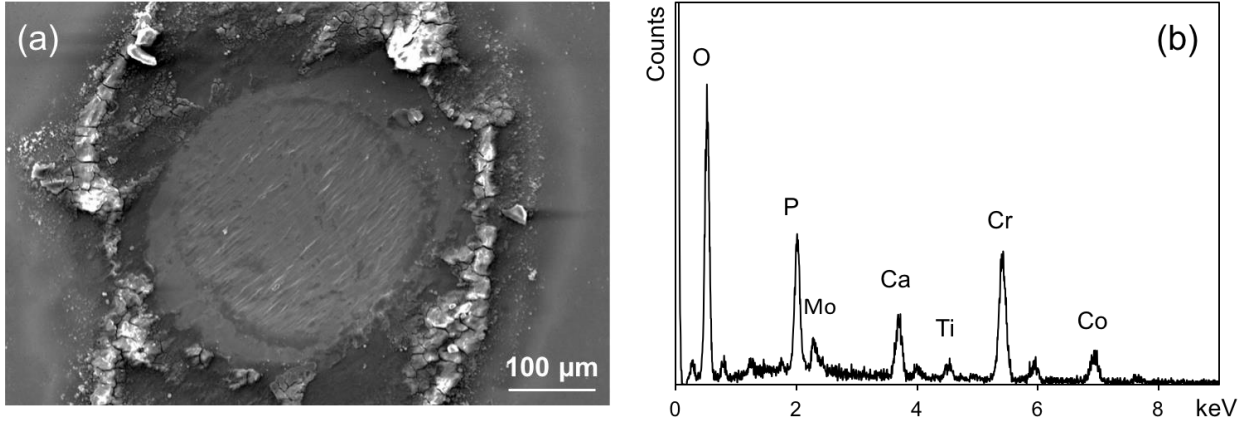
Figure 9. (a) SEM image of CoCrMo sample after fretting test. (b) EDS spectrum of the fretting corrosion products.

Figure 9a shows image of wear damage done on a CoCrMo control sample. The wear length appears to be larger than the wear amplitude used. This is caused by the Hertzian contact stress generating a contact area already larger than the total wear amplitude used in the fretting test. Bare CoCrMo substrate group is subjected to significant wear damage with substantial fretting wear particles surrounding the wear perimeter. The wear particles contain mainly Cr, Ca, P, O with depleted Co (Figure 9b), which is similar to corrosion particles obtained from retrieved implants [10]. As can be seen in Figure 10 and Figure 11, the wear damage is largely reduced by the coatings on CoCrMo alloys. However, in Figure 10, the ZrN coating was worn out during fretting test. The backscattered electron image of the wear scar shows depletion of the coating with similar composition to CoCrMo alloy. Two types of fretting wear particles were observed on ZrN-coated CoCrMo. The first type (Figure 10c) contained mainly Zr and O. These particles were detected surrounding the wear scar, which were generated when the coating was still protecting the CoCrMo surface. Another type of particles (Figure 10d) contained Zr and O incorporated with Cr and P, which are the main elements observed with uncoated CoCrMo wear products. This type of wear particles was observed within the wear area indicating its formation after coating depletion. The wear scar of TiSiN coating in Figure 11, on the other hand, showed an intact coating surface from back-scattered images after fretting. Wear particles (Figure 11c) of mainly Ti, Ca, P, O were found on the coating surface.

Elevation of Co and Cr ion concentrations in the human body is a contemporary concern with total hip replacements containing CoCrMo alloy [66]. Theoretically, assuming all the Co and Cr released from CoCrMo alloys during fretting tests turned into ions, the Co/Cr ion concentration ratio should be approximately 2.36/1. However, in the control group, we found that the Co ion concentration is more than 100 times over the Cr ion concentration. High Co/Cr ratios were also extensively reported in the serum of patients with CoCrMo hip implants [7,10,67,68]. This higher than stoichiometric Co/Cr ratio could be due to low solubility of Cr ions in neutral pH environment [69,70] resulting in low but similar Cr ion concentrations in all groups and Cr rich wear particles. This is confirmed in our EDS analyses of the wear particles. The EDS spectrum on the fretting corrosion particles showed mainly Cr with depleted Co (Cr/Co is 3.35/1 in Figure 9b), which is similar to that reported in retrieved hip implant studies [10,71].

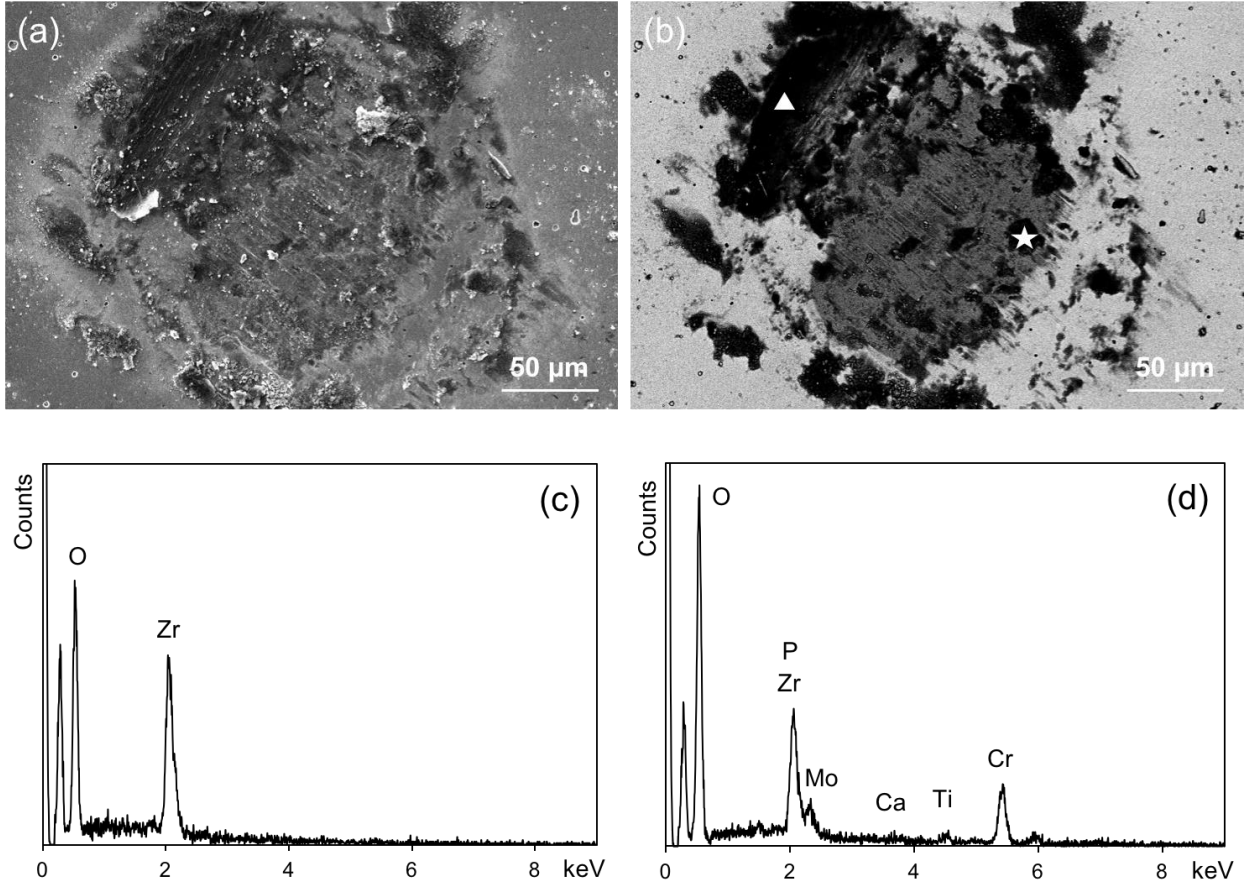
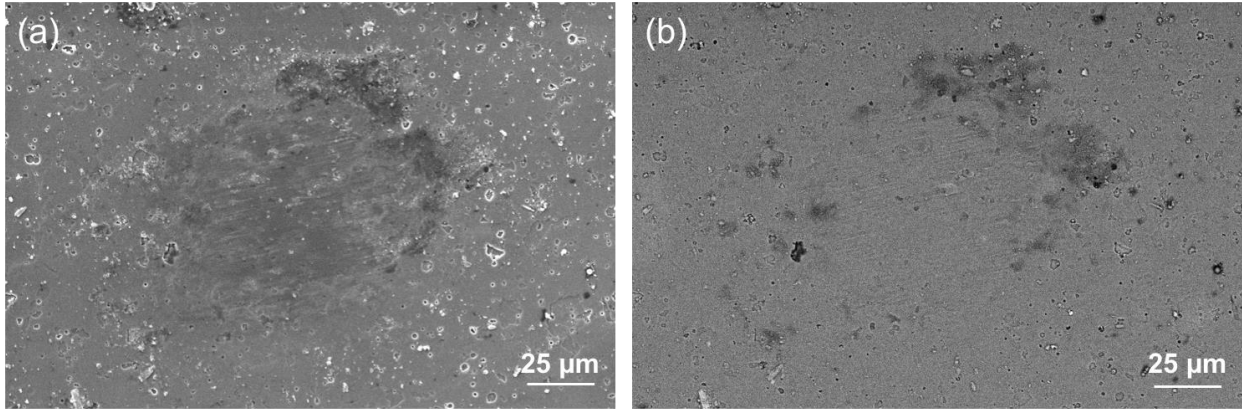
Figure 10. (a) Secondary electron (SE) and (b) Backscattered electron (BSE) images of ZrN coating on CoCrMo after fretting test. EDS spectra of fretting corrosion products formed (c) before (triangle spot) and (d) after (star spot) depletion of the coating.

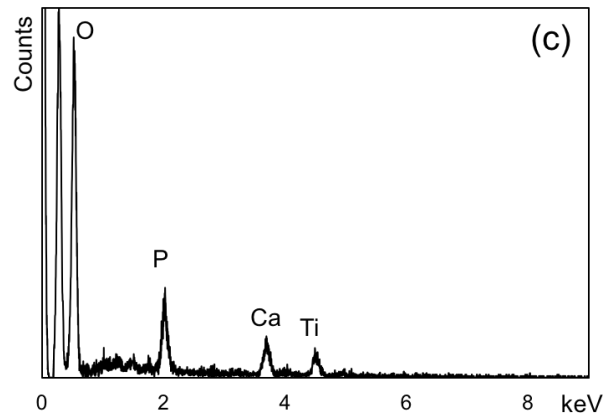
Figure 11. (a) SE and (b) BSE images of TiSiN coating after fretting test. (c) EDS spectrum of the fretting corrosion products.

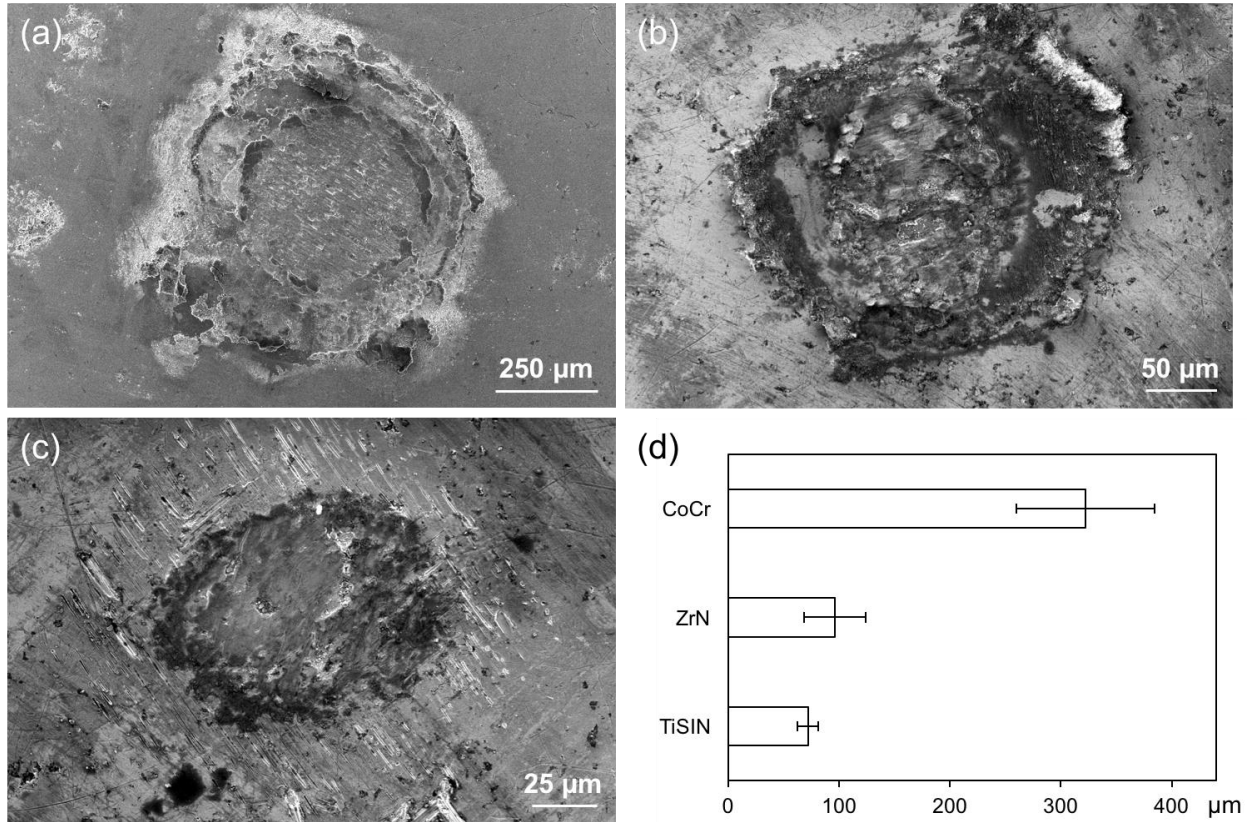
Figure 12. SEM images of Ti6Al4V spheres after fretting against (a) CoCrMo, (b) ZrN and (c) TiSiN. (d) Comparison of wear diameter on Ti6Al4V spheres from each group.

Wear scars of Ti6Al4V spheres are shown in Figure 12. Interestingly, Ti6Al4V spheres in the bare CoCrMo group displayed the greatest wear damage. The wear damage is substantially reduced in both coating groups with TiSiN having the smaller wear scar. The wear diameters on Ti6Al4V spheres from each group are quantified and presented in Figure 12d. It is worthwhile to note that scratches were observed surrounding the wear areas in both coating groups but not in bare CoCrMo group. Also, more severe scratches were found in TiSiN coating group compared to ZrN. This might be caused by defects that were originally observed on the coating surfaces (Figure 2).

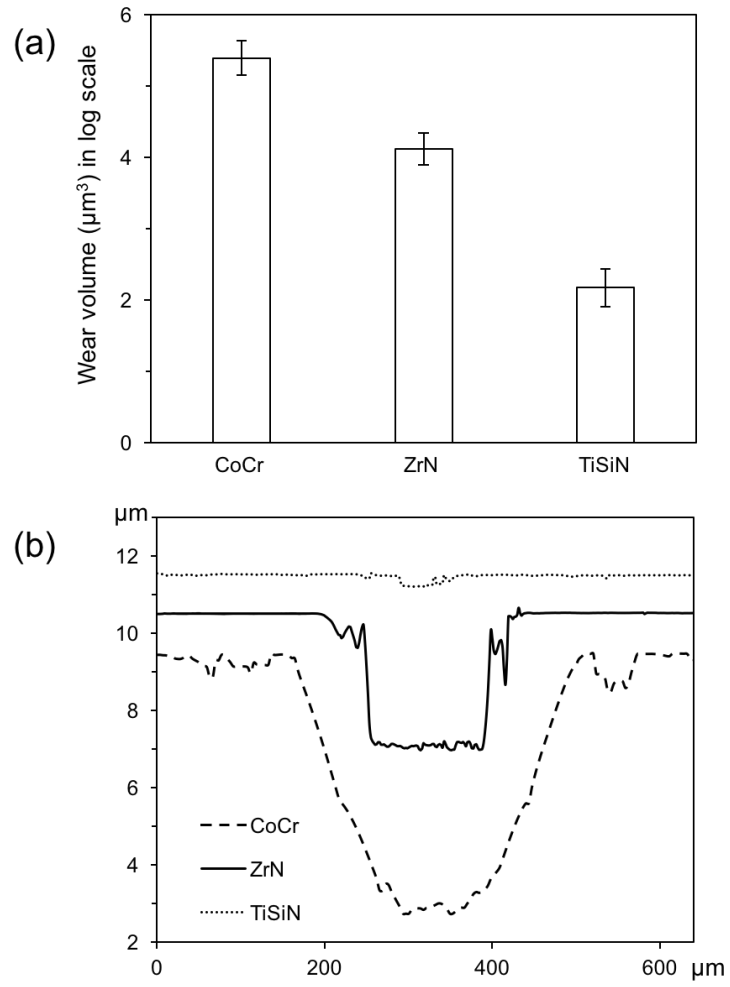
Figure 13. (a) Wear volume and (b) Wear track comparison of CoCr, ZrN and TiSiN after fretting against Ti6Al4V.

Figure 13 shows results obtained from optical profilometer. Wear damage is largely reduced in the arc-PVD coated groups. However, ZrN showed significantly larger wear volume and deeper wear depth compared to TiSiN. TiSiN demonstrated intact coating surface with the lowest wear volume and only around a 300-nm deep wear scar. Figure 14 shows concentrations of Co and Cr ion that were released during fretting corrosion tests. Significantly lower Co ion was released in two coating groups. Cr ion, however, showed similar concentrations among all groups.

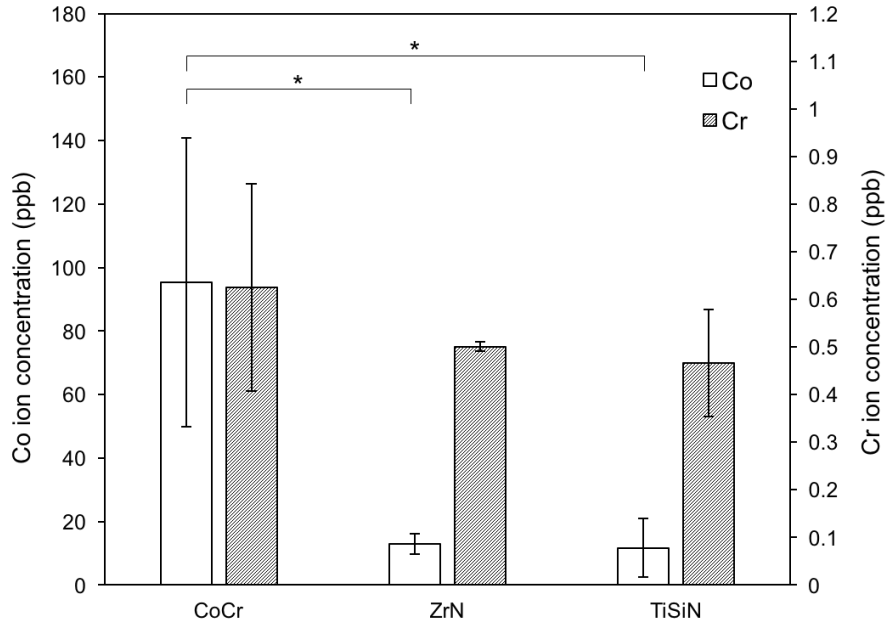
Figure 14. Concentrations of Co and Cr ion released during fretting test. Please note the different scales used for plotting Co and Cr ions. $p < 0.05$ is marked by *.

The main focus of this study is to investigate the improvement in fretting corrosion resistance of CoCrMo and the subsequent metal ion release due to coating deposition. From Figure 14, Co ion concentrations in the testing fluid are significantly lower in both coating groups showing effective protection by the coatings. This is further supported by the results (Figs. 9-13) that both coatings significantly improved the fretting resistance of the CoCrMo substrate. Interestingly, the difference in Co release between the two coating groups is not apparent even though ZrN coating was depleted after fretting tests. It is likely that the depletion happened close to the end of fretting tests. The improvement in fretting resistance can be directly linked to coating quality that can be assessed through modulus, hardness, adhesion, residual stress, and surface morphologies such as roughness. Hardness and elastic modulus have been proven to be crucial mechanical properties in providing wear resistance of hard coatings. It has been widely acknowledged that the ability of a hard coating to resist crack initiation and propagation is proportional to H/E or H^3/E^2 ratio [72,73]. Using hardness and elastic modulus values obtained in Table 1, H/E and H^3/E^2 are 0.072 and 0.150 for ZrN while the ratios are 0.105 and 0.459 for TiSiN. It is apparent that the ratios for TiSiN coatings
