ELUCIDATING THE MECHANISMS OF DAMAGE IN FOAM CORE SANDWICH COMPOSITES UNDER IMPACT LOADING AND LOW TEMPERATURES

Alejandra Castellanos and Pavana Prabhakar*

Dept. of Civil & Environmental Engineering
University of Wisconsin-Madison
Madison, WI 53706

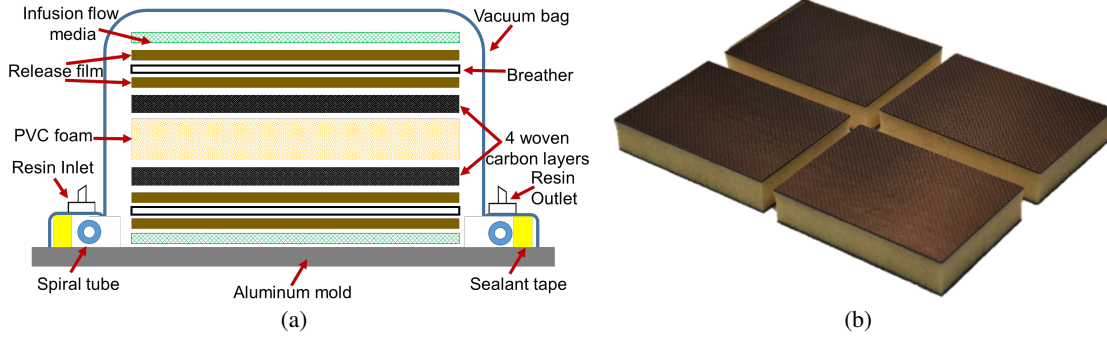
Figure 1: (a) VARTM process configuration; (b) Samples obtained from each sandwich composite panel

Woven carbon fiber/vinyl ester sandwich composites with PVC core were manufactured by vacuum assisted resin transfer molding (VARTM) process [28] as seen in Figure 1(a). Woven plain weave carbon fabric and vinyl ester resin were purchased from Fibre Glast (www.fibreglast.com), and the H100 PVC foam was purchased from Aircraft Spruce (www.aircraftspruce.com). Vinyl ester was considered as the resin due to superior UV resistance and low water absorption as compared to polyester resins [29, 30]. PVC was considered due to their low cost, low density, fire retardancy and high insulation and damping properties [31]. The mechanical properties of the constituent materials are given in Table 1.

A total of 16 panels of 305 mm length x 254 mm width were manufactured. Four samples (shown in Figure 1(b)) were water jet cut from each panel. Impact test samples were randomly chosen from the set of all the samples fabricated to distribute any manufacturing induced effects on the impact response. Four samples were selected for testing for each combination of temperature and impact energy.

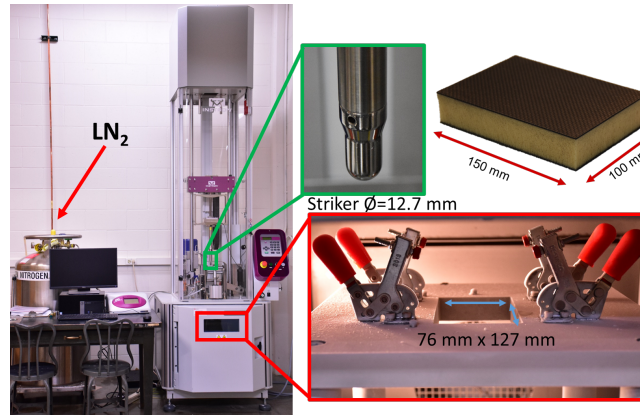
Figure 2: CEAST 9350 Drop Tower Impact System

Drop-weight impact tests were performed using a CEAST 9350 Drop Tower Impact System with a load cell capacity of 22.4 kN and an in-built environmental chamber as shown on Figure 2. A metal fixture with a rectangular opening of 76 mm x 127 mm and toggle clamps were used. These clamps apply pressure in the vicinity of the four corners of the samples to prevent their motion during an impact event. The rectangular sandwich samples had dimensions of 150 mm length x 100 mm width (refer to Figure 2) with an average thickness of 27.43 ± 0.16 mm. The core thickness was 25.4 mm, and each facesheet had an approximate thickness of 1 mm. A hemispherical striker with a fixed mass of 10 kg and a diameter of 12.7 mm was used to impact the samples at the center of the top facesheet in the out-of-plane direction [36]. The impact energies chosen were 7.5 J, 15 J, 30 J, and 60 J, which corresponded to impact velocities of 1.22 m/s, 2 m/s, 2.45 m/s and 3.46 m/s, respectively. All these tests were conducted at low-velocities, that is, below 10

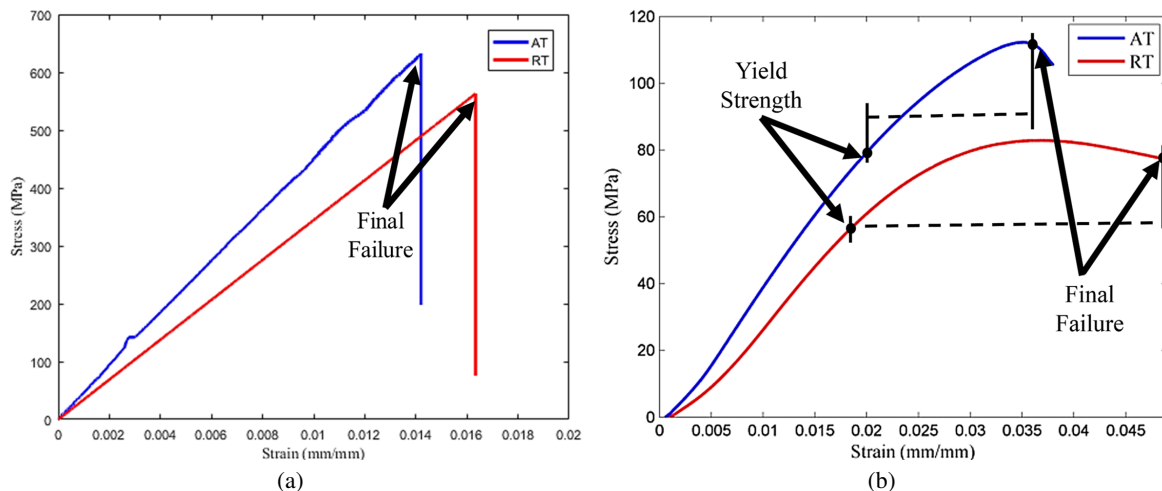
Figure 3: (a) Typical tension stress-strain plots of woven carbon/vinyl ester at RT and AT, and (b) Typical compressive stress-strain plots of vinyl ester at RT and AT

Tension tests on woven/carbon vinyl ester composite samples were conducted in the current study at 25 °C (RT) and -50 °C (AT). It was observed that the elastic modulus and ultimate tensile strength increased by approximately 15% and 11%, respectively, while the strain to failure reduced approximately by 14% when the temperature decreased from 25 °C to -50 °C. Representative tensile stress-strain responses at RT and AT are shown in Figure 3(a), which show a reduction in the ductility and increase in the brittleness at AT [43]. Kim et al. [44] attributed the increase in brittleness of the laminate under tension to the fibers. As the temperature decreased from 25 °C to -50 °C, the brittleness of the fibers increased.

Compression tests on pure vinyl ester were conducted in RT and AT. Representative compressive stress-strain responses of samples tested at 25 °C and -50 °C are shown in Figure 3(b). When the temperature decreased from RT to AT, the yield strength (here denoted as the stress recorded at ≈ 0.02 strain), ultimate strength and elastic modulus increased by approximately 55, 49 and 28%, respectively. However, the strain to failure reduced by approximately 30% with the decreased of temperature. This implies that the apparent elastic modulus and compressive strength of the resin increased at low temperatures. On the other hand, the resin also became more brittle at low temperatures and therefore was unable to withstand large deformations as compared to the samples tested at 25 °C.

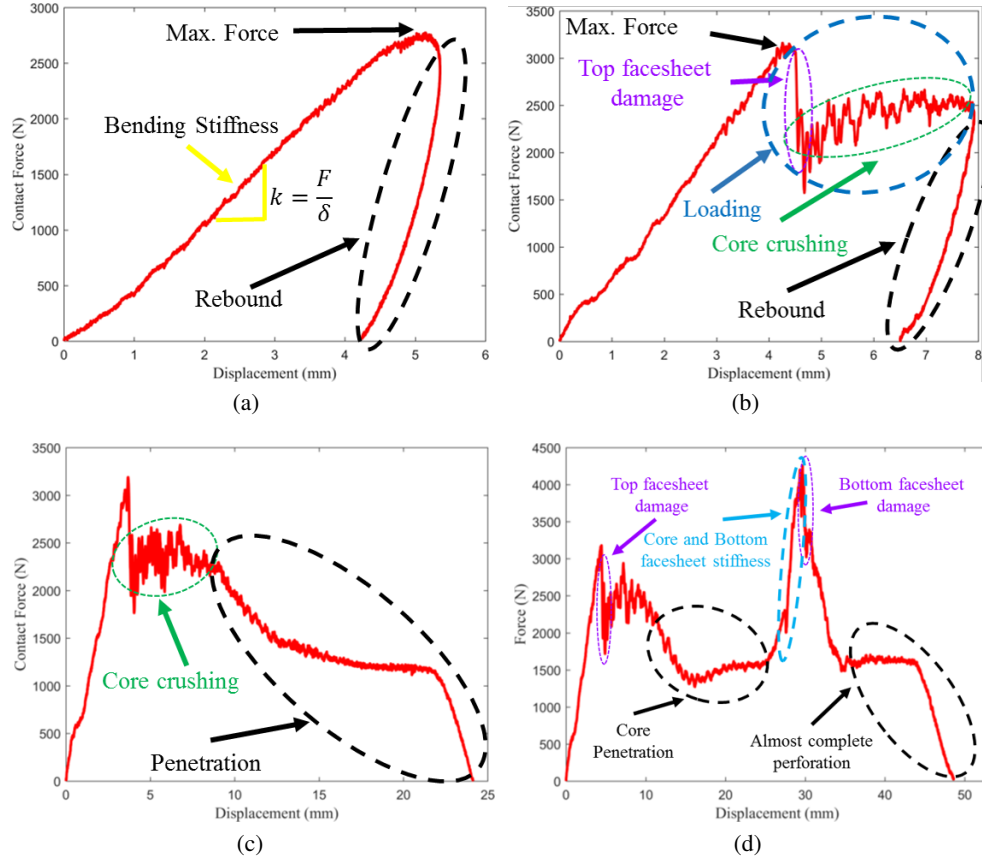
Figure 4: Typical load deflection responses of foam core sandwich composites under low-velocity impact loading: (a) Rebounding, (b) Partial loading and rebound, (c) Partial Perforation and (d) Complete Perforation

Contact of the impact striker with the impacted face of a sandwich composite sample (top facesheet) generates the contact force and deflection during an impact test, which is recorded by the data acquisition system of the impact machine. Typically, contact force-deflection responses have an initial linear ascending region from which the initial bending stiffness [45] is determined. These graphs were obtained from the impact tests performed in the current study. Four characteristic dynamic impact responses are shown in Figure 4, where the post-peak regimes upon reaching the maximum contact force have very different behaviors. There can be three possibilities: rebounding, penetration, and perforation by the striker. In Figure 4(a), the striker rebounds from the sample upon reaching a maximum contact force. A rebounding case is characterized by a gradual decrease in the displacement while the contact force diminishes to zero. Figure 4(b) shows a typical response of a descending regime that combines loading and unloading (rebounding). Here, there is a sudden drop in load after the maximum contact force is reached, which is typically due to damage in the top facesheet (impacted surface), such as fiber fracture, delamination or matrix cracks. This is followed by a small increase in load as the displacement increases, which is due to the crushing of the core by the striker. This is expected as energy dissipation occurs through plastic deformation of the core and damage in the facesheet [46]. Similar behavior has been observed previously by Daniel [47]. Finally, the striker rebounds without damaging the bottom facesheet. Figure 4(c) shows a representative case of striker penetration, where the striker perforates the top facesheet and the core of the sandwich composites, with no damage in the bottom facesheet. The displacement continues to increase with reduction in contact force, which implies that there is no rebound. Figure 4(d) shows a representative case of perforation of the sandwich composite by the striker. This graph is characterized by two peak forces. The first peak and its post-peak response represents the perforation of the top facesheet and the core by the striker. Beyond that, the contact force increases, resulting in a second peak, which is larger than the first peak. This is attributed to the stiffness of the bottom facesheet which is subjected to local in-plane tensile loading. If the bottom facesheet is damaged, a sudden drop in contact force follows the second peak, which is typically due to fiber fracture. This is followed by an increase in displacement with reduction in contact force, which implies complete perforation of the sandwich composite.

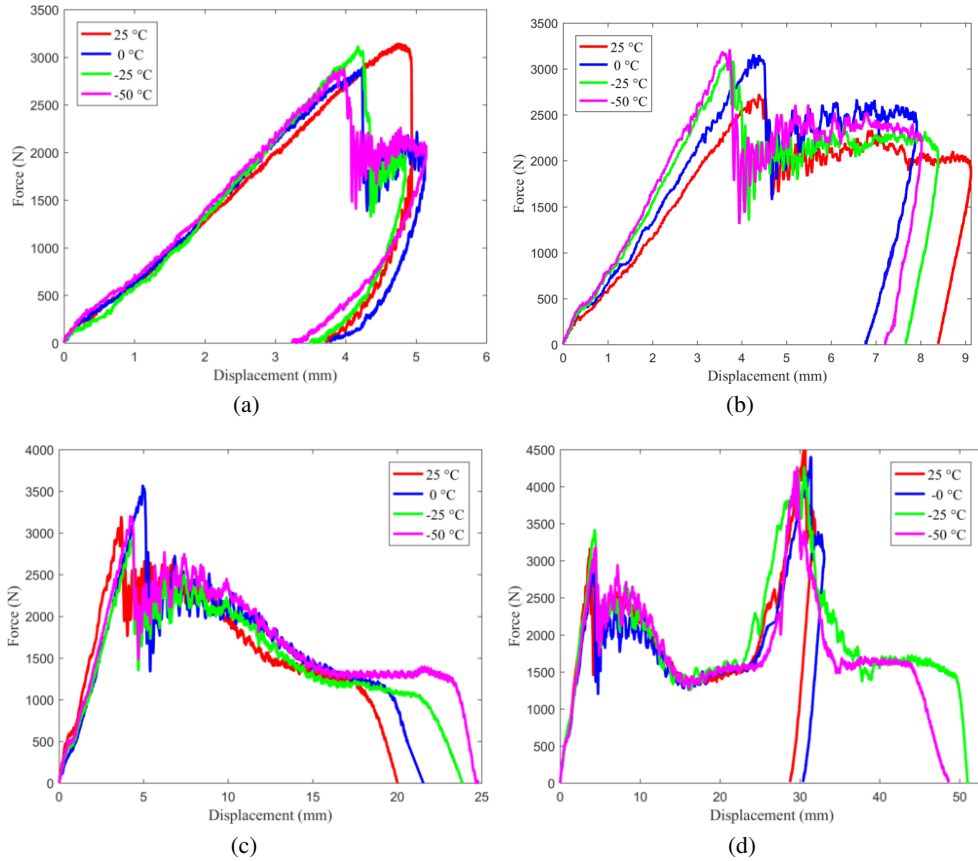
Figure 5: Representative contact force-displacement responses for all temperatures under impact energies of: (a) 7.5 J, (b) 15 J, (c) 30 J and (d) 60 J.

Figure 5(a) corresponds to an impact energy of 7.5 J. A drop in the contact force is observed upon reaching the maximum contact force at 25 °C. This indicates damage in the top facesheet, upon which the striker rebounds from the sample. However, at 0 °C, -25 °C and -50 °C responses, damage in the top facesheet is accompanied with core crushing. This is indicated by the small increase in the contact force after the first vertical drop. Finally, the striker rebounds from the specimens without further penetration into the samples. This can be seen by the gradual decrease in the displacement while the contact force diminished to zero. Figure 5(b) corresponds to an impact energy of 15 J, where all the graphs manifest a sudden drop after the maximum contact force is reached, which implies that the top facesheet experienced damage along with a noticeable amount of indentation on the impacted surface. After that, the striker rebounds from the specimens. The indentation is manifested by an increase in residual displacement of the striker after rebound. For this impact energy, only crushing of the core and perforation of the top facesheet by the striker

is observed. Figure 5(c) corresponds to an impact energy of 30 J, where the striker perforates the top facesheet (drop in load after the maximum force is reached) and penetrates through the foam core at all temperatures. The core penetration by the striker is indicated by a decrease in the contact force with increasing displacement after the drop in load of the maximum contact force.

Figure 5(d) corresponds to an impact energy of 60 J. All the responses have two peaks for contact force. The first peak and post-peak response correspond to the perforation of the top facesheet and core penetration by the striker, respectively. The second peak corresponds to damage of the bottom facesheet. The second peak is higher than the first peak due to higher strength of the bottom facesheet under tension [48] as compared to the compressive strength of the top facesheet. The graphs at 25 °C and 0 °C have the same profile. After the second peak, the displacement of the striker diminishes to zero as the contact force reduces to zero. This implies that the striker reaches the bottom facesheet, stresses it and then rebounds from the bottom facesheet [49]. In contrast, at -25 °C and -50 °C, the striker almost entirely perforates the samples and gets lodged in the bottom facesheet with no rebound. This can be seen after the second peak, where the contact force diminishes to zero as the displacement increases. These damage modes are described in more detail in the “Damage Mechanisms” section.

At 60 J, the sandwich composite samples experienced two peaks in their contact force-displacement responses (Figure 5(d)) in all in-situ test temperatures including $-50\text{ }^{\circ}\text{C}$. Correspondingly, the energy-time response of a sample tested at 60 J at $-50\text{ }^{\circ}\text{C}$ manifested two zones of sudden slope reduction represented by E_I as shown in Figure 8(d). The first slope reduction indicates complete perforation of the top facesheet and core penetration by the striker. The second slope reduction corresponds to damage in the bottom facesheet and debonding between the core and bottom facesheet. In contrast to the room temperature case, here $E_{max} = E_{abs}$, which implies that the striker did not rebound as it perforated the bottom facesheet of the sample. It can be concluded that the samples tested at low temperatures ($0\text{ }^{\circ}\text{C}$, $-25\text{ }^{\circ}\text{C}$ and $-50\text{ }^{\circ}\text{C}$) experienced more damage than those at $25\text{ }^{\circ}\text{C}$. This is manifested by an increase in energy absorption at low temperatures under all the impact energies.

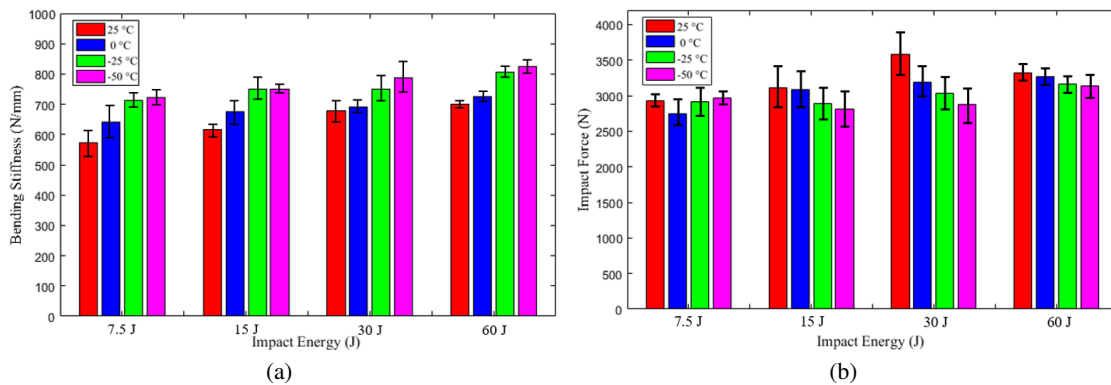
Figure 6: (a) Average bending stiffness and (b) Average first maximum contact force with increasing impact energy and four different temperatures (25 °C, 0 °C, -25 °C and -50 °C).

Figure 6(a) shows the average bending stiffness values that were calculated using the initial ascending regime of the contact force - displacement responses, which corresponds to the top facesheet. At all impact energies, the bending stiffness increases with reducing temperature, which is expected based on the description given in subsection “Influence of temperature on the contact force-displacement responses”. The first maximum contact force values (first peak on a contact force-displacement graph) is shown in Figure 6(b). For impact energies of 15 J, 30 J and 60 J, the contact force has a decreasing trend as the temperature decreases from 25 °C and -50 °C. This is attributed to the top facesheet failure due to embrittlement of sandwich composites at low temperatures. At an impact energy of 7.5 J, the peak contact forces oscillate with changing temperature, as the top facesheet is minimally damaged within the prescribed temperature range (25 °C and -50 °C).

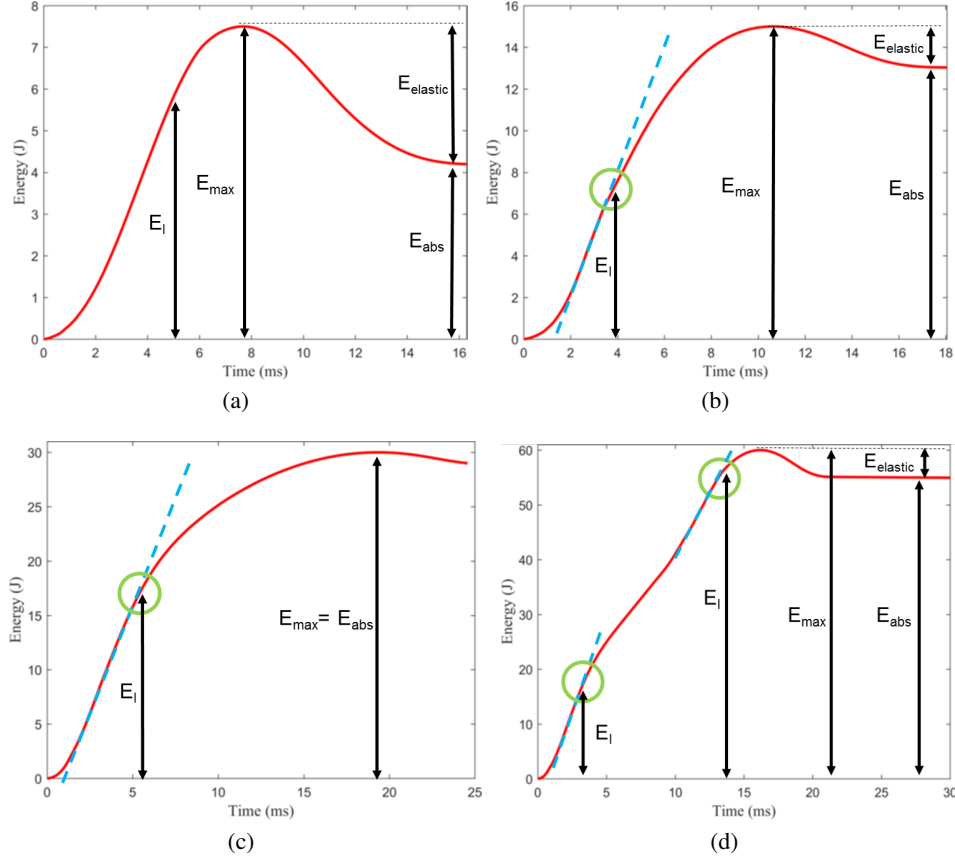
Figure 7: Representative energy-time responses for samples impacted at 25 °C at:(a)7.5 J, (b) 15 J, (c) 30 J and (d) 60 J.

corresponds to the energy absorbed by the sample through internal deformation and damage, which in this case (7.5 J at 25 °C) is predominantly delamination in the top facesheet. The difference between E_{max} and E_{abs} is the elastic energy $E_{elastic}$, which is the energy not absorbed by the specimen and is returned to the system by the rebound of the striker.

Figures 7(b), 7(c) and 7(d) show the energy-time response of a sample tested at 15 J, 30 J and 60 J each at 25 °C. These graphs were obtained from the impact tests performed in this study.

In contrast to the energy-time response of the samples impacted at 7.5 J, the samples impacted at 15 J absorbed more energy and the slope of this curve reduced beyond E_I . This is attributed to the damage mechanisms such as fiber fracture and core crushing observed at 15 J. In this case, the striker rebounded from the sample which can be observed by the elastic energy, $E_{elastic}$. In Figure 7(c) at 30 J, $E_{max} = E_{abs}$, which implies that the sample completely absorbed the impacted energy. The reduced slope beyond E_I indicates that the top facesheet was completely perforated and the core was penetrated by the striker. Next, recall that two peak forces were observed in the force-displacement responses at 60 J (Figure 5(d)) due to damage in the top and bottom facesheets along with the core. Therefore, in Figure 7(d) at 60 J, the first regime with reduced slope corresponds to the perforation of the top facesheet and core penetration, while the second reduced slope corresponds to fiber fracture at the bottom facesheet and debonding between the core and the bottom facesheet. A small amount of elastic energy is remaining as a result of the striker rebounding from the bottom facesheet.

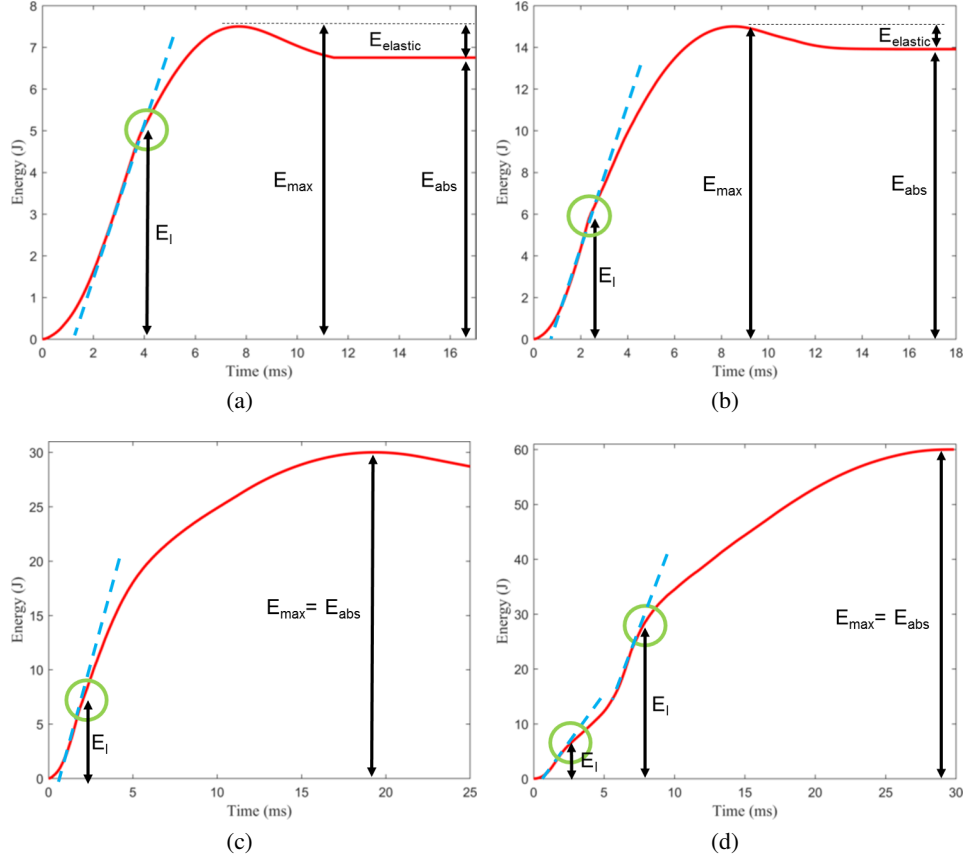
Figure 8: Representative energy-time responses for samples impacted at $-50\text{ }^{\circ}\text{C}$ at:(a)7.5 J, (b) 15 J, (c) 30 J and (d) 60 J.

Energy-time responses of samples tested under impact energies of 7.5 J, 15 J, 30 J and 60 J each at -50 °C are shown in Figures 8(a), 8(b), 8(c) and 8(d), respectively. These graphs were obtained from the impact tests performed in this study. Under 7.5 J, a distinct reduction in the slope of the curve after E_I is observed in contrast to the samples at room temperature. This implies that even at 7.5 J of impact energy at -50 °C, fiber fracture and delamination in the top facesheet and minimal core crushing were observed. Figure 8(b) shows the energy-time response of a sample tested at 15 J at -50 °C. Again, the slope of the curve reduced beyond E_I due to fiber fracture and delamination at the top facesheet and core fracture. At 7.5 J and 15 J, the striker rebounded from the samples, which is manifested as the remaining elastic energy in the plateau regions of the graphs. The energy-time response of a sample tested under

30 J at $-50\text{ }^{\circ}\text{C}$ is shown in Figure 8(c). $E_{max} = E_{abs}$ implies that the impacted energy was completely absorbed by the sandwich composite and the striker did not rebound from the specimen. This is similar to that observed at room temperature. The reduced slope beyond E_I indicates complete perforation of the top facesheet and core penetration by the striker.

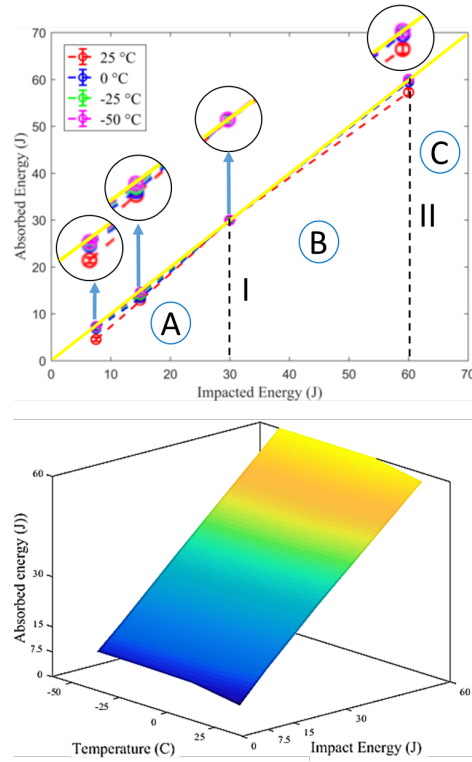
Figure 9: Energy profile diagram for the sandwich composite specimens.

To better understand the energy absorption process, an energy profile diagram was generated that shows the relationship between the absorbed energy E_{abs} and the impacted energy E_{max} [49]. The absorbed energy was obtained by integrating the area under the curve of the contact force-displacement responses for each test conducted. Figure 9 shows the energy profile diagram, where each point on the graph represents the average value of the absorbed energy corresponding to an impacted energy at a particular temperature. The yellow line connects the points when the impact energy is equal to the absorbed energy. ‘‘I’’ represents the perforation threshold for the top facesheet. Regardless of the in-situ test temperature under 30 J, the striker completely perforated the top facesheet. ‘‘II’’ represents the perforation threshold for the bottom facesheet only at low temperatures. That is, the striker only caused minimal fiber breakage at

the bottom facesheet at 25 °C. Hence, the absorbed energy was less than the impacted energy, resulting in the rebound of the striker. At 0 °C, the samples absorbed almost all the energy due to an increase in debonding between the bottom facesheet and the core. At -25 °C and -50 °C, the striker got lodged into the bottom facesheet, resulting in perforation of the bottom facesheet.

In summary, there are three zones in the energy profile diagram: A, B and C. Zone A represents the impact energy where the main damage mechanisms were fiber fracture, delamination and matrix cracking at the top facesheet and core crushing. Zone B represents the impact energy where the main damage mechanisms were perforation of the top facesheet and core fracture. Zone C represents the impact energy where the main damage mechanisms were perforation of the top facesheet, transverse shear fracture in the core, core crushing, debonding between the bottom facesheet and the core, and fiber fracture at the bottom facesheet.

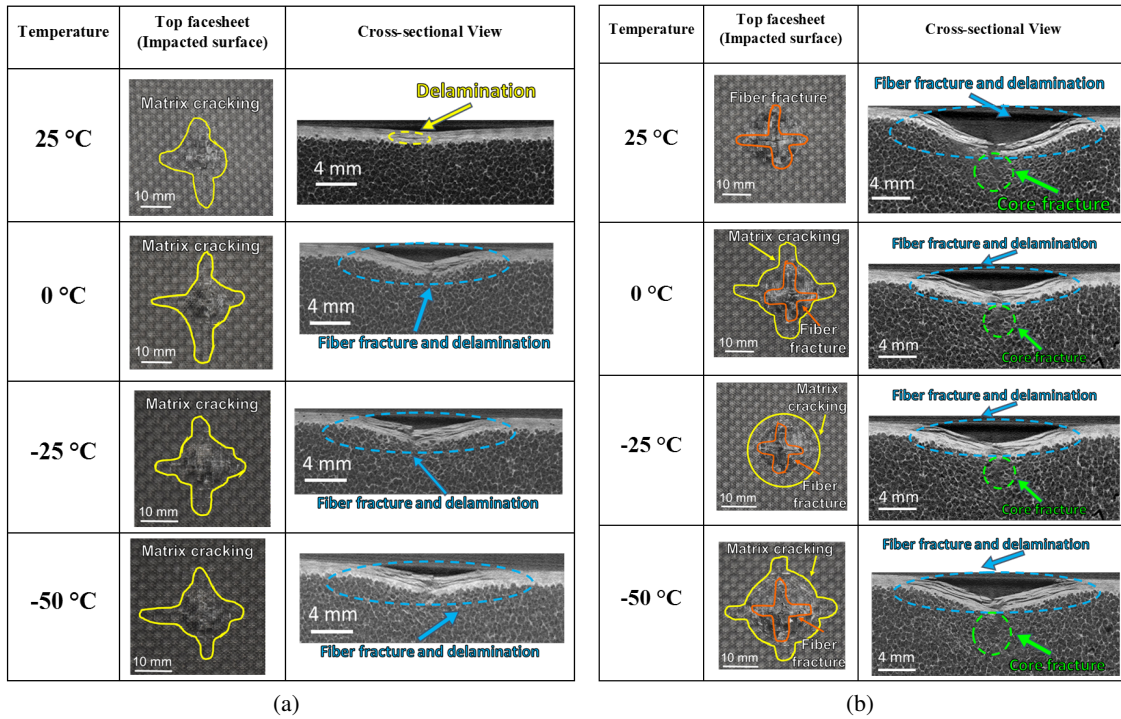
Figure 10: Top facesheet and cross-sectional view of the sandwich composite specimens impacted at (a) 7.5 J at 25 °, 0 °C, -25 °C and -50 °C, and (b) 15 J at 25 °, 0 °C, -25 °C and -50 °C.

The samples impacted under 7.5 J of energy at 25 °C experienced delamination and matrix cracking at the top facesheet as shown in Fig. 10(a). At 0 °C, -25 °C and -50 °C, the dominant damage mechanisms were matrix cracks, fiber fracture and delamination at the top facesheet while the core experienced small localized compression. The bottom facesheet was not damaged. The fiber fracture and delamination are manifested as a sudden drop in load in the contact force-displacement responses. The samples impacted under 15 J of energy at all temperatures experienced fiber fracture, matrix cracking and delamination at the top facesheet and localized core crushing/fracture as shown in Figure 10(b). Again, the bottom facesheet did not exhibit any damage. The samples impacted under 30 J of energy at all temperatures exhibited penetration of the striker into the core as shown in Figure 11(a). The top facesheet was perforated with

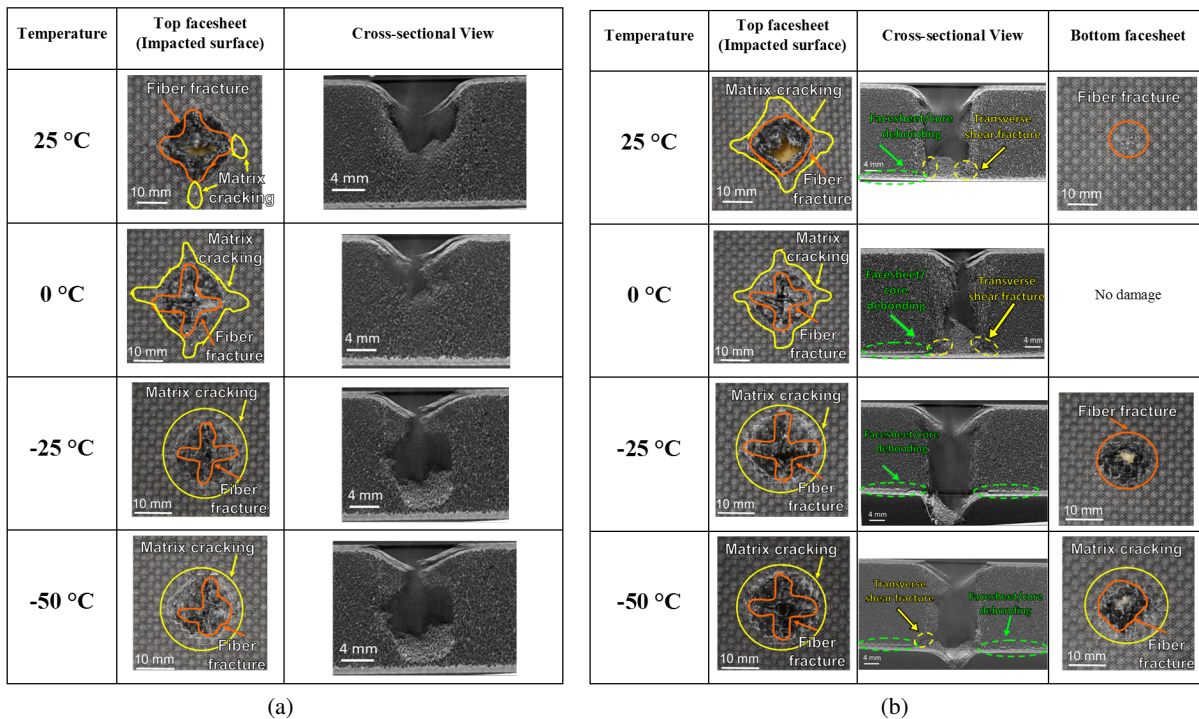
Figure 11: Top facesheet and cross-sectional view of the sandwich composite specimens impacted at (a) 30 J at 25 °, 0 °C, -25 °C and -50 °C, and (b) 60 J at 25 °, 0 °C, -25 °C and -50 °C.

evident matrix cracking surrounding this area. As the temperature decreased, the penetration of the striker into the core increased. This is attributed to the brittleness of the top facesheet and the matrix at low temperatures, which enabled the striker to perforate the top facesheet easily and to cause more damage to the core. There was no evident damage at the bottom facesheet at 30 J. The samples impacted under 60 J of energy at all temperatures exhibited varying extent of damage at the back facesheet, with almost complete perforation of the bottom facesheet at -25 °C and -50 °C as displayed in Figure 11(b). At 25 °C, the top facesheet was completely perforated, the foam core was crushed up to the bottom facesheet. This resulted in debonding between the facesheet/core and transverse shear fracture in the core. With reducing temperatures, the laminates became stiffer resulting in less deflection and bending. Therefore, at 0 °C, there was not visible damage at the bottom facesheet. The main failure mechanisms were debonding between the core and the bottom facesheet, transverse shear fracture of the core, and perforation of the top facesheet. At -25 °C and -50 °C, the sandwich composite samples were almost completely perforated by the striker, accompanied by the striker getting lodge into the back facesheet. At -50 °C, it is expected that the sample became more brittle resulting in higher debonding between the bottom facesheet and the core than those tested at -25 °C.
