How internal waves could lead to wreck American and Indonesian submarines?

Yury Stepanyants

School of Sciences, University of Southern Queensland, Toowoomba, Australia;
Department of Applied Mathematics, NSTU n.a. R.E. Alekseev, Nizhny Novgorod, Russia

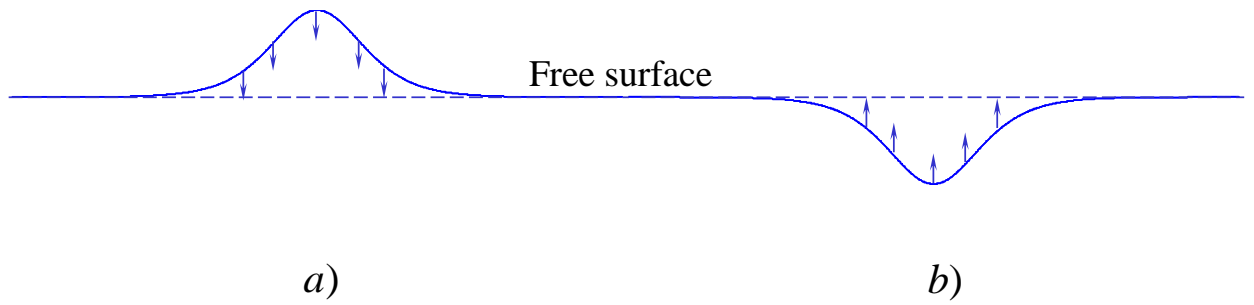
Fig. 1. a) The elevation of the free surface of a liquid caused by an external disturbance. b) The lowering of the level of the free surface after liquid particles have passed their equilibrium position, shown by the dashed line. The arrows indicate the directions of the action of gravity forces on liquid particles.

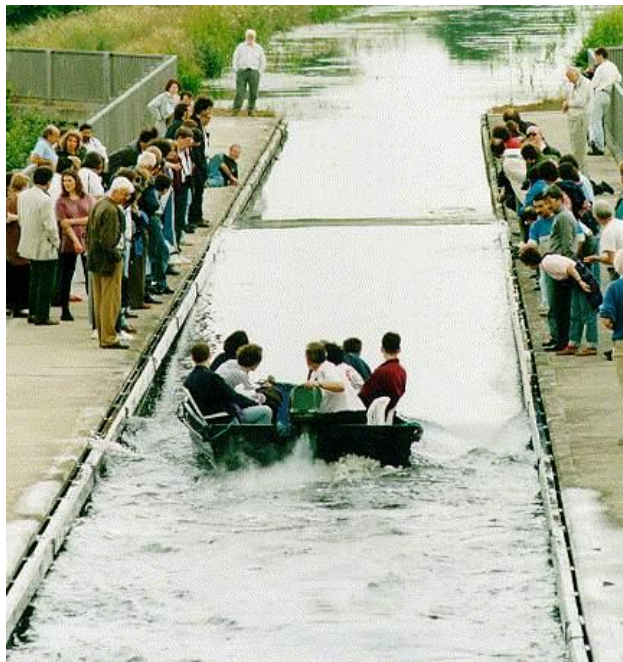
Fig. 2. A solitary wave (soliton) created in a canal by a fast-moving motor boat (from free access on the Internet – see, for example, [4]).

A team of scientists using modern means have demonstrated how a solitary wave in the same canal can be created, similar to that observed by Scott Russell (see Fig. 2). It should be noted that solitary surface waves can only be of positive polarity, i.e. in the form of an elevation of the liquid surface, as in Fig. 2.

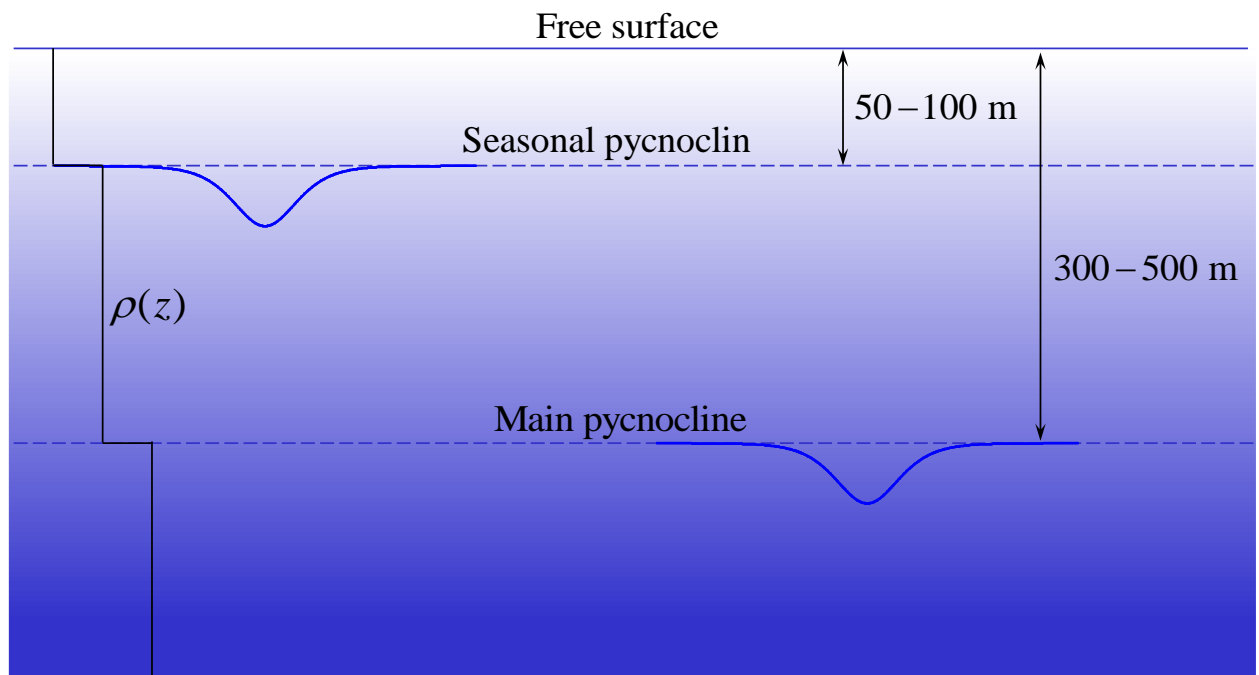
Fig. 3. A simplified three-layer model of stratification of the World ocean with the abrupt change of density $\rho(z)$. In fact, instead of sharp density jumps in the ocean, a noticeably pronounced but smoothed density transition from layer to layer occurred as indicated by the continuous variation in shading.

A simplified model of the water density variation with the depth in the ocean can be represented as shown in Fig. 3. The upper freshened layer, the thickness of which ranges from 50 m to 100 m, depending on the season, is formed due to the influx of solar heat, precipitation, and wind mixing. It is followed by a fairly well-pronounced jump in the density, called the *seasonal pycnocline*. Then the next layer of almost constant density extends, at the lower boundary of which a rapid change in density occurs again, after which the density of the liquid remains practically constant down to the bottom. The boundary separating the lowest ocean layer from the intermediate layer is called the *main oceanic pycnocline*. It exists in the ocean all the time, regardless of weather or seasonal changes on the surface.

More details about the nature of internal waves can be found in the article by J. Apel [6] (in the section Background and Theory) (see also [7]). A specific feature of internal solitary waves (ISWs) in the deep ocean is that, unlike surface waves, they usually have negative polarity, i.e. they are exhibited by a moving *depression* of the pycnocline, as shown schematically in Fig. 3.

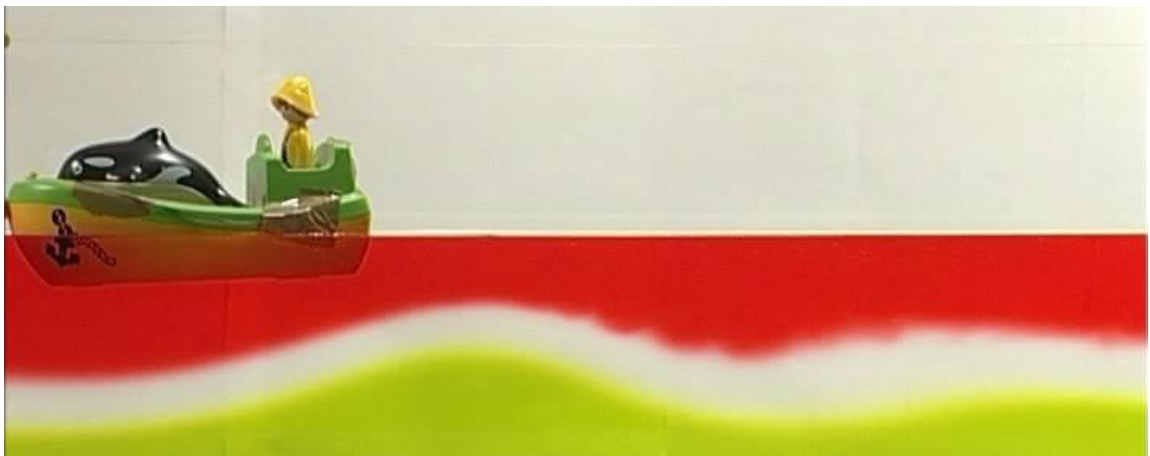
Fig. 4. Excitation of internal waves in a laboratory flume by a slowly moving boat model [5]. The top layer (red) contains the light liquid, the middle layer (white) contains the heavier liquid, and the bottom layer (light green) contains the heaviest liquid.

Internal waves of rather large amplitude, up to 150 m, can exist at both interfaces of the layers. Moreover, such waves hardly disturb the free surface; it is almost impossible to see them if the ocean is completely calm and there are no wind waves. Figure 4 illustrates the excitation of internal waves in a laboratory flume by a slowly moving boat model. The tank is filled with a liquid consisting of three layers of different densities; the layers are tinted by dyes. It is clearly seen that the moving model excites internal waves at the interface between the layers, leaving the surface of the liquid unperturbed.

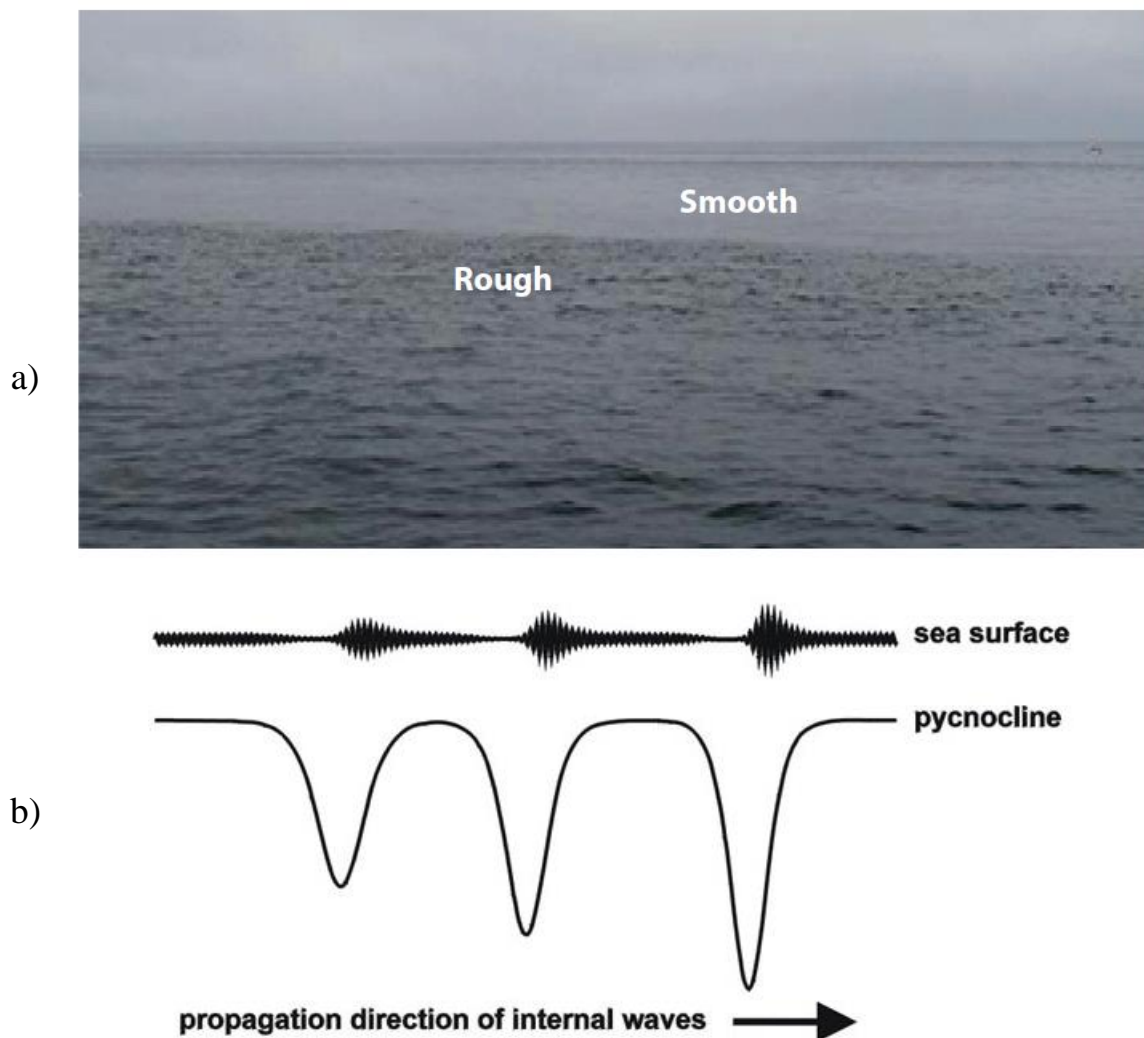
Fig. 5. Photo of the ocean surface (a) with areas of increased roughness and suppressed waves above an internal wave slowly moving in the water [9]. Increased surface wave excitation occurs above the descending wave slope, and suppressed – above the rising wave slope, as shown in figure (b) from [7]. The arrow shows the direction of propagation of internal waves.

In the presence of surface wind waves, internal waves, creating flows in the near-surface layer of the liquid with velocities up to 20 cm/s (which is comparable to the velocities of wind ripple propagation), produce modulation of surface waves. On the steep section of the front of an internal wave moving in the deep ocean, there is an increase in surface ripples, whereas on the rear slope of the wave there is a partial suppression of waves (see Fig. 5).

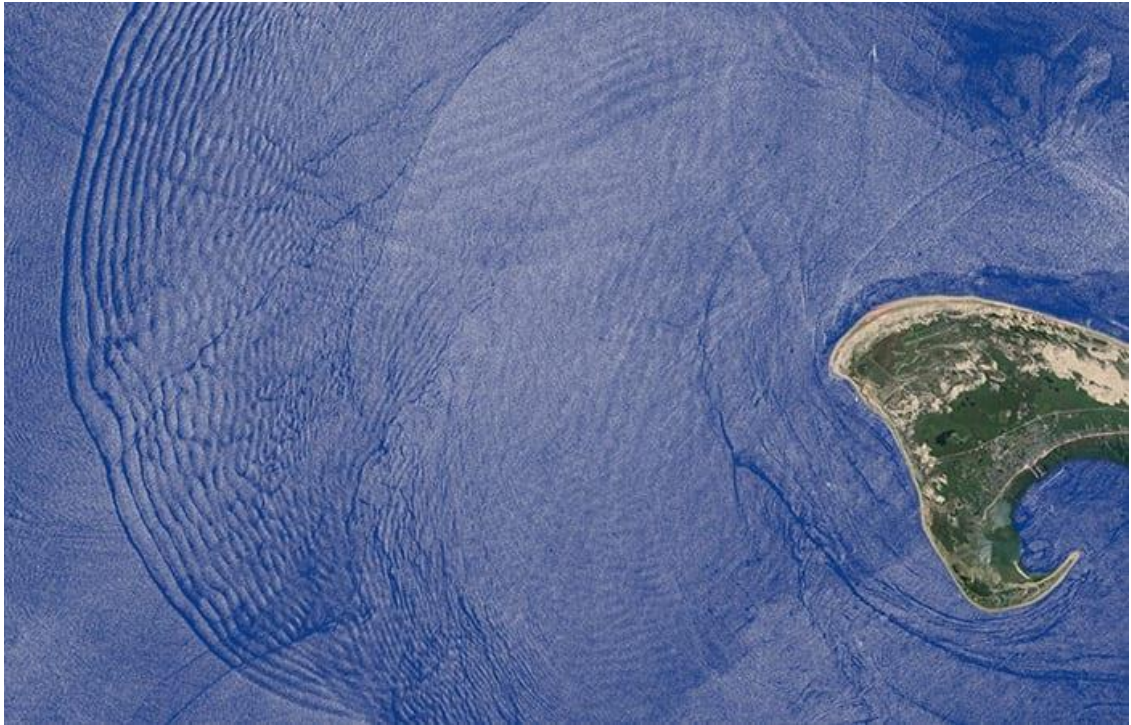
Fig. 6. Satellite photograph of alternating light and dark stripes formed on the ocean surface by internal waves [10]. Waves travel from the Atlantic Ocean to the eastern coast of United States through the Gulf of Maine skirting Cape Cod.

As a result, stripes extending for many kilometres appear on the surface of the ocean, moving along with an internal wave propagating in the bulk of water. These stripes are clearly visible to the naked eye and are even observed in photographs obtained from satellites (see, for example, Fig. 6). The Internet is replete with photographs of this kind, see, for example, atlases [6–8].

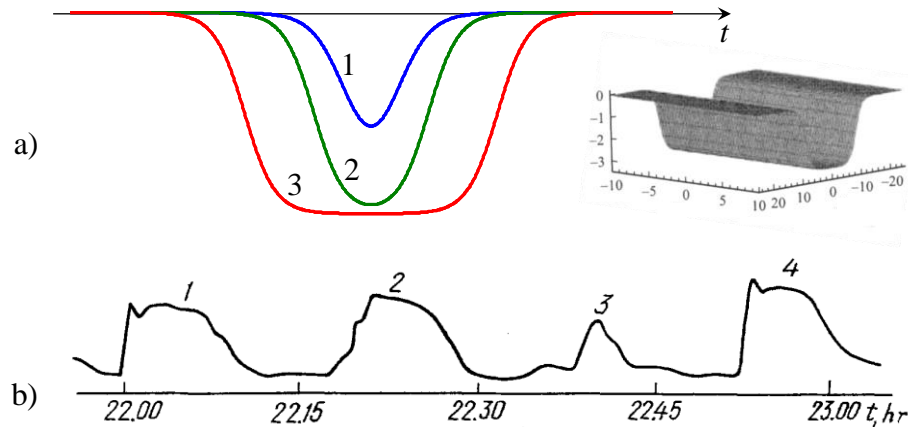
Fig. 8. a) Theoretically predicted shapes of solitons in the deep ocean within the framework of the model Gardner equation at various amplitudes [17]. Curve 1 refers to small and moderate amplitude bell-shaped solitons; curve 2 – to large-amplitude solitons; curve 3 – to solitons of very large amplitude (scales along the horizontal and vertical axes are not shown, the figure is of a qualitative nature). b) Experimentally measured pycnocline perturbations on the shelf of the Sea of Japan [18] (the amplitude of the solitary wave #4 was ~3 m).

An important result of this study is the conclusion that solitons of large amplitude in the deep ocean become similar to trenches with a flat bottom (see inset to Fig. 8a), whereas in shallow-water basis, for example, on a shelf with a near-bottom pycnocline, they are similar to elevations with a flat top. Experimental studies have shown that this type of ISWs is indeed observed in the oceans and seas. In particular, Fig. 8b) illustrates the recorded pycnocline perturbations on the shelf of the Sea of Japan [18]. The amplitude of the solitary wave #4 was 3 m whereas the depth of the shelf was 30 m, and the pycnocline was located at the depth of 25 m. As one can see, the shapes of pulse disturbances #1, #2, and #4 are close to the theoretically predicted curve 3 in Fig. 8a), whereas the shape of the smaller-amplitude pulse #3 is close to the shape of a KdV soliton (cf. with line 1 in Fig. 8a).

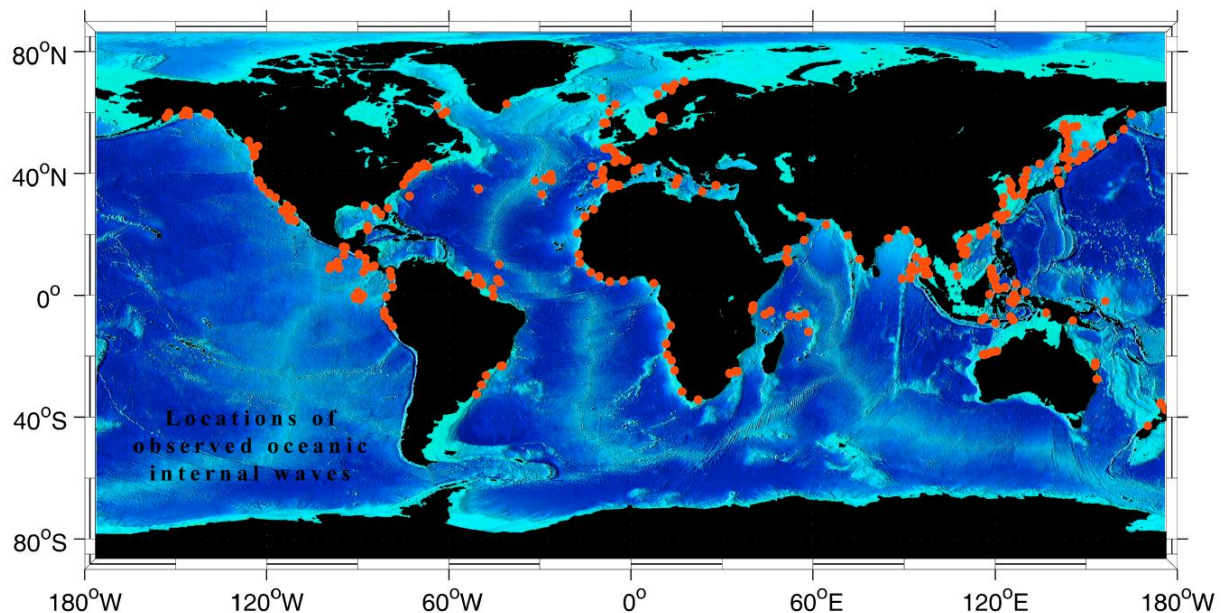
Fig. 9. A map from the Jackson's atlas [6] depicting the sites of observation of large-amplitude ISWs.

The review [11] presented for the first time a map of ocean regions in which ISWs were observed. Subsequently, this map was significantly extended by C. Jackson and is now publicly available on the website [6] (see also [7, 8]). In Fig. 9 from the atlas [6] it can be seen that ISWs are observed almost everywhere in the oceans. The density of points on the map is only due to the convenience of conducting experimental work in certain areas of the World Ocean. The lack of data on the Pacific and Southern Oceans is due to the relative inaccessibility of the regions, the high cost of experimental work there, and lack of intensive navigation in them. Therefore, it is not known what surprises can still be expected in these vast and poorly studied areas of the World Ocean.

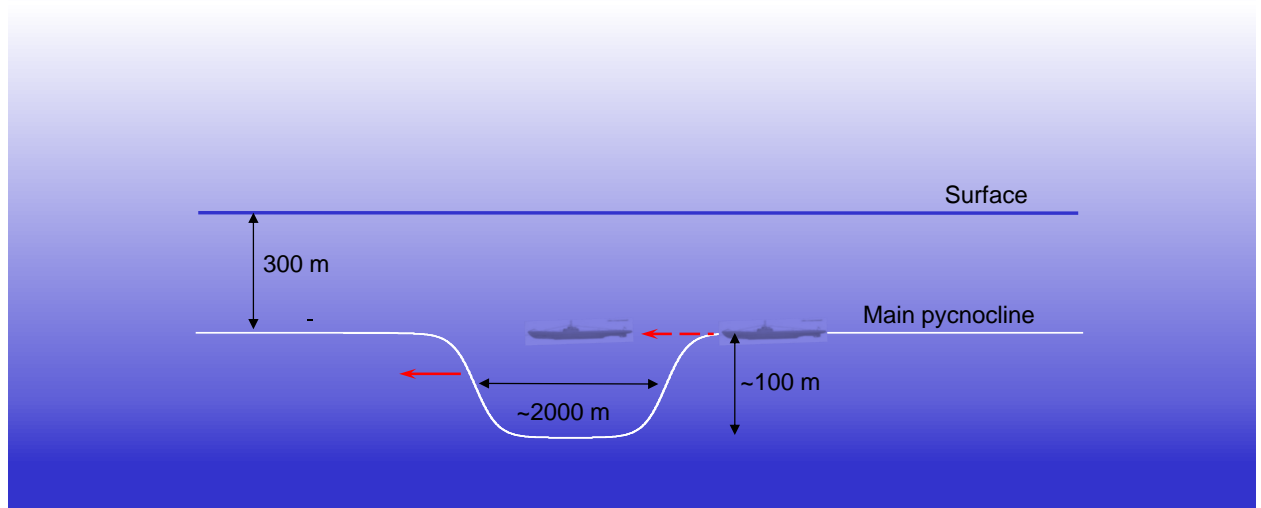
Fig. 10. Schematic representation of a submarine overtaking a solitary wave over the main pycnocline. The drawing is not to scale.

What danger can ISWs pose to submarines? Let's imagine that a submarine with a displacement of 4,300 tons (which roughly corresponds to the lost American submarine "Thresher") moves under the main pycnocline located at a depth of 300 m, where the density at a temperature of 4°C and salinity 35‰ (35 ppm) is $\rho_2 = 1,027.8 \text{ kg/m}^3$. The submerged displacement is defined as the weight of the liquid displaced by the body, therefore, with the indicated displacement, the volume of the submarine is $V \approx 3,375 \text{ m}^3$. The submarine is in a neutral, suspended state so that the force of gravity is compensated by the Archimedean buoyancy force. Suppose it suddenly turns out to be in a water of lower density $\rho_1 = 1,027.4 \text{ kg/m}^3$ (these values correspond to the data on stratification at the site where the nuclear

submarine “Thresher” sank [19]). Then, the Archimedean force decreases so that an additional gravity force $f = (\rho_2 - \rho_1) g \approx 3,9 \text{ kg}/(\text{m}^2\text{s}^2)$ acts on each cubic meter of the submarine, where $g = 9.81 \text{ m/s}^2$ is the acceleration due to gravity. Therefore, an excess force of $F = fV = 1.3 \cdot 10^4 \text{ kg} \cdot \text{m/s}^2$ acts on the entire submarine, which corresponds to a load of 1.35 tons. With such a load, the submarine will begin to submerge and can quickly reach the maximum depth, at which is designed for its durable body, if you do not take emergency measures for its ascent. Here it is appropriate to give simple estimates for the submarine model in the form of an ellipsoid of revolution around its long axis. Let us assume that the submarine, moving horizontally, suddenly passes from the region under the pycnocline with the density ρ_2 to the core of ISW with a lower density ρ_1 , being at the same horizon (see Fig. 10). Then, in the simplest case, its vertical coordinate z as a function of time t is determined by the differential equation:

The solution to the above equation with the zero initial conditions is a simple function of time: $z(t) = a t^2/2$, where $a = -(\rho_2 - \rho_1)g/(\rho_s + k\rho_0)$ is the acceleration of a submarine submersion

due to the lack of buoyancy. If we substitute here the above values of the parameters, we get $a \approx -0.002 \text{ m/s}^2$. Suppose that the submarine moves at a speed of 6 knots ($\approx 3 \text{ m/s}$) catching up an ISW of 100 m amplitude. Such a wave can travel at a speed of 2–2.5 m/s (see the Table above) having a characteristic width of about 1,000 m. To overtake the ISW with a speed difference of 1.5 m/s, the submarine will need 667 seconds (11 minutes). During this time, with the indicated acceleration, the submarine can theoretically submerge to an additional 445 m if urgent actions are not taken to keep it at a given horizon. In fact, a submerged submarine sinking additionally $H = 100 \text{ m}$ from the pycnocline horizon of 300 m may already turn out to be catastrophic. The time required for such a dive at the given parameters is $t_s = (2H/a)^{1/2}$, which is 316 sec (5.3 min).

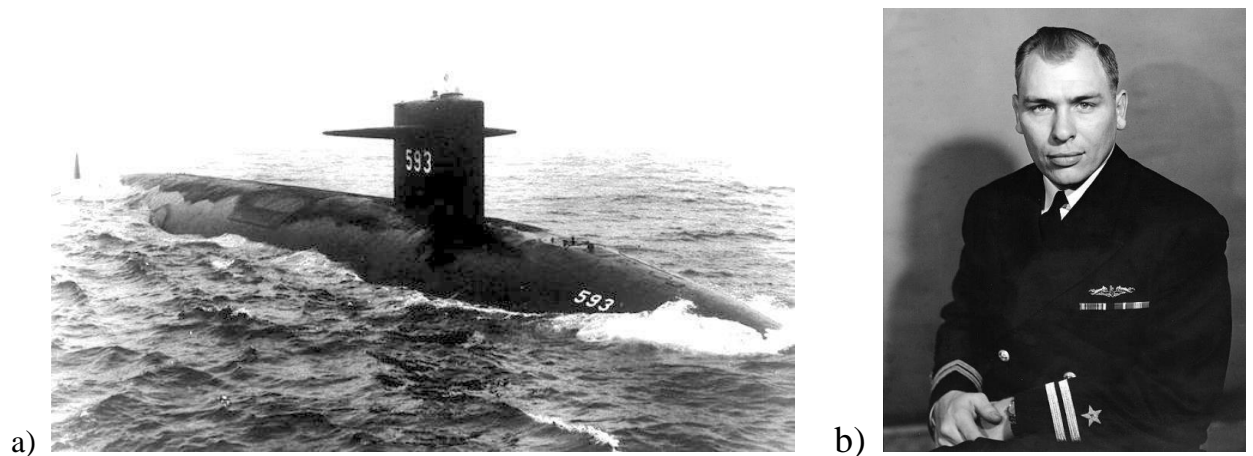
Fig. 11. a) Submarine “Thresher”. b) A commander Lieutenant Commander John Wesley Harvey (1927–1963), graduate of the United States Naval Academy. Completed an additional training course on nuclear reactor control. He served on the nuclear submarine “Nautilus”, the world's first nuclear submarine. Member of two Arctic expeditions of the submarine fleet to the North Pole. Appointed commander of the “Thresher” in January 1963. Photos are taken from the open sources on the Internet.

Reportedly, the “Thresher” nuclear submarine was repaired and tested in the Gulf of Maine off the east coast of the United States. The nuclear submarine “Thresher” (a thresher is a certain type of shark) was launched from the Portsmouth shipyard in 1958. At that time, “Thresher” was the most modern attack submarine of the US Navy distinguished by high maneuverability with a displacement of 4,369 tons (according to other sources, 3,420 tons), a length of 85 m, an underwater speed of up to 30 knots (~15 m/s) and having a maximum immersion depth of 400 m (see Fig. 11).

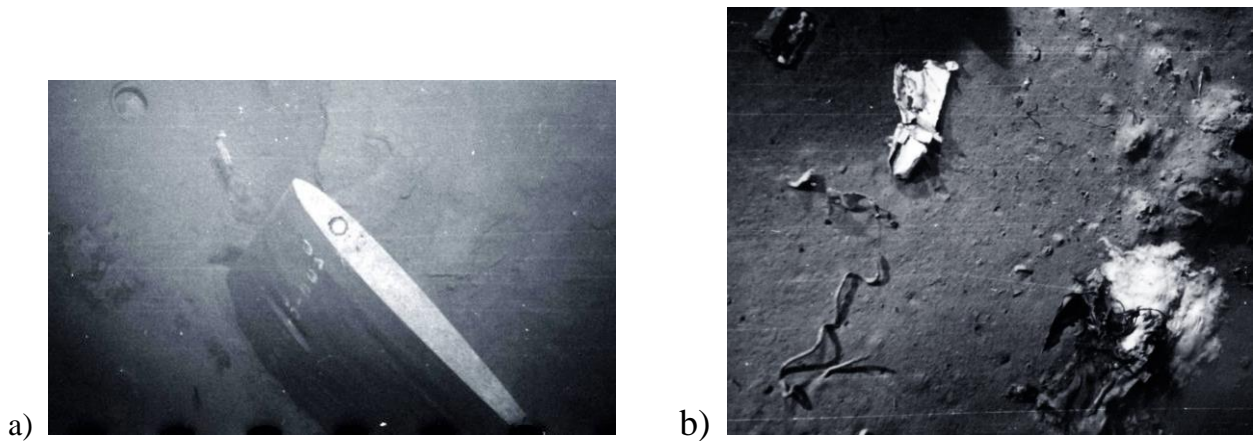
Fig. 12. a) The top of the Thresher rudder with an element of navigation lights photographed by the bathyscaphe "Trieste" in October 1964. b) Elements of thermal insulation on a board of the "Thresher". Photos are taken from open sources on the Internet.

After a long search, the remains of the submarine, which had split into six large pieces within a radius of 300 meters, were recovered by means of the bathyscaphe “Trieste” at a depth of 2,560 meters southeast of Cape Cod, Massachusetts. According to experts, “Thresher” fell to the bottom with a stern down at a very high speed. On impact on the bottom, the submarine broke into pieces and plunged deep into the silt. In Fig. 12 one can see photographs of individual fragments of the sunken nuclear submarine. Many hypotheses were put forward about the reasons for the death of the submarine, among which there were suspicions that “Thresher” was somehow destroyed by a Soviet submarine (it must be borne in mind that these events took place in the midst of the Cold War). But let's approach the analysis of events and messages using established facts.

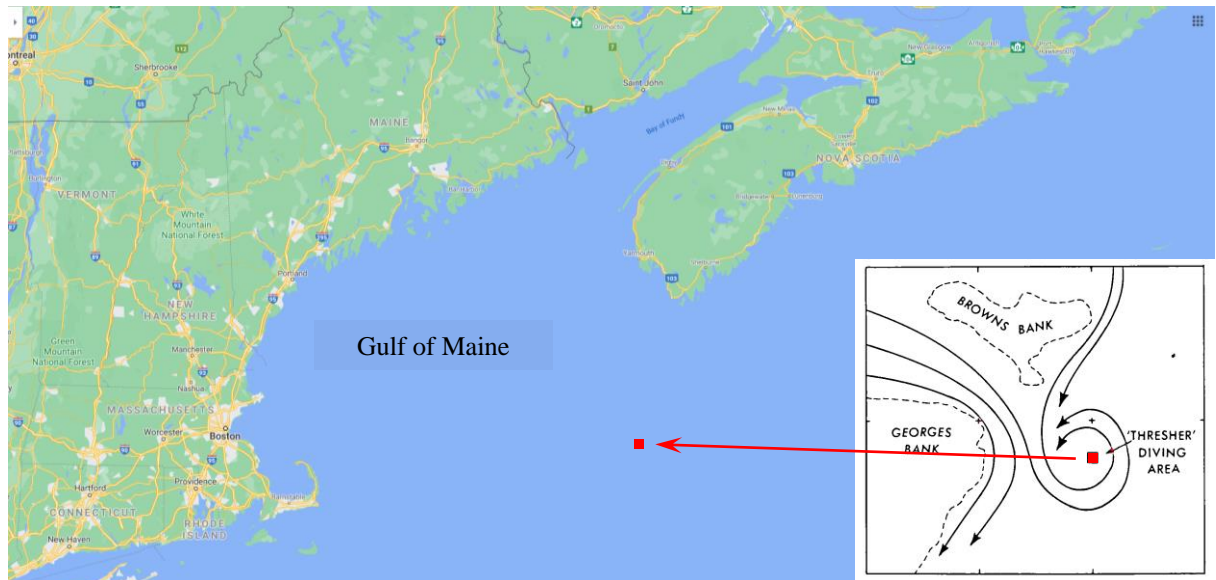
Fig. 13. To the hypothesis of C. Iselin about the accident of the nuclear submarine “Thresher”. The red squares mark the approximate place (41°46'N, 65°03' W) where the submarine was lost.

According to Iselin's hypothesis, "Thresher" could have been lost due to a huge underwater vortex and the additional impact of an internal wave [19]. Red marks in Fig. 13 show the site of the submarine wreck, and the inset taken from Iselin's article [19] shows two underwater banks, Georges Bank and Browns Bank. Iselin assumed that the whirlpool could have been created by a past storm, which redirected the eastern current in the Browns Bank area to the south, whereas in normal weather it bypasses the bank in the northern part from east to west. This eastern current, meeting with the permanently presented current emanating from the Gulf of Maine between the Georges and Browns Banks, could have formed a vortex. The vortex motion of the liquid mass creates a decrease in the pycnocline, on which, possibly, an additional decrease was superimposed due to the 100-meter internal wave arriving at the same point. Further Iselin suggested that if, by coincidence, the "Thresher" found itself exactly in the place where the

vortex and the internal wave that came up here were located, then it could be pulled into the depths due to a sharp drop in buoyancy. He also assumes that events were developing too rapidly, so that the crew did not have time to work out an emergency ascent.

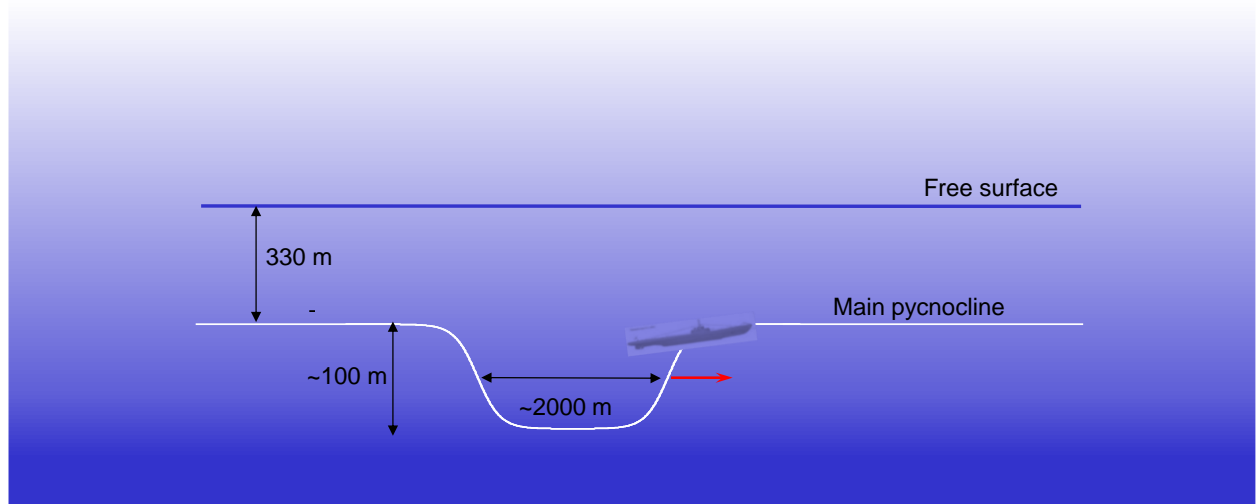
Fig. 14. A hypothetical scheme of the accident that occurred with the nuclear submarine "Thresher". Reconstruction by the author.

[19], but, it is possible that “Thresher” did not move at all). Suppose that the submarine is overtaken by ISW in the form of a Gardner soliton with an amplitude of 100 m or more, moving at a speed of 2.5 m/s and having a shape of a trench as shown in the inset to Fig. 8a). This will cause the boat to sink to the stern and lose buoyancy, at first smoothly, and then more and more rapidly (see Fig. 14).

Apparently, not at all because something happened onboard of the submarine, otherwise the commander would know exactly what to report. But if the submarine suddenly starts to sink at the stern for an incomprehensible reason for the commander, then he cannot report anything concrete, except to report on the very fact of the boat sinking (*“Have positive up angle.”*). It seems to the commander that the problem is not serious, which his crew will try to eliminate by blowing up the main ballast tanks, therefore he reports his actions: *“Attempting to blow. Will keep you informed”*. All actions of the commander look completely correct and logical, given the lack of understanding of the essence of the problem (at that time, the existence of large-amplitude ISWs was not known). But the submarine is being pulled into the depths faster and

faster. The blowing of the tanks does not keep pace, and the horizontal rudders are not effective at low speeds, the boat overshoots the maximum permissible depth, after which the collapse becomes inevitable. The crew had only a few minutes to eliminate the buoyancy deficit (see the above estimates of submarine immersion with a sharp change in water density) but, as it became known later during the investigation of this accident, the mechanism for purging the tanks during an emergency ascent was extremely imperfect; it did not allow the tanks to be blown out in a short time due to the icing of the valves caused by the rapid expansion of the highly compressed air. It turned out that the same problem was quite common in the American submarines of the previous generation.

Probably, having picked up speed when falling, by inertia, the boat slipped through the level of neutral buoyancy in the centre of the ISW by tens or even hundreds of meters, where the external pressure was already prohibitive. Falling stern forward, the boat collapsed; its fragments were later found scattered within a radius of 300 m. On impact on the bottom, it fell apart. Naval historian Norman Friedman concluded from recently declassified commission materials that inadequate crew training exacerbated the problem, as the crew was unable to respond quickly enough to save the sub. However, the seamen cannot be blamed for the poor functioning of the ballast system. In those conditions, when the count of time went by seconds, the crew, presumably, did everything in their power, but the tragedy was not in their power to prevent. The ballast system was too sluggish. This is essentially confirmed by the author of an article in the American magazine *Popular Mechanics* Kyle Mizokami [20]: “*A trove of recently declassified files on the tragic 1963 sinking of the nuclear-powered attack submarine USS Thresher confirm the U.S. Navy didn’t cover up the mysterious accident – and, in fact, there was no single event or error that caused the sub to sink*”.

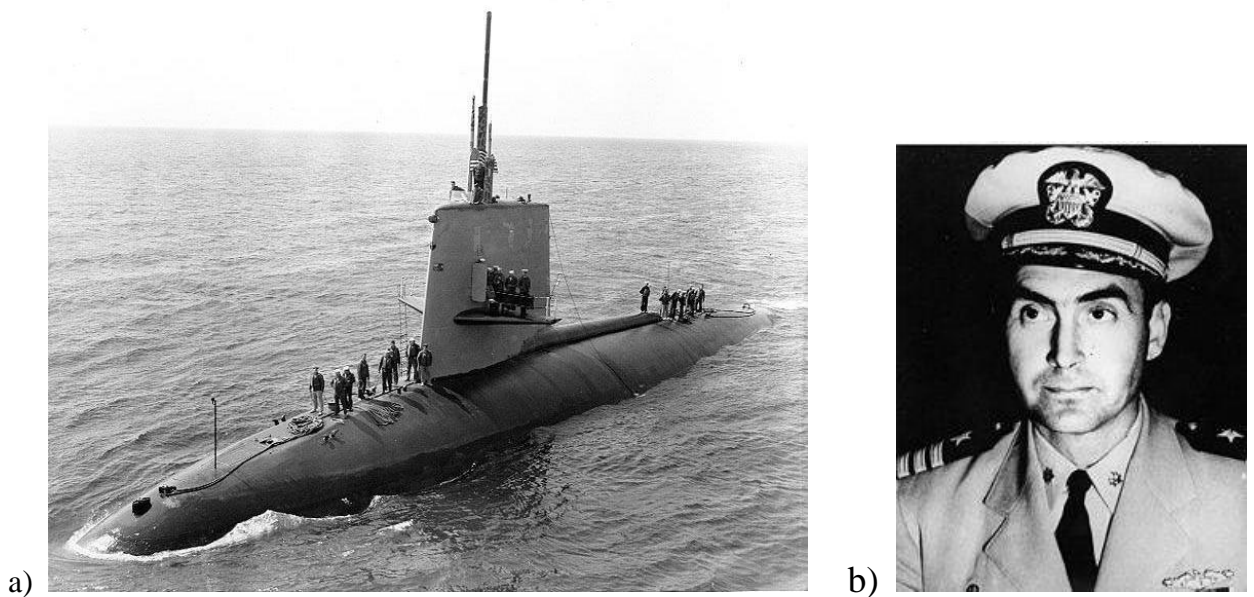
Fig. 15. a) Nuclear submarine “Scorpion”. b) Submarine commander Francis A. Slattery (1931–1968).

The “Scorpion” was one of the US nuclear attack submarines with almost 8 years of service in the Navy (Fig. 15). The boat got its name in honour of the submarine of the same name “Scorpion”, which mysteriously disappeared in 1944 during the Second World War. A similar fate befell this boat.

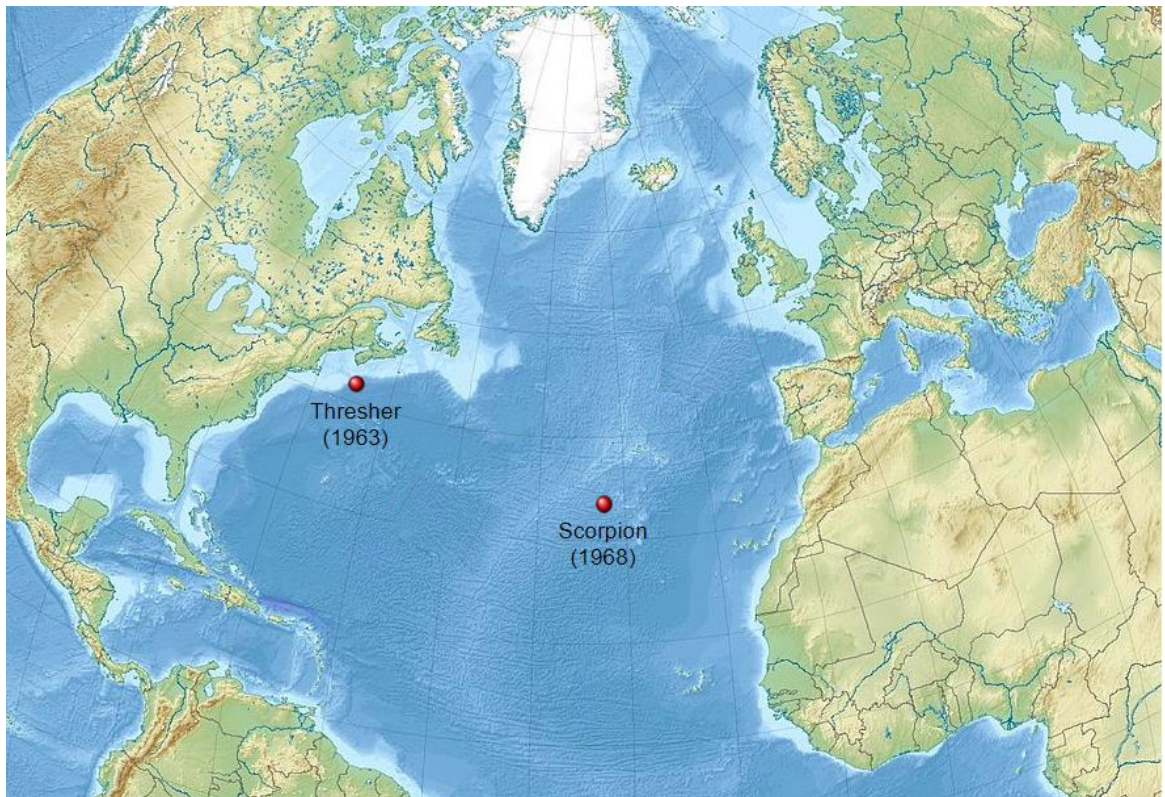
Fig. 16. The places where the submarines “Thresher” and “Scorpion” were lost.

But let us imagine that the “Scorpion” overtook a large-amplitude ISW moving with the speed of 2.5 – 3.0 m/s. Such large ISWs were repeatedly recorded in the central Atlantic, including near the path along which the “Scorpion” was moving (see Fig. 16). In particular, in the work of

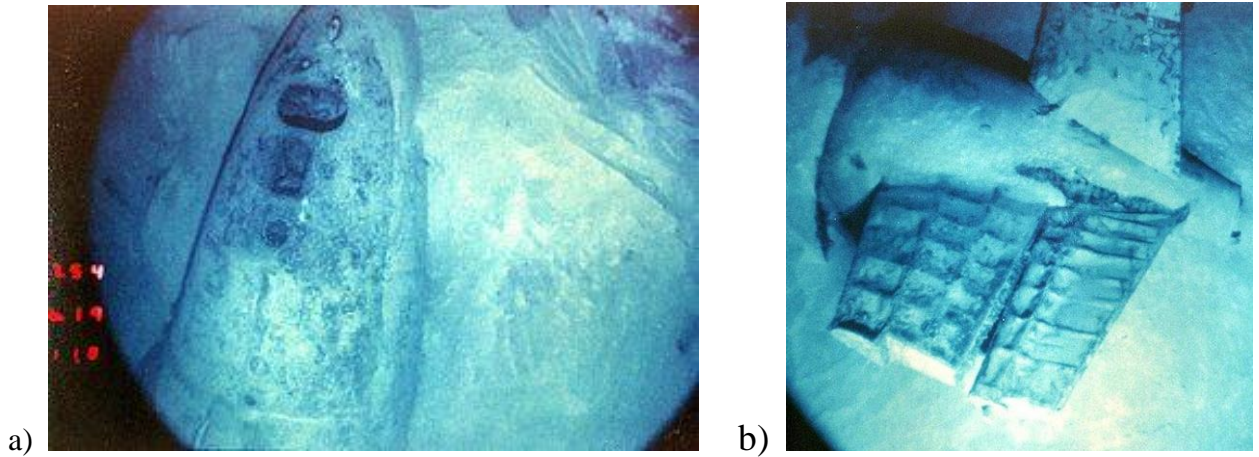
Fig. 17. Bow (a) and aft (b) parts of the sunken nuclear submarine “Scorpion”.

Spokesman Commander Frank Thorp said after the investigation that: “While the precise cause of the loss remains undetermined, there is no information to support the theory that the submarine's loss resulted from hostile action or any involvement by a Soviet ship or submarine”. The conspiracy theory that the Scorpion was attacked by a Soviet submarine recently surfaced again in a book “Scorpion Down” by a military columnist Ed Offley but none of the experts seem to take it seriously. One of the participants in the investigation, Ross Saxon, who examined the sunken boat from the bathyscaphe “Trieste-2” said that the boat did not fall apart into small pieces, but, apparently, its hull collapsed on impact on the bottom. *No traces of torpedo damage were visible on the hull* (see Fig. 17).

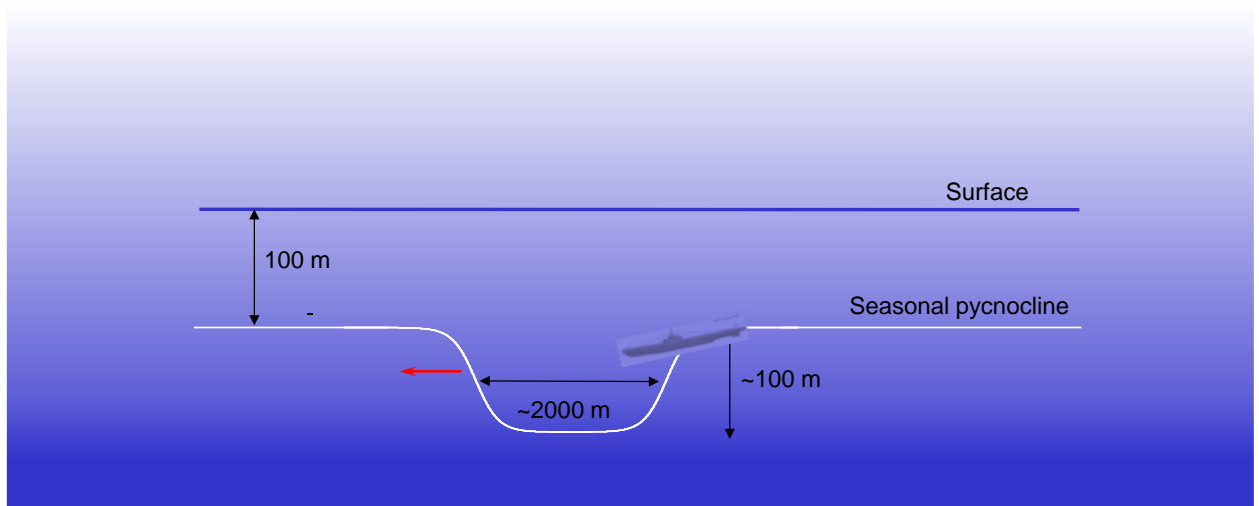
Fig. 18. The hypothetical scheme of the accident that could occur with the nuclear submarine “Scorpion”. Reconstruction by the author.

At the indicated speed difference, catching up with the ISW and entering the area of reduced density, the submarine began to lose buoyancy, and not evenly, but as if sliding down a steep hill with its nose down (see Fig. 18). At the same time, the running engine also pushed the boat from behind. On a relatively steep slope of the ISW, the submarine could even flip or turn 180° from the intended course (imagine a log slipping down of a steep hill). The team had no time to level the course after such a somersault; it was necessary to urgently take measures for an emergency ascent, when every second is precious, so the boat continued to move in the opposite direction from the intended course. The time for an emergency ascent was sorely lacking, because according to available information, the ballast system on the boat was also outdated, like on the

submarine “Thresher”. As it was later found out, during the recent overhaul “on the “Scorpion”, no alterations were made to the emergency blowing system of the main ballast tanks” [21]. As a result of the immersion, one of the compartments (probably the bow one) was the first to crack, and the sea water under high pressure $\sim(10 - 20)$ atm began to fill it quickly. Apparently, this first clap was later discovered in hydrophone recordings. But the boat was still alive, although it was already doomed, and continued to move in the opposite direction, fighting for survivability. The first compartment was filled with water and began to pull the boat further down. Then, one after another, the bulkheads between the compartments began to collapse with a crash, which led to a series of subsequent claps recorded by hydrophones. Of course, this is only the author's reconstruction of the reasons for the death of the nuclear submarine “Scorpion”, but it is no more fantastic than all other versions, and, perhaps, even more realistic.

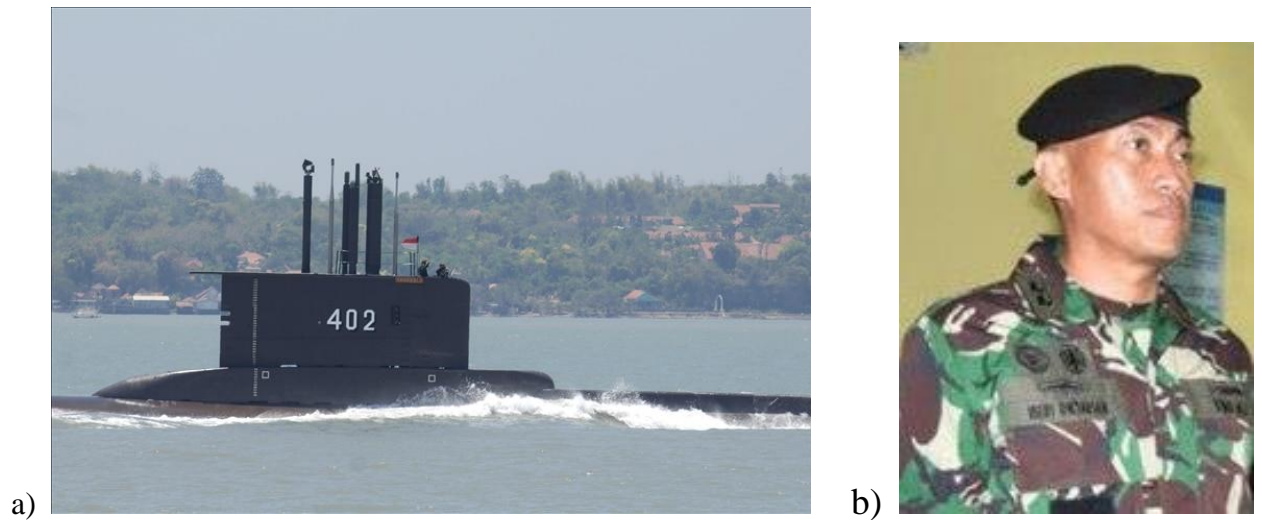
Fig. 19. a) Indonesian submarine “Nanggala-402”. b) The submarine commander Lt. Col. Heri Oktavian (1979–2021).

Diesel submarine of the Indonesian Navy “Nanggala-402” was built in Germany in 1978 (Fig. 19). A boat with a crew of 53, led by Lieutenant Colonel Heri Oktavian, was on a training exercise in the Bali Sea. On the morning of April 21, 2021, the Indonesian naval forces lost contact with the boat shortly after it was given permission to dive deep for a torpedo firing exercise. Soon from one of the helicopters, and then from the search ships, a message was received about an oil slick in the alleged location of the submarine. Ships from different countries joined an intensive search for the missing submarine and after a few days her remains were found in the Bali Sea at a depth of 838 m. The boat split into at least three parts – the hull, the main part and the stern. A remote-controlled camera captured the final resting place of the submarine along with the crew on the seabed 96 km north of the Bali Island.

The submarine parameters which are of interest to us are the underwater displacement of the boat was 1,390 tons, the working diving depth was 200 m, safe diving depth – 257 m, maximum diving depth – 500 m, the underwater speed was 25 knots (~12.5 m/s). A disaster with a submarine could develop according to the same scenario as in the case of the death of the nuclear submarine “Scorpion”. If the boat were sailing at a great depth, as it was assumed under the conditions of the exercise, and encountered a high-amplitude ISW, then it could, as described above, “peck its nose” and fall 100 m lower, experiencing an additional load of almost 7 tons. The engines only increased the sinking effect, pushing the boat deeper (see Fig. 18), and the delay in rudder control and the inert ballast system made it impossible to cope with the problem.

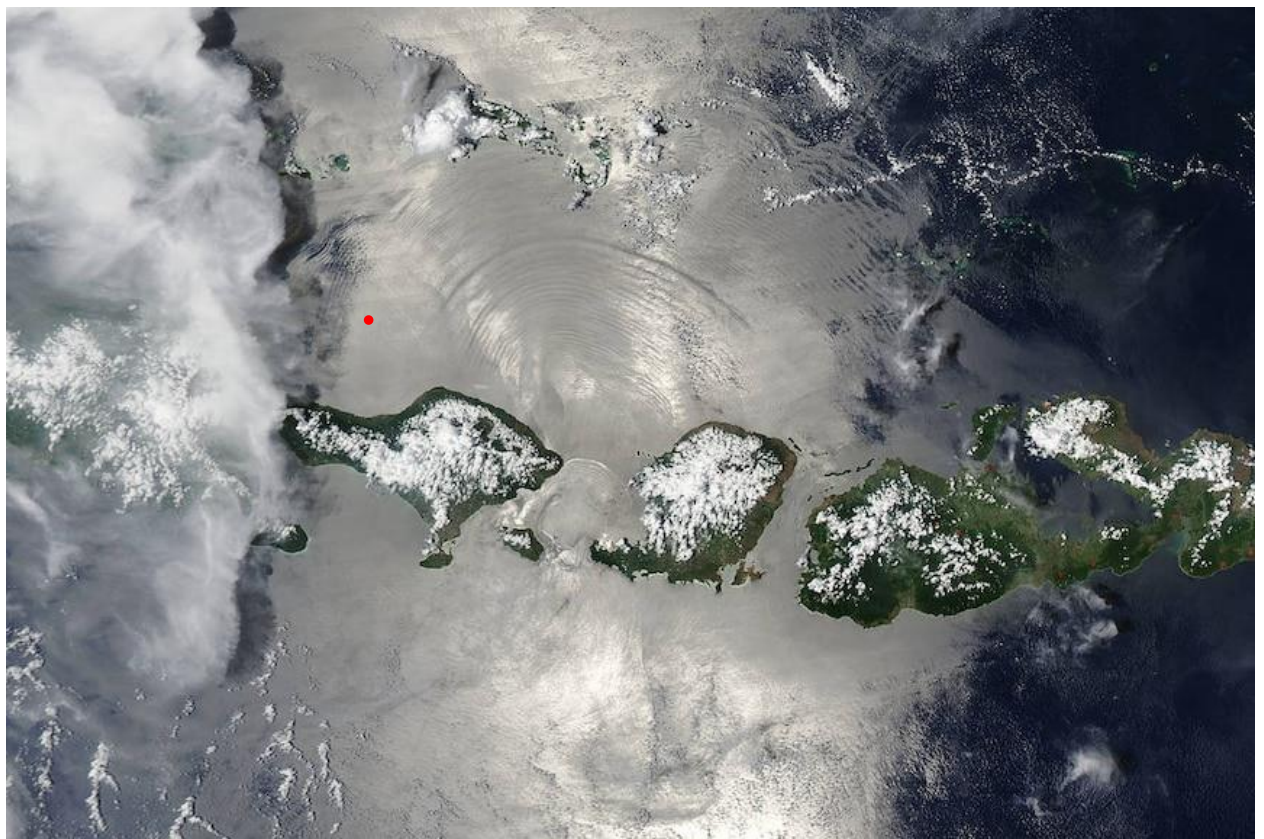
Fig. 20. Satellite image of stripes formed on the surface of the Bali Sea by internal waves. Waves emanate from the Lombok Strait between Bali (left) and Lombok (right). The picture was taken in 2016 (NASA: Jeff Schmaltz, MODIS Land Rapid Response Team, NASA GSFC) [1]; such trains of internal waves regularly appear in this area. The red dot marks the approximate place of the sinking of the “Nanggala” submarine.

To the southeast of the place where the submarine perished, there is a strait about 40 km wide between the Bali Island and Lombok Island (see Fig. 20). In this place, intense currents and internal waves are regularly observed, which noticeably intensify every two weeks; one example is shown in Fig. 20. According to Bernadette Sloyan of the Australian research organization CSIRO, Tasmania Oceans and Atmosphere Division, “The Indonesian seas are a very small part of the ocean, but they account for about 10% of the tidal energy of the oceans” [22].

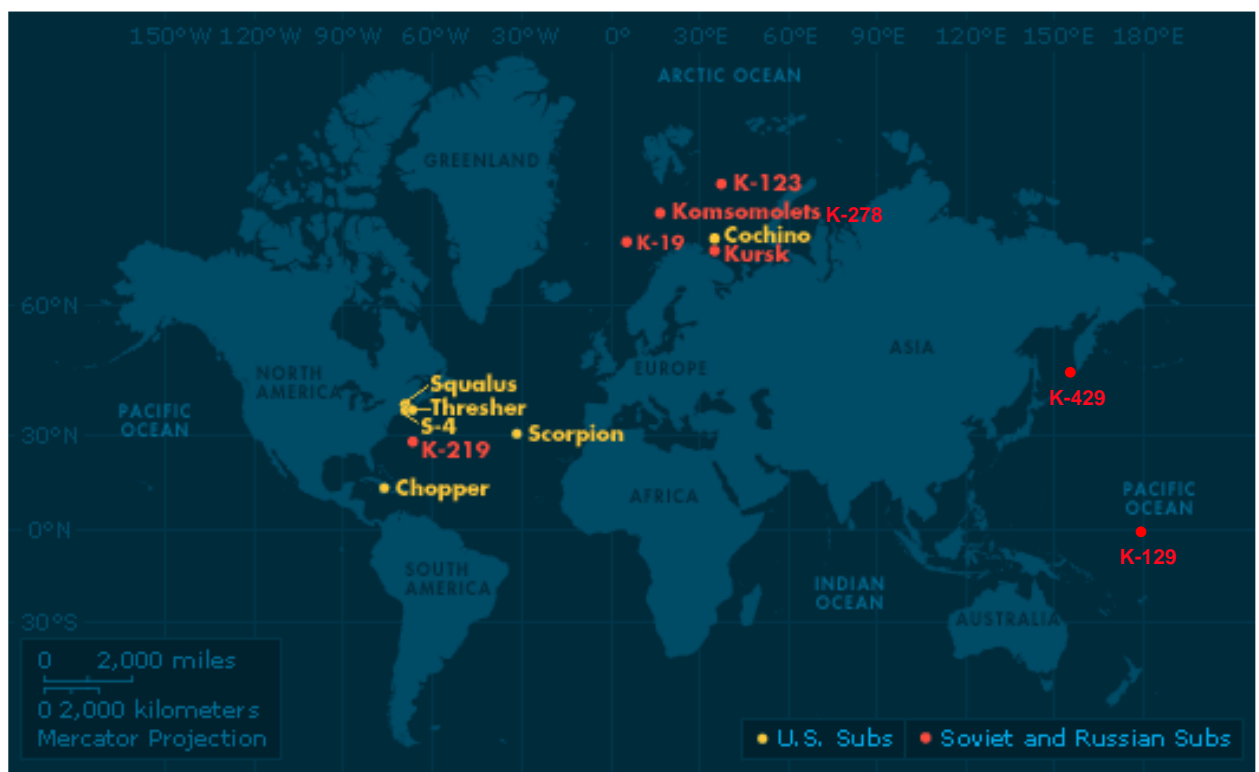
Fig. 21. Dismal statistics of the largest losses of submarines of the USSR/Russia and the United States.

In conclusion, a brief summary of the largest losses of submarines of the USSR/Russia and USA is presented in Fig. 21. We only can wish to the submarines that remain “on Eternal Patrol” in the ocean, may their crews and civilian specialists Rest in Peace.
