Partial Discharges detection in 1 MV power supplies in MITICA experiment, the ITER Heating Neutral Beam Injector prototype

Keywords: ITER, PRIMA, MITICA, Heating Neutral Beam Injector, High Voltage Power Supply, Insulation design, Partial Discharges detection

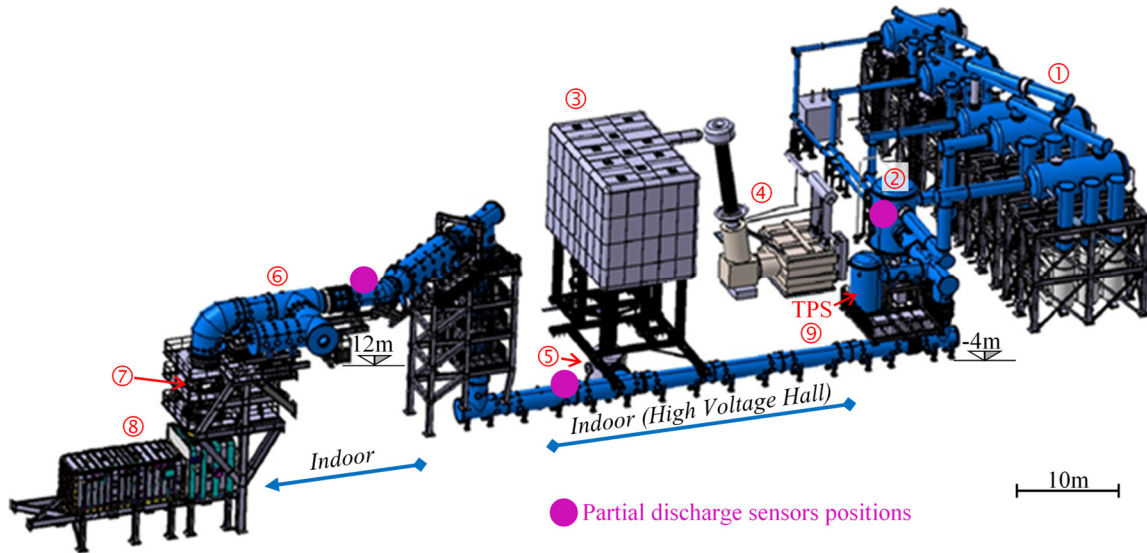
Fig. 1 Overall view of the MITICA PS system.

- the Acceleration Grid Power Supply (AGPS, see detail 1 in Fig. 1) [3], feeding a voltage down to -1 MV dc across the electrodes of the electrostatic accelerator, composed of five -200 kV series connected DC Generators (DCG); each DCG consists of a three phase step up oil insulated transformer which high voltage output is rectified by a three phase diodes bridge contained inside a SF₆ pressurized tank; DCG output conductors are connected to a RC Filter unit (DCF, detail 2) via SF₆ gas insulated lines;
- a large -1 MV dc air insulated Faraday cage, the High Voltage Deck1 (HVD1, detail 3) [4][5], hosts ISEPS,

the Ion Source and Extraction Power Supply system [6] providing power to the Ion Source for production and extraction of the negative ions; ISEPS is fed by an Insulating Transformer (detail 4) [7] and its output conductors are routed from the HVD1 to the Transmission Line (TL) through an air-to-SF₆ Bushing (High Voltage Bushing Assembly, HVBA, detail 5); these equipment, insulated in air, are installed inside a High Voltage Hall (HVH) with controlled ambient conditions (air temperature, humidity and dust level) [5];

TL (detail 6), composed of 3 subsequent sections (TL1 to TL3 [3]), connects AGPS and ISEPS to the beam source installed inside MITICA Vessel (detail 8) through the SF₆-to-vacuum HV Bushing (HVB, detail 7). Provisionally, during the insulation and integrated tests, the Short Circuiting Device (SCD) is installed in place of the beam source. The SCD, insulated in SF₆ at 0.13 MPa abs, is provided with five movable spark gaps, to simulate grids breakdown (BD); five fixed parallel spark gaps limit the voltage to the HVB admissible value (-1 MVdc in total, 200 kV for each stage).

The equipment, procured by European (EUDA) and Japanese (JADA) Domestic Agencies (DA's), performed successfully acceptance tests in Factories, either as a mockup of reduced dimensions (HVD1 [5]) or as a full scale sample ([3], HVBA [5]) before delivering at PRIMA site. MITICA Power Supply system has been installed from 2016 to 2019 and High voltage withstand tests (consisting of three consecutive voltage applications: 1.2 MV x 1 h, 1.06 MV x 5 h, after the 5 h application 5 peaks at 1.265 MVdc level [3]) have been performed in five subsequent steps from September 2018 to November 2019, according to the installation progress and after connecting equipment belonging to different procurements. Tests were carried out remotely, by applying voltage with the Testing Power Supply (TPS) generator (rated for 1.3 MV, 10 mA, detail 9 in Fig. 1) according to the following sequence:

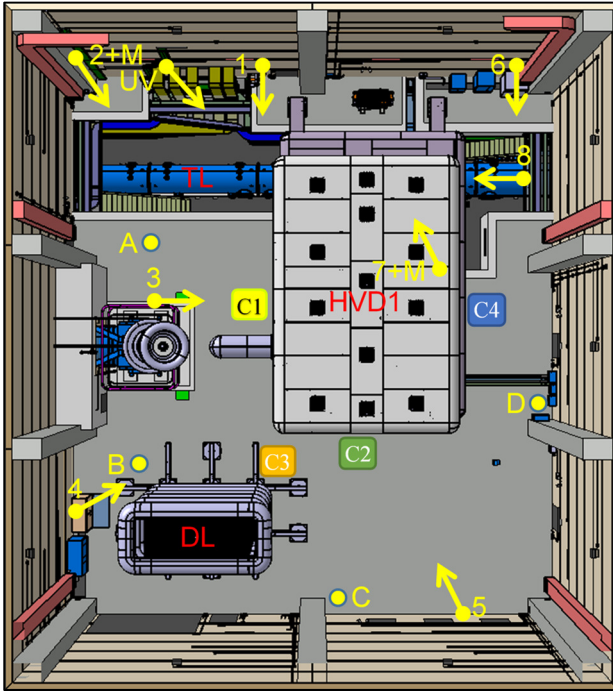
Fig. 2 Plan view of diagnostics layout in HVH.

- 2) the diagnostic instrumentation has then to be moved to the subsequent positions (from “B” to “D” in Fig. 2) and the voltage application sequence as per point 1 repeated; the same to be done also for the remaining positions;
- 3) once tested all the positions, the voltage has to be further raised, in step of 100 kV, from 300 kV to 600 kV and the tests repeated for all the positions;
- 4) after the completion of point 3, the voltage has to be raised from 600 kV to 700 kV and then, with step amplitude reduced to 50 kV, to 800 kV;
- 5) finally, the test sequence has to be completed raising gradually the voltage from 800 kV to 1000 kV with the instruments positioned subsequently in the four observation points inside the HVH.

- two additional capacitive field probes, for a total of 4: 3 of them located on the floor in correspondence of three HVD1 sides (“C1”, “C2”, “C4” in Fig. 2), the fourth (“C3”) below the DL; the probes, which signals were sent through coaxial cables to the four inputs of an oscilloscope located very close to probe “C2”, are

- one camera in the visible field provided with microphone (“7+M” in Fig. 2 and Fig. 3) to detect any occurrence of light or sound produced inside the HVD1;
- a microphone installed nearby the vessel (“M” in Fig. 3) to detect the sound occurrence generated by a discharge inside the vessel;
- high speed camera looking at the SCD fixed spark gap,
- 6 ambient microphones installed along the plant trying to identify the location of the sound occurrence associated to a BD event and its propagation along the

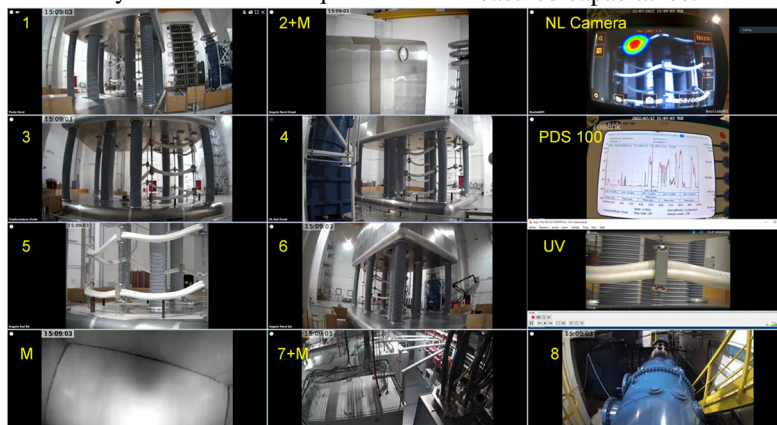
Fig. 3 Instruments and cameras online monitoring inside MITICA control room.

- Acoustic sensors:** the chosen off-the-shelf solution was the NL Camera [9], equipped with a matrix of 124 microphones to catch sounds emitted by corona occurrence and instantly showing the sound source location on the camera's monitor; the instrument has been installed on a tripod, provided with a camera to display out of the HVH, segregated during the tests, on MITICA control room for online monitoring (see Fig. 3);

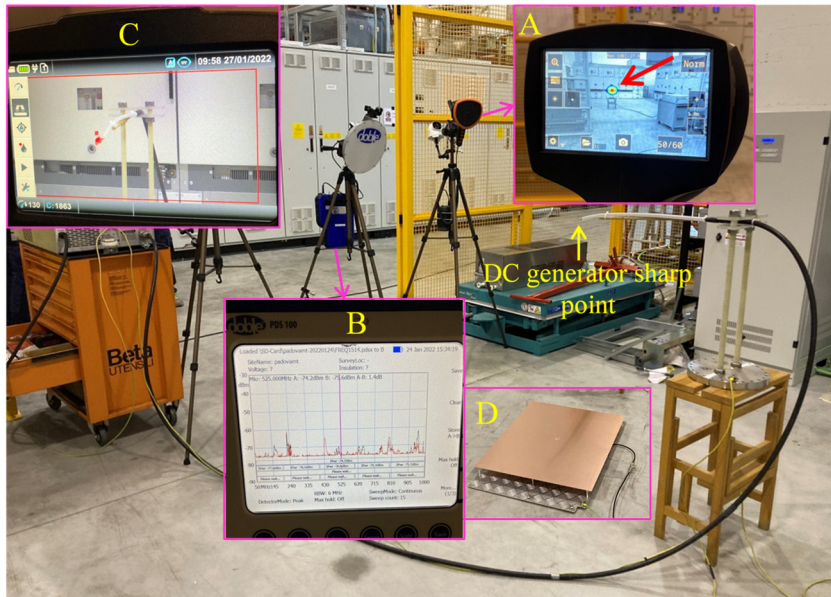
detection in DC application. The NL camera (A), the PDS100 (B), the DayCor camera (C) and the capacitive field probe (D) were installed in front of a sharp point supplied by a negative DC voltage generator to produce corona effect (see Fig. 4).

Fig. 4 Test setup for instruments verification. Displays show acquisitions at 5 m from the sharp point.

The instruments A, B and C, positioned at a distance of about 1.5 m from the PD source for a first scan, were later moved at about 5 m from the sharp point, supplied at -40 kV in both cases, and the measurements were repeated. All the instruments showed a similar sensitivity, detecting the “corona” inception at -27 kV whilst the extinction voltage was -20 kV for both the distances from the source. As visible in Fig. 4, the NL camera (A) identifies the corona source (sharp point) with a coloured area while the DayCor camera (C) indicates the source of defect with a red dots cloud superposed on the background ambient image. It has to be noticed that DayCor camera detects as well the natural activity present in air, therefore also in case of no corona occurrence some red dots could be present on the screen but they are widespread and their number is quite low. The PDS100 (B) screen shows instead the variation of the acquired signal curve (in black) with respect to the background noise (in red) recorded after instrument positioning before voltage application. The capacitive field probe (D) was firstly characterized by recording its output to a step electric field produced applying a DC voltage to a metallic sheet installed 50 mm above the capacitive probe. The DC generator step voltage was set at -250 V, Fig. 5 shows that the field probe signal decreases to zero voltage with the decay time (~ 10 ms) determined by the probe capacitance (9.5 nF) and the input resistance of the digital oscilloscope (1 M Ω). Once installed at about 1 m from the sharp point connected to the DC voltage generator (see Fig. 4) the capacitive field probe output signal remained (correctly) at zero voltage up to 20 kV, then increasing the applied voltage at corona occurrence the output signal raised to a negative value of few tens of millivolt. A more accurate analysis of the record had shown that this was due to the short time between two subsequent corona pulses, shorter than the characteristic discharge time of the capacitive probe, determining therefore a mean value slightly different from zero. The tests described showed the

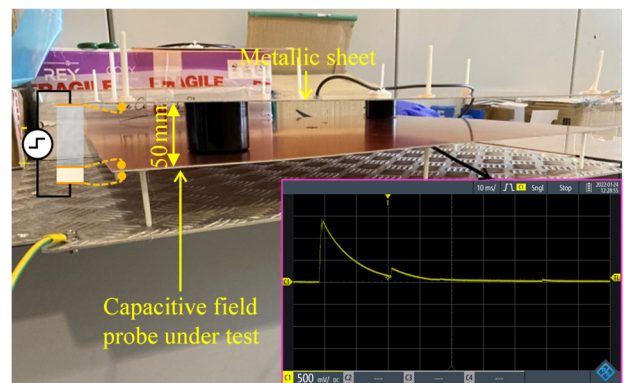
Fig. 5 Test setup for probe answer to a step electric field.

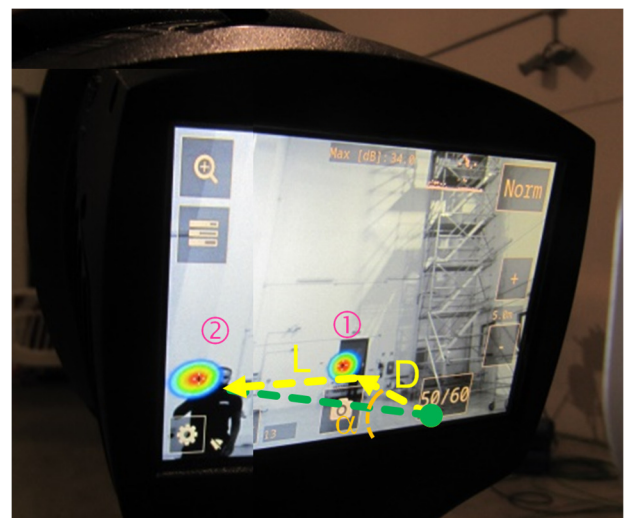
Fig. 6 Test to determine NL camera field of view.

This was done by using a commercially available piezoelectric gas lighter; once activated it generated several “small” sparks that produced sound and modified

the electric field. For both instruments in turn, the lighter was aligned with the equipment axis at the maximum available distance “D” (about 14 m) in the HVH and hence the capability of the sensors to detect the event verified (see ① in Fig. 6 for NL camera). Then the lighter was moved horizontally out of the axis and the test repeated to detect the maximum horizontal distance “L” for which the sensors were able to detect the event (see ② in Fig. 6 for NL camera). The corresponding angle α was calculated; the field view of each sensor, equivalent to the double of α , was determined in 60° for NL camera and 130° for PDS100 respectively.

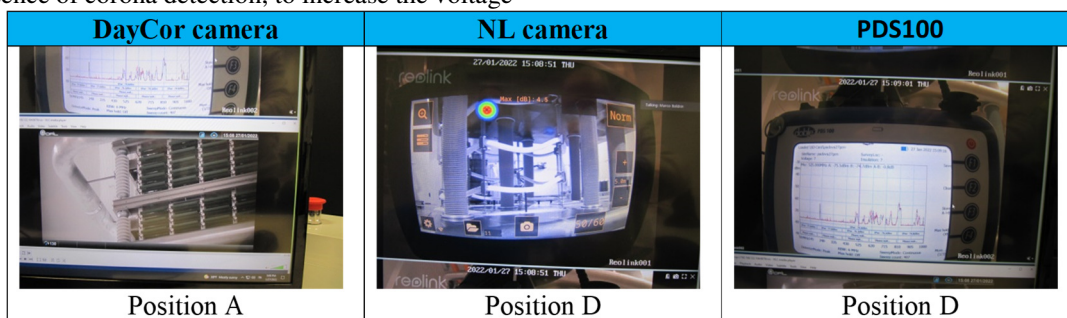
Fig. 7 Test at 500 kV.

A first test session was carried out from January 24th until January 28th 2022. Only two capacitive field probes, C1 and C3 in Fig. 2, were used and their signals acquired through a digital oscilloscope remotely controlled. Few minutes after having reached 500 kV, after an irregular TPS current behaviour, the voltage dropped to zero. No indication of “corona” or other phenomena were noticed during the tests. Fig. 7 shows the last available data at 500 kV: it has to be evidenced that NL camera always pointed out one (two) coloured areas on the HVD1 bottom side (depending from the observation point) but it has been clarified that such noise was generated by HVD1 cooling plant and was not correlated with any PD generation, being present in the same location also without voltage application.

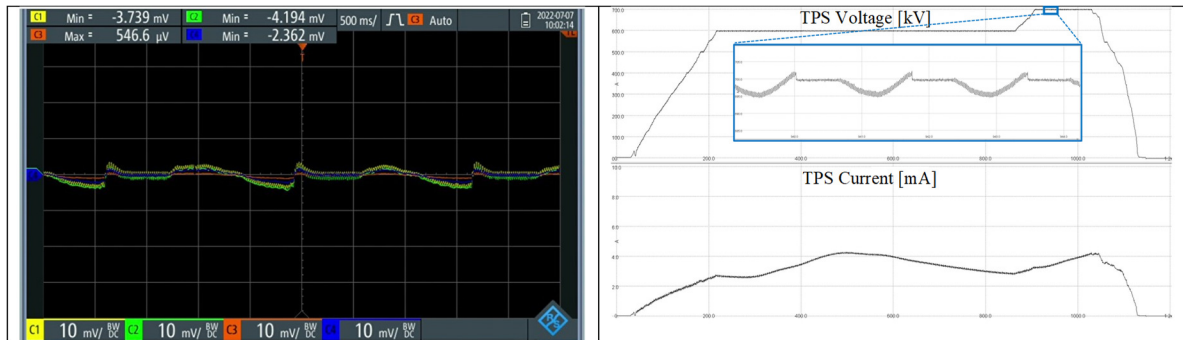
- oscillation of the four field probe signals (see Fig. 8): the four signals oscillated with a “period” of about 1.8 s but the signal of probe 3, closer to DL, had smaller amplitude; the oscillations could be correlated with the regulation of the voltage applied to HVD1 by the TPS, measured by the probe acting as low voltage branch of a voltage divider completed by its stray capacitance towards the HVD1;

Fig. 8 Field probes (oscillation at 700 kV) and TPS V-I signals.

To understand the reason of the shift of the signal of field probe C2 in the previous test, the session started with all the PD diagnostic instruments (PDS100, NL and DayCor cameras) installed in position C, in front of the probe, to discriminate the signal drift due to corona inception from signal drift due to coupling or interference. The test voltage was gradually increased in steps of 100 kV, maintaining the application for some minutes every time, up to 700 kV lasting for 10 min. No shift at all was detected on the signal probe, which showed only the voltage ripple applied to HVD1 by the TPS (see Fig. 8 for reference).

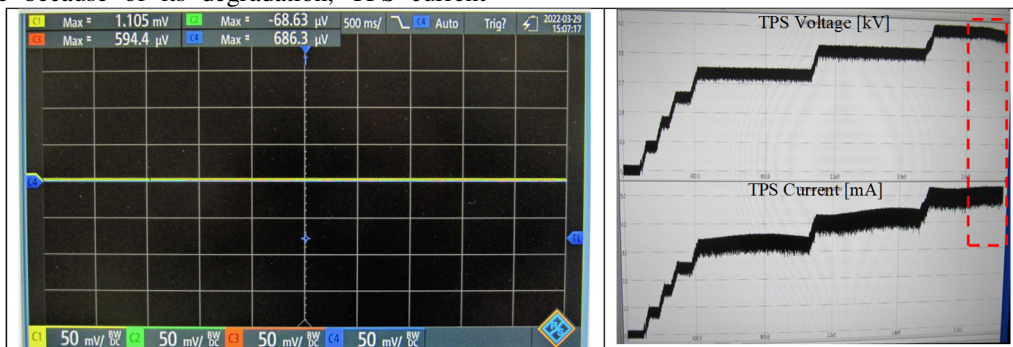
- field probes signals identical with almost null value: after investigation, it was clarified that this behaviour occurred when, due to the water conductivity increase because of its degradation, TPS current

exceeded the set threshold and consequently output voltage slightly decreased (see red rectangle in Fig. 9, switch of TPS from voltage to current control);

Fig. 9 Field probes (600 kV after 10 min) and TPS V-I signals.

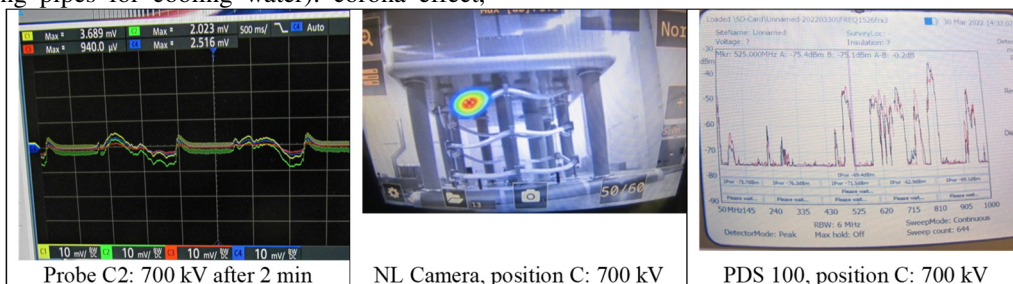
- Shift of one field probe signal: starting from about 700 kV a shift of the signal of field probe C2 was randomly noticed, while the other field probes signals continued to oscillate around zero (see Fig. 10 left). The amplitude of the shift of the C2 trace was not constant, ranging from 1 to 15 mV without any apparent correlation with TPS applied voltage. Some hypothesis was done to explain the shift of the capacitive probe signal (the nearest one to the HVD1 insulating pipes for cooling water): corona effect,

continuous variation of the electric field distribution due to no-ionizing phenomena, measuring error. By analysing the measurements of the other PD diagnostics (NL camera and PDS100) in different observation positions no evidence of corona was found (see Fig. 10 centre and right for position C), therefore corona effect indication by the probe was deemed unlikely and the understanding of the reason of the shift was left to further verifications.

Fig. 10 C2 field probe (shift at 700 kV) and PD measurements.

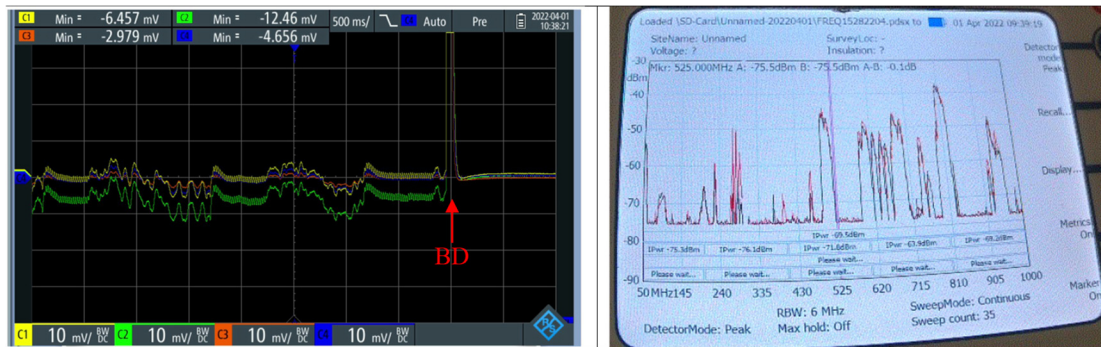
from the HVH was heard at 870 kV and the voltage dropped to zero. Moreover, the camera looking at SCD captured a flashover inside the vessel. The diagnostic systems did not show any indication of pre-discharge before failure (Fig. 11).

Fig. 11 Field probes and PDS 100 (position D) at BD instant.

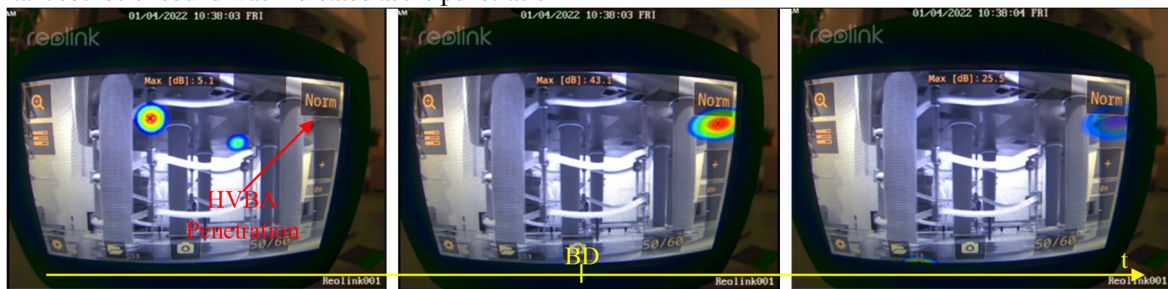
Only NL Camera (see Fig. 12, temporal sequence from left to right) allowed to identify during post analysis the change of the source of sound: before the BD the usual sound sources are visible, while at the flashover a new important source of sound was indicated at the penetration

of the HVBA in the HVD1 (sound intensity is reported on display top position). The comparison between the frames sequence indicates that the sound propagated from the HVBA to the HVH and not vice-versa.

Fig. 12 NL Camera (posit. D) frames sequence at BD event.
