# Chloride-induced corrosion of steel in concrete – insights from bimodal neutron and X-ray microtomography combined with ex-situ microscopy

The steel-concrete interface (SCI) is known to play a major role in corrosion of steel in concrete, but a fundamental understanding is still lacking. One reason is that concrete's opacity complicates the study of internal processes. Here, we report on the application of bimodal X-ray and neutron microtomography as in-situ imaging techniques to elucidate the mechanism of steel corrosion in concrete. The study demonstrates that the segmentation of the specimen components of relevance – steel, cementitious matrix, aggregates, voids, corrosion products – obtained through bimodal X-ray and neutron imaging is more reliable than that based on the results of each of the two techniques separately. Further, we suggest the combination of tomographic in-situ imaging with ex-situ SEM analysis of targeted sections, selected on the basis of the segmented tomograms.

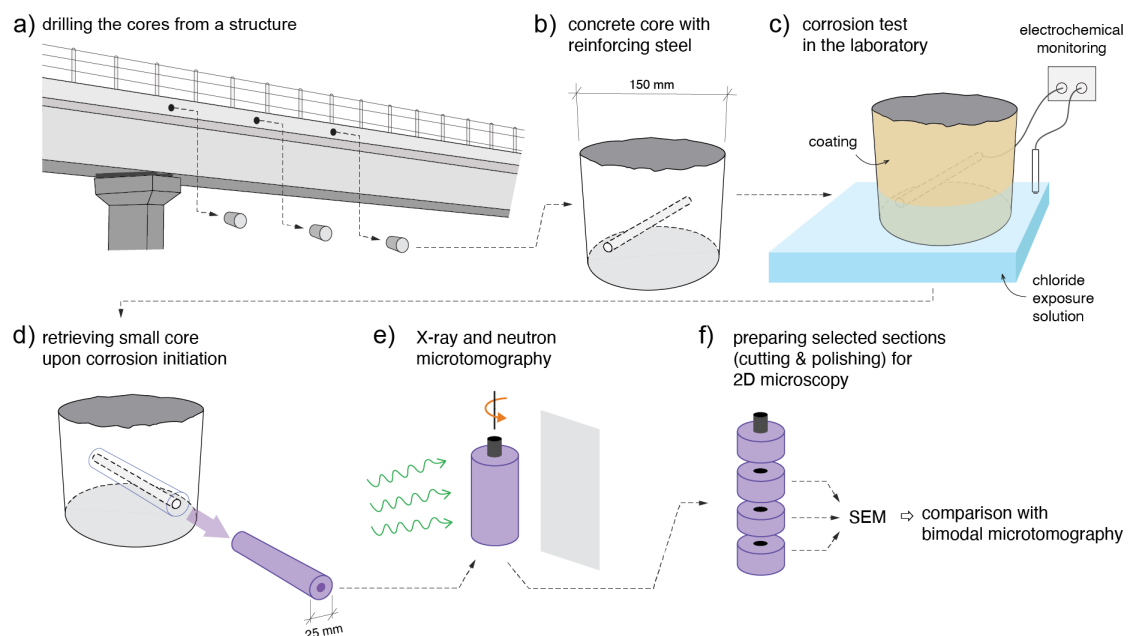
Figure 1. Sequence of experiments from retrieving samples from a reinforced concrete bridge (a,b) over corrosion testing in the laboratory (b) to the in-situ study of the samples in an early stage of corrosion by means of X-ray and neutron microtomography (d,e) and comparison with classical ex-situ microscopy (f).

it contained a ribbed reinforcing steel bar of diameter 10 mm (Figure 1b). The rebar was oriented horizontally in the structure (first reinforcing steel layer). No sample was corroding at the time of coring, as evidenced by potential measurements [31] on the structure prior to sampling. More information about the structure from which specimens have been collected are reported in Table 1.

To induce corrosion of the embedded reinforcement, the reinforced concrete samples were placed in a 10% sodium chloride solution to allow for chlorides to diffuse into the concrete and to trigger corrosion of the steel bar (Figure 1c). The electrochemical potential of the embedded steel bar was continuously monitored with the help of a reference electrode and a datalogger (multimeter with input impedance >1 MΩ), until a drop of the potential indicated initiation of corrosion, which occurred after around 2 years from the start of the exposure of the cores to the sodium chloride solution (Supplementary Figure S1). A more detailed description of the sample preparation protocol and the corrosion test can be found in Ref. [32].

After corrosion initiation, a core of 25 mm diameter was extracted from the tested specimen, such that the entire 150 mm long rebar was centrally located in the 25 mm core (Figure 1d). A total of four such cores were obtained, labelled as B1-E1-H-1 to B1-E1-H-4. The cores were transferred to the facilities for neutron and X-ray microtomography at the TU Delft (X-Ray microCT: Civil Engineering and Geosciences, neutron microCT: Reactor Institute Delft) as soon as corrosion initiated, so that the mechanism of corrosion of steel in concrete could be studied in a very early stage (shortly upon chloride-induced corrosion onset) and in-situ, that is in a largely undisturbed state (Figure 1e).

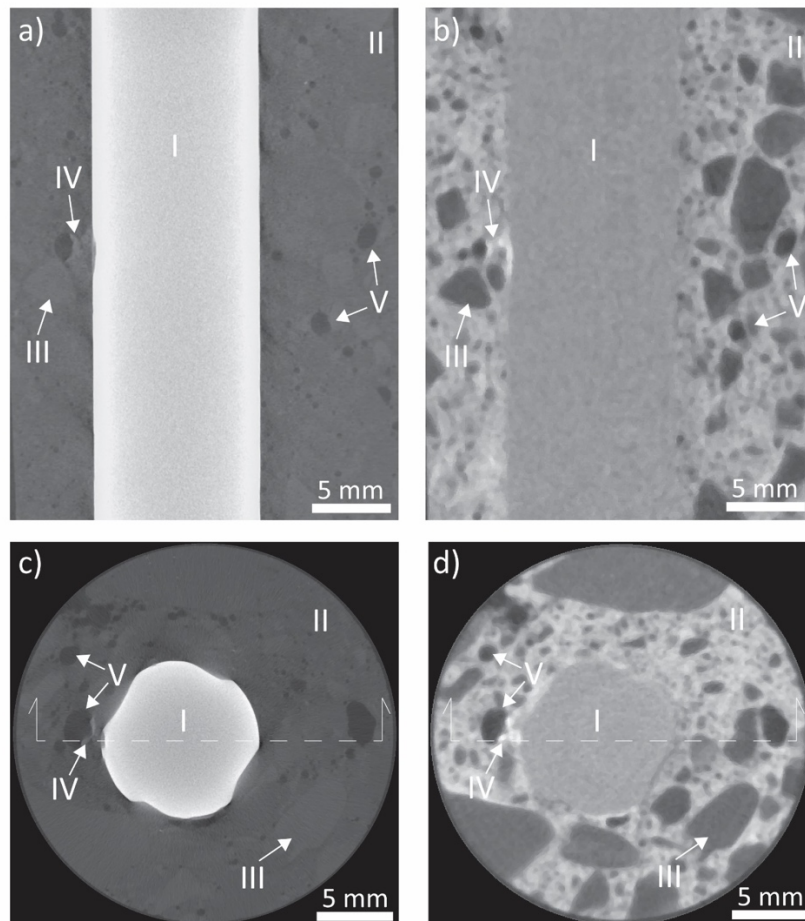
Figure 2. Comparison of reconstructed sections of the two imaging modes X-ray (a,c) and neutrons (b,d), illustrating the pronounced differences in attenuation (grey level) between the two modes for different phases, such as the rebar (I), cementitious phases (II), aggregates (III), corrosion products (IV), and voids (V). The dotted lines visible in the horizontal slices of X-rays and neutron images, respectively, indicate the cross-section lines of the respective vertical images. Image analysis and detection of components were conducted on high-resolution data, of which image quality may differ from the one herein visible.

An example of reconstructed vertical and horizontal sections of both X-ray and neutron imaging of the reinforced concrete sample is shown in Figure 2. The reinforcing steel bar is clearly visible in the X-ray imaging mode due to the pronounced X-ray attenuation behavior of steel. Furthermore, voids (black) and cement paste/aggregates (dark grey) can be distinguished in this imaging mode, but further distinctions between the solid phases constituting the concrete are difficult to be performed due to the noise and shadows consequent to the X-rays exposure of the specimen. On the other hand, the neutron imaging mode allows the distinction of hydrated cement phases from voids and aggregates. Additionally, a major difference in the two modes is the creation of artifacts in X-ray imaging near the rebar. This is clearly visible as dark areas due to the presence of the ribbed rebar surface, while the neutron imaging mode is largely free from such artifacts.

It should be noted that the visual distinction of the different features based on grey values and shape may in Figure 2 as shown here, namely in the form of a converted and compressed image format, possibly even printed on paper, not work as well as this was possible when the original images were viewed on a high-quality computer screen and with specialized software (VG studio).

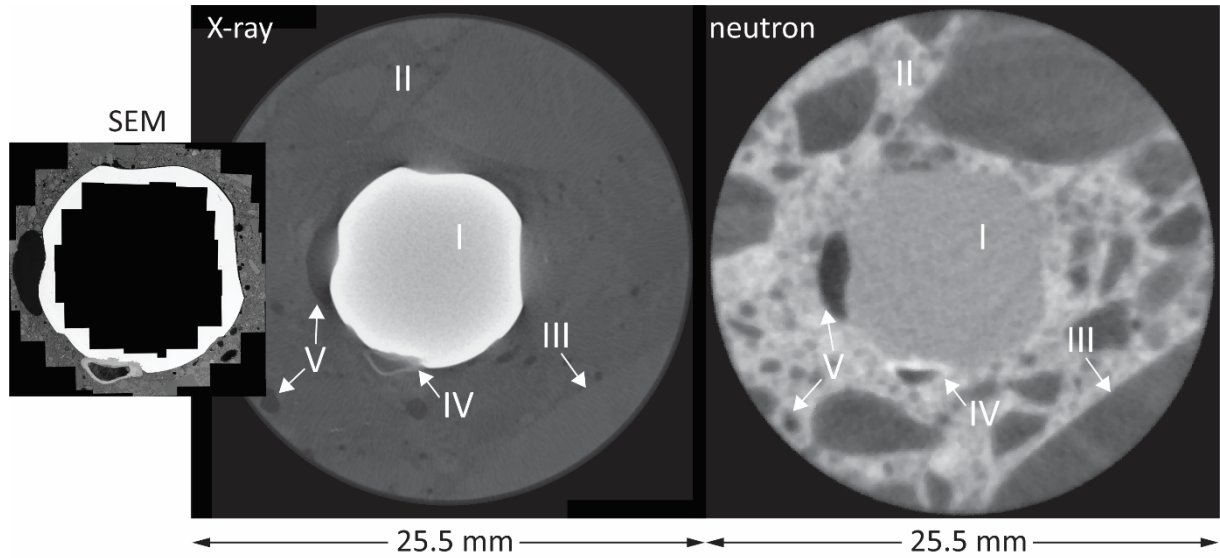
Figure 3. Comparison (at identical size and orientation) of cut and polished section viewed in SEM (stitched image) with the corresponding reconstructed sections from X-ray and neutron imaging modalities, illustrating the different specimen phases such as the rebar (I), cementitious phases (II), aggregates (III), corrosion products (IV), and voids (V). Note that through SEM only the steel-concrete interfacial region was imaged, while in both X-rays and neutron images the concrete matrix of the core is fully visible. To better observe the characteristics of the SCL as well as the occurrence of corrosion pits, the SEM micrograph with higher magnification is also visible in Figure 8a. Note that the orientation of the reinforcement in the images may be different from the actual orientation of the steel when it was embedded in concrete, of which no information could be obtained.

Figure 3 shows an example of one inspected horizontal section where conventional ex-situ scanning electron microscopy was compared to the corresponding section as reconstructed from the X-ray and neutron tomography, respectively. The SEM micrograph shown here was composed by image stitching (from recording numerous high-resolution images along the SCI region). The SEM image in Figure 3 was adjusted to ensure identical size and orientation of the rebar and the features in the concrete matrix between all three imaging modes. It becomes apparent that the resolution of the images differs considerably. SEM yields the highest resolution of the different imaging modes, clearly in the submicron range. The pixel size of the microtomography was 25 and 49  $\mu\text{m}$  for X-ray and neutron imaging modalities, respectively. By directly comparing the reference images acquired through X-ray and neutron microtomography and the respective SEM micrograph representative of the same specimen portion, a number of observations can be made based on the geometry of the specimen herein analyzed as well as on the specific image acquisition properties:

- X-ray shows considerable artefacts surrounding the rebar, where both darker and brighter regions are clearly apparent, which are absent in the SEM and neutron images. These artifacts are more pronounced than those observed in similar studies where cylindrical steel bars were used [15, 26, 36, 37] because of the ribbed geometry of the reinforcement embedded in the specimen herein investigated. Nevertheless, the availability of neutron images and SEM micrographs allows for a precise distinction of the constituents of the SCI. For specimens with similar geometry and characteristics, the calibration of X-ray images with complementary techniques is therefore advised.

- Through both X-ray and neutron imaging, macro-air voids (overall larger than around 80–200  $\mu\text{m}$ ) and corrosion product build-up at the SCI can be detected. However, the volume of corrosion products may be mis-estimated due to the interfacial artifacts in the case of X-ray imaging and by the similar gray scale value to that of hydrogen-rich components (e.g., cement hydration products) in the case of neutron imaging. Corrosion attacks at the reinforcement can also be reliably detected, especially in X-rays images. The extend at which this detection can occur mainly depends on the resolution (i.e., voxel size) of the image stack. In the present case, the smallest corrosion attacks that could be detected were around 50  $\mu\text{m}$  deep.

- The detection of interfacial macro air voids with a diameter smaller than around 80–200  $\mu\text{m}$  through X-ray and neutron microtomography was hampered. At the right and top-right side of the reinforcement, a few interfacial voids are indeed visible in the SEM micrograph but not according to the respective X-ray and neutron image. In the case of X-rays, the detection of interfacial voids was hindered by image noise and shadows at the SCI. In the case of neutrons, the hampering was caused by the need of a voxel size lower than the 49  $\mu\text{m}$  herein obtained as well as by the ring artifacts coming from both the neutron image acquisition procedure and the specimen geometry. As further apparent from the SEM images reported in Figure 4, these air voids are often separated from the steel reinforcement by a thin (10-20  $\mu\text{m}$  thick) cement paste layer, which was also not visible from both the X-ray and neutron images.

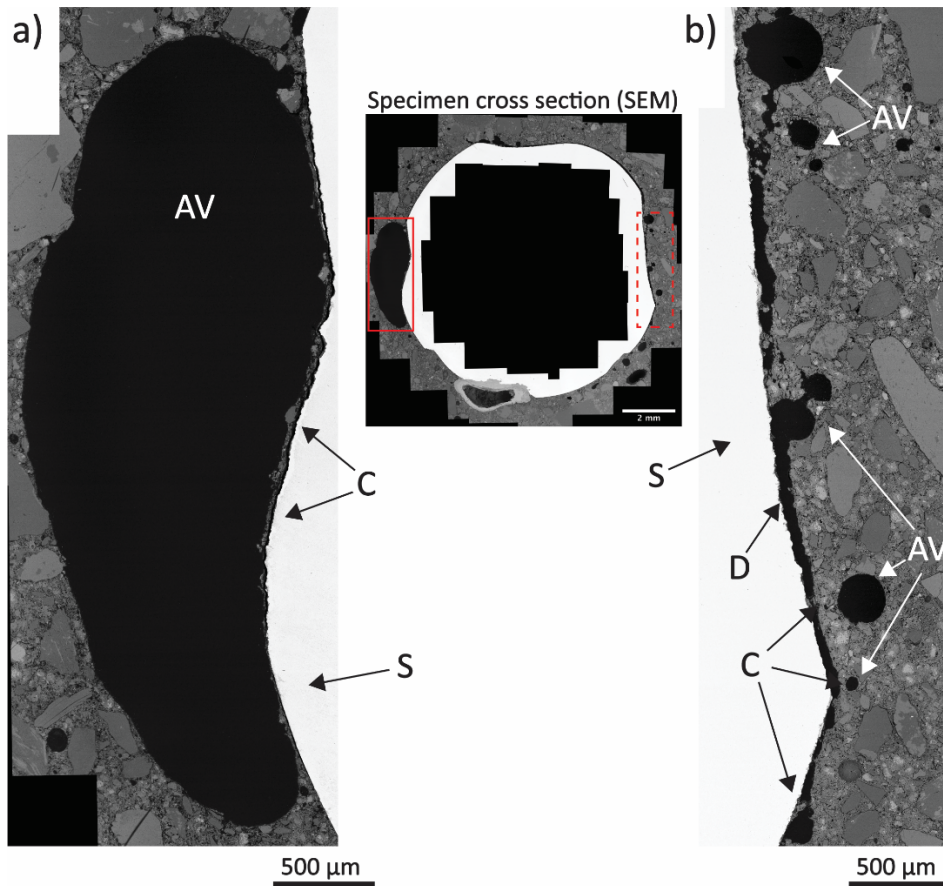
Figure 4. SEM image of the specimen cross section (center) with areas where interfacial air voids are found at higher magnification, showing the different phases (S=steel; C=cement paste; AV=air void; D=debonding between steel and concrete; the solid and dotted red boxes highlight the portions reported at higher magnification in a) and b), respectively);

a) interfacial macro-air void, separated from the steel by a thin layer of cement paste of around 20  $\mu\text{m}$  thickness; b) multiple small interfacial voids separated from the steel by a layer of cement paste with variable thickness.

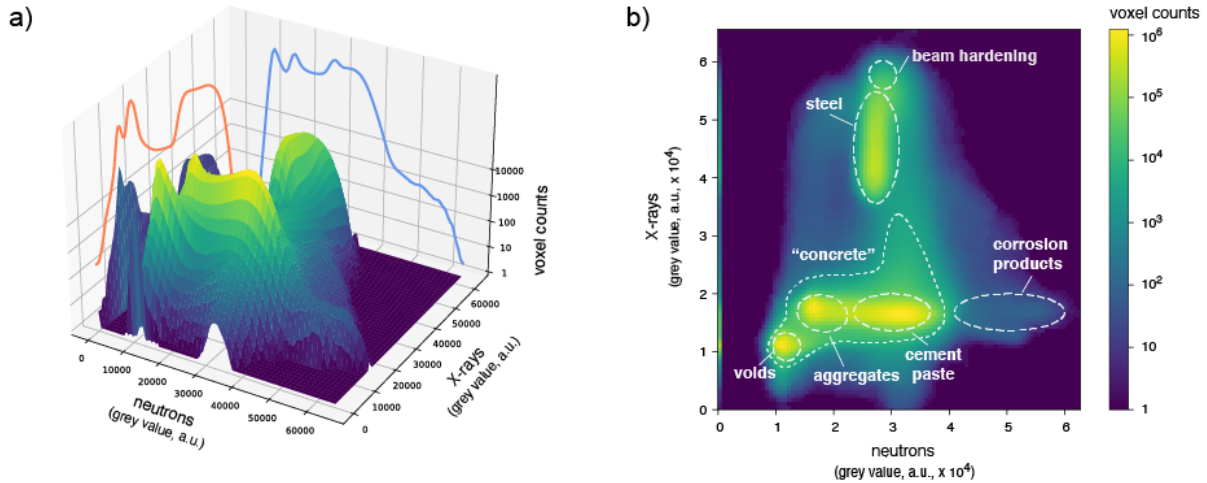
Figure 5. Bivariate histogram displaying the number of voxels associated with certain X-ray and neutron attenuation intensities of the whole image stack (representative of the whole specimen); a) three-dimensional visualization, b) two-dimensional plot with indicated interpretations of the combined X-ray and neutron attenuation behavior in terms of features encountered.

To improve the image segmentation and, therefore, the identification of different components of the specimens, a bivariate histogram composed of the X-ray and neutron attenuation coefficients can be used (Figure 5). By coupling the X-ray and neutron attenuation coefficients in a bivariate histogram, regions of pixels (or voxels) can be segmented based on the behavior that the representative elements have when exposed to both X-rays and neutrons. Given the complementarity of the information that the two techniques provide when applied to reinforced concrete specimens, a more reliable segmentation can be potentially obtained through this methodology [38].

In Figure 5 a bivariate histogram of the number of voxels associated with certain X-ray and neutron attenuation coefficients is visible for the whole image stack of a here imaged specimen. A three-dimensional visualization of the two X-ray and neutron attenuation coefficient histograms is visible in Figure 5a, while the respective two-dimensional plot is reported in Figure 5b. In this latter case, it is possible to identify areas that belong to certain components of the specimen based on the behavior observed when simultaneously exposed to X-rays and neutrons (e.g., the attenuation coefficient measured for each voxel) and, therefore, improve the reliability of the segmentation. Elements like air voids can be easily identified in the region of  $1-1.3 \times 10^4$  grey value, given their small X-ray and neutron attenuation and their consequent darkest color in the collected images. Similar operations can be conducted to identify and quantify the steel reinforcement as well, which has the highest X-ray attenuation coefficient ( $3.7-5.5 \times 10^4$  gray value) and, therefore, it can be easily segmented. Since steel has a similar neutron attenuation coefficient to that of some portions of the cement paste, a reliable segmentation of the reinforcement based on the neutron image stack would be a challenging process, highlighting the potential of this bimodal methodology. The same issue occurs when aggregates, cement paste, and corrosion products must be segmented in X-ray images. Given the slightly higher X-ray attenuation coefficient of corrosion products, a segmentation of them may be possible but likely sensitive to inaccuracies when conducting quantitative analysis. A way more complex process would be segmenting the cement paste and the aggregates separately, given their almost identical X-ray attenuation. However, the availability of the neutron images deeply facilitates the segmentation of these three components. Aggregates, cement paste, and corrosion products have three distinct neutron attenuation coefficients because of their different content of hydrogen, ranging between  $1.5-2.2 \times 10^4$ ,  $2.4-3.7 \times 10^4$  and  $4.1-6.0 \times 10^4$  gray value, respectively. By combining all these information and the different response that the reinforced concrete elements have to X-rays and neutrons, a reliable and precise segmentation of each specimen component can therefore be obtained, as reported in the Supplementary Information (Figure S2-S3).

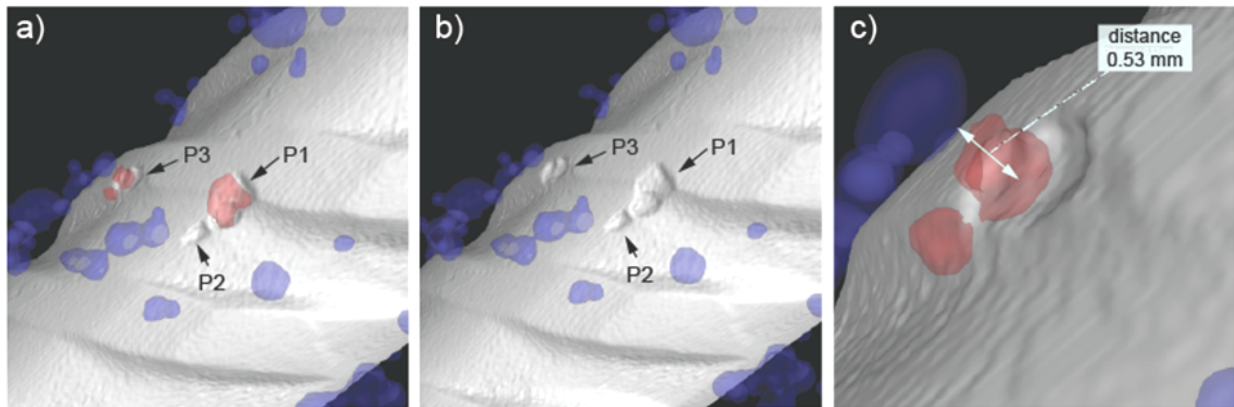
Figure 6. Examples of segmented 3D renders illustrating interesting features at the steel-concrete interface (cementitious matrix and aggregates suppressed in the displaying mode for clarity): a) corrosion initiation pits in the rebar and presence of corrosion products (red) and macroscopic concrete voids (blue); b) same but without displaying the corrosion products, to better reveal the pits; c) illustration of a measurement of the distance between a macroscopic concrete void and a pit (higher magnification than a and b). Rebar diameter = 10 mm.

interfacial zone with segmented features (e.g., the steel, the voids and the corrosion products) is shown in Figure 6. In Figure 6a, several corrosion “pits” (a more detailed discussion related to the adequacy of this term follows below) can be observed with the build-up of corrosion products in their vicinity. The same pits, namely P1, P2 and P3, are better visible in Figure 6b, where corrosion products are not displayed. The pits in the front side of the reinforcement (P1, P2) are without an air void in their immediate vicinity, whereas the pit more aside (P3) formed in the proximity of a small air void (at a distance of about 500  $\mu\text{m}$ ), as visible in Figure 6c. The influence of air voids will be discussed in section 3.3.2. Here, we will discuss features related to the size and geometry as well as the distance between individual corrosion attacks.

Figure 6 shows relatively flat and shallow “pits” (in the range of 50-100  $\mu\text{m}$  depth and 200-600  $\mu\text{m}$  width and length). The here apparent morphology of the localized corrosion attack was representative of the numerous other pits observed in the other specimens. The ratio pit width:depth and pit width:length were generally clearly larger than 1. It may be questioned whether so shallow localized corrosion attacks may still be termed “pits”, considering classical pitting corrosion theory. According to the theory underlying pitting corrosion of passive metals, the stability of newly formed pits is significantly affected by the geometry of the pits. When the local conditions to depassivate the steel are present (e.g., the necessary chloride concentration in relation to hydroxyl ions), metastable pits form and grow at a rate that depends on various factors, including metal composition, pit electrolyte concentration, and pit bottom potential [39]. While autocatalytically growing, the anodic and cathodic corrosion reactions separate spatially during pitting. The local pit environment becomes depleted in oxygen, which shifts most of the cathodic reaction to the exposed surface where there is higher availability of this reactant. A consequence of this classical pitting corrosion mechanism is the in-depth growth of a corrosion pit while the rest of the metal surface remains passive [40]. Transport processes between pit bottom (where ferrous ions are released) and the outside areas (where cathodic reaction occurs) are an important factor in pit growth, which is markedly affected by the geometry of the pit (depth, width) [41]. Moreover, the availability of negatively charged ions different from hydroxyl ions (such as chloride ions) is crucial in order to maintain stable pit growth, as the migration of hydroxyl ions into the pit may lead to repassivation [42, 43].

The occurrence of corrosion "pits" close to each other as shown in Figure 6 may raise further interesting points of discussion. Admittedly, it is unclear from the available in-situ images, which were taken at one point in time, whether the different visible corrosion "pits" had formed in a sequence (the first one forming, then repassivating, followed by formation of another one, etc.) or whether they occurred simultaneously. Additional information on this question is available from the electrochemical monitoring of the corrosion process, especially the transition from passive state to active corrosion. The potential of the rebars was continuously monitored during chloride exposure. According to the experimental protocol, a decrease of at least 150 mV, maintained over at least 10 days, was used as the criterion to determine stable corrosion initiation [32]. Supplementary Figure S1 shows the potential vs. time during this corrosion initiation period for the different specimens. These data show a clear drop in potential (by 200-300 mV). Moreover, in 3 out of the 4 specimens, it was clearly apparent from the potential measurements that no repassivation events occurred over the following approx. 10 days; in one case (B1-E1-H-1), some slight potential variations were visible, however, no full repassivation was apparent. This electrochemical data thus suggests that a sequence of initiation of a pit, followed by repassivation of the same, subsequently followed by initiation of *another* pit, etc. was unlikely. Furthermore, since the observed pits have a similar size, we consider it unlikely that several pits occurred and always repassivated without this having been appreciable in the potential monitoring, until one more dominant pit had formed and caused the distinguished potential decrease that was generally observed. Thus, the systematic experimental observation of numerous corrosion "pits" close to each other likely is the result of *simultaneous* localized corrosion at different nearby locations.

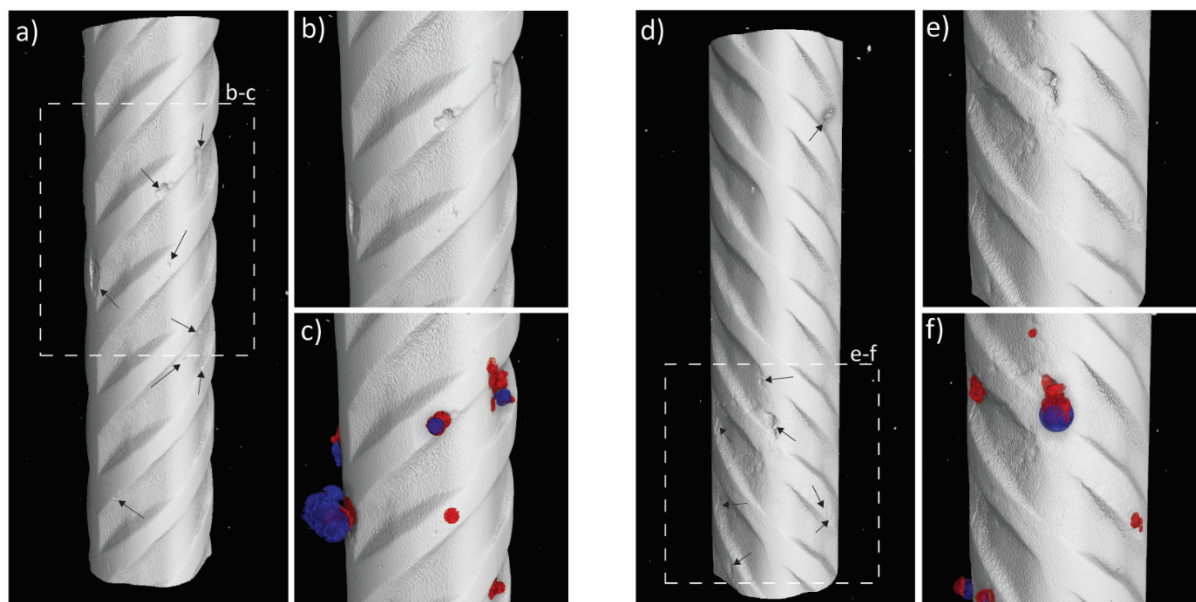
Figure 7. Examples of segmented 3D renders illustrating interesting features at the steel-concrete interface (cementitious matrix and aggregates suppressed in the displaying mode for clarity): a) render of pristine steel of specimen B1-E1-H-2, indicating corrosion attacks with black arrows (the dotted square is the magnified portion of the specimen); b) higher magnification portion of the corrosion attacks of B1-E1-H-2; c) higher magnification portion of the corrosion attacks of B1-E1-H-2 showing corrosion products (red) and interfacial voids (blue) in the proximity of the corrosion attacks; d) render of pristine steel of B1-E1-H-3, indicating corrosion attacks with black arrows (the dotted square is the magnified portion of the specimen); e) higher magnification portion of the corrosion attacks of B1-E1-H-3; f) higher magnification portion of the corrosion attacks of B1-E1-H-3 showing corrosion products (red) and interfacial voids (blue) in the proximity of the corrosion attacks.

From Figure 7 and Table 3, relevant information about the factors influencing the mechanism of corrosion initiation of steel in concrete can be obtained. First, in every specimen several initiation spots were observed, on average between 6 and 11 per imaged portion of each specimen. Second, a very large number of interfacial air voids was found (in total more than 150). Remember that these reinforced concrete specimens were taken from an engineering structure. It is important to highlight that out of the 31 identified corrosion spots, only about half of them occurred in the proximity of an interfacial void. It is also interesting to note that most interfacial air voids (>90%) were actually not characterized by corrosion attacks in their vicinity. These results indicate and confirm that the presence of air voids at the SCI do not necessarily create the most sensitive locations for corrosion to initiate per se, but that other intertwined factors play a fundamental role to create the conditions for corrosion to be triggered.

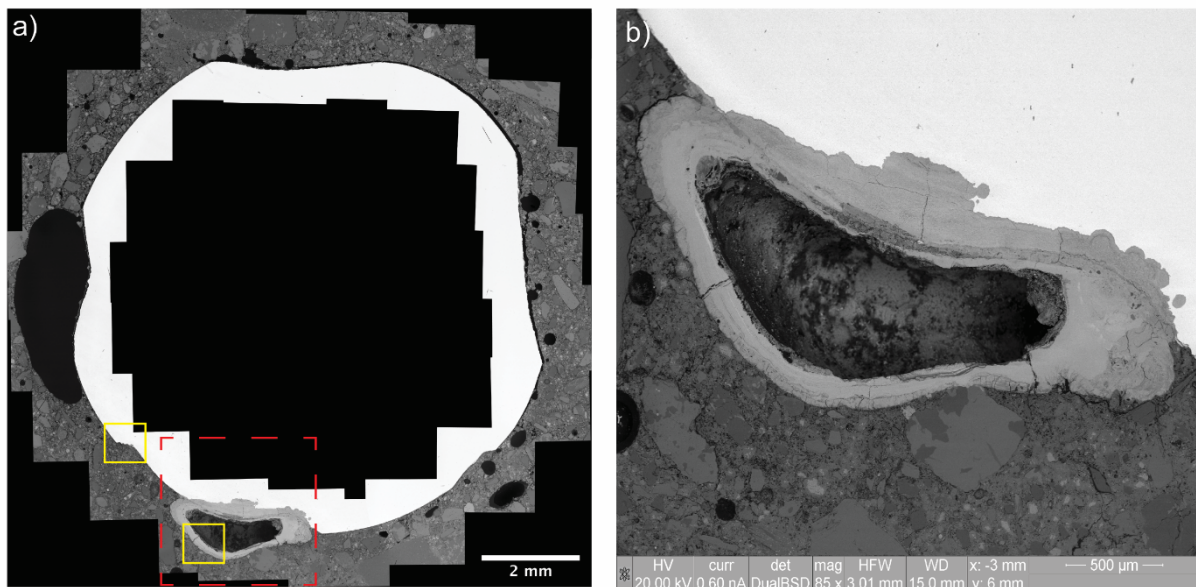
Figure 8. SEM micrograph of a corroding section (BSE detector, acquired at 20 kV and 85x magnification): a) overview of the corroding section made by stitching together the micrographs collected at the SCI, where the rebar is visible in white, the corrosion products in light gray, the concrete matrix in dark gray and the air voids in black (the red dotted-line box is representative of the zoomed-in area reported in Figure 8b, while the yellow boxes are areas shown at higher magnification in Figure 9a-b); b) Corrosion site in proximity to an interfacial air void, which is partially filled by corrosion products. Note that the orientation of the reinforcement herein reported may be different from the actual orientation of the steel when it was embedded in concrete, of which no information could be obtained.

The results reported in Table 3 are in line with the findings related to the observations arising from the SEM observations reported below. In Figure 8 the SEM micrograph of a corroding section is visible, highlighting some regions of interest (ROIs) at higher magnification reported in Figure 9.

As it is visible from Figure 8, different air voids are found at the SCI. Microscopic air voids with a diameter ranging between 50-200  $\mu\text{m}$  are visible at the right and top-right side of the steel bar, often separated by a thin layer of cement paste (10-20  $\mu\text{m}$  thick). A few small air voids are also visible at the bottom side of the steel. In the proximity of these interfacial microscopic voids, no corrosion sites can be observed. More interestingly, two macroscopic air voids are clearly visible at the left and bottom side of the bar, both significantly bigger than 1 mm. While the latter one is partially filled by corrosion products that precipitated into it from a corrosion pit in its vicinity, the former one is completely empty, and it is not in proximity of any corrosion pit. These observations are in line with the results reported in Table 3, according to which most microscopic and macroscopic air voids at the SCI did not per se create the most sensitive locations for corrosion to occur. Nevertheless, Figure 8 may suggest interesting points that need further analysis and experimental evidence to be clarified. Among others, an important reflection relates to the moisture conditions of the SCI. The growth of a corrosion site at one specific location and the lack of any corrosion attack where other interfacial voids are visible Figure 8 may suggest that the moisture conditions at the SCI may significantly vary around the steel cross section, regardless the exposure of the bigger scale specimen. Variations in moisture state of the concrete at the steel concrete interface upon capillary water uptake may occur depending on variability in pore structure [24].

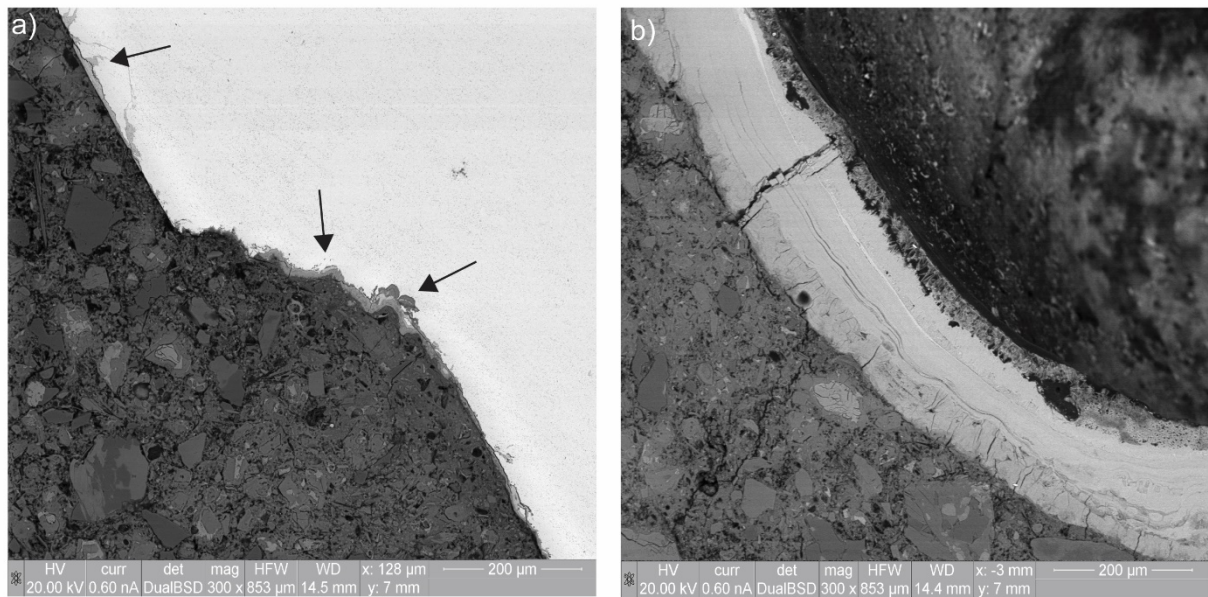
Figure 9. SEM micrographs of corrosion pits at the SCI of a corroding rebar: a) small corrosion pits formed at the SCI without any macro defect present; b) layered morphology of corrosion products precipitated at the edges of an interfacial air void.

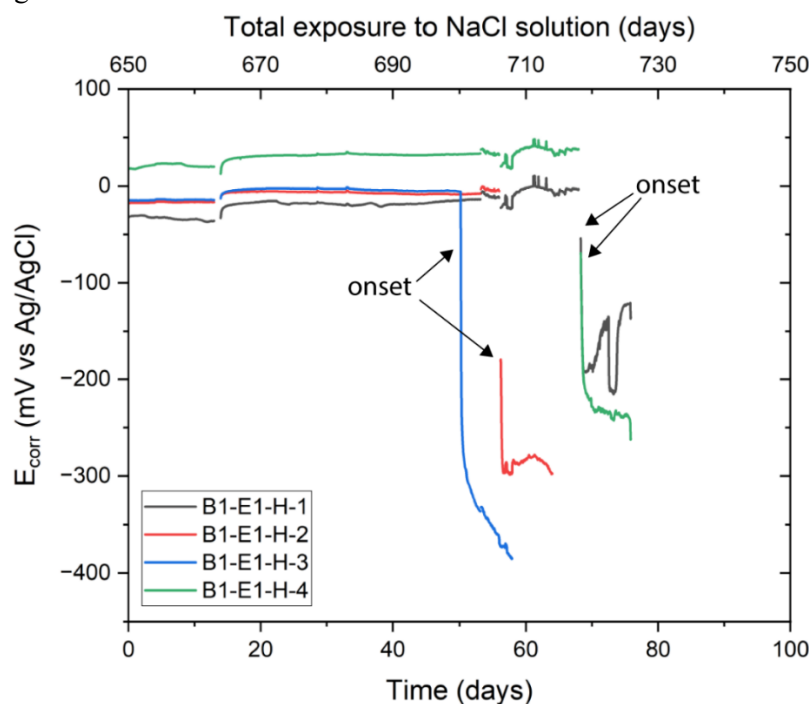
Figure S1. Potential measurements of reinforced concrete specimens over time (vs. Ag/AgCl/KCl<sub>sat</sub>), after which coring and X/n computed tomography scanning was conducted. Only the last measurements before corrosion onset are reported (the total duration of the exposure to NaCl solution is visible from the top x-axis)

The potential measurements to electrochemically monitor the corrosion onset of reinforced concrete cores are reported in Figure S1.

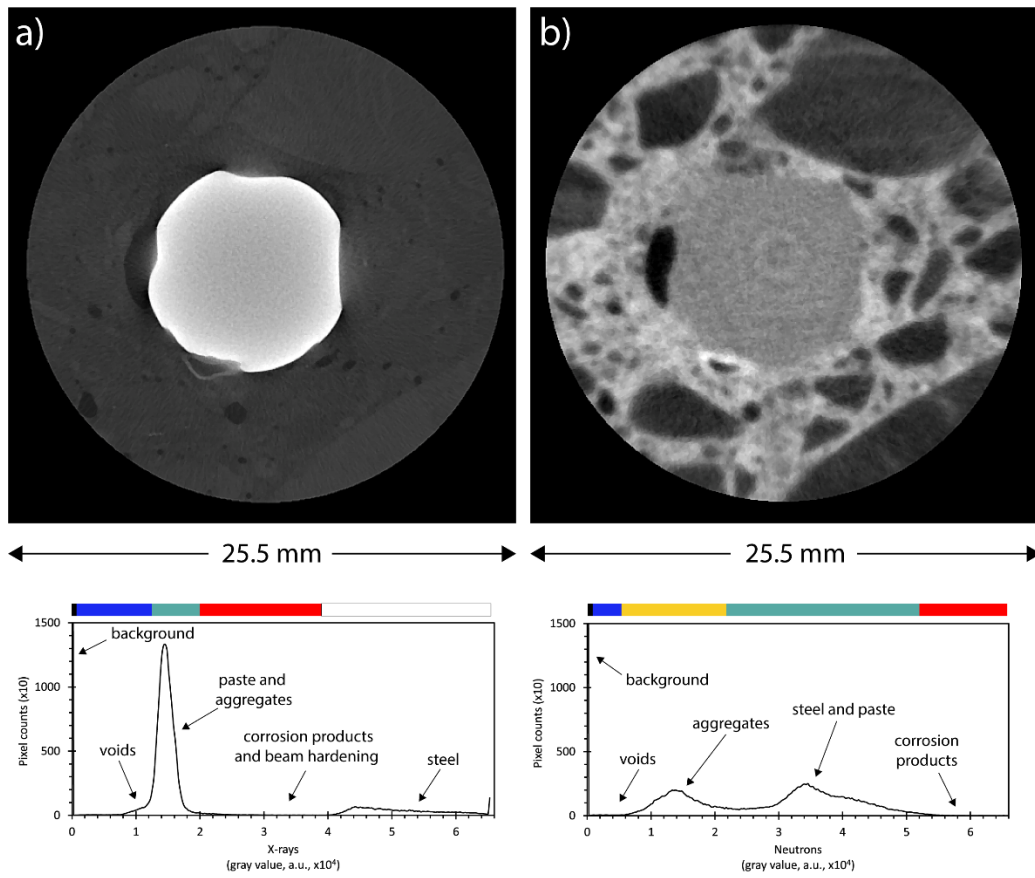
Figure S2. 2D X-ray (a) and neutron (b) cross-section images, with respective grayscale value (GSV) histograms and color ranges of the different segmented components.

An example of the results of the segmentation procedure based on the images' gray-scale value (GSV) and bivariate histograms is visible in Figure S2-S3. For this example, a 2D cross-section image of the reinforced concrete specimen has been considered. Segmentation of both X-rays and neutron scans of the same cross sections has been performed by thresholding the respective GSV histograms (Figure S2), and the segmentation results are visible in Figure S3. Segmentation has been also performed using the bivariate histogram of the same cross-section (previously reported in the core manuscript, Figure 5). A K-Means clustering algorithm was used to differentiate the specimen's components as a basis for further segmentation. The pixel clusters related to aggregates, cement paste, voids, and background could be identified. On the other hand, the beam hardening effect present at the steel-concrete interface (SCI) made the segmentation between steel and corrosion products less sharp. To overtake this limitation, the steel region of the image was segmented via the X-ray GSV histogram, while the corrosion products were segmented via the neutron GSV histogram. The absence of any beam hardening effects would potentially make this procedure completely automatic. Since in the present paper no quantitative analysis was performed, the final segmentation allowed to gather the necessary information for the purpose of the study (e.g., measuring the corrosion attacks' dimensions, observing the interfacial characteristics where they occurred, counting and measuring the dimensions of interfacial air voids, etc.). Nevertheless, the removal

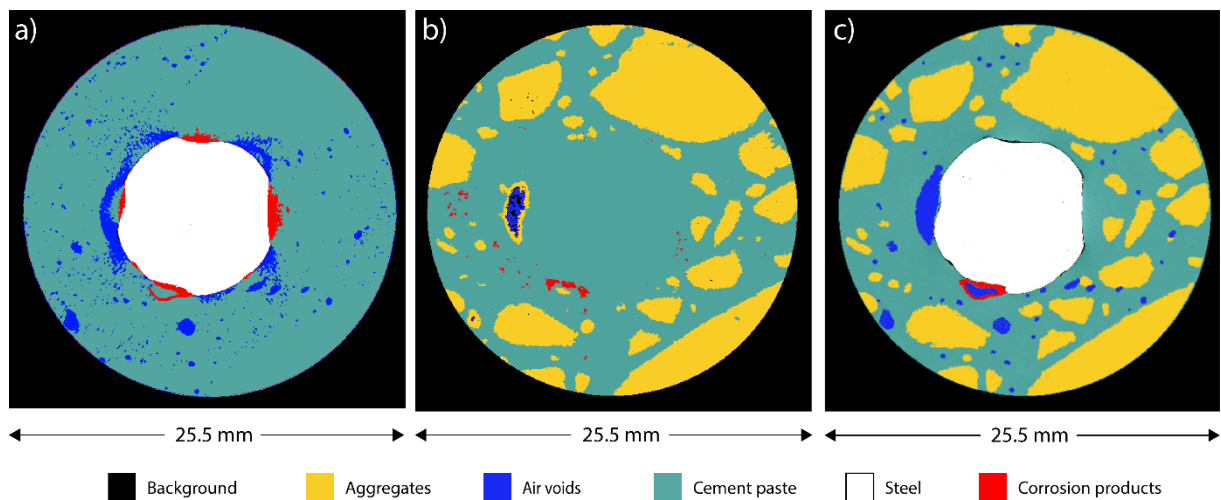
Figure S3. Results of the segmentation procedure using the X-rays GSV histogram (a), the neutron SGV histogram (b), and the respective bivariate histogram (c).

or reduction of beam hardening effects is crucial for further studies that would focus on the micro-scale details of the SCI as well as on quantitative analysis of high number of images. The results of the segmentation based on the bivariate histogram of the present 2D cross-section are visible in Figure S3.
