Sensitive optical coating defect detection via second harmonic generation

Authors: J. Lukeš^{1,2}, V. Hájková³, M. Hlubučková¹, V. Kanclíř^{1,2} and K. Žídek¹

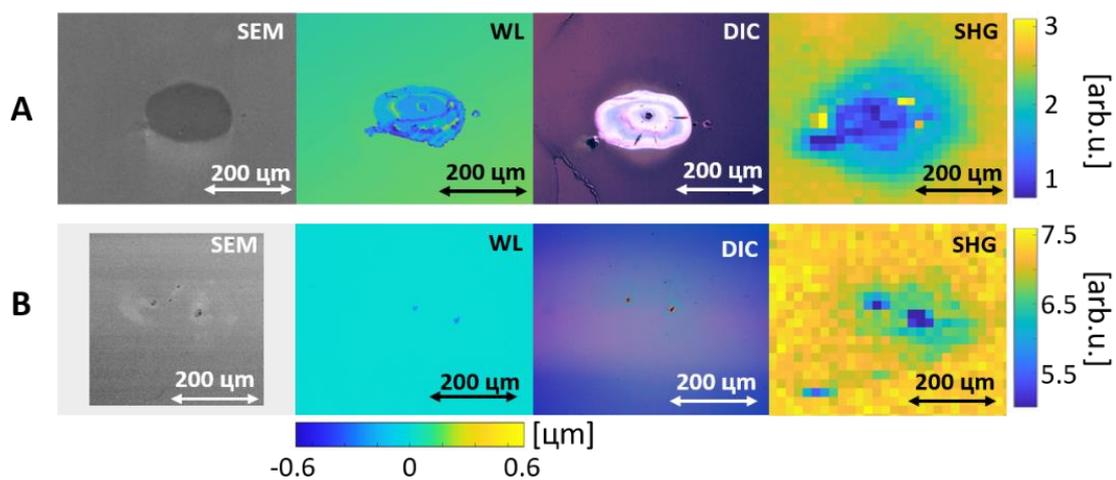
Figure 1 – Comparison of different methods for imaging of LIDT damage – SEM (Scanning electron microscopy) in BSE mode; WL (White light interferometry); DIC (Differential interference contrast microscopy); SHG (Second-harmonic generation method) 70 deg. pP pol. Laser: $\lambda = 1028 \text{ nm}$. All maps use the same scale. Panels A: Sample A: Si_3N_4 layer (400 nm); Panels B: Sample B: Si_3N_4 layer (300 nm). Both at N-BK7 substrate

In Figure 1, upper line (sample A), we provide an example of a damaged spot apparent to the naked eye. The ellipse-shaped burnt area in the middle corresponds to a delaminated and melted layer. The spot was investigated using various methods, and the corresponding maps were cropped and scaled to show the same area. For scanning electron microscopy (SEM) and white light interferometry (WLI) the central spot is clearly visible, while no changes are visible in the surrounding area around the damaged spot. This arises due to the strong sensitivity of the methods on the surface chemical properties for SEM and morphology for WLI. Both these properties were modified in the burnt central part, while stayed the same outside of this area.

Differential interference contrast microscopy (DIC) shows changes in the immediate vicinity of the spot, above and below, where there are “brighter” areas. The color variation represents a change in the optical path and, therefore, a change in the thickness or refractive index of the layer. Such changes may be caused, for

example, by changes in mechanical stress in the layer connected with subtle variations in refractive index and thickness^{19,20} or surface topography^{21,22}. Images from DIC for both samples in Figure 1 were heavily adjusted in terms of contrast and color balance to highlight changes around burnt spots.

Finally, we investigated the spot using SHG at a high incident angle of 70 deg. and pP polarization configuration, which denotes the p-polarized incident beam and P-polarized measured SHG – see Figure 1A, SHG panel. The burnt area itself is prominent with a very low SHG efficiency (dark blue part). SHG intensity for this feature was decreased by 60% compared to the pristine layer. Nevertheless, it is surrounded by an extensive damaged area with a decreased SHG by 30% compared to the pristine layer (lighter blue and green area). This area extended hundreds of microns beyond the apparent damage. According to the SHG intensity, the area of laser-induced changes in the layer is much larger than previous methods suggest, and the changes gradually transition to a pristine layer SHG.

The damage on the second example spot (Figure 1B) is subtle but again shows a trend similar to the previous case. The most notable features are burnt spots, which correspond to local imperfections – absorbing spots – which were placed in the focal laser spot center. SEM and the WLI are again sensitive to the burnt spots themselves. A severe problem for SEM for both samples was the local charging, which obscured the measured maps. For instance, the brighter “shadow” below the spot for Sample A is an artifact induced by charging. Similarly, a brighter area around two spots on sample B might be caused by charging, or it can arise from real changes in the sample since the shape of the area resembles the area measured with SHG. In this case, the charging artefacts disqualified SEM from providing reliable interpretation.

The DIC microscopy is able to detect small changes around the two burnt spots extending tens of microns. Note that the gradual shift in color observable across the whole image can be ascribed to the image vignetting, i.e. uneven light collection efficiency. Nevertheless, also here the SHG image (pP pol., 70 deg.) shows superior sensitivity, as the variation in SHG can be observed in the burnt spots (dark areas) but also in the area extending almost 200 μm far from the burnt spots.

Figure 1 demonstrates the sensitivity of SHG for a certain experimental configuration. Nevertheless, SHG in thin films originates from several sources, such as interfaces, internal mechanical stress, or bulk quadrupolar interaction. Their proportion can be tuned by changing both the polarization and the incident angle. Therefore, we studied the polarization dependence of SHG from the damaged sites – see Figure 2. The measurements were

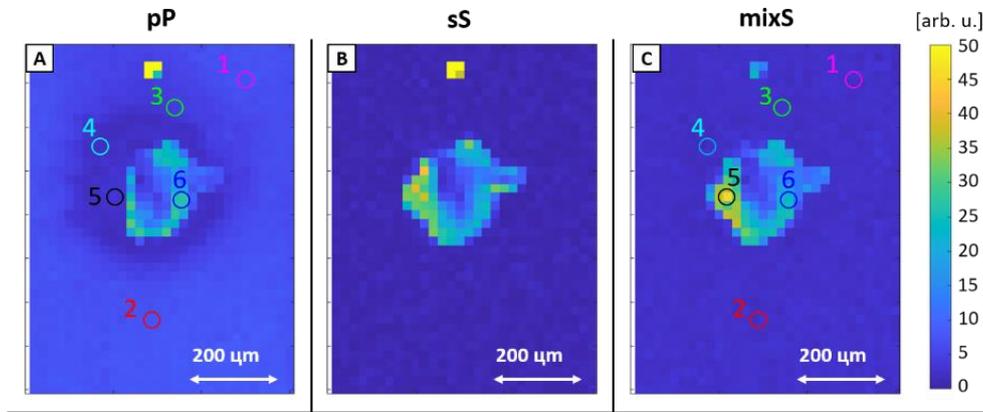
Figure 2 – Polarization dependence of SHG – an area of the damaged spot was observed under different polarization configurations (pP – A, sS – B, and mixS – C), incident angle 30 deg. Six selected sites (marked by circles in panels) were measured under different incident angles – see Figure 3. Sample A: Si₃N₄ layer (400 nm) @ N-BK7 substrate. Laser: $\lambda = 1028$ nm.

performed with an incidence angle of 30 deg. and in three polarization configurations – pP, sS, and mixS, where “mix” indicates the equal contribution from p and s polarization. This measurement was carried out for a highly damaged spot, where the SHG in the pP configuration (see Figure 2A) was able to track extensive changes in the layer far beyond the visibly damaged area.

The materials with ∞m symmetry, which is the case for both the pristine Si₃N₄ layers, the N-BK7 substrate, and all involved interfaces, are expected to emit the strongest SHG in the pP configuration and none in the sS configuration²³. In accordance with the expectations, the pristine layer featured low SHG in the “sS” configuration (mean int. 0.7 arb.u.), and significant SHG in the “mixS” (2.5 a.u.) and “pP” (7 a.u.) configurations. Small SHG in the “sS” configuration can be explained by residual mechanical stress and layer microstructure, which both elevate the local symmetry.

The “pP” configuration has proved to be the most sensitive case, where the SH intensity was altered both in the damaged spot itself and in its vicinity. The s-polarized incident beam promotes SHG from the visibly damaged spot with a very high contrast. This can be ascribed to the changed local symmetry in the burnt spot. Note that the bright SHG spot in the upper part of the images in Fig. 2 is an example of an SHG signal of a particle attached to the layer surface. We verified this by remeasuring the same area after the cleaning procedure.

Overall, by combining the polarization and angle-dependent measurements, we are able to discern areas with distinct behavior – see Figures 2 and 3. The internal damaged part features entirely different SHG properties – likely due to the remaining melted layer material with an entirely different morphology from the original layer. The area surrounding the central damaged spot can be ascribed to the layer, which went through a heating cycle but was only partly modified. Analogously to annealing, laser-induced heating can lead to changes in internal stress²⁴ and layer microstructure²⁵. As such, the SHG will feature the same polarization properties and similar angle dependence, but the total intensity will vary. Potentially, differences in the angle dependence can be interpreted by a theoretical model in terms of surface and bulk SHG contribution and test various models of changes in the layer.

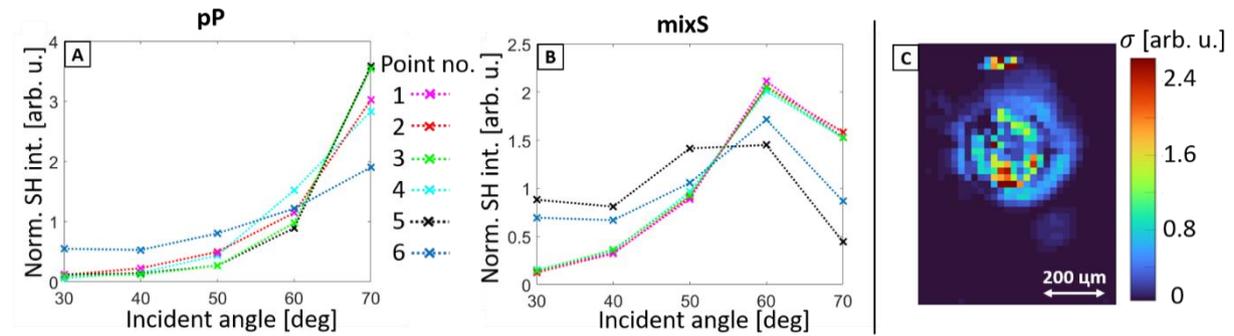
Figure 3 – A,B: Incident angle dependence for marked spots in Fig.2 (A: pP polarization, B: mixS polarization), intensities were separately normalized by their mean values; C: map of SHG angular dependence variation for “pP” pol. scheme – see text for σ calculation. Sample A: Si_3N_4 layer (300 nm) @ N-BK7 substrate. Laser: $\lambda = 1028$ nm.

More information about the damaged spot can be attained from the dependency of SHG on the incident angle. We provide the information for six selected spots from Fig. 2, which correspond to the pristine layer, burnt spot, and modified layer. We measured the incident angle dependence for “pP” and “mixS” polarizations for these spots. The resulting angular dependences in Fig. 3 were normalized to allow for a better comparison between the shapes. For two spots in the pristine layer surrounding the damage (**Points 1 and 2**), SHG angular dependences overlap perfectly. This indicates that the layer in these areas was not changed and illustrates the noise level in this measurement. **Points 3 and 4**, which were in the near vicinity of the burnt spot, have in the “mixS” configuration (Figure 3 B) the same angle dependency as the pristine layer, although in the “pP” configuration, changes are more noticeable. This behavior corresponds to the case where the overall symmetry is conserved, while the contribution of different SHG sources varies and alters the angular SHG dependence. **Points 5 and 6**, which were in the burnt spot itself, have largely different angle dependencies compared to the pristine layer - both in amplitude and shape. That means that the local morphology of the layer is entirely different. We can speculate that this results from local inhomogeneities, which also led to the light scattering.

Finally, we used the SHG dependence on incident angle θ to quantify the observed changes in the layer. We selected a spot on the layer edge as a reference $I_{11}(\theta)$ and calculated the total SHG angular dependence variation σ for each pixel $\{i,j\}$: $\sigma_{ij} = \sum_{\theta} (I_{ij}(\theta)/\langle I_{ij}(\theta) \rangle - I_{11}(\theta)/\langle I_{11}(\theta) \rangle)^2$. To focus on the shape variations, we normalize each pixel dependence by its mean value. As a result, the low variation values corresponded to a

similar shape of incident angle dependence – see Fig. 3 C for the “pP” configuration. We observed that concentric areas around the epicenter of the burnt spot feature similar angle dependence of SHG, which corresponds well with the expected distribution of the laser energy.

While this map was very useful to identify areas with an analogous laser-induced modification, it should be evaluated together with the corresponding SHG intensity map (see Fig. 3A). For instance, the dark “ring” around the burnt spot in Fig. 3C does not imply a lack of laser-induced damage. Instead, it corresponded to changes, which led in this particular configuration to a similar angular dependence, while showing decreased SHG intensity.
