Mechanism on Failure of Cooled Infrared Detector Illuminated by CW laser

Abstract:

Key words: cooled infrared detectors, laser damage, thermomechanical, failure mechanism

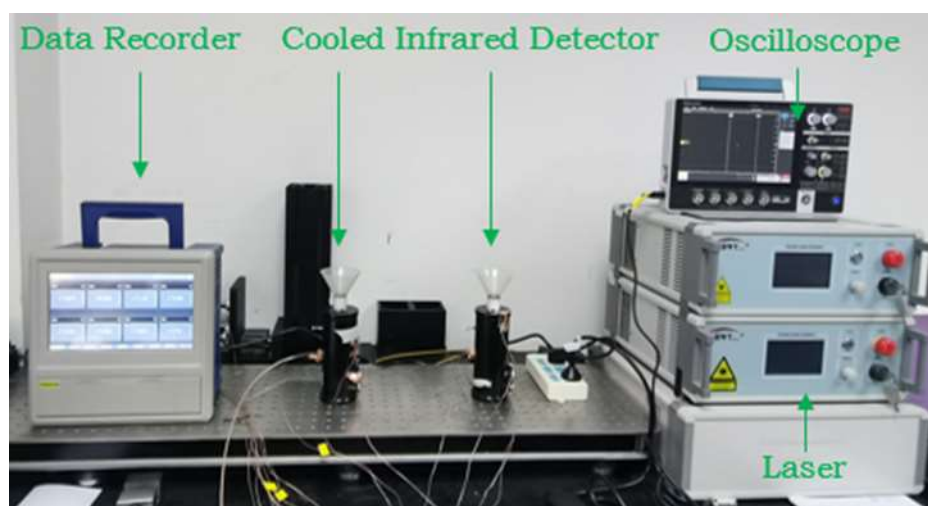
Fig. 1 Diagram of the experimental set-up made up of Laser, Oscilloscope, Data recorder and the Cooled Infrared Detector under test

The experimental set-up established in present work is shown in Fig.1, the cooled InSb photovoltaic detector is illuminated by a continuous wave laser of wavelength 808nm, and the signal output end of the detector is connected to the oscilloscope through a Bayonet Nut Connector (BNC) so that open-circuit voltage change of the detector can be monitored in real time. The detector is mainly composed of a photoelectric chip unit and a liquid nitrogen Dewar which maintains the low-temperature environment for the chip unit. The photoelectric chip is designed to work in the optimum operation wave band of 2~5um, whose performance parameters are shown in Table 1.

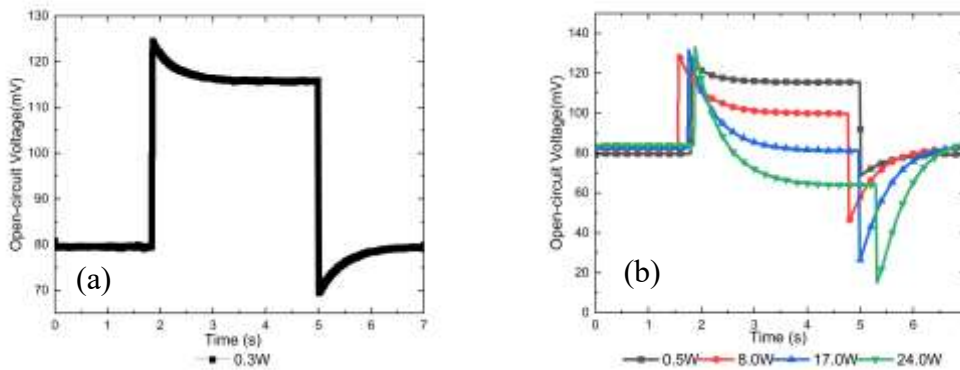
Fig. 2 (a) Typical characteristic of time history of the open-circuit voltage of the detector during illumination and (b) Time history of the open-circuit voltage of the detector when being illuminated by laser of power 0.5W, 8.0W, 17.0W and 24.0W

When the detector chip reaches a thermodynamic equilibrium state around its operating temperature within the liquid nitrogen Dewar, the open circuit voltage stabilizes at 80mV. Once the thermal boundary conditions are altered by the influence of high power density laser, the chip temperature as well as its open-circuit voltage immediately changes. The shape of the voltage curves is close to a square wave when the laser power is lower than 1W as the temperature variation is not obvious under these conditions. When the laser power increases, the temperature variation becomes larger. Therefore, it's more difficult for the system to stabilize at initial state, and the time spent on reaching a new equilibrium state would be longer.

The sequential process of saltation and stabilization in open-circuit voltage curve, which is triggered by the start-up and shut-down of laser, is described as the “double-

ear” [15, 50, 51] phenomenon. This process is a typical over-saturation phenomenon of photovoltaic (PV) type detectors under continuous laser illumination. The abrupt variations observed in the open-circuit voltage at the starting moment of the 1st and 3rd stages are likely attributable to the rapid fluctuations in carrier concentration induced by the start-up and shut-down of the laser. And the gradual decrease of the open-circuit voltage before stabilization during the 2nd stage is due to the cumulative heating of the detector chip caused by prolonged laser illumination, as previous research has demonstrated that the open-circuit voltage gradually decreases as the operating temperature increases [49]. When the laser power is maintained at a relatively low level, the temperature increase induced by laser illumination can be rapidly dissipated by the liquid nitrogen Dewar. When the laser power gradually increases, the temperature rise of the chip gets more pronounced. It takes longer for the carriers to reach thermal equilibrium again, so the steady value of open-circuit voltage in the 2nd stage becomes smaller [52, 53].

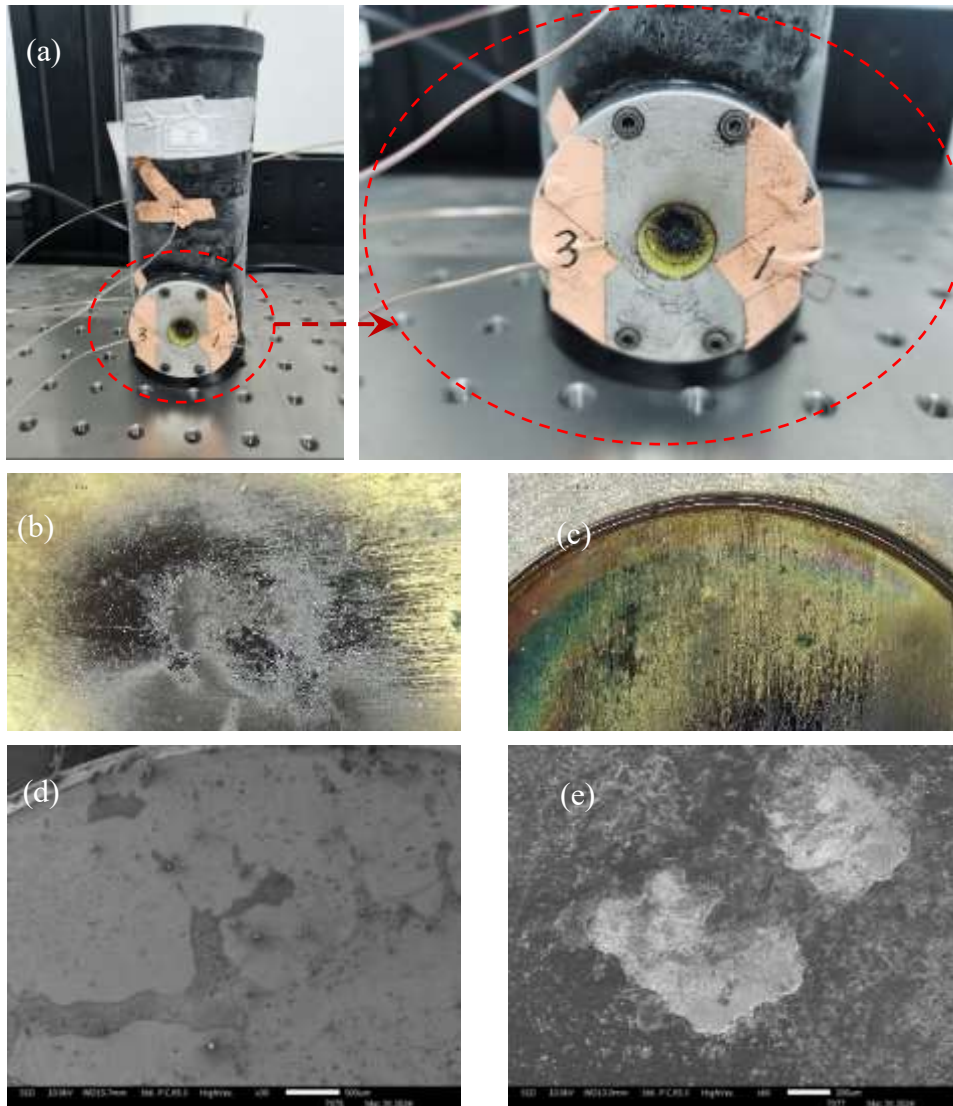
Fig. 3 (a) Frost on the outer surface of the detector after the vacuum break down; the typical damage morphology upon exterior surface of the optical window: (b) color darkening in the central of the optical window directly illuminated area, (c) melting of the surface films of the optical window, (d) pollutants on the outer surface and (e) craters on the outer surface of the optical window

When the laser power reaches 27 W, the detector undergoes permanent failure, accompanied by an audible cracking sound, after 5 seconds of illumination. Visual inspection revealed distinct cracks on the optical window's exterior surface, with the surface films in the central laser spot region exhibiting significant carbonization. Following a period of cooling, the temperature of the detector's outer cylinder

decreases below 0°C, leading to progressive frost formation that eventually results in complete snow coverage across the entire external surface of the device, which is shown in Fig. 3(a) with the left one for global diagram and right one for partial enlarged view.

The surface films in the illuminated zone is completely burned on the exterior surface, which is in the form of black paste, as shown in Fig. 3(b). Furthermore, the material in adjacent area surrounding the illuminated zone has also been melted and deteriorated to a certain extent as shown in Fig. 3(c). It can be deduced that the temperature on the exterior surface rises more substantially than that on the interior surface. This distinction might be resulted from the impurities and pollutants [25] attached to the exterior surface as shown in Fig. 3(d), which would form a lot of localized absorption peaks of the laser near the contaminated area. According to the research of C. R. Haas et al [54], temperature rises rapidly near the pollutants and the process of ablation will be speeded up with the chemical reaction between the coating films material, water and oxygen in the air at high temperatures. Ultimately, there are craters caused by the ablation of material on the outer surface of the optical window, as shown in Fig. 3(e).

Physically speaking, the aforementioned damage patterns of the optical window should largely attribute to the rapid temperature elevation and high thermal stress developed by laser illumination. These include the melting/ ablation as well as the fracture of the films on the exterior surface of the optical window, the interface delamination between the surface films and the glass substrate, and cracking of the zinc selenide (ZnSe) glass substrate. The melting/ ablation of surface films will lead to the change of light absorptivity of the optical window severely, the cracking of the glass substrate and interfaces between the substrate and films has significant influence on the transitivity and absorptivity of light. As a consequence, the optical performance of the detector will be altered apparently due to a dramatic change in the optical property of the detector's optical window.

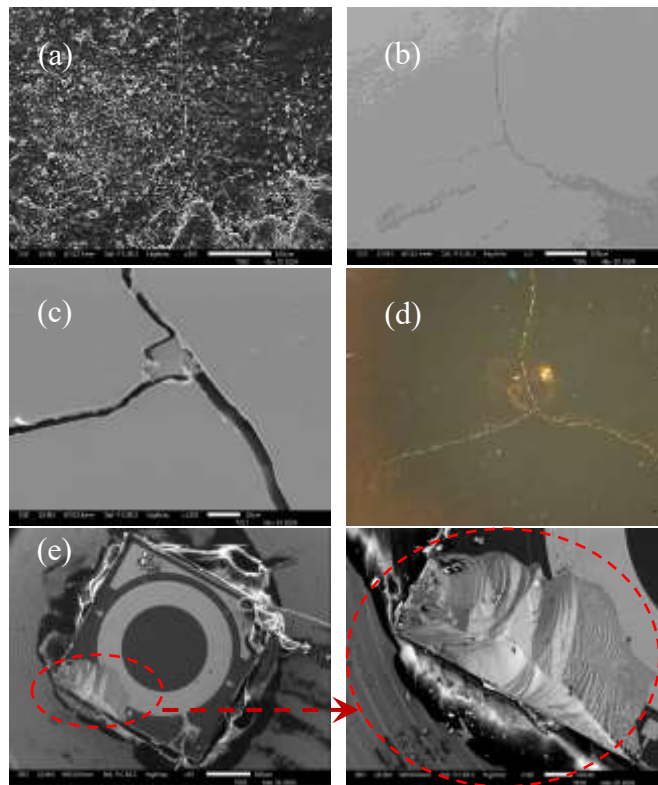
Figure. 4 The cracking morphology of the optical window: (a) the exterior surface, (b) the interior surface, (c) the glass fragment around the intersection point of the cracks by SEM and (d) the interior surface by OM; and (e) the surface morphology of the corner breakage of the detector chip caused by disassembly by SEM for comparison

Selenide (ZnSe) layer. The melting point of Ytterbium fluoride and Zinc Selenide is 1157°C and 1525°C respectively. From the perspective of appearance, such optical window in study is a piece of smooth and yellowish transparent glass in the shape of a flat-disc before destruction, as shown in Fig. A1. After being permanently damaged by the laser illumination, the central region on the exterior surface appears to turn black and three main cracks intersect near the center of illuminated region, as shown in Fig. 4(a). It is revealed by Figs. 4(b)~4(d) that the angle of any crack to the another among these three cracks is approximately 120°. However, the interior surface of the optical window appears to maintain smooth and homogeneous with no obvious ablation phenomenon observed, while a piece of glass fragment detaches from the whole glass at the intersection point of the cracks.

The detector chip is also observed under the optical microscope and the scanning electron microscope (SEM) for comparison. As shown in Fig. 4(e) with the left one for global view and right one for partial enlargement, the surface of the detector chip is homogeneous and smooth with neither cracks nor surface color change resulted from laser illumination on it. Except for the missing corner broken from the detector chip due to the processing of disassembly, there is no obvious damage caused by laser

illumination on it. All these evidences prove that when the detector permanently fail after test, mechanical damages occur on the optical window only, while the detector chip stays intact before the disassembly. It could be concluded that the permanent failure of the cooled InSb infrared detector is owing to the breakdown of the vacuum layer sustained by the integrity of the whole structure and destructed by the cracking of the optical window by the action of both high temperature elevation and thermal stress.

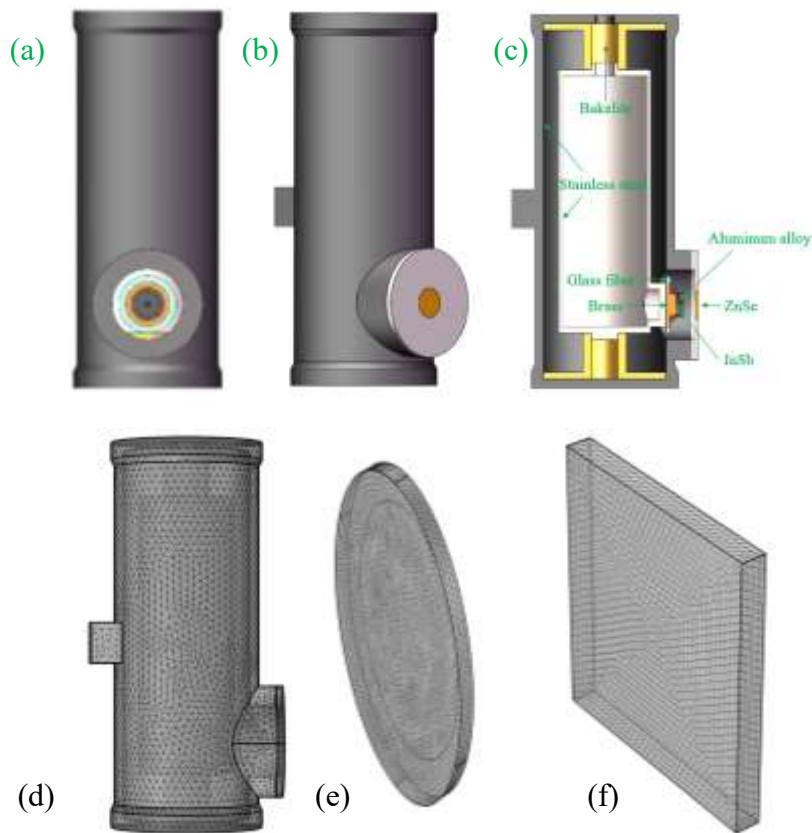
Fig. 5 The diagram of the geometrical structure: (a) inner parts behind the optical window, (b) outer surface and (c) cutaway view; The diagram of the numerical discrete mesh: (d) whole structure, (e) window glass and (f) sensor chip.

As shown in Figs. 5(a), (b) and (c), the cooled InSb infrared detector is mainly composed of four parts: the outer and the inner cylinder, connecting components between the outer cylinder and the inner cylinder, the cold finger and the semiconductor chip. The materials of the four parts aforementioned are stainless steel, aluminum alloy, Bakelite, brass, and indium antimonide in sequence. This could also be partially found in Fig. A2 with the photograph of the detector with removal of the optical window.

The discrete mesh model is shown in Figs. 5 (d), (e) and (f), in which the contact interfaces between the adjacent components are assumed to be smooth and continuous ideally for both thermal and mechanical analysis. This approach may partially obscure the non-uniform geometric characteristics of actual interfaces, potentially leading to three critical analytical deviations: 1) artificial enhancement of effective thermal conductivity, 2) underestimation of thermal gradient magnitude, and 3) inadequate characterization of stress concentration phenomena. Although, the numerical model in present work has taken into account of the nonlinear relationship between the thermo-physical parameters of the materials and their thermodynamic temperature. And the

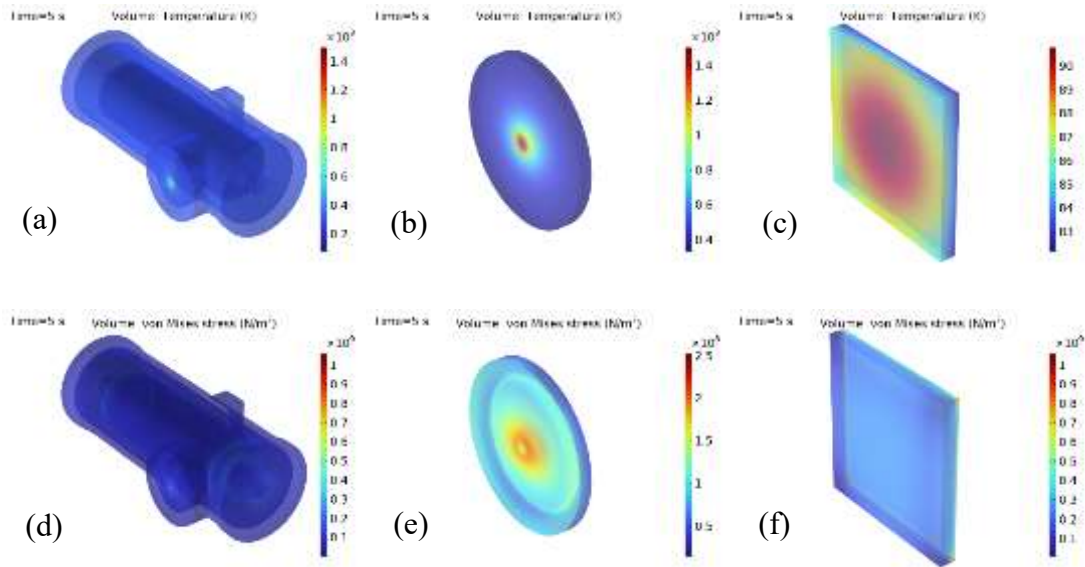
Fig. 6 Contour maps of temperature and stress under illumination by 27W laser (t=5s):

(a) temperature of the whole structure, (b) temperature of the optical window, (c) temperature of the detector chip. (d) stress of the whole structure, (e) stress of the optical window and (f) stress of the detector chip.

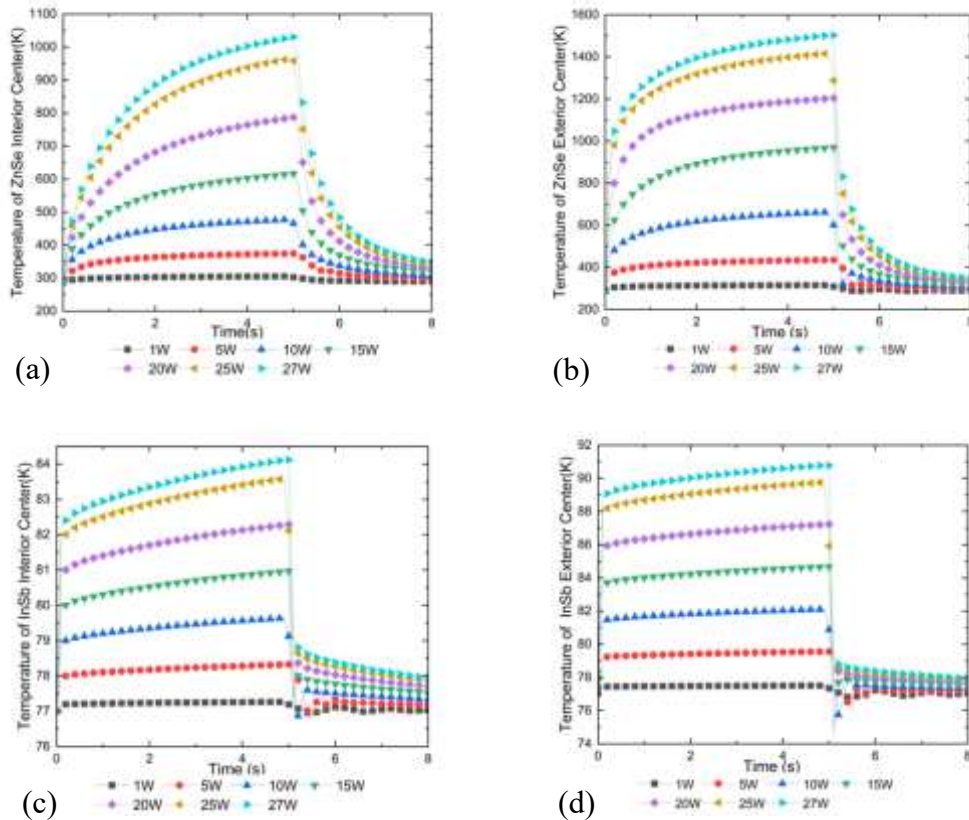
Fig. 7 Time dependent variation of the temperature of the of the optical window and the detector chip with the laser power ranging from 1W to 27W: (a) interior surface center of the optical window, (b) exterior surface center of the optical window, (c) interior surface center of the detector chip, (d) exterior surface center of the detector chip.

As for the optical window, it is revealed that the temperature at the centers of both the exterior and interior surface always increases monotonically with time during illumination with laser power varying from 1W to 27W. As the laser power increases gradually, higher peak temperature would always be reached at the exterior surface center of the optical window. And it could be observed from Fig. 7(a) and Fig. 7(b) that the temperature changing rate at the exterior surface center is higher than that of the interior surface center during illumination. Therefore, the temperature difference between the exterior and interior surface center also increases with increasing the laser power.

In the cooling stage after illumination, the time-history of temperature of detector chip as shown in Fig. 7(c) and Fig. 7(d) differs obviously from that of the optical window. This difference might be resulted from the following facts. For the optical window, it relies on convective heat transfer on the external surface and heat conduction in heat dissipation, which makes it take at least 2~3s to cool down to the temperature level before illumination. For the detector chip, it is connected with the low-temperature environment by the material of high thermal conductivity(brass), so the temperature returns to the level in the pre-illumination state much more abruptly with the laser

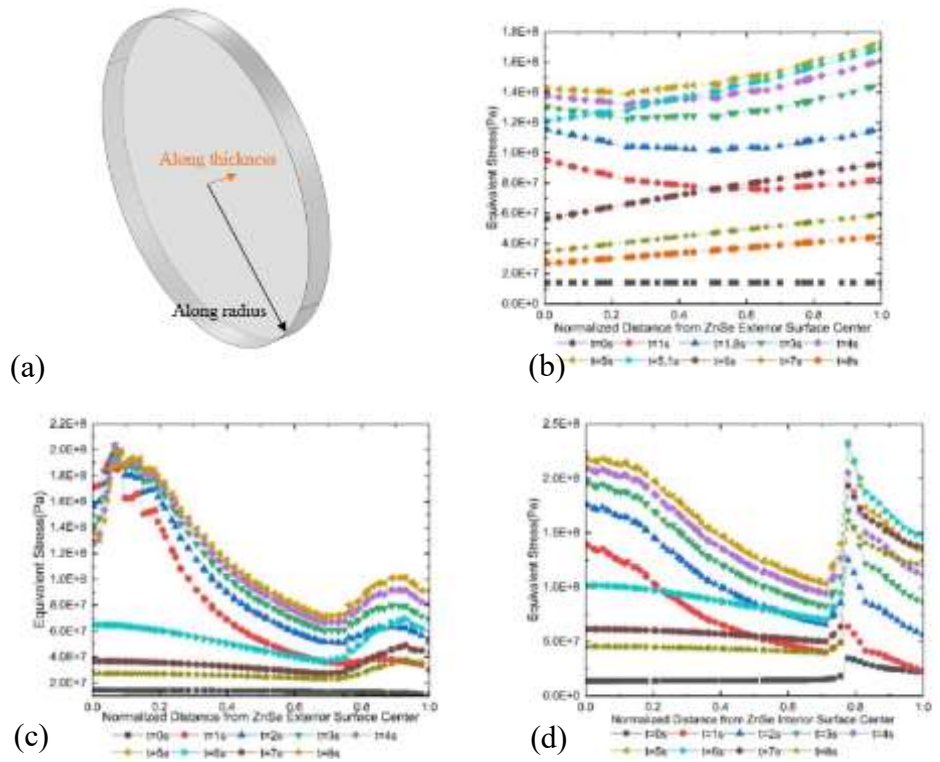
Fig. 9 Equivalent stress distributions of the optical window projected along different directions: (a) schematic diagram of projection directions, (b) projection along thickness from the exterior surface center to the interior surface center, (c) projection along the radial direction from the exterior surface center to the exterior surface edge (d) projection along the radial direction from the interior surface center to the interior surface edge.

As shown in Fig. 9(a) and Fig. 10(a), the path from the centroid of the exterior surface to that of the interior surface is selected for analyzing the variations along the thickness direction. For analysis along width direction, the path from centroid to the

According to the results of the optical window, the equivalent stress upon the interior surface increases at a faster rate than the exterior surface during illumination and therefore the comparative difference of the exterior surface and surface is reversed with the continuing of illumination. Before the instant $t=1.8s$, the equivalent stress on the exterior surface is higher than that on the interior surface. However, it turns out that the equivalent stress on the interior surface exceeds the exterior surface after $1.8s$ and late in the course of illumination, as shown in Fig. 9(b). The spatial distribution of the stress along width direction also varies with time. As shown in Fig. 9(c) and Fig. 9(d), the equivalent stress varies a little along width direction both on the exterior and interior surface in the pre-illumination and post-illumination state (5-8s). During illumination, the equivalent stress level increases as a whole with time. And it grows faster in certain regions near the centroid and the edge, resulting in two peaks in corresponding regions. But the comparative difference of the two peaks are distinctive on the exterior surface and the interior surface. On the exterior surface, the peak equivalent stress near the centroid is two times as large as the one near the edge at the shut-off time of the laser illumination ($t=5s$). While, the magnitudes of the two peaks are closer to each other at the same time ($t=5s$) on the interior surface.

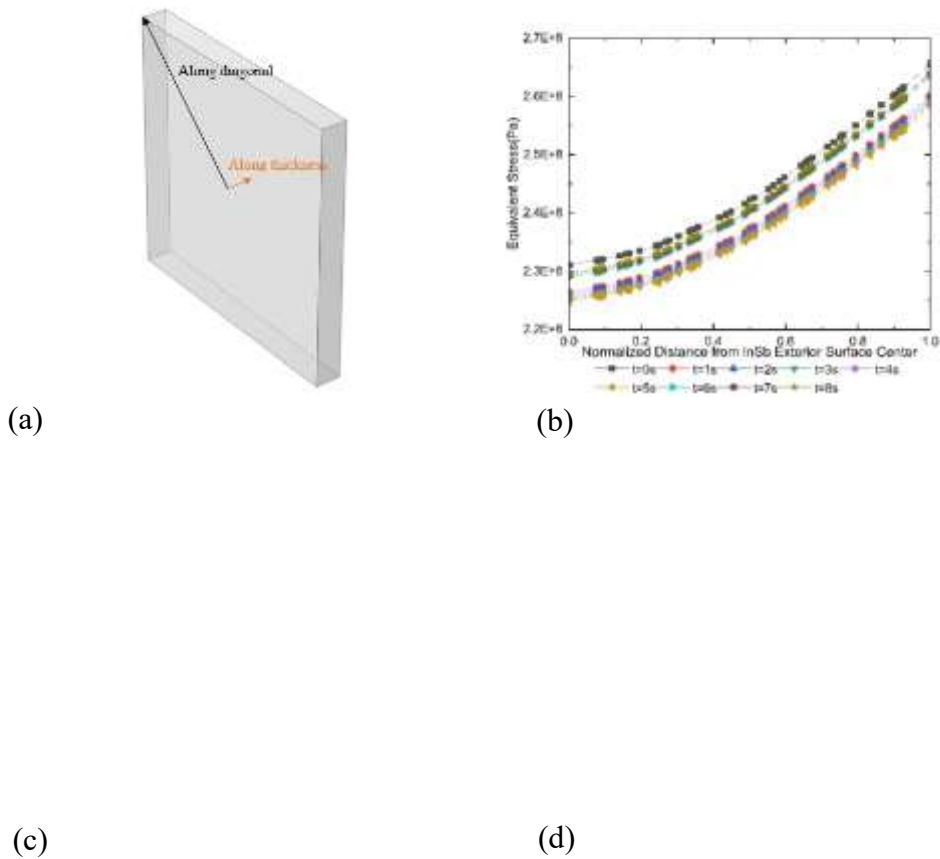
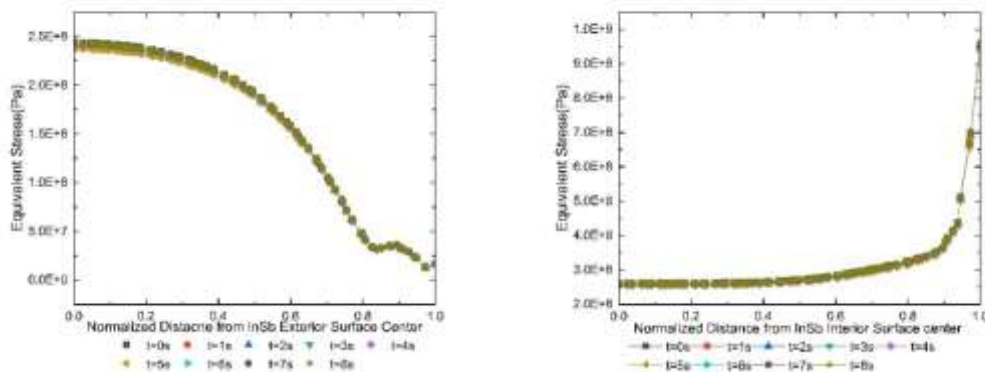
Fig. 10 Equivalent stress distributions of the detector chip projected along different directions: (a) schematic diagram of projection directions, (b) projection along the thickness direction from the exterior surface center to the interior surface center, (c) projection along the diagonal direction from the exterior surface center to the exterior surface corner, (d) projection along the diagonal direction from the interior surface center to the interior surface corner.

The distribution of the equivalent stress in the detector chip barely changes in the time range from 0s to 8s along both width and thickness direction. The equivalent stress continually increases from the exterior surface center to the interior surface center, as shown in Fig. 10(b). Along the direction of width, it decreases continuously from the centroid to the corner on the exterior surface but increases continuously from the centroid to the corner on the interior surface, as indicated by Fig. 10(c) and Fig. 10(d). It could be deduced that the characteristic of spatial distribution of the equivalent stress in the detector chip changes slightly with time during illumination by laser with power 27W.

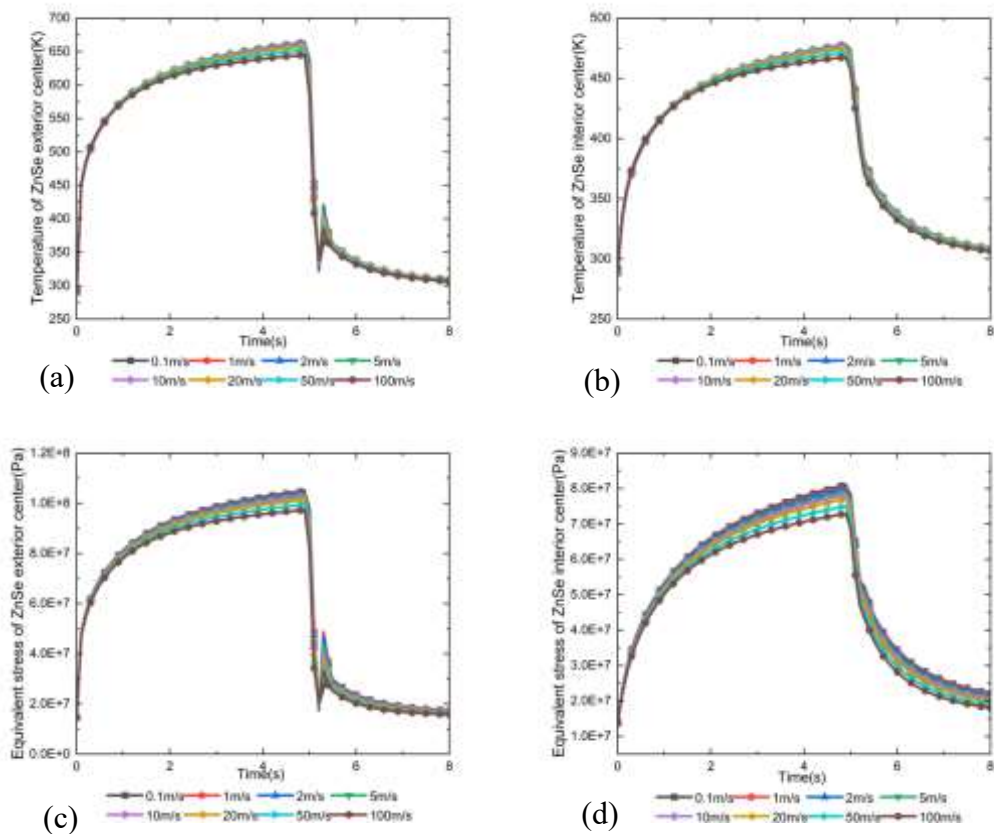
Fig. 11 Time-dependent temperature and equivalent stress curves of the optical window under illumination of 10W laser with velocity of forced convection ranging from 0.1m/s to 100 m/s: (a) temperature of the exterior surface center, (b) temperature of the interior surface center, (c) equivalent stress of the exterior surface center (d) equivalent stress of the exterior surface center.

When the laser power equals to 10W, the dependence of thermomechanical outcomes on the velocity of forced convection outside the optical window is also discussed in present work. The velocity of forced convection ranges from 0.1 m/s to 100 m/s. It is indicated that the optical window is the mostly affected component by the variation of convection velocity. The peak temperature of the centroid both on the exterior and interior surface of the optical window during illumination (0~5s) decreases when the velocity varies from 0.1 m/s to 100 m/s, as shown in Fig. 11 (a) and Fig. 11 (b). At the same time, the peak equivalent stress of the surface center on the optical window during illumination (0~5s) also decreases with the increasing velocity of forced convection. Moreover, the equivalent stress of the interior surface center reduced more apparently than that of the exterior surface center, as shown in Fig. 11(c) and Fig. 11(d). The peak value of equivalent stress of the exterior surface center in the case of 100 m/s is reduced by around 10% compared to that for the case of 0.1m/s.

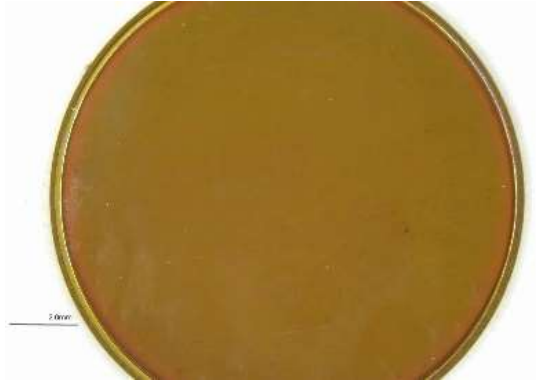
Fig. A1 The optical window before damage

Figure A1 shows a photograph of the window glass that has not undergone the laser irradiation test.

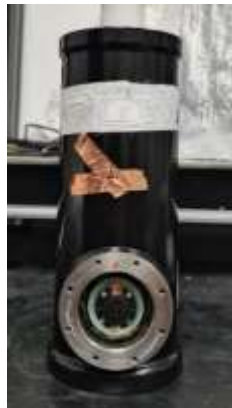
Fig. A2 The realistic structure of the detector

Figure A2 is the photograph of the detector that display partially its inner detail with the removal of the optical window.

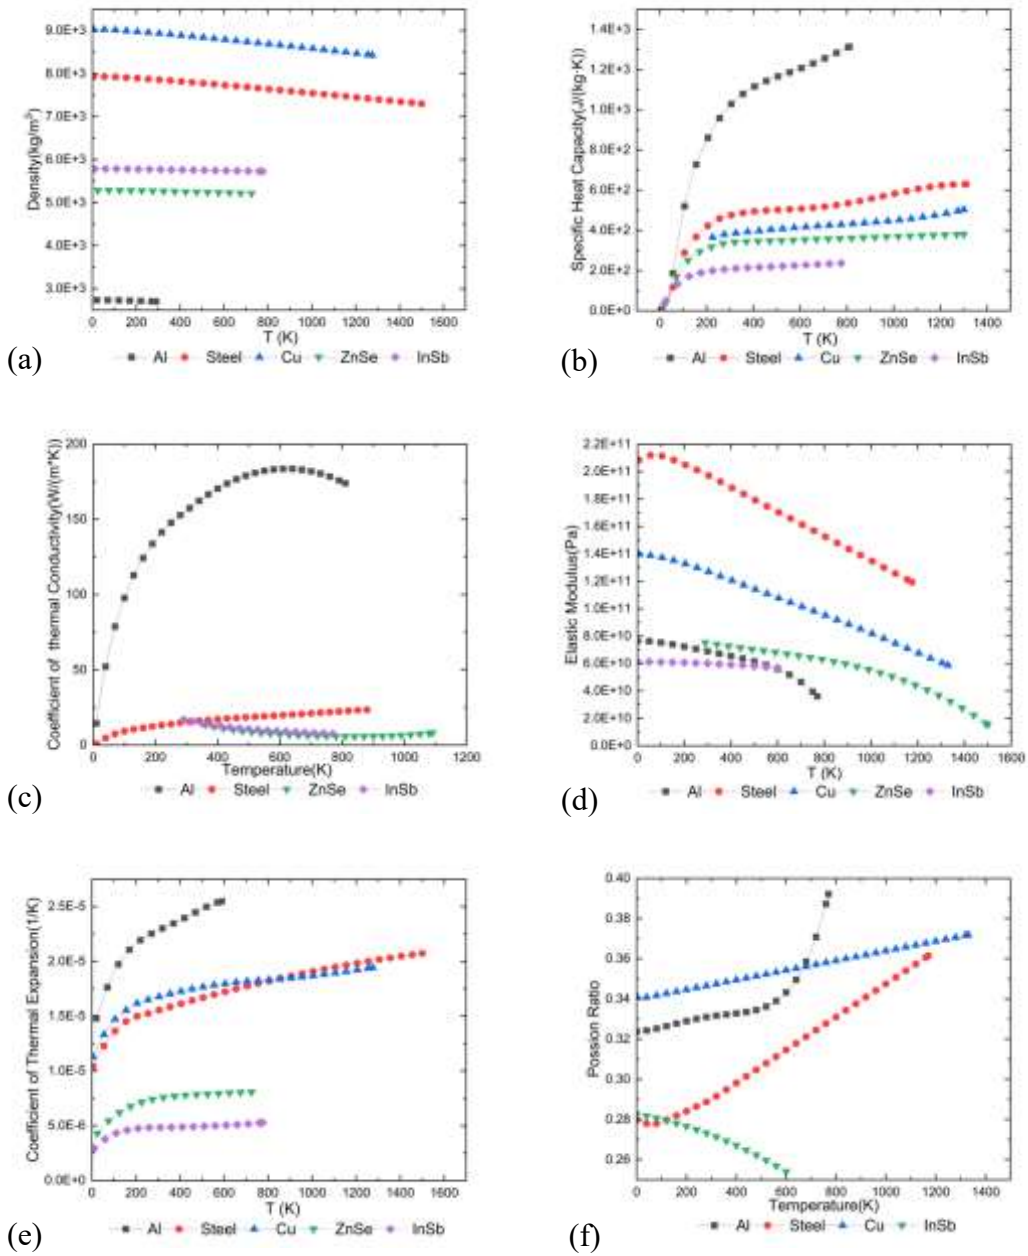
Fig. A3 Temperature-dependent parameters variation in different materials applied.

- (a) Density (b) Heat capacity (c) Coefficient of thermal conductivity (d) Elastic Modulus (e) Coefficient of thermal conductivity (f) Poisson's ratio [55]

temperature dependences of the parameters including density, heat capacity, thermal conductivity, thermal expansion coefficient, elastic modulus and Poisson's ratio are shown in Fig. A3.

Figure A3 shows the temperature dependences of the parameters including density, heat capacity, thermal conductivity, thermal expansion coefficient, elastic modulus and Poisson's ratio.

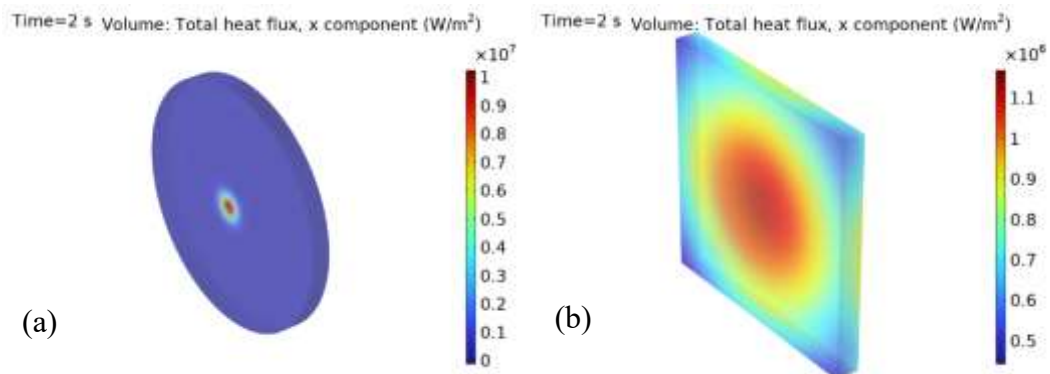
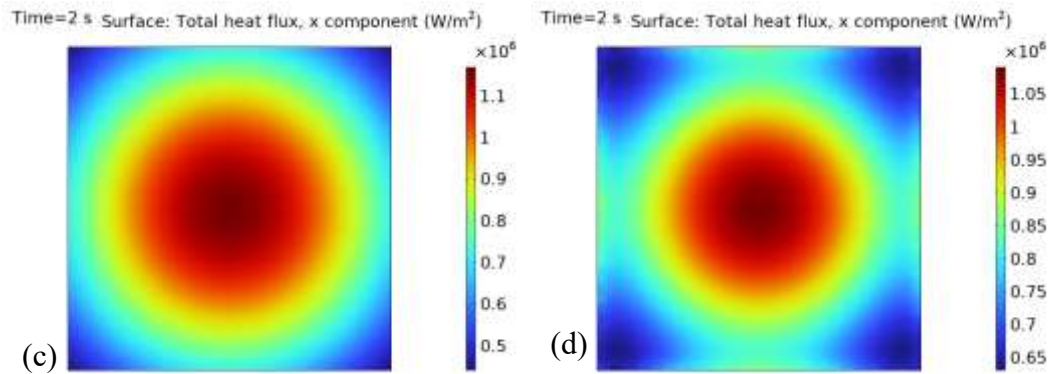
Fig. A4 contour maps of x component of total heat flux (along thickness) of the optical window and the detector chip under illumination by a 27W laser ($t=2s$)

(a) The optical window (b) The detector chip (c) The exterior surface of the chip (d) The interior surface of the chip

Figure A4 depicts the contour maps of the x-component of total heat flux at the instant $t=2s$ with x being the direction along thickness of both the optical window glass and the chip.

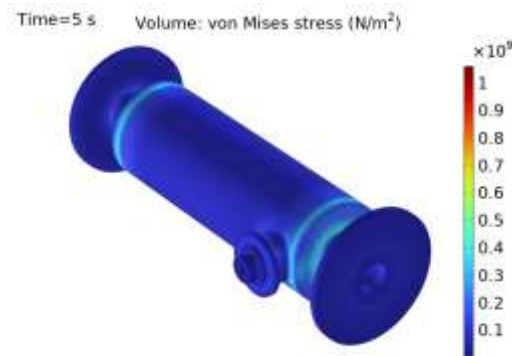
Fig. A5 contour map of equivalent stress in the inner cylinder of the Dewar at the end of illumination ($t=5s$)

Figure A5 shows the contour map of equivalent stress in the inner cylinder of the Dewar at the instant of $t=5s$ when the illumination is shut off.

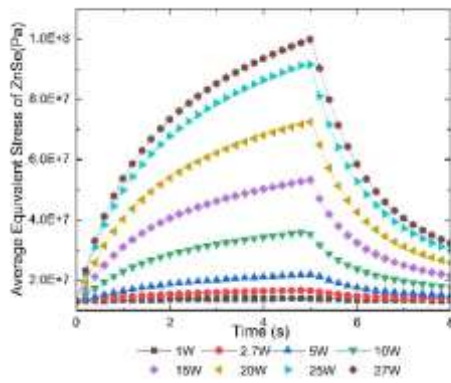
Fig. A6 Time-dependent variation of volume averaged equivalent stress of the optical window with the laser power ranging from 1W to 27W

The temporal evolution characteristics of the volume averaged equivalent stress of the optical window shows a monotonic increasing trend during illumination(0~5s), as shown in Fig. A6. When the laser is turned off, the volume averaged equivalent stress starts to decrease. As a result, the peak value of the volume averaged equivalent stress appears at the moment of shutting-off laser($t=5s$). The peak equivalent stress in the optical window grows gradually with the laser power increasing from 1W to 27W. Moreover, the peak equivalent stress during illumination with the laser power 27W is about ten times as large as that of the case with the laser power 1W. Such monotonic increasing of equivalent stress is also appropriate for most regions except for the central area on the exterior surface of the optical window when the detector is illuminated by laser with a relatively high power, as shown in Fig. 8(a) and Fig. 8(b). The equivalent stress of the centroid on the exterior surface achieves the peak value after being illuminated for about 1s when the laser power exceeds 25W. After that, it decreases gradually with successive illumination. When the adopted laser power is high enough, this phenomenon tends to exist in a very small range on the exterior surface of the optical window, whose radius is shorter than one tenth of the optical window's radius. Such unexpected decrease of equivalent stress in the optical window during the process of illumination under high power should be due to the fact that its temperature has reached an inflection point from which the thermal conductivity of zinc selenide (ZnSe) begins to increase as shown in Fig. A3. If the laser power density absorbed by the optical window is given, the temperature gradient would therefore reduce due to the increase of thermal conductivity. As a consequence, the equivalent stress in high-temperature regions of the optical window turns out to be decreasing with time during illumination.

Figure A6 and A7 show the time history of the volume averaged equivalent stress of the optical window and the detector chip with the laser power ranging from 1W to 27W, respectively.

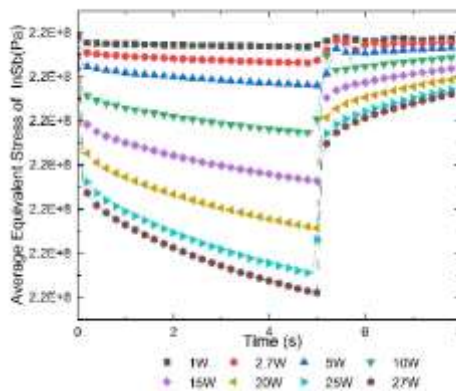
Fig. A7 Time-dependent variation of volume averaged equivalent stress of the detector chip with the laser power ranging from 1W to 27W

On the contrary, the volume averaged equivalent stress in the detector chip decreases monotonically during illumination(0~5s), as shown in Fig. A7. It reaches the valley value at the moment of shutting-off laser($t=5s$), and begins to rise at that moment, but it never exceeds the magnitude in the pre-illumination state. Such temporal evolution characteristic of the equivalent stress is almost the same for all the points on the detector chip. Although, the variation of the equivalent stress at the exterior surface center is more obvious than that of the interior surface, as shown in Fig. 8(c) and Fig. 8(d). The relative change of the equivalent stress during illumination is less than 5% of the value in the pre-illumination state when the laser power is 27W.
