An Investigation into the Radiation Damage of the Silicon Detectors of the H1-PLUG Calorimeter within the HERA environment

Abstract

The silicon detectors used in the H1-PLUG calorimeter have shown increasing aging effects during the '94 run period of the electron proton storage ring HERA. These effects were particularly manifest as degradation of the signal to noise level and the calibration stability. The reasons for this behaviour have been found to be correlated with radiation damage to the silicon oxide passivation edges of the detectors in strong and fluctuating increases of the leakage currents and in severe changes of the flat band voltages. Depletion voltages however are found to be stable and therefore bulk damage of the silicon can be excluded. A comparison with measurements made by thermoluminescence dosimeters as well as related laboratory experiments suggest that the aging is due to very low energetic electrons and photons.

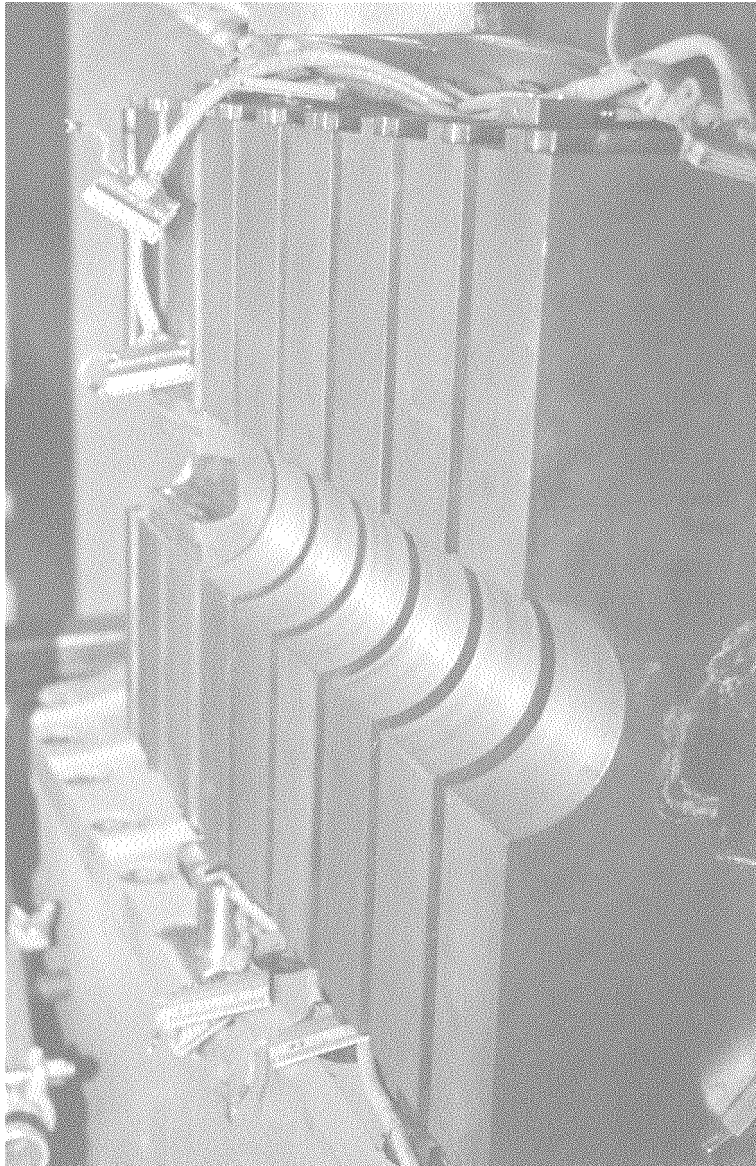
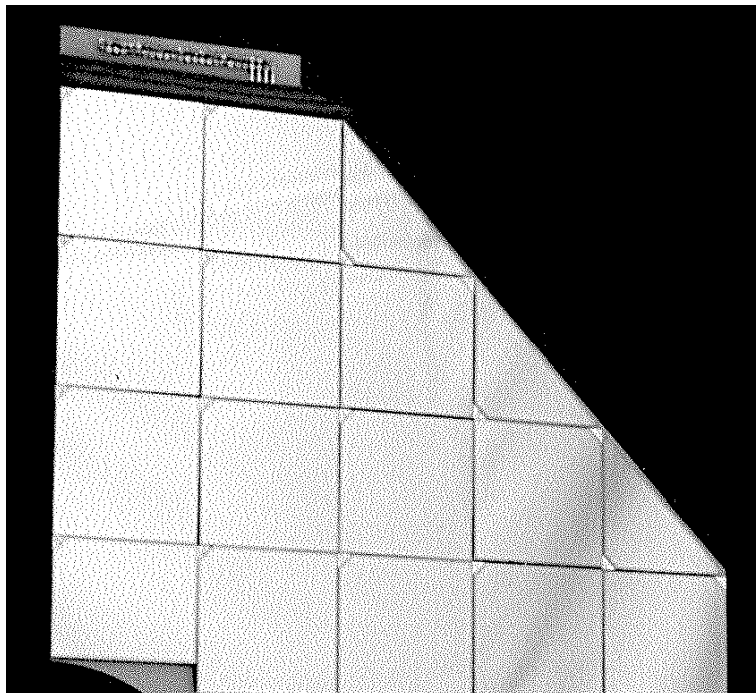
The PLUG is mounted in the return yoke of the magnet, one half is shown in the left part of figure 1 with the slots in between the copper absorbers visible for the 8 detector modules. The inner part of such a module is displayed in the right part of figure 1. It is instrumented with a total number of 42 detectors most of which are square shaped ($5 \times 5 \text{ cm}^2$) complemented by rectangular wafers close to the beam pipe and triangular ones at the outer rim. All detectors have a total thickness of around $400 \mu\text{m}$ [6]. The silicon detectors are fabricated in our own laboratory using a unique combination of a Schottky barrier process and planar technology [7].

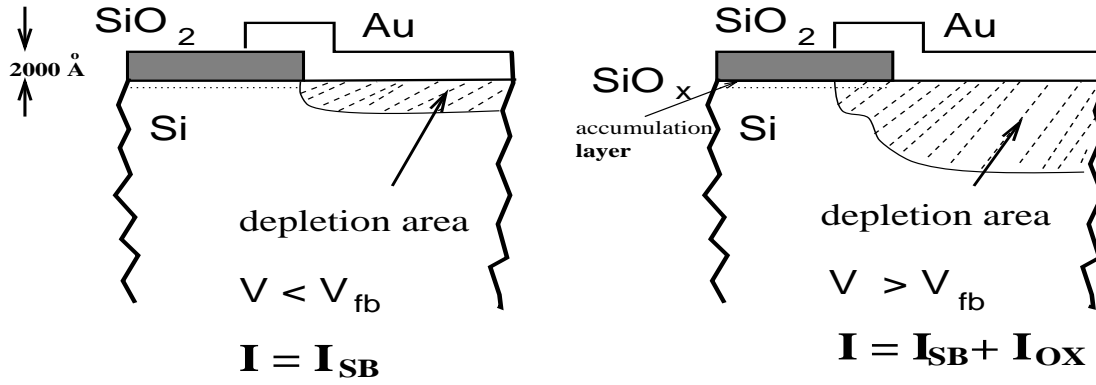
Figure 2: Schematic cross section of one detector, the border of the depleted region is indicated for different voltages.

In the figures 2 and 3 the features discussed above are shown for a typical PLUG detector after all technological process steps have been completed but prior to being used during actual beam runs. Figure 2 visualizes the principal electric field extension at the detector edge below and above flat band voltage, the C-V and I-V characteristics are shown in fig. 3. In the given example the flat band voltage turns out to be 1.5 V. This is both seen in the dramatic decrease of the detector capacitance and the jump of the reverse current at that point. For larger voltages the capacitance turns out to be inversely proportional to \sqrt{V} as to be expected by eq. (4) and reaches its geometrical limit of 630 pF at the depletion voltage ($V_d = 22V$), while the current saturates at the same point.

Due to the fact that the front electrode partially overlaps the oxide passivated edge of the silicon detector, the C-V (capacitance/voltage) characteristic given by eq. (4), has to be modified for low voltages. This overlapping "field plate" region forms a MOS (Metal-Oxide-Silicon) capacitance in parallel to the diode itself.

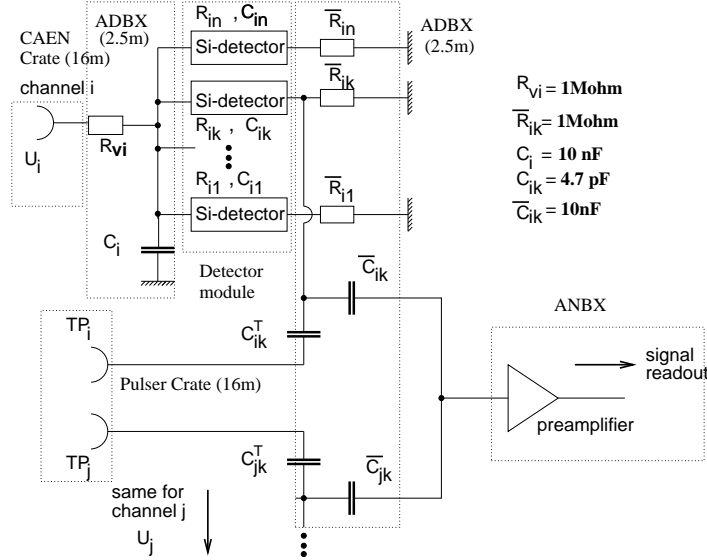
Figure 4: Simplified circuit diagram of the PLUG readout for a given bias channel i and signal readout k .

In fig. 4 a simplified circuit diagram of one read out channel is shown. The signal output of two detectors located in adjacent planes, for instance in the first and second, but at the same r , Φ position of the calorimeter, are connected to one preamplifier. An appreciable ganging had also to be used for the bias supply of all 672 detectors from only 80 available bias channels. Unfortunately a bias distribution box, as used for the LAr calorimeter had to be ruled out because of unacceptable limitations for the detector current. Due to the exposed position of the PLUG calorimeter in the very forward angular range, some radiation damage had to be expected with resulting larger increase of the reverse current for the innermost detectors closest to the beam pipe. In order to achieve a similar accuracy in current monitoring throughout the calorimeter, a bias ganging of only 3 detectors was

foreseen for the innermost detectors, extending to a connection of up to 14 detectors to one bias supply at the outer rim. At a given operational voltage each detector may be symbolized by its capacitance C_{ik} and the reverse current by a parallel resistor R_{ik} . A common filter network R_{vi}, C_i for the n detectors, belonging to one bias module, is used for the reduction of low frequency noise picked up via the long bias transfer line between the unit located in the electronic trailer of the H1 experiment and the PLUG. The individual bias resistors \bar{R}_{ik} on the other side of the detectors enable the signal readout via the likewise individual coupling capacitors \bar{C}_{ik} . For calibration purposes a charge is induced via the charge terminator capacitance C_{ik}^T . It has to be noticed, that the actual realisation of the block diagram is contained in 5 different electronic units (indicated by dotted lines in fig. 4) connected by cables of varying length. The bias unit and the pulser crate are located in the electronic trailer, the adapter box ADBX (bias distribution and readout ganging) and the analog box ANBX sit behind the return yoke of the magnet and the PLUG calorimeter itself.

Especially the cables between the detectors and the coupling capacitors together with any inherent stray capacitance add a constant value of $C_{S,ik} \approx 300\text{pF}$ to the voltage dependent detector capacitance $C_{D,ik}$. Thus C_{ik} in fig. 4 is the sum of both these values.

The signal noise can only be measured for each electronic channel, connected to two detectors ganged together as seen in fig. 4. Capacitance and noise characteristics are measured simultaneously. For the capacitance we use the mean value of the signal distribution and the noise is extracted from its standard deviation. The noise performance contains two contributions, one of which is due to the input capacitance of the preamplifier and the second corresponds to the detector noise. For newly commissioned detectors the second contribution is negligible. Hence the combination of I-V (ganging in one plane) and noise-characteristics (ganging of two detectors in two consecutive planes) provides a tool to identify single bad detectors.

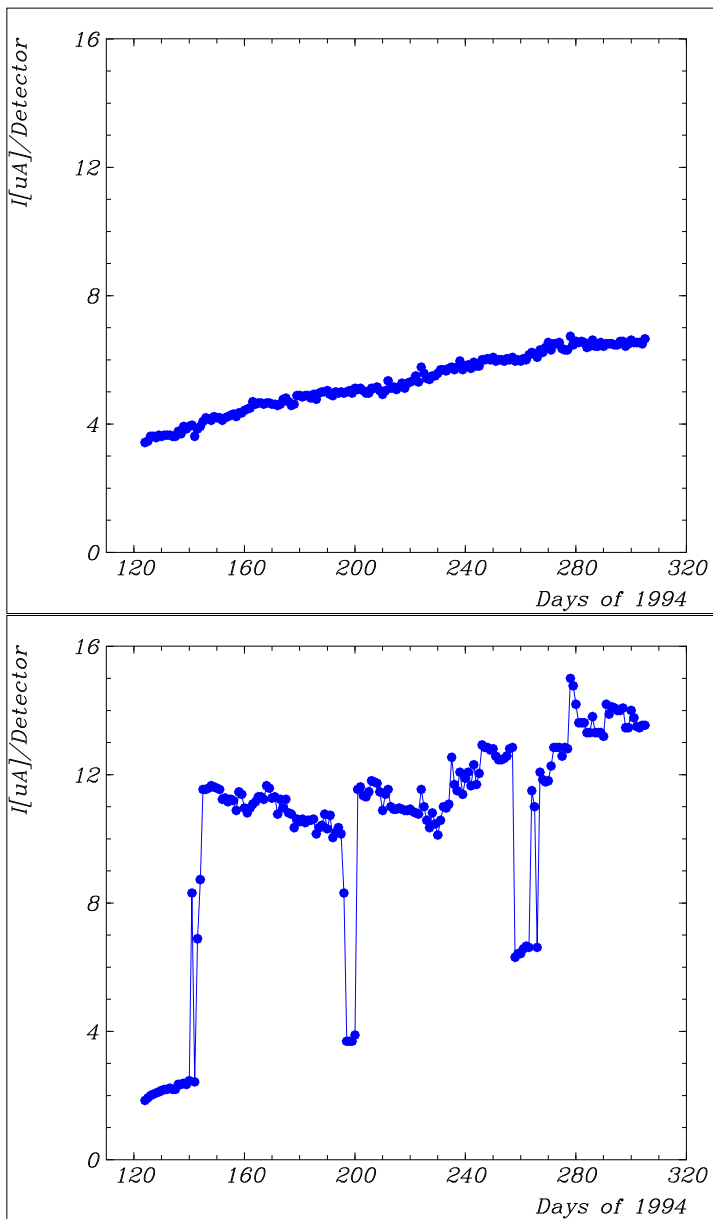
Figure 6: Reverse current on a long time scale given for a normal "good" bias-voltage-channel (left side) and one containing at least one "bad" detector (right side), see text.

In figure 6 the reverse current as a function of time given in days is plotted for two typical bias-voltage-channels. The first channel shows a continuous development of the reverse current with an almost linear tendency. The increase of the reverse current is due to an increase of the surface contribution as investigated e.g. in ref. [8]. Synchrotron radiation creates new generation centers of charges inside the interface (Si-SiO_2) causing a higher surface current (see fig. 2). This increase is proportional to the absorbed dose. Therefore a radial dependence of the increase is observed with inner detectors showing the strongest effect. Details are discussed in sect. 7. The data were taken on day 242 of the run period (compare fig. 6).

The second channel shows a faster linear increase of the reverse current and its evolution is distorted by strong jumps of the current. These jumps are abnormal, they can be explained by a local break-down of the depletion towards the border of a detector causing a short circuit in the corresponding bias-voltage-ring. The jumps provide high noise spoiling the measurement. Therefore detectors showing break-down have to be removed from the readout ⁴.

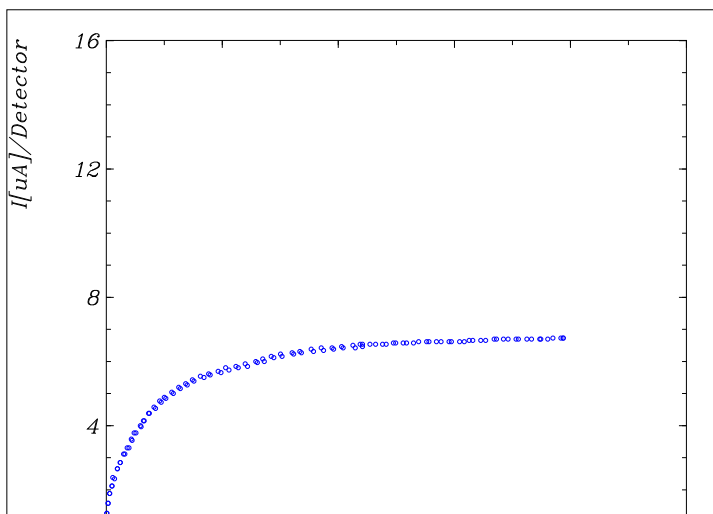
In figure 7 the I-V characteristics of the same two bias-voltage-channels are shown. The reverse current of the first channel has the typical dependence of the applied voltage. The curve shows a decreasing slope until the depletion voltage is reached (fig. 3) proving that all detectors connected to this channel are operational.

The second channel shows the normal evolution up to values of about 20 V and above this voltage the I-V characteristic is governed by an ohmic behaviour. No saturation of the current is observed indicating that at least one detector of this channel shows a break-down .

The I-V characteristic of the 648 detectors installed in the PLUG during the 94 run period has been analysed. 7 % of the detectors show a break-down as demonstrated in fig. 7 and are no longer

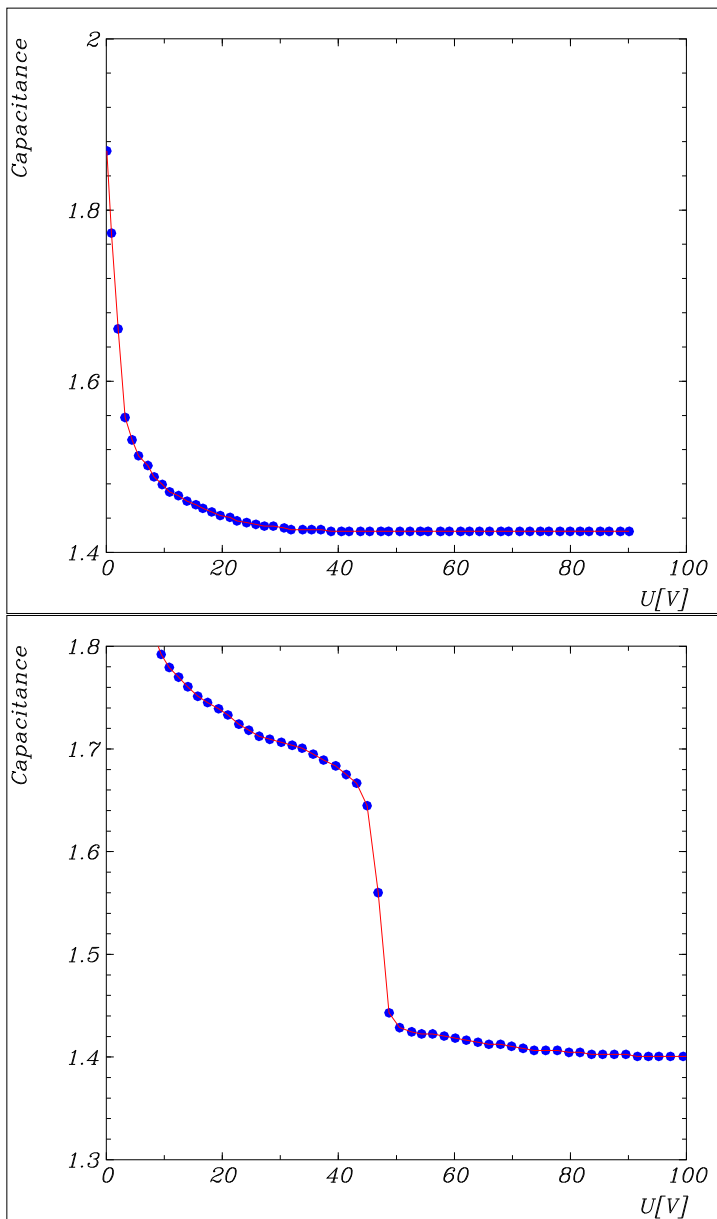
Figure 9: The normal C-V characteristic and the C-V characteristic for a detector with an increased flat band voltage are given as a function of the voltage V .

Figures 8 and 9 illustrate the C-V characteristics of two typical detectors. Figure 8 shows the C-V characteristic of a detector as a function of $1/\sqrt{V}$ and figure 9 the C-V characteristic as a function of the voltage V.

The right part of the figures 8 and 9 represent a different detector with an increased flatband voltage of 45 ± 2 V. This increase is due to radiation damage of the SiO_2 passivation at the border of the detector. The observed flatband voltage is lower than the depletion voltage of 82 V, still visible in the C-V characteristic.

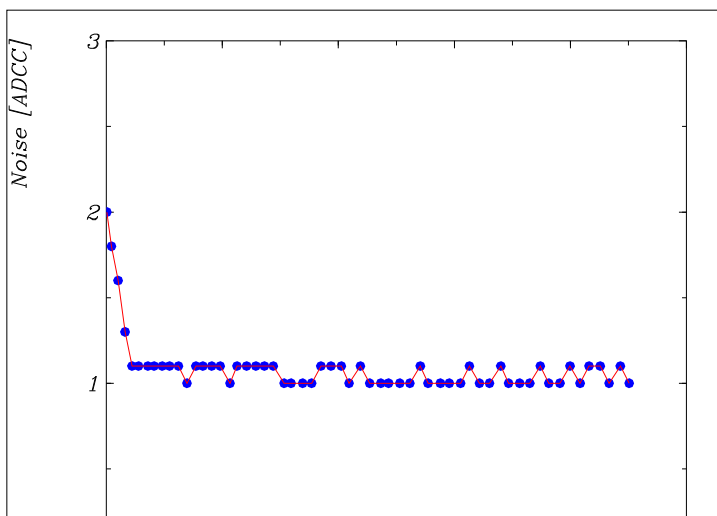
The detector noise is shown in figure 10 for both of the preceding detectors as a function of the voltage V . It follows for both the evolution of their C-V characteristics (see fig. 9). This is purely an effect of the used preamplifiers being sensitive to the detector capacitance, so that the detector noise itself can be neglected for undamaged detectors. The first detector has a noise of one ADC count corresponding to ~ 8300 electrons. The noise of the second detector drops down at the voltage which corresponds to the increased flat band voltage and it also stays constant above this value.

Figure 11 shows the noise performance of a detector, which is not operational due to high noise. Above 20 V indicating break-down the noise increases linearly up to 30 ADC counts (~ 1 GeV). This observation is in good agreement with the break-down of the I-V characteristic in figure 7. This detector has of course to be excluded from the readout in order not to spoil the energy measurement.

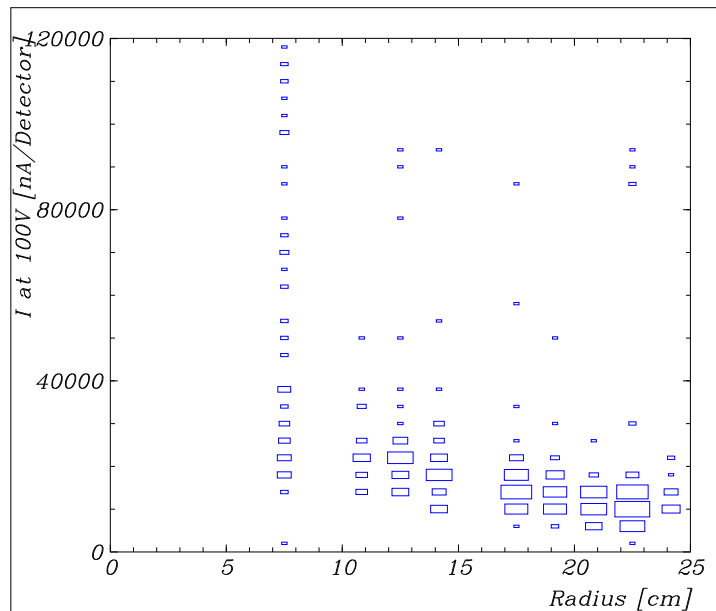
Figure 12: The detector reverse current at 100 V is correlated with the radial position of the detector.

In figure 12 the correlation of the reverse current measured at 100 V and the radial position is shown for the remaining 92 % of detectors. A clear radial dependence of the increase of the reverse current is observed. The closer a detector is mounted to the beampipe the higher is its current. 14 % of the detectors have a current higher than $6 \mu A$. Most of these detectors are situated in the innermost ring. In addition to the radial dependence it should be mentioned that detectors in the most backward plane where the electron beam hits first are damaged more than detectors of the front plane, through which the incoming proton beam passes first. This indicates once more that the increase of the reverse current is caused by electromagnetic radiation.

The reverse current is strongly increasing with time from some 100 nA's to several μA 's per detector. The increase is highest for the innermost and most backward detectors, where the electromagnetic radiation flux impinging on the PLUG is greatest. In total 7 % of the detectors show a break-down in their I-V characteristic. These are mainly the innermost detectors exposed to the highest radiation dose. These detectors are no longer operational due to missing depletion of the silicon and must therefore be replaced for the next run period.

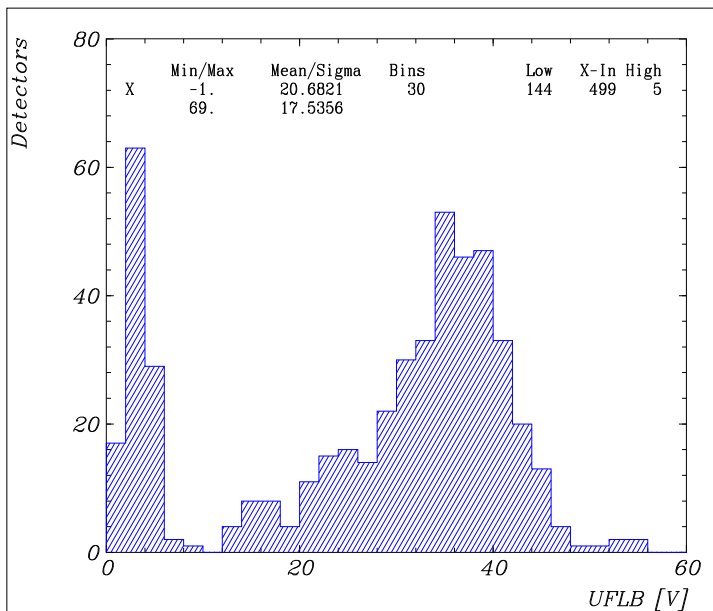
Figure 13: The distribution of the flat band voltages at the end of the '94 run period is presented.

Figure 13 shows the distribution of the measured flat band voltages. Two classes of detectors are visible. The first class has an unchanged flat band voltage of about 2 V. The second class is characterized by an increased flat band voltage of around 35 V.

from the latest production batches. They were fabricated from wafers with a different oxide and show a negligible flat band voltage shift (fig. 13, 14). So far it can be stated that the radiation hardness of silicon oxides depends strongly on the chosen technology [12].

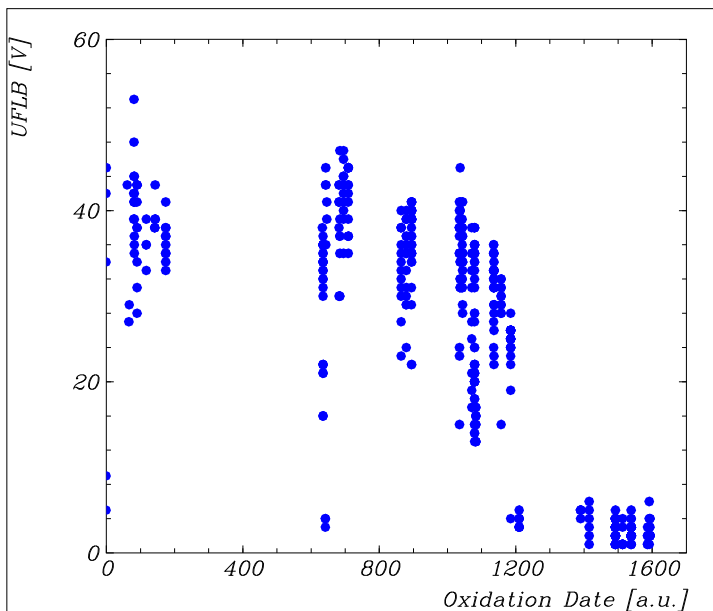
Figure 14: The correlation of the flat band voltages with the oxidation date is given. Newly fabricated detectors show no increase of the flat band voltage.

Figure 14 illustrates the correlation of the flat band voltage with the oxidation date of the detector. The correlation with the oxidation date shown over the time period 1990-1993, during which the detectors were produced in different oxidation batches, proves that the newly fabricated detectors show no increase of the flat band voltage while the older ones are characterized by a saturating value of around 35 V. I

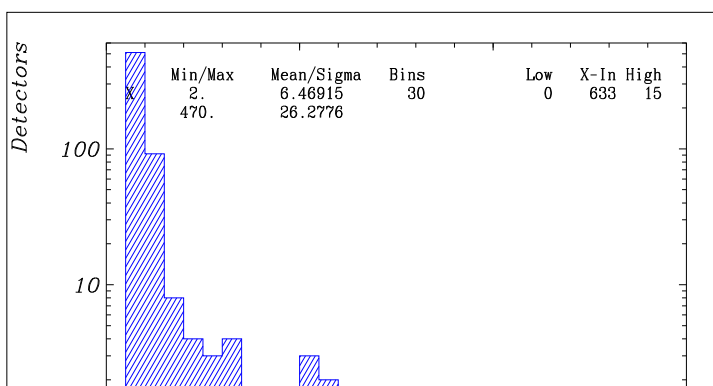
Figure 15 represents the noise distribution of all detectors after the '94 run period. Most detectors do not exceed the electronic noise of 1-2 ADC-counts (see sect. 6.3). 6% of the detectors have a noise higher than 5 ADC-counts.

The noise analysis reveals that detectors, which are unstable and show break-down, have high noise. Hence they have a bad signal to noise ratio and spoil the overall energy measurement of the calorimeter. Therefore, noisy detectors have to be identified as quickly as possible in order to exclude their signals from the readout. In addition detectors showing break-down affect the other detectors included in the same bias voltage channel. The fluctuating current of the bad detector leads to an equivalent fluctuation of the effective voltage for all other detectors showing up in an increased noise. To avoid this perturbation of other detectors by damaged ones it would be useful to have individual switches in order to be able to remove the bias voltage for every single detector. This is foreseen for future developments.
