# THE ENVIRONMENT EFFECT ON OPERATION OF IN-VESSEL MIRRORS FOR PLASMA DIAGNOSTICS IN FUSION DEVICES

First mirrors will be the plasma facing components of optical diagnostic systems in ITER. Mirror surfaces will undergo modification caused by erosion and re-deposition processes [1,2]. As a consequence, the mirror performance may be changed and may deteriorate [3,4]. In the divertor region it may also be obscured by deposition [5-7]. The limited access to in-vessel components of ITER calls for testing the mirror materials in present day devices in order to gather information on the material damage and degradation of the mirror performance, i.e. reflectivity. A dedicated experimental programme, First Mirror Test (FMT), has been initiated at the JET tokamak within the framework Tritium Retention Studies (TRS).

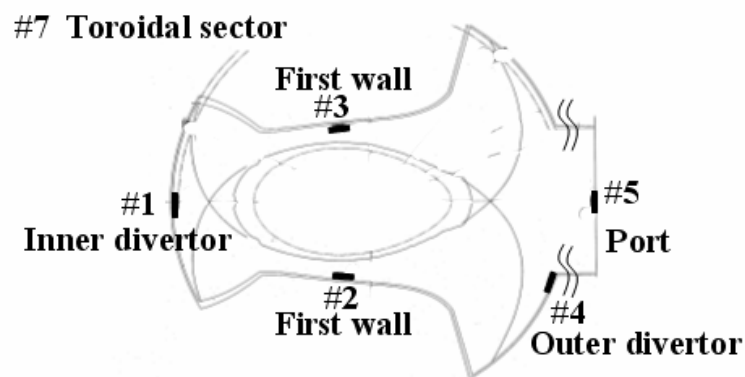
Fig. 1. The scheme of locations of SS mirror samples inside the LHD vessel.

Three SS mirrors with size 20x10x1 mm were mechanically polished, cleansed in an ultrasonic bath filled with acetone, and then the spectral reflectance at normal incidence was measured in the wavelength range 200-700 nm. The samples were installed inside the LHD vacuum vessel in locations indicated in Fig. 1 by numbers 1, 3, and 5: the sample #1 was positioned near the divertor region, #3 – close the plasma edge, and #5 – quite deeply in the diagnostic port in the same poloidal cross section and in the same plane as #1 (central plane). After samples were removed the reflectance was again measured in the same way, and the surface of samples were analyzed by several methods: Auger electron spectroscopy (AES), ion backscattering technique (RBS) using 1.5 MeV He<sup>+</sup> ion beam, scanning electron microscopy (SEM), profilometry, and ellipsometry at the wavelength 632.8 nm. These data are presented in detail in [4].

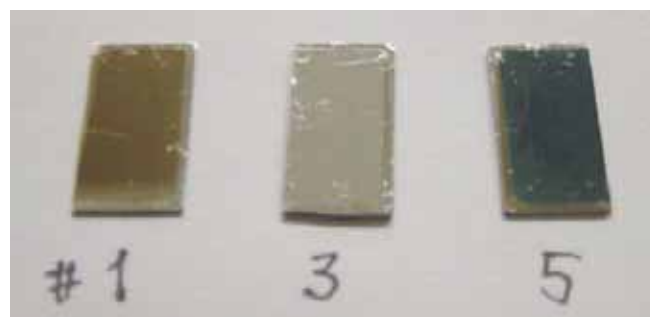
Fig. 2. The photos of samples after they were taken out of the LHD vacuum chamber.

The photos of Fig. 2 show how mirror samples looked just after finishing their exposure in LHD vacuum vessel. As a result of exposure in LHD the reflectance of all samples has changed from the identical initial level, Fig. 3.

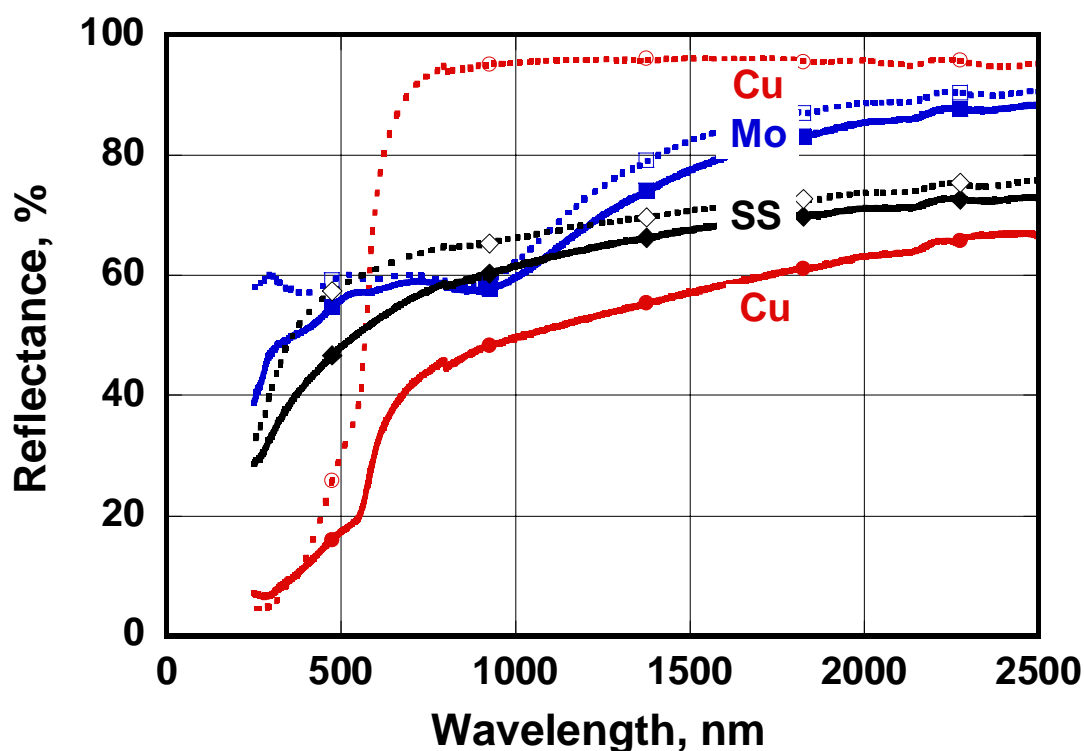
Fig. 8. Reflectance of mirror samples before (dotted lines) and after (solid lines) exposure inside Tore Supra.

Total and diffusive reflectance values were measured before and after exposure in the Tore Supra tokamak by means of a spectrophotometer ( $\lambda=250-2500$  nm) and significant change of reflectance was observed for all samples, but especially for Cu, as Fig. 8 shows. From measurements by con-focal microscopy the surface roughness of the Cu mirror samples after exposure increased by factor 7 and a net erosion profile depth amounted  $\sim 2.8 \mu\text{m}$ , while the surface roughness of the sc Mo samples did not change with a net erosion profile depth only  $\sim 0.12 \mu\text{m}$ .

It was found that all exposed mirror samples became not only eroded but also coated with some deposited layers what is the main reason for change of the total reflectance.

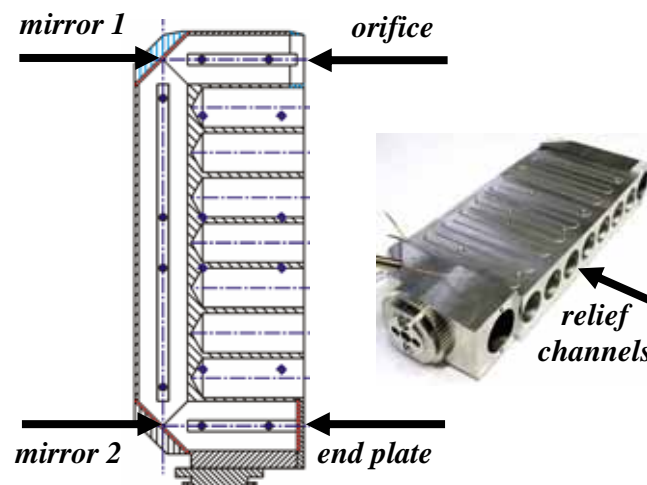
Fig. 10. Periscope system with mirror 1 (closest to the plasma), mirror 2 and the end plate. The tubes (35mm) are wrapped inside with exchangeable steel foils fixed at the wall by bars. The photograph shows the stainless steel body without end plate. Relief channels reduce weight.

The set-up of a periscope-like system on TEXTOR simulates the ITER diagnostic ports transmitting the plasma radiation to further distant sensors. Two plane mirrors were installed in tubes facing each other at a distance of 275 mm. The mirrors are oriented 45° with respect to the line of sight. The orifice (35 mm diameter) is oriented perpendicular to the toroidal direction.

The second end was closed with a polished end plate as is shown in Fig. 10. The SOL fluxes hit the first mirror under 45°. Carbon transport inside and deposition can be investigated after dismantling of the system. The deposition patterns on exchangeable steel foils wrapped inside the tubes complete this information. The stainless steel body can be heated up to about 500°C. Mirrors made from TZM (99% Mo, 0.1% Zr, 0.5% Ti) were used for the pilot experiment. The edge closest to the plasma was kept at 25 mm from the LCFS and the system exposed to 89 (partly neutral beam heated) plasma pulses ( $n_e = 1.5$  to  $4.5 \times 10^{19} \text{ m}^{-3}$ ) with a total plasma exposure time of 1047 s. The temperature was 150 °C.

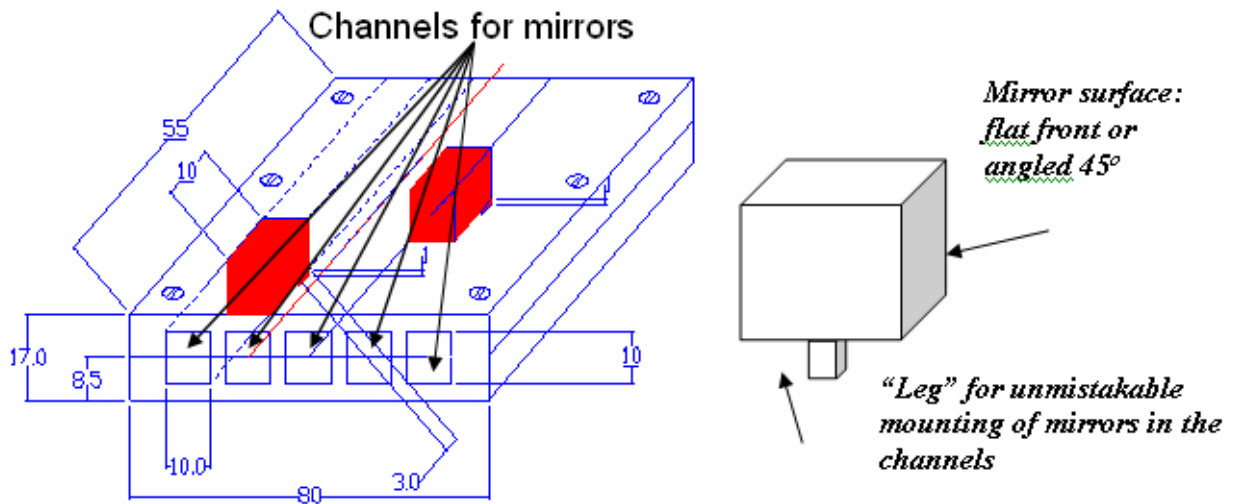
Fig. 15. A schematic view of a cassette and a mirror block for the test in JET.

Fig. 15 exemplifies a design of a stainless steel cassette with several channels in which the mirrors are mounted. The number of channels in a cassette, three or five, is dependent on the

The cassettes are of a “pan-pipes” shape and they are composed of two detachable plates. The construction enables studies of deposition both inside the pan-pipes channels and on the mirror surfaces. Moreover, the exposure of mirror surfaces at various inclination angles and aspect ratio with respect to plasma is possible. Effects of sample temperature on deposition in the divertor may be studied by comparison with the QMB data [16]. Figures 15 a-c show the location of mirrors and other deposition monitors in the divertor base and the inner carrier. The arrangement of devices in the outer divertor is similar to that in the inner leg (see Fig. 15 d). There are also cassettes placed on the main chamber wall (Fig. 16) protected by magnetic shutters which open when the magnetic field is on. This ensures avoiding the deposition of beryllium during its evaporation on the JET wall. Installation of all the deposition monitoring devices in the JET vessel is compatible with remote handling [17]. The construction phase and commissioning of the diagnostic tools for TRS (including FMT) is to be ready for installation in 2004. The experiment itself will be carried out in 2005 until the next opening of the JET vessel.

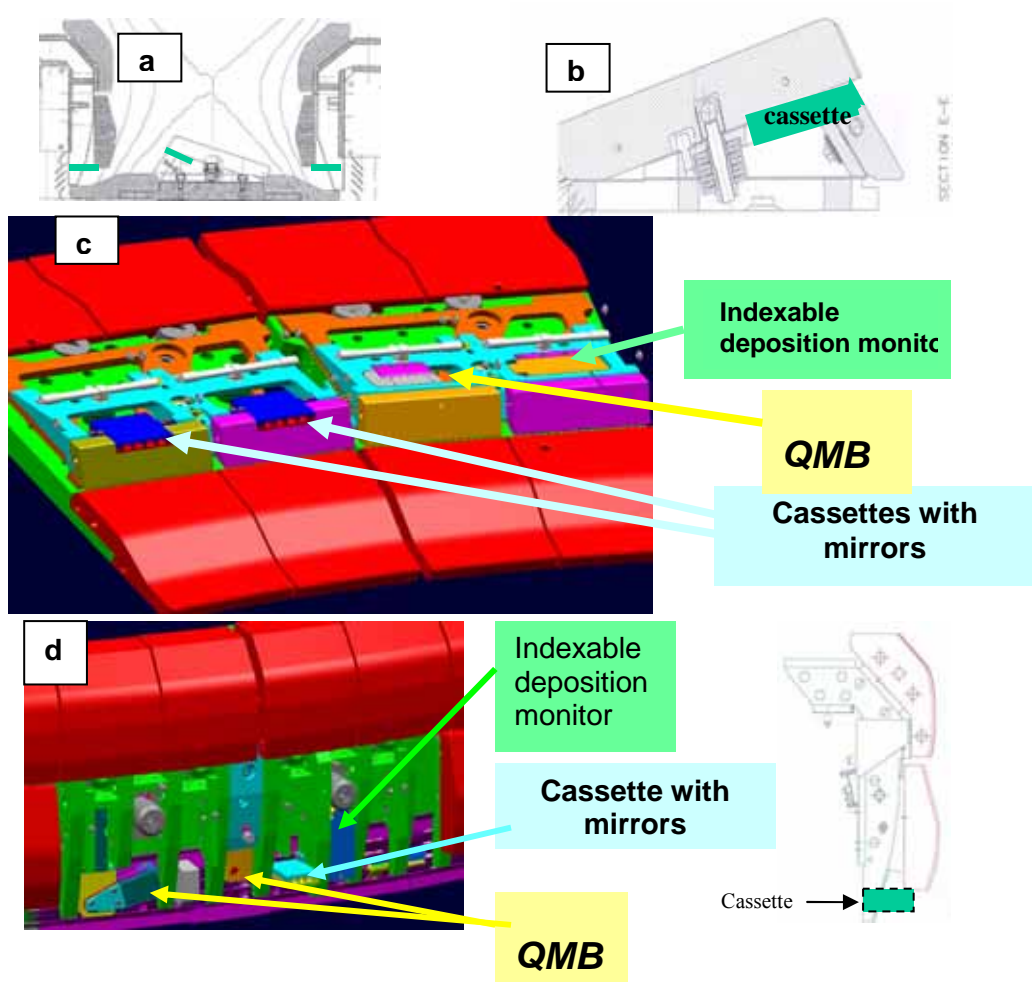
Fig. 16. (a) Divertor cross-section with a mirror cassettes (green boxes) in the inner, the outer carrier and below the load bearing plate (LBP made of carbon fibre composite); (b) base divertor module with a cassette; (c) location of several devices for monitoring the deposition mounted in the base divertor modules [Load Bearing Plate is removed]; (d) location of tested mirror and other deposition monitors in the inner divertor.
