# Proton Radiation Damage Experiment on a Hybrid CMOS Detector

We report on the initial results of an experiment to determine the effects of proton radiation damage on an X-ray hybrid CMOS detector (HCD). The device was irradiated at the Edwards Accelerator Lab at Ohio University with 8 MeV protons, up to a total absorbed dose of 3 krad(Si) ( $4.5 \times 10^9$  protons/cm<sup>2</sup>). The effects of this radiation on read noise, dark current, gain, and energy resolution are then analyzed. This exposure is the first of several which will be used for characterizing detector performance at absorbed dose levels that are relevant for imaging devices operating in a deep-space environment.

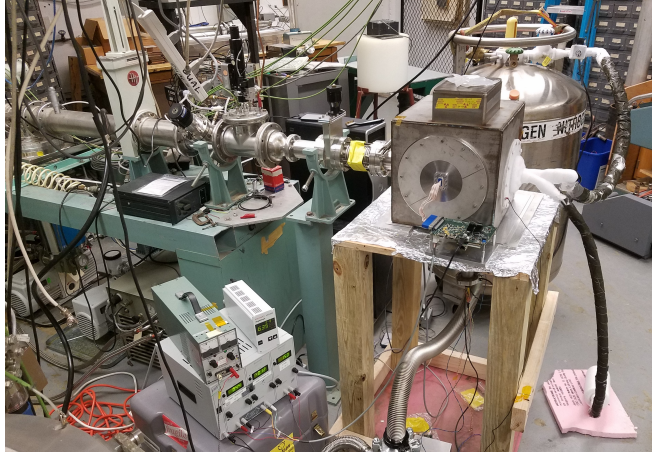
Figure 1: The “Cube” vacuum chamber contains the Hybrid CMOS Detector, along with all necessary electronics and cooling hardware. It was precisely aligned and mounted to the tandem Van de Graff accelerator at Ohio University in preparation for irradiation.

This experiment was conducted as part of a collaboration with the Edwards Accelerator Laboratory, operated by the Department of Physics and Astronomy at Ohio University. By mounting our detector setup on their tandem electrostatic accelerator, we are able to irradiate a controlled portion of the detector by utilizing a custom mask composed of thin tungsten sheets. The dose of 8-MeV protons was delivered over a period of  $\sim 10$  seconds and was measured using an upstream Faraday cup and beam-profile monitor that had been previously calibrated against the beam current and beam areal distribution measured at the detector position using a quartz window viewer. The detector was cooled to its operating temperature of 150K and left unbiased during this time. Exposure to X-rays was controlled by using a radioactive Iron-55 source that is mounted on an internal shutter system of the vacuum chamber. This allows us to switch between taking X-ray data and dark frames without breaking the primary vacuum. Figure 1 shows our “Cube” vacuum chamber mounted on the end of the accelerator just before irradiation. Because the proton beam measures roughly  $1\text{cm} \times 2\text{cm}$  in this case, proper alignment and orientation of the Cube was of high priority, and was accomplished with the use of a theodolite.

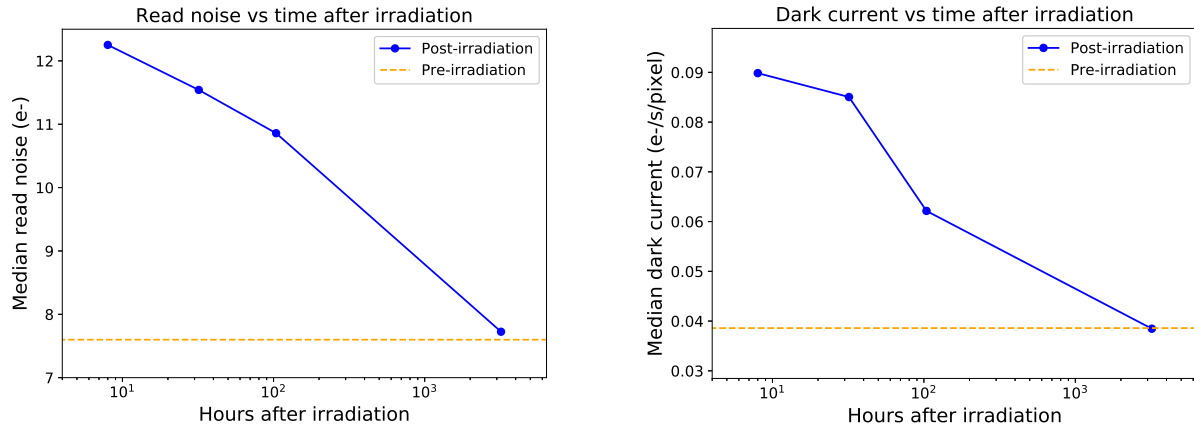
Figure 2: (Left) A plot of median read noise vs time for the damaged region of the detector. (Right) A plot of median dark current vs time for the damaged region of the detector. After several months of storage at room temperature, both characteristics appear to have returned to pre-irradiation levels.

The read noise of the detector has been evaluated for each pixel within the damaged region over a large number of images at several epochs after irradiation. A plot of median read noise vs. time can be seen in Figure 2. By analyzing each pixel individually, we can identify regions of the detector that are inherently noisier than others, as shown in Figure 3. Due to significant pre-existing differences in read noise between channels, along with

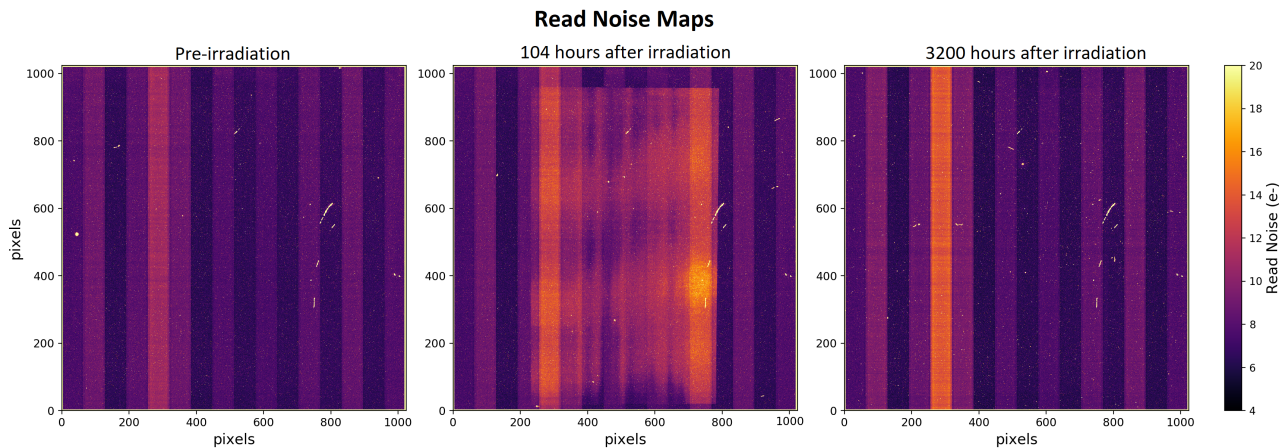
Figure 3: A map of the read noise across the detector as measured pre-irradiation (Left), 104 hours after irradiation (Middle), and 3200 hours afterward (Right). The damaged region can be seen in the middle, with the control regions on either side. Differences in read noise between channels appear as vertical striping in all images.

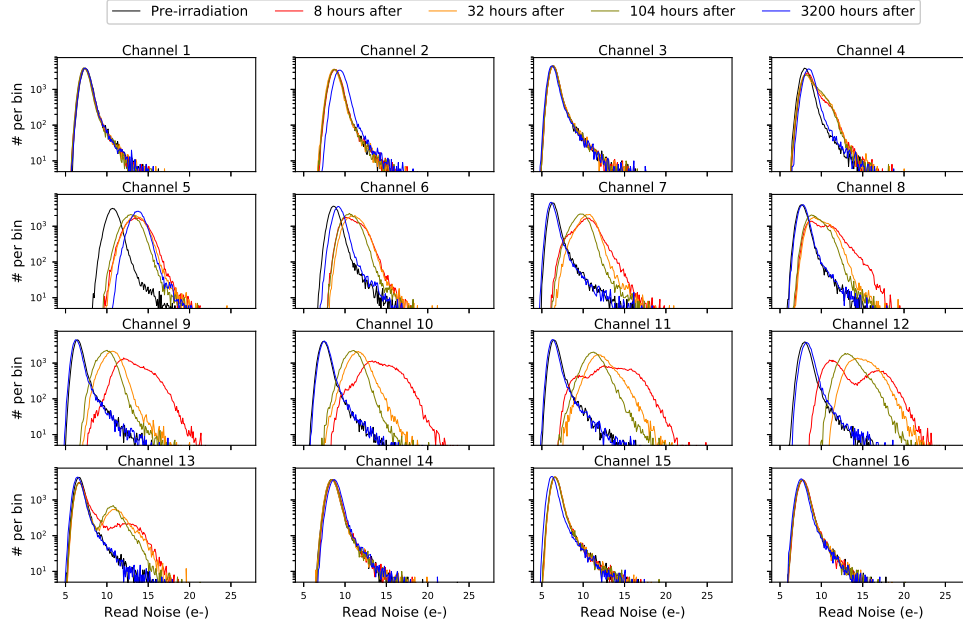
Figure 4: A read noise histogram of each readout channel is compared at multiple epochs after irradiation. When viewed in this way, the differences in read noise between channels become clear, and it can be seen that the read noise generally returns to pre-irradiation values by the time of the measurements at 3200 hours. Channels 5-12 were fully irradiated, while channels 1-4 and 13-16 were at least partially shielded by a tungsten mask. One exception to the norm is Channel 5, which is exhibiting uncharacteristically high read noise relative to the other channels pre-irradiation, as well as post-irradiation. This is likely to be related to the test stand electrical interface, as opposed to radiation damage.

potential nonuniformities in the proton beam, we find it insightful to also view a histogram of the read noise on a channel-by-channel basis, as shown in Figure 4. After a large initial shift, read noise appears to have returned to pre-irradiation levels.

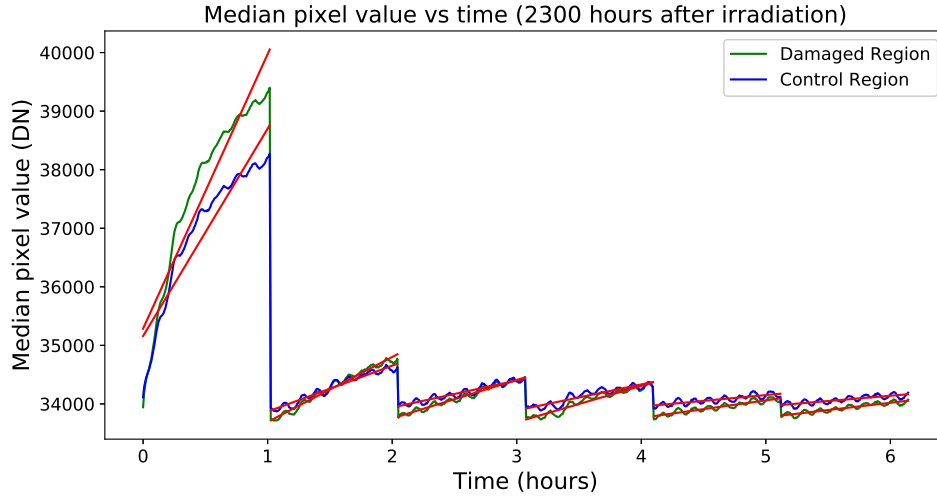
Figure 5: The dark current is compared between the damaged and control regions of the detector by performing a linear fit to the median pixel values of each image in a ramp. As expected, the dark current is higher in the damaged region. The small scale fluctuations are caused by the temperature control system oscillating around the set value of 150K. The changing slope from initial to final ramp indicates a long timescale charge-clearing effect as well. The dark currents cited in this paper are calculated once the slope has reached an equilibrium point after several hours.

We measured the dark current by performing non-destructive reads of the detector during a series of one-hour ramps. No X-ray source was on while the images were being collected, and ramps containing many images were taken so that the accumulated dark signal could be distinguished from the noise floor, as shown in Figure 5. We assume that dark current and read noise are constant during each ramp, and perform a linear fit to the median pixel values of each image to determine the dark current. Pixels that show signs of having interacted with a cosmic ray by exhibiting a sudden, large increase in signal are automatically flagged and removed from the analysis, as are the eight adjacent pixels surrounding them. Dark current is also analyzed for each individual pixel, demonstrated in Figure 6, and the results are histogrammed, as shown in Figure 7. After a large initial shift, the measured values of dark current appear to be returning to pre-irradiation levels as the detector anneals.

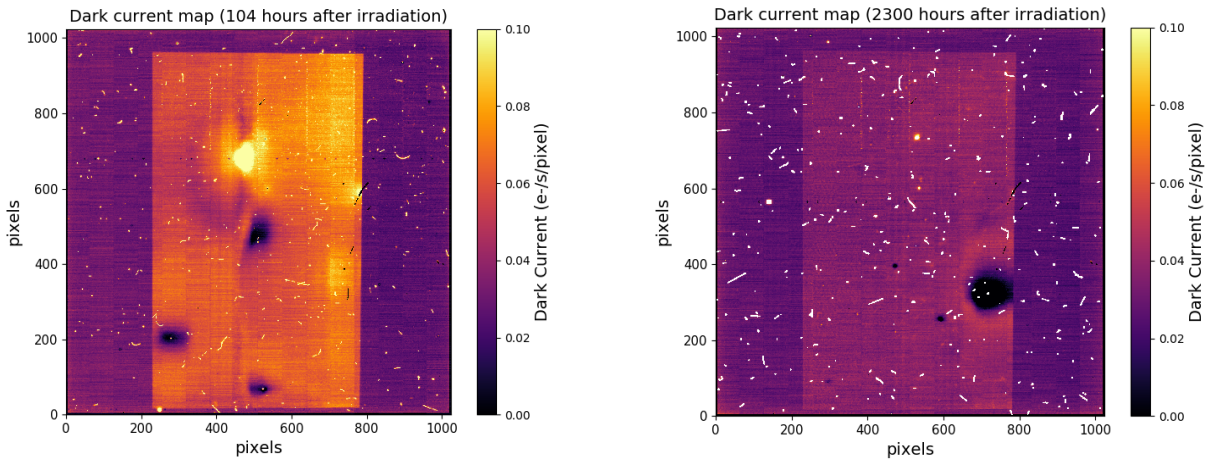
Figure 6: A map of the dark current across the detector during a one hour ramp, taken 104 hours (Left) and 2300 hours (Right) after irradiation. The damaged region can be seen in the middle, with the control regions on either side. Cosmic rays appear scattered over the image, and the activation events described in Section 3.4 appear as bright and dark spots.

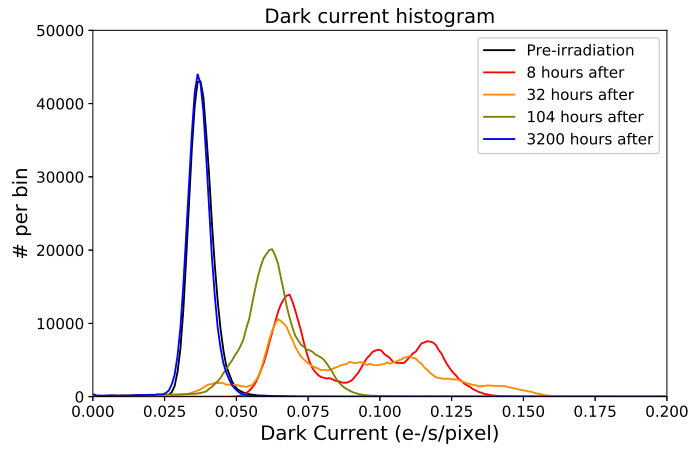
Figure 7: A dark current histogram of the damaged region is compared at multiple epochs after irradiation. As the detector anneals, the dark current appears to return to pre-irradiation levels and the distribution recovers its Gaussian profile. The strong tails are produced by the activation events discussed in Section 3.4.

the large number of affected pixels, histograms of the dark current contain significant non-Gaussian features, as demonstrated by Figure 7.

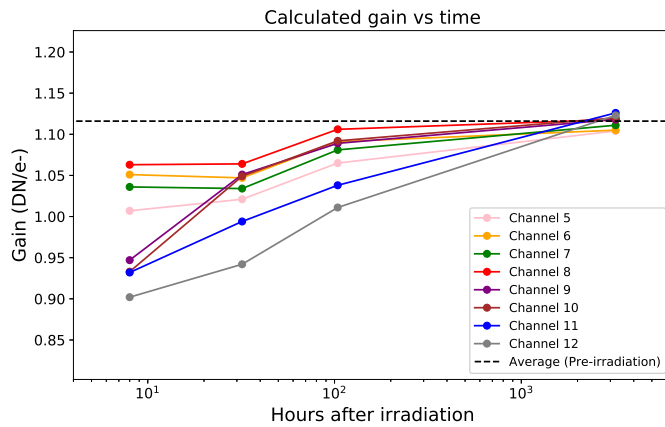
Figure 8: A plot of the calculated gain vs time at several multiple epochs after irradiation. After a large initial shift, gain appears to have returned to a nominal level.

We measured the detector gain and energy resolution by utilizing a radioactive Iron-55 source mounted on a shutter system inside the vacuum chamber. After irradiation, a distinct shift in the DN value of the centroid peak was observed over the measurement period. It is uncertain whether this change represents an actual shift in the gain of the readout amplifiers in the ROIC, or a decrease in the number of electrons that are produced by each X-ray that are reaching the collection node. Interpreting this shift as an effective gain change, we plot the gain of each channel as a function of time in Figure 8. Following annealing during several months of storage, the energy resolution was not significantly degraded from its pre-irradiation value of 6.9% at 5.9keV.
