Healing Gradient Degradation in Nb₃Sn SRF Cavities Using a Recoating Method

Eric Viklund*
*Department of Materials Science and Engineering, Northwestern University and
Fermi National Accelerator Laboratory*

Sam Posen,† Brad M. Tennis, and Grigory Eremeev
Fermi National Accelerator Laboratory
(Dated: May 2, 2024)

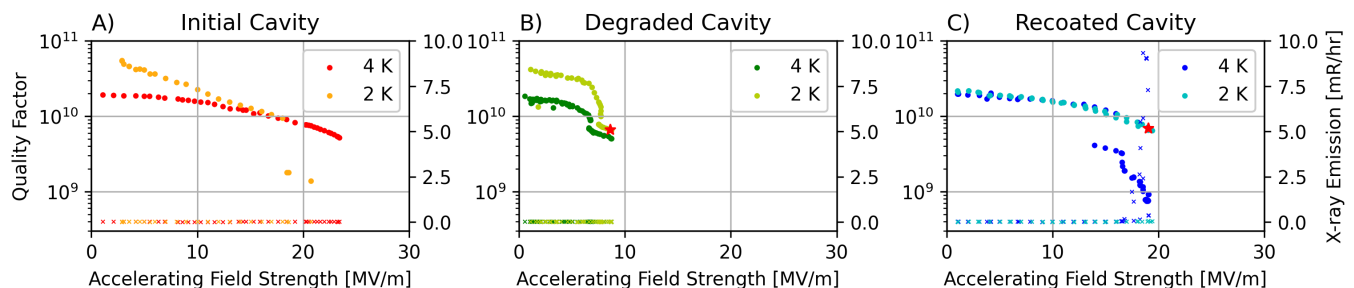
FIG. 1. The quality factor, indicated by dots, and X-ray emissions, indicated by x, versus the accelerating gradient of the cavity after the initial coating (A), after the degradation (B), and after the recoating (C). The quality factor and accelerating gradient of the T-maps in figure 2 are indicated by a red star.

After initially coating the cavity it achieves a peak accelerating field of $24\,MV\,m^{-1}$ and a maximum Q of 2×10^{10} at $4\,K$. The peak accelerating gradient after degradation is $8\,MV\,m^{-1}$ and a maximum Q of 1×10^{10} at $4\,K$. The cavity displays a decrease in the quality factor at around $6\,MV\,m^{-1}$ before a quench. A similar decrease in the quality factor is observed for other cavities affected by performance degradation[4, 5] and in Nb_3Sn cavities treated with centrifugal barrel polishing[18]. Temperature mapping is displayed in figure 2 and is utilized to locate the quench source responsible for the performance degradation. A single hot spot on the equator of the cavity is present. Visual inspection of the cavity did not display visible defects near the quench location.

To heal the cracks causing the performance degradation, we apply a recoating procedure. During this recoating procedure, the cavity was heated to $1000\,°C$ and exposed to Sn vapor for $1\,h$. Sn vapor was provided by $0.85\,g$ of Sn heated to $1250\,°C$. The reasoning behind these parameters is that only a small amount of Sn is necessary to fill the microscopic cracks in the film. Applying too much Sn causes the film to become too thick and negatively impacts the surface roughness of the film. During the coating process only a small fraction of the Sn evaporated leaving behind a large amount of the initial Sn still in the crucible.

After the recoating procedure is applied the cavity's performance increases. The peak accelerating gradient increases to $19\,MV\,m^{-1}$ and the quality factor is 1×10^{10} at $4\,K$. Temperature mapping of the cavity after recoating demonstrates that the initial hot spot is healed with no detectable heating from that area. This indicates that the defect causing the performance degradation is repaired by recoating. At higher gradients another small hotspot appears in a new location close to the equator. Additionally, there is also a larger hot spot closer to the iris, which appears just before the cavity quench. This additional hotspot is accompanied by a large increase in x-ray emissions, figure 1, which may indicate that heating is caused by multipacting. Higher accelerating gradients are not attainable even after $5\,h$ of processing. The cavity did not display any signs of multipacting during the $2\,K$ measurement.

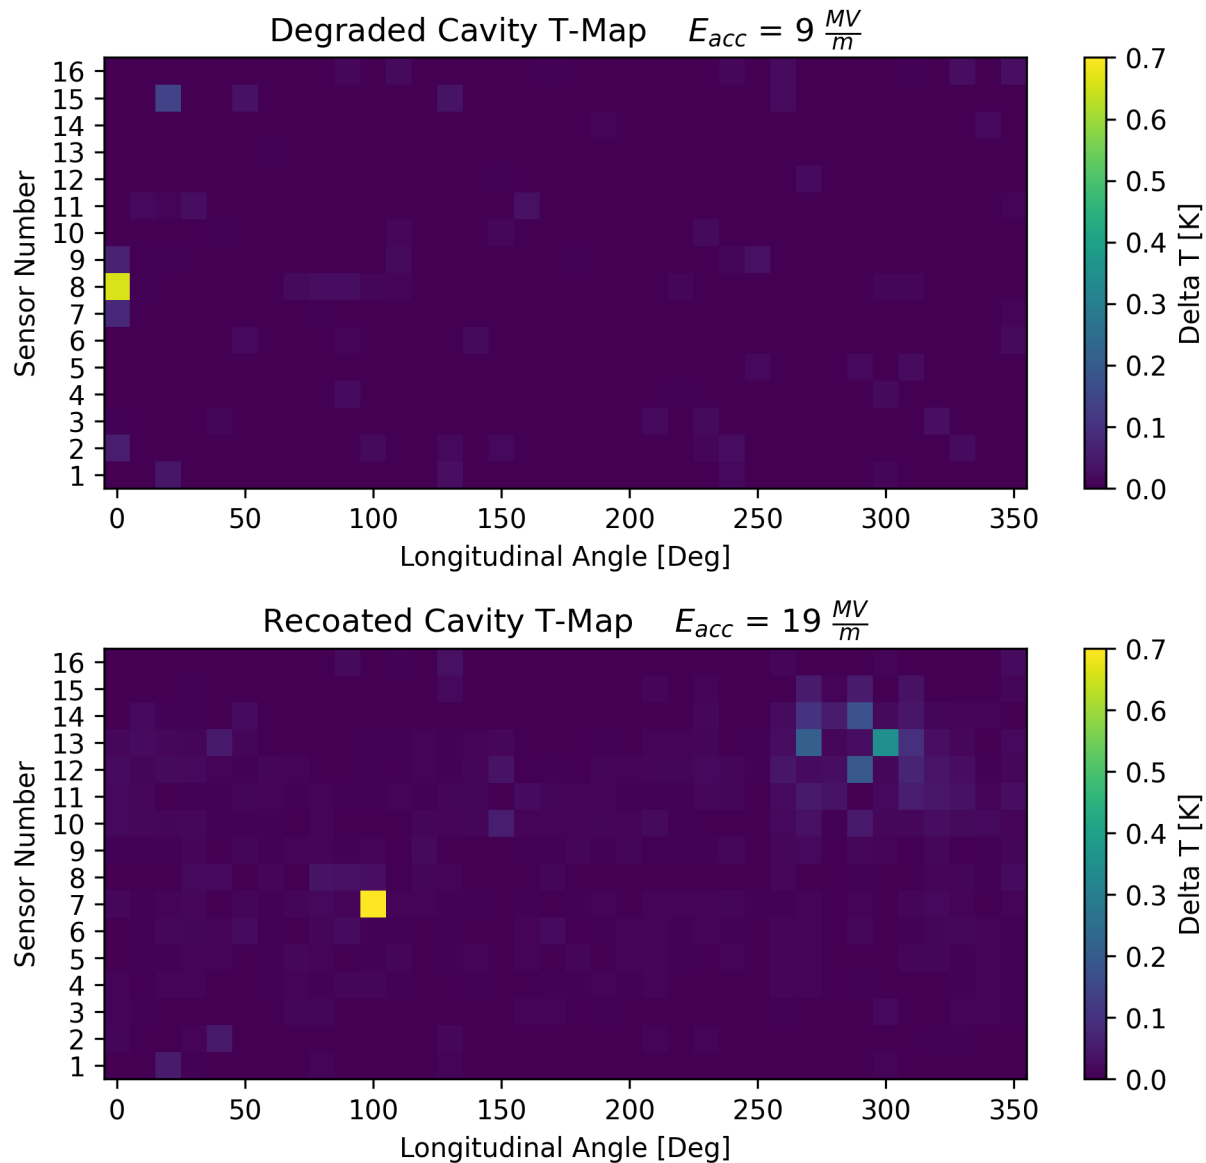
FIG. 2. Temperature maps of a cavity's surface prior to quench as measured before (top) and after (bottom) the recoating is applied. The temperature of the hot spot near the equator of the recoated cavity exceeds the maximum value of the color bar and achieves a maximum value at $3\,\mathrm{K}$

Using a low temperature $(1000\,^\circ\mathrm{C})$, short duration $(1\,\mathrm{h})$ Sn recoating process, we are able to heal a degraded Nb_3Sn cavity that suffered damage during transportation. The recoating process improved the maximum gradient of the cavity from $8\,\mathrm{MV\,m^{-1}}$ to $19\,\mathrm{MV\,m^{-1}}$, which is close to the initial performance of the cavity of $24\,\mathrm{MV\,m^{-1}}$. Temperature mapping measurements of the cavity demonstrate that a single hot spot on the equator of the cavity was responsible for the performance degradation. After the recoating process this defect becomes healed leading to

less heating and a higher maximum electric field gradient. Ultimately, the performance is limited by a second hot spot.

substrate through the crack. If the crack penetrates the Nb_3Sn film, Sn can diffuse into the crack and react with the Nb substrate creating a region of new Nb_3Sn. This new region acts as a bridge for electrical currents to flow through the film and prevents current from flowing through the Nb substrate, which has a higher resistivity than does Nb_3Sn. This is an example of self healing [17].
