Operation of PAL-XFEL LLRF

J. Hu[†], J. Hong, K.H. Kim, S. Jung, D. Na, Y. J. Park, S.-H. Kim, S. Park, C.-K. Min, H.-S. Kang, H.-S. Lee, PAL, POSTECH, Pohang, South Korea

Abstract

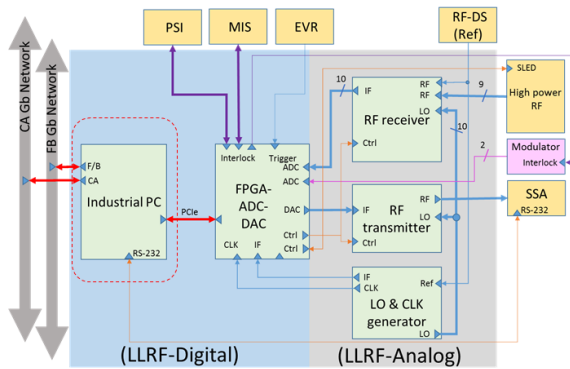
Figure 5: LLRF structure. PPC is emphasized by dotted line.

The symptoms were disconnection of EPICS channel access, PPC freezing and PPC shutdown. The frequency of occurrence was about once in a few months and the occurred stations were random. The first aid applied was re-booting of the problematic PPCs, which usually recovered the PPCs. In case of irrecoverable LLRF sets the replacement of the LLRF sets with a spare sets.

With some investigation it was identified that the problems came from the degradation of power supplies of the PPCs. To see why the PSs were degraded, a simple current analysis was done as shown in figure 6. It was judged from the analysis that the occasional use of the power supplies higher than the recommended value (3.5A, 70% of the indicated specification) caused the reduction of the lifetime of the power supplies.

All the PPCs' PSs were upgraded Feb. 2019. After the upgrade, the problematic sets were recovered but some sets which had not shown the problems newly showed the symptoms (table 4). Therefore, we will be conducting further investigation.

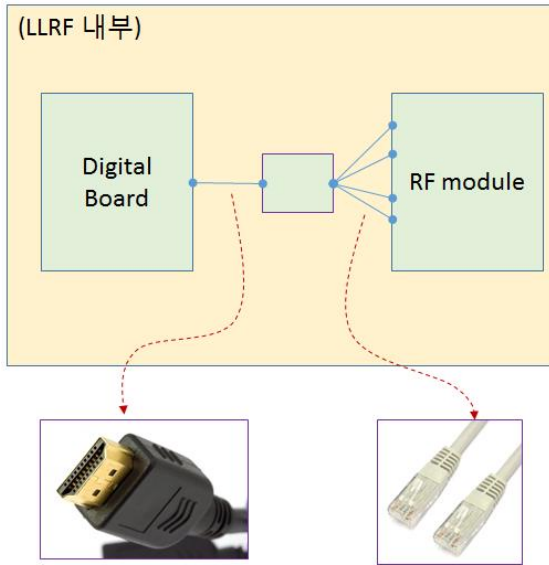
Figure 8: Block diagram illustrating the connections between the digital board and the RF module of PAL-XFEL LLRF.

Symptoms that seem to be irrelevant were due to incomplete connection of connectors. Figure 7 shows the internal picture of a PAL-XFEL LLRF unit. As one can see from the figure, many RJ45 connectors and 2 HDMI connectors are used.

Figure 8 shows a block diagram of the connection of cables between a digital board and a RF module illustratively. This configuration enables the internal connection simple, very efficient and high-speed operation but not perfect. Through reconnection of the cables, all the sets were recovered. We will search for better solutions such as new venders or new types of connections.
