Setups for eliminating static charge of the ATLAS18 strip sensors

KEYWORDS: Silicon strip sensors, Electrostatic charge, Recovery techniques

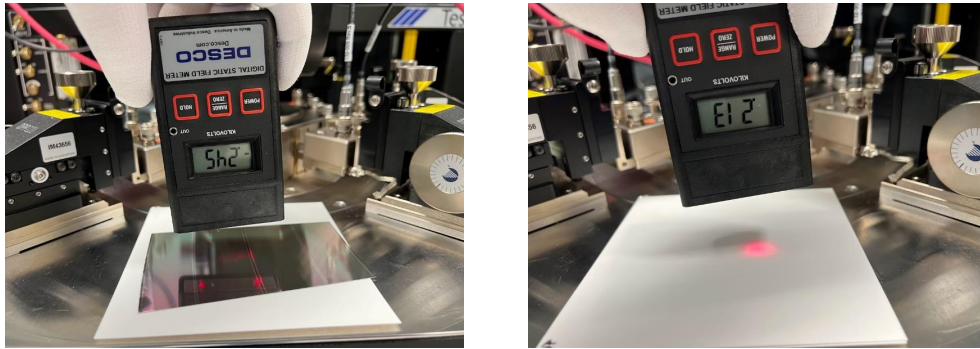
Figure 1. Measurement of static charge on sensors and sheets with an electrostatic fieldmeter in FZU.

The QC sites have measured a significant electrostatic charge present on the surface of a considerable number of sensors and their plastic sheets, see Figure 1 for measurement in FZU. The plastic sheets are used to provide mechanical protection for the sensors within paper envelopes. The sensors themselves have a negative static charge, while the plastic sheets carry a positive charge. In both cases, the electrostatic charge can reach the values of several hundreds of volts per inch, see Figure 2.
