# **An Endangered National Heritage Site - The Cape Observatory**

*IS Glass (SAAO)*

The SAAO Cape Town campus was declared a National Heritage Site in December 2018, just short of its 200<sup>th</sup> anniversary, but is now in a run-down condition. As the former Royal Observatory, it is the oldest scientific institution in South Africa and probably in all Africa. It has a fascinating and well-documented history and surely deserves better. For many years maintenance has been neglected and many of the old telescopes and buildings are in a poor state. They are beginning to show signs of serious decay. Some examples are given.

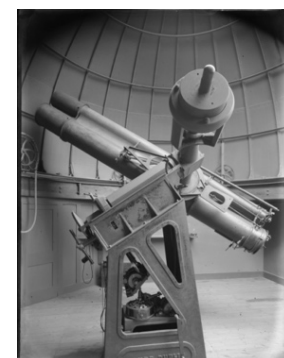
*Fig 1 (a,b): The Astrographic dome is currently used as a junk room, containing many boxes of unused equipment. These are gathering dust and dirt.*

- Astrographic: The building should be cleaned up and the original telescopes replaced on the mount. The screws and fittings are probably all still there.

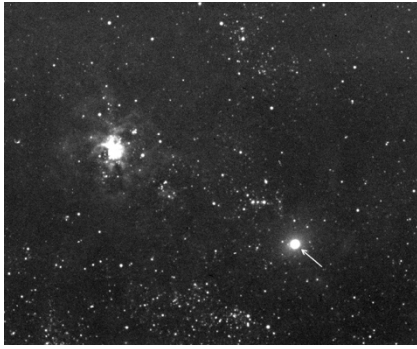
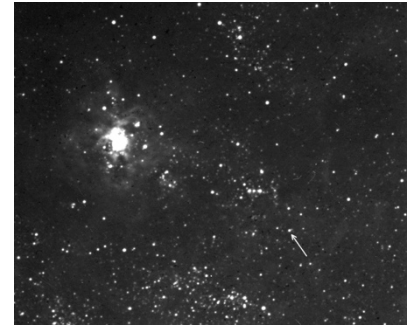
*Figs 3 and 4: Plates of the 30 Dor Region showing SN 1987A when brightest and Right: the same region showing the precursor of the supernova, Sk -69° 202. Both were taken with the Astrographic (thanks to the late Mr J. Churms).*

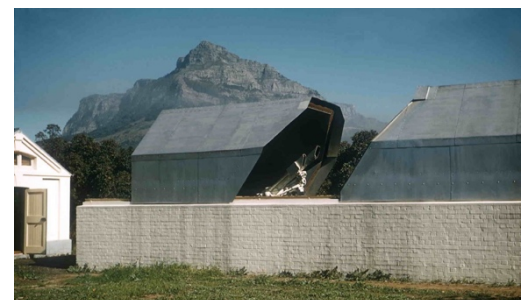
*Fig 6: The Lyot Coronagraph In better days. This telescope followed the Sun automatically from dawn to sunset. The  $H\alpha$  filter was thermostatically controlled.*

- Lyot: Clean up.
- 6-inch: replace/repair roof
- 1849 dome/Photo heliograph: Repair woodwork.
- All: clean regularly. Paint as necessary.

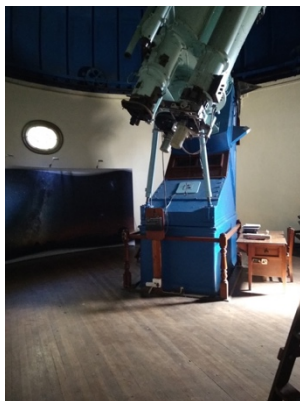
*Fig 7: This 24-inch telescope was the largest refractor in the Southern Hemisphere when constructed. It was mainly used for spectroscopy until 1926 and afterwards for stellar parallaxes until ca 1980. It remains usable.*

Its rising floor needs to be maintained periodically and such occasional attention as it has received in recent years is thanks to the efforts of Wim Filmalter, a retired engineer who is a member of the Astronomical Society of Southern Africa. He has made some recommendations on improving the performance of the hydraulic system whose seals currently tend to develop leakage problems.

This telescope is frequently used on open nights and the rising floor is something that people are usually surprised by and remember for many years afterwards. The telescope itself and its building are also showing signs of age and neglect.

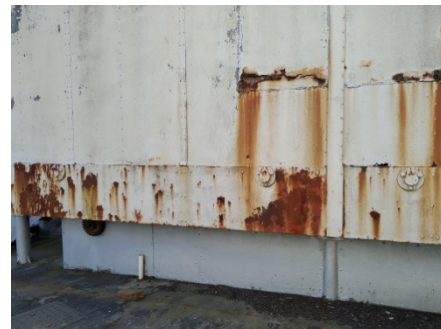
The outer buildings of the installation – the collimator houses and mark houses – are insecure and filthy, unprotected from weather, and their deep shafts (see Fig. 15) are easily accessible by children and extremely dangerous. Their keys are probably lost.

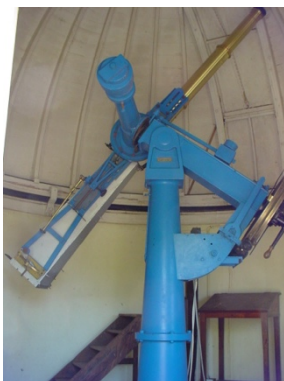
*Fig 24: This telescope is currently on a Troughton & Simms mount.*

The telescope is in working condition for solar spot viewing though not kept clean. The woodwork of the dome is in need of repair in various places. The paint is peeling. The telescope itself was cleaned and overhauled in 2009.
