# Defect detection in III-V multijunction solar cells using reverse-bias stress tests

## Abstract:

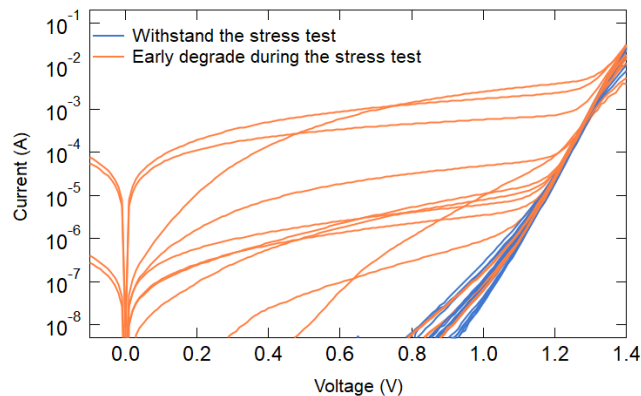
Starting with the previous characterisation of the devices, in Fig. 3 the initial forward dark I-V curves of the devices submitted to the stress test is depicted. The blue curves correspond to the devices that withstand the stress test applied later on without degrading, and the orange curves correspond to the devices that do not pass the reverse bias stress test, and therefore, catastrophically fail during it. As expected, all devices that initially have a low shunt resistance, and therefore, a high current at low values of voltage, do not pass the stress test. However, focusing on the devices that have a good initial forward I-V curve, three of them fail at a reverse voltage below the breakdown voltage. This confirms the findings of previous work: a forward dark I-V curve measurement is not enough to predict the failure of the devices during the reverse bias stress test.

Fig. 3. Initial forward dark I-V curves of the GaInP devices submitted later on to the stress test.

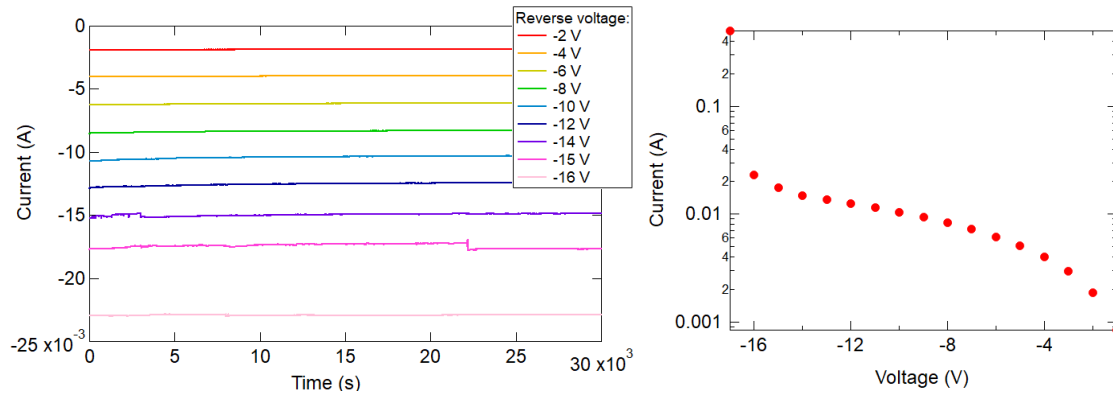
While the devices are subjected to a reverse voltage for 30 seconds, current data is taken every 3 ms, so that it is possible to monitor whether the device has suffered any damage, even before measuring its forward dark I-V curve. As can be seen in Fig. 4, the current remains almost constant around an average value which increases with the applied voltage. This increase is more or less pronounced depending on the initial characteristics (shunting) of the device. For higher values of current, and as we approach the value at which the device fails, more abrupt variations in the current over time can be seen. These variations are present especially in devices with a

poor initial forward dark I-V curve, and may indicate the existence of microplasmas [2]. Furthermore, at the voltage at which the failure occurs, the current increases abruptly to a value of 0.5 A (see graph on the right at Fig. 4), which is the value established as the protection or limit current, indicating the presence of a short circuit or a considerable decrease in the shunt resistance.

Fig. 4. Variation of the current with the time and the reverse voltage applied during the reverse bias stress test (graph on the left). Representation of the average value of the current measured for 30 seconds versus the reverse bias voltage applied (graph on the right).

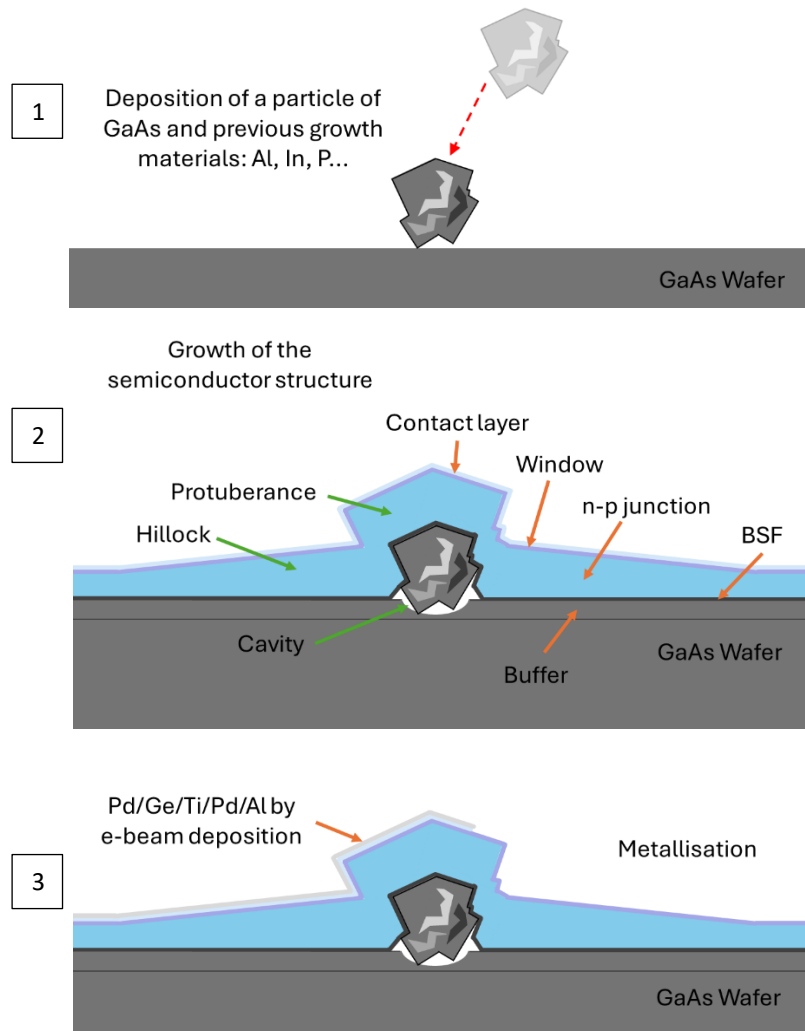
The morphology of the defects shown in Fig. 10 suggest the presence of leakage paths. The particle itself has p- and n-type layers, since it comes from previous depositions of materials with some doping. Also, during the growth of the semiconductor structure, as the upper layers adapt to the particle shape, areas with high mechanical stress and dislocations are formed. In addition, due to the non-uniformity of the GaInP layer thickness, there may be areas where the n-p junction is closer to the metal, and therefore more likely to cause a shunt as the applied reverse voltage increases.

Under reverse bias, most of the current will flow through the leakage paths created at the hillock. Note that the total resistance of these leakage paths is lower if there exist a metal region nearby or over the defect, facilitating the achievement of high leakage currents. High current densities

lead to high power dissipation, and therefore increase of the temperature in small areas, as studied in silicon solar cells [13]. The higher the reverse voltage applied, the higher the current densities, power dissipated and temperature at the defect. Moreover, this thermal runaway process can lead to electromigration of the metal [14], forming a shunt large enough to cause the short-circuit of the device and the appearance of burnt and melted regions in the metal deposited on the defect responsible for the failure.

Fig. 11. Diagram explaining the process of defect formation. (1) Particle detached from the reactor chamber and deposited in the wafer. (2) Growth of the semiconductor structure and formation of the hillock, the bulge and cavities under the particle. (3) Metallisation.

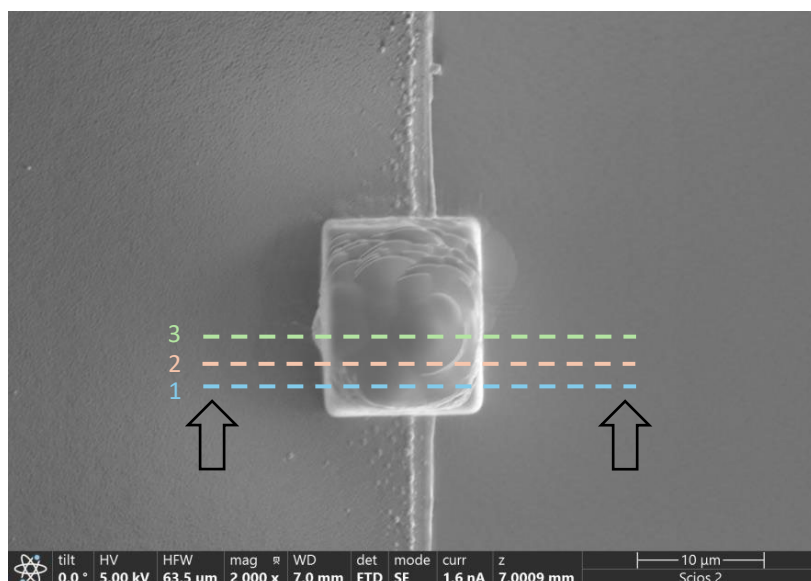
First, in Fig. 1 you can see a general top-view image of the analysed hillock growth defect. The defect is partially covered with metal (Pd/Ge/Ti/Pd/Al front metal grid). Then, in Fig. 2, the same defect is shown, but with platinum deposited to prevent the particle from detaching during the study.

Fig. 2. Same defect than in Fig. 1 but with platinum deposited.

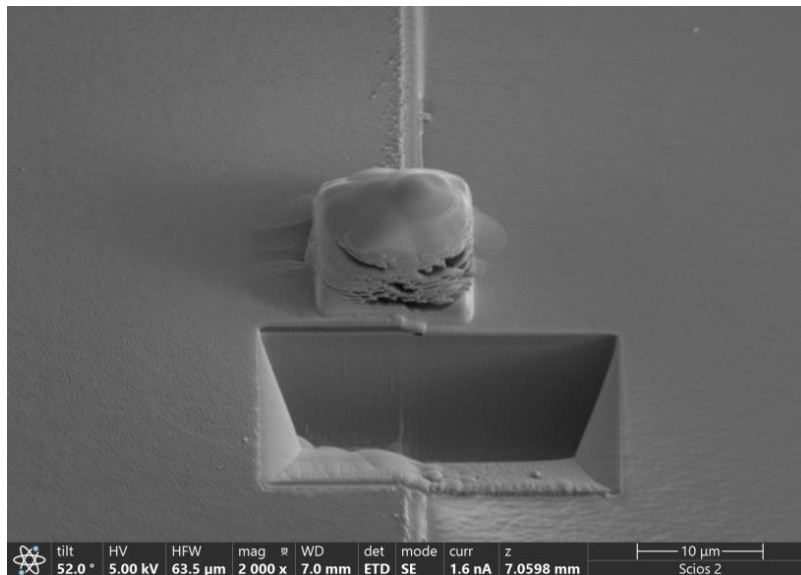
Focused ion beam (FIB) etch processing is then used to create trenches (as the one shown in Fig. 3) from the edge towards the centre of the defect, exposing the cross section of the structure. In Fig. 4, some resulting SEM cross-section images are included. To understand which part of the defect each image corresponds to, in Fig. 2, dashed lines corresponding to the approximate position of each cross-section image have been drawn. Arrows have also been included to understand from which side the defect is being viewed.

Fig. 3. Trench done by FIB.

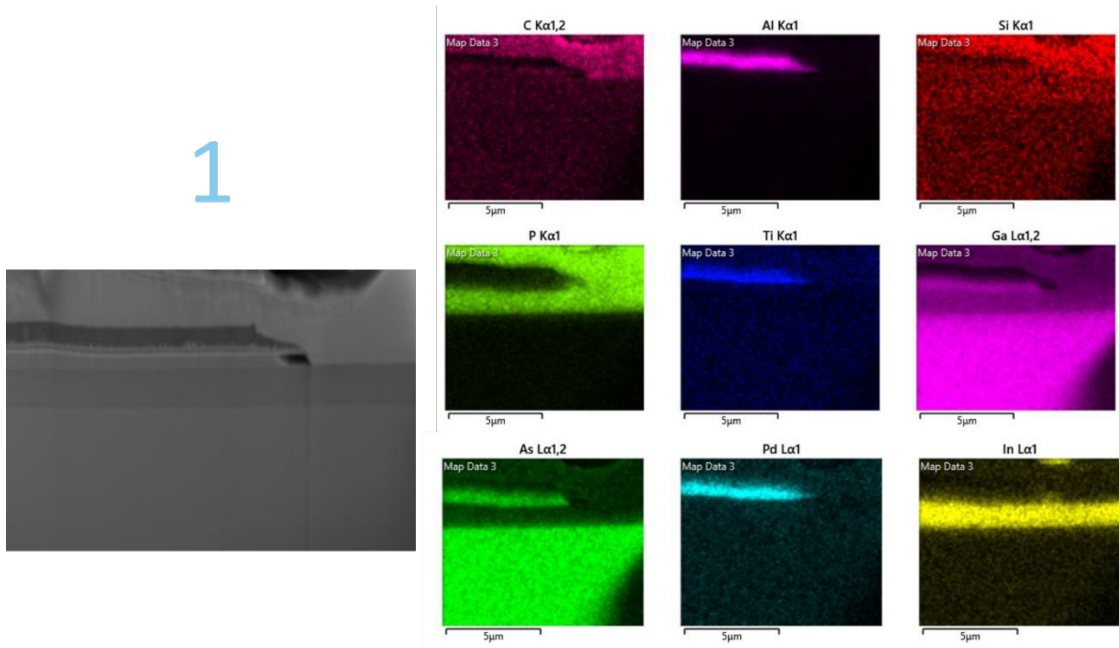
Fig. 5 shows how each layer is dominated by the corresponding materials of a GaInP mono-junction deposited on a GaAs substrate, with GaAs contact layer, AlGaInP BSF layer, AlInP window layer and Pd/Ge/Ti/Pd/Al front metal contact. The same materials can be detected in Fig. 6, as we have the same structure but following the shape of the defect.

Fig. 5. EDX maps with the composition of part of the structure of image 1 in Fig. 4.

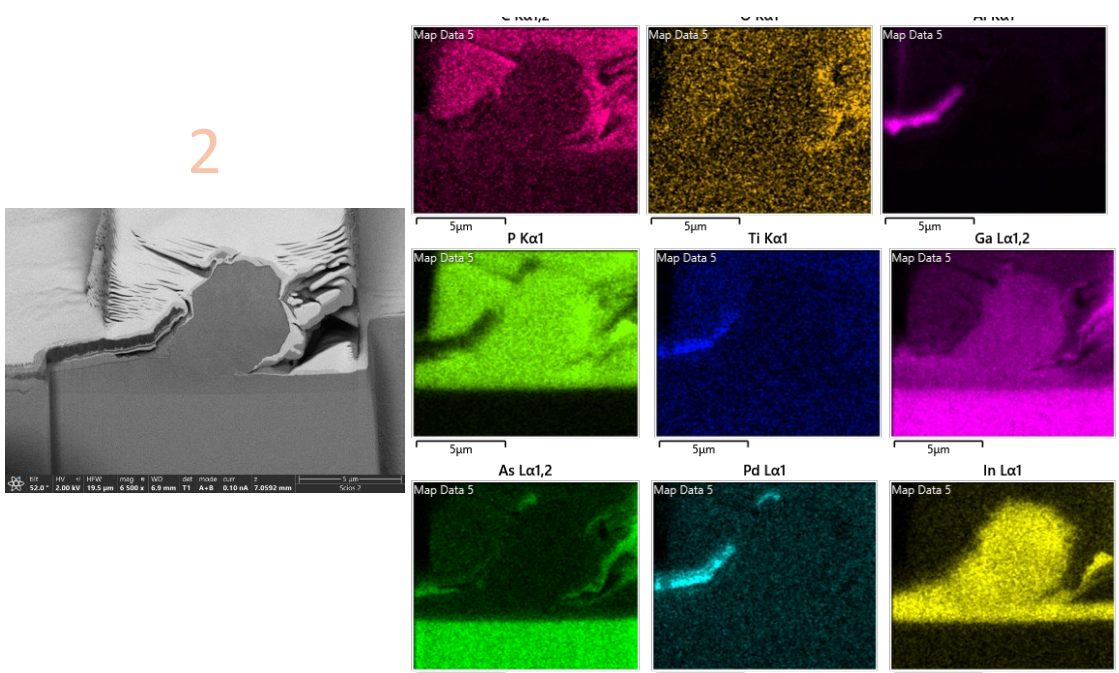
Fig. 6. EDX maps with the composition of part of the structure of image 2 in Fig. 4.

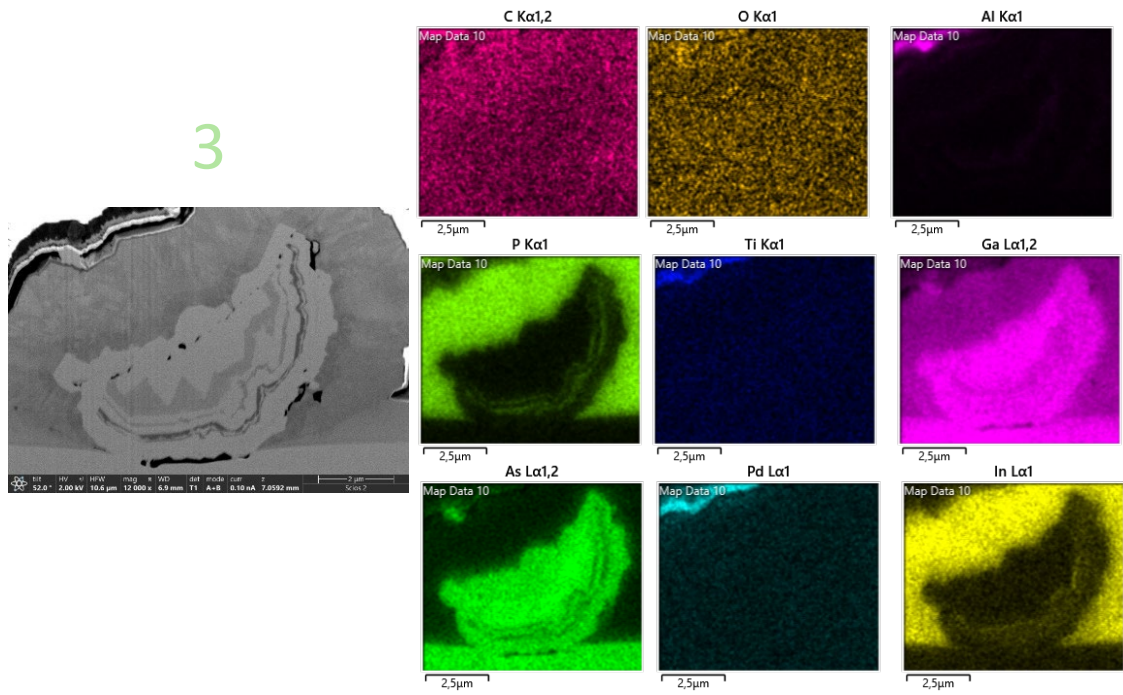
Finally, in Fig. 7, we can see that the particle causing the defect formation is composed mainly of gallium and arsenic. However, as can be seen in the SEM image, there are layers inside the particle of other materials, whose composition cannot be detected with EDX. That is why, new images are taken by zooming in on the particle, which are included in Fig. 8. As can be seen, the layers inside the particle present gallium, aluminium, phosphorus and indium signals. These materials correspond to the ones used in the GaInP, GaAs, AlGaInP and AlInP typical layers deposited during the growth of triple-junction solar cell structures in the reactor used.

Fig. 7. EDX maps with the composition of part of the structure of image 3 in Fig. 4.
