Irradiation of TiBe₁₂ and CrBe₁₂ with He⁺ ions and ex-situ transmission electron microscopy to investigate ion damage as a proxy for neutron irradiation damage in nuclear fusion

Jo Sharp^{1*}, Viacheslav Kuksenko², Ramil Gaisin³, Graeme Greaves¹, Jonathan Hinks¹, Pavel Vladimirov³, Stephen Donnelly¹

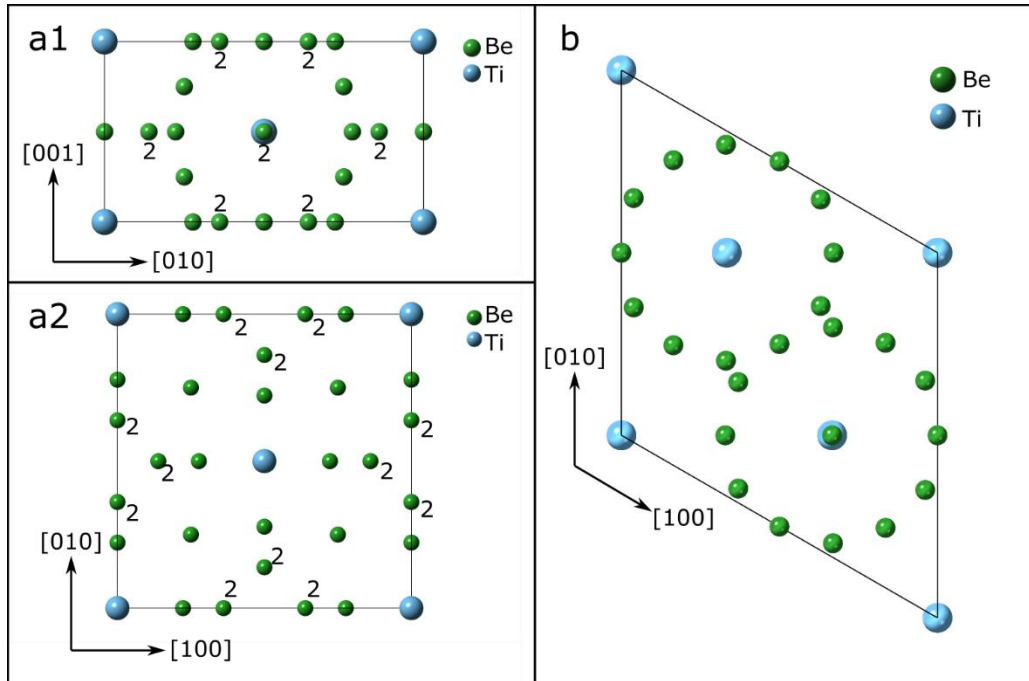
Figure 1 Structures of MBe_{12} and M_2Be_{17} structures, where green is Be and blue is M. Image (a1): MBe_{12} from [100] direction with Be2 type sites labelled. (a2): MBe_{12} structure from [001] with Be2 sites labelled. (b): M_2Be_{17} structure from [001].

A second phase, M_2Be_{17} , is also found in some systems, such as Ti-Be, but not others, such as Cr-Be. Its structure is monoclinic, with cell parameter c being close but not necessarily the same as a and b, and the non-orthogonal angle nominally 120° . The M_2Be_{17} structure is made by the addition of an extra (001) plane into the MBe_{12} structure, a shift of $\frac{1}{2} \langle 110 \rangle$, and some small shifts of Be sites to minimise stress. The crystallographic axes used to describe M_2Be_{17} are defined in a different orientation to those of MBe_{12} ; [001] of MBe_{12} is in the (001) plane of M_2Be_{17} perpendicular to [010] [7]. The structure of M_2Be_{17} thus has somewhat lower symmetry. Figure 1 illustrates the two structures: a1 and a2 are views of MBe_{12} viewed down [100] and [001] respectively; b is M_2Be_{17} viewed down the [001] axis.

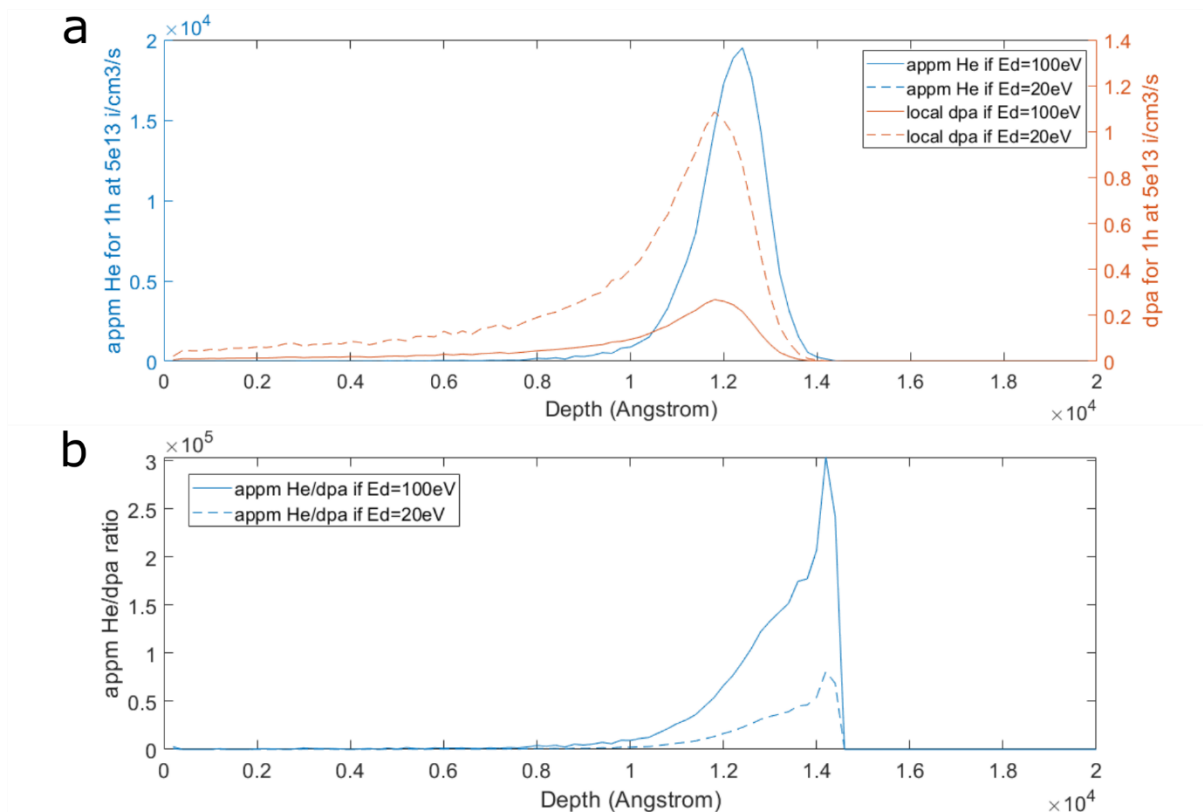
Figure 2 Damage plots calculated using SRIM. (a) appm He (left axis) and dpa (right axis) for approximately the time and flux used; the appm He plot is the same for both displacement energies. (b) Resulting ratios of (appm He)/(dpa)

The thickness of 2μm and He energy of 300kV were chosen to place the predicted peak ion implantation depth approximately halfway through the beryllide slab in order to lessen surface effects, modelled using the *Stopping and Range of Ions in Matter* (SRIM) Monte Carlo simulation code [13]. The “quick” method in SRIM was used according to Stoller’s recommendation [14]; the displacement energy E_d of these materials is not yet known, so SRIM calculations were carried out using E_d of 20eV and 100eV, assuming the unknown accurate value is somewhere within that range, and both profiles were contained suitably within 2μm thickness. Resulting plots of damage in displacements per atom (dpa), ppm He and the ratio between them are given in Figure 2. The appm He curve is identical for both range-end E_d values.

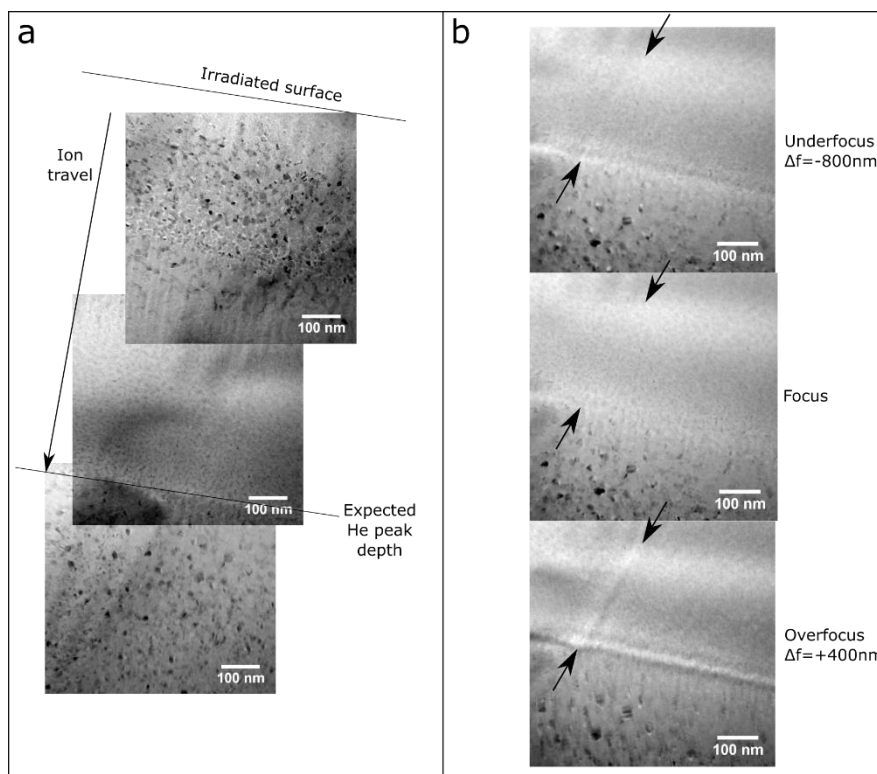
Figure 3 (a) Montage of bright field images through TiBe₁₂ sample irradiated at 387°C. Irradiated surface and depth of peak implanted He concentration (calculated using SRIM) are marked. (b) A selection of the images either side of focus used to identify bubbles. A planar fault is indicated by arrows.

A low magnification montage is shown in Figure 3a; the material further into the cross section than the He concentration peak is speckled, while the irradiated material above the He concentration peak is smooth. There is also some speckling near the entrance surface where less He is expected to stop. A through-focus set of images from the He concentration peak depth is shown in Figure 3b; a range of defocus values and magnifications was used to look for Fresnel fringes that would indicate bubbles, but none are seen – either there are none or they are sub-nm and too small to see in the available magnification range.

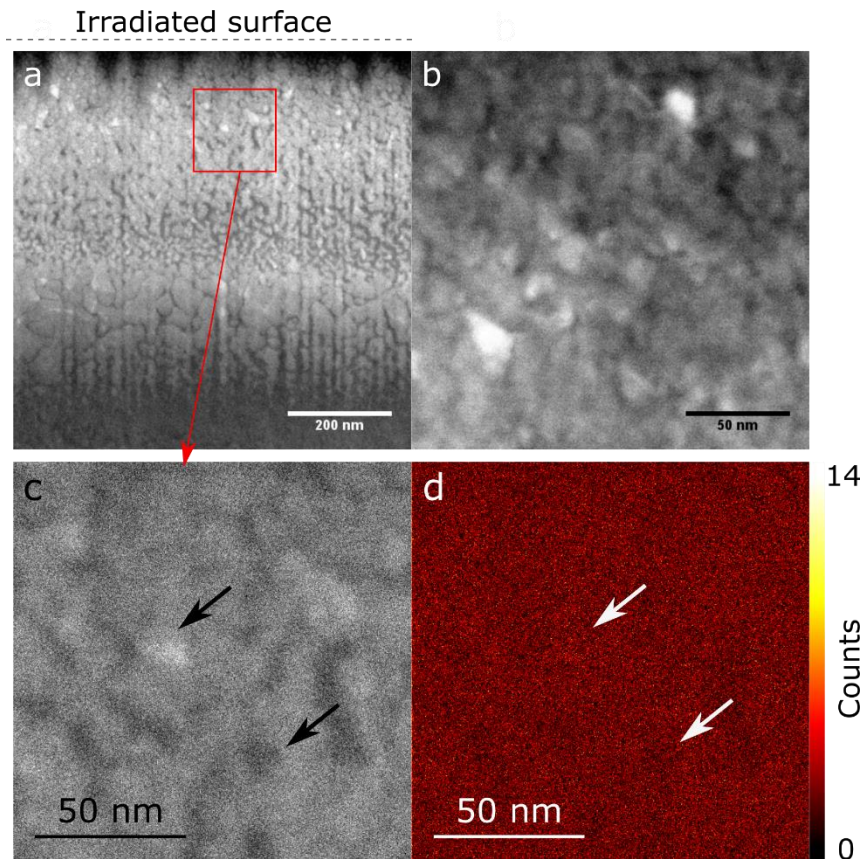
Figure 4 HAADF-STEM images from TiBe_{12} sample irradiated at 387°C . (a) Speckled contrast under the irradiated surface – annotation shows the approximate position of the irradiated surface. (b) small-grained unirradiated region beneath the He zone. (c) higher magnification HAADF-STEM image of the region in the red box in (a). (d) Cu EDS map of the region in (c) showing a slight correlation of Cu with the speckling, for example the light and dark patches marked by arrows.

High-angle annular dark field scanning TEM (HAADF-STEM) images are shown in Figure 4. Image (a) shows the speckled region below the irradiated surface, with a region expanded in image (c). Image (b) shows at higher magnification the unirradiated speckled region below the He concentration peak. The only element whose map corresponds to the speckles in the HAADF STEM image is a slight

correlation in the Cu map, shown in Figure 4d. This implies adherence of Cu resputtered from the grid during FIB.

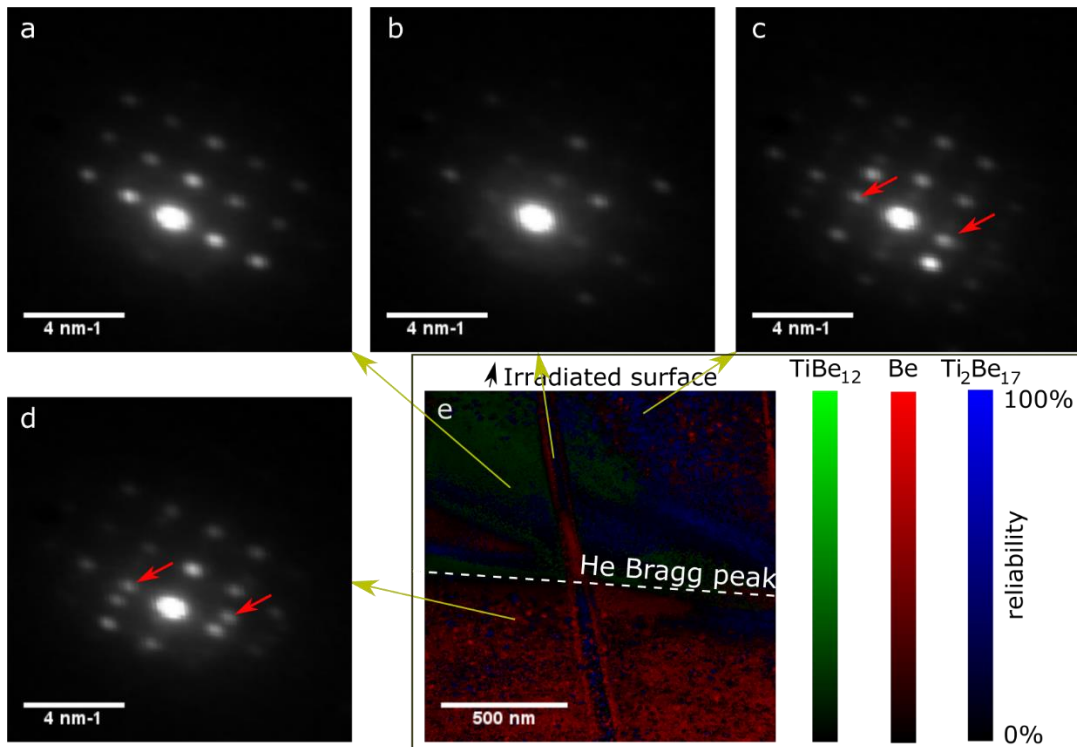
Figure 5 Precession diffraction phase mapping from around a fault in the TiBe_{12} sample irradiated at 387°C. (a) Pattern from non-speckled area indexed as TiBe_{12} ; base [001] pattern. (b) Pattern from planar fault, indexed as $\text{Ti}_2\text{Be}_{17}$; this is the base TiBe_{12} pattern with some spots missing. (c) Pattern from speckled area near irradiated surface, TiBe_{12} [001] base pattern with Be pattern superimposed. (d) Pattern from speckled area in unirradiated material downstream from the He concentration peak, also the TiBe_{12} [001] base pattern combined with Be pattern. (e) Precession phase map indexed by Nanomegas software. The rotation of the diffraction patterns with respect to the image is not calibrated in this figure.

In order to find out whether the material under the redeposition is single-phase TiBe_{12} and whether it was single-grained or polycrystalline, precession diffraction mapping was employed, giving the results in Figure 5. Selected area diffraction patterns match the previously expected structure of TiBe_{12} , body centred tetragonal. Traditional selected area diffraction using a selected area aperture identifies this grain to be near the [001] zone axis, as do the nanodiffraction patterns from the non-speckled part of the sample such as that in Figure 5a; during original He irradiation, the He ion beam would have been near to $[\bar{1}\bar{1}0]$. The speckled unirradiated region is indexed as Be by the ASTAR software; diffraction patterns from this region such as that shown in Figure 5d, however, contain the same TiBe_{12} [001] grain diffraction pattern as in the smooth areas, with additional diffraction spots of stronger intensity from the redeposited phase (arrowed red in 5d and 5c). This indicates that the TiBe_{12} under the redeposition is a single grain. This overlapping pattern is only a few spots, so the indexing has a lower certainty; it may have been mis-indexed as Be and the redeposition may actually be TiBe_{12} , and the Cu identified by EDS. This is also the case for the speckled region at the top, shown in diffraction pattern Figure 5c. Diffraction pattern (b) is referred to in the next subsection.

This planar fault is also shown in the precession diffraction map of Figure 5. There appears to be a band of $\text{Ti}_2\text{Be}_{17}$ structure along the planar fault running vertically down the centre of the precession phase map in Figure 5e (coloured blue), similar to the planar defects found by Banerjee et. al. [7] despite being on a different habit plane. A diffraction pattern from the fault is shown in Figure 5b, which has the same spot positions as the base TiBe_{12} [001] pattern but with different patterns of spot intensity. This could be a mis-index due to the intensity distribution, or this could genuinely be $\text{Ti}_2\text{Be}_{17}$ with a fully coherent interface (i.e. plane spacings in common) in an orientation relationship with the surrounding TiBe_{12} . There also appears to be an area of $\text{Ti}_2\text{Be}_{17}$ in the top right of precession phase map Figure 5e; this region is bent or tilted off zone and the diffraction pattern (not shown) only has a few spots, so this region is probably bent TiBe_{12} that has been mis-indexed due to a sparse diffraction pattern.

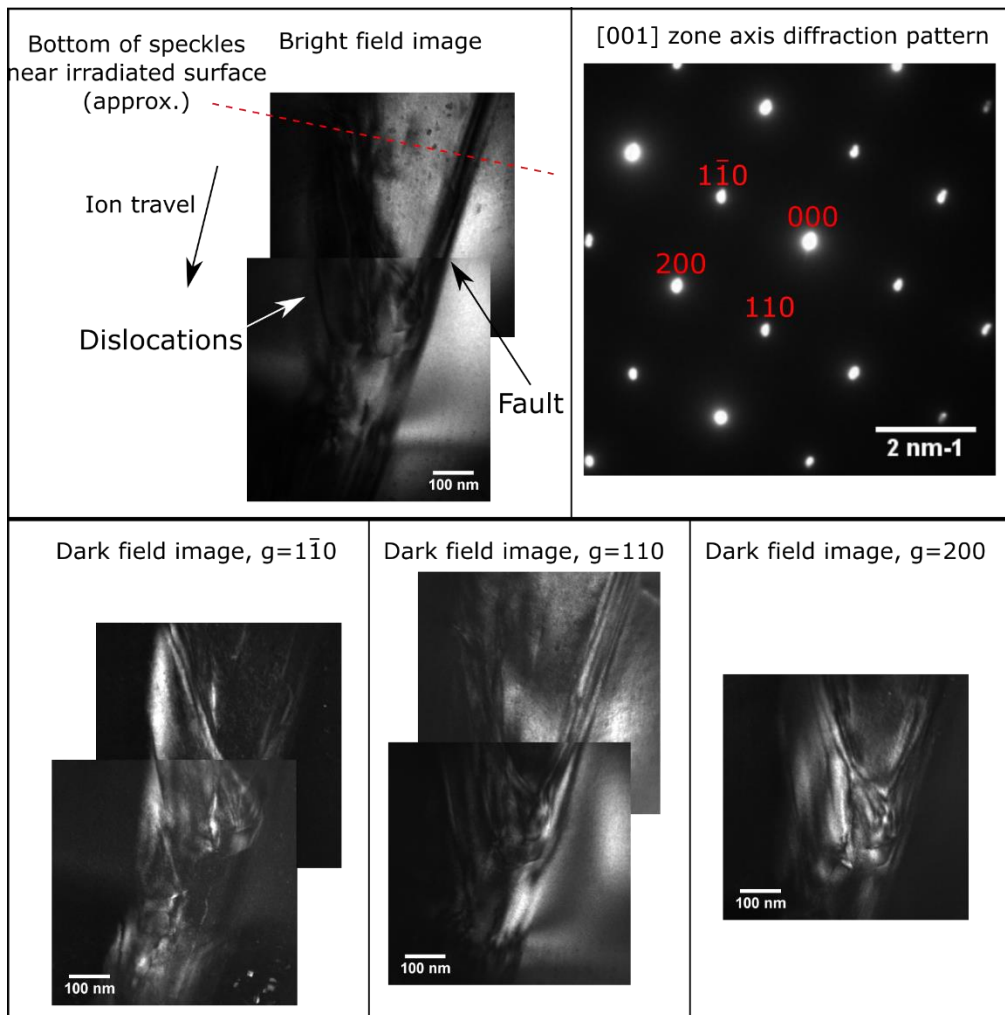
Figure 6 A planar fault in the 387°C irradiated TiBe_{12} sample taken using BF and different DF spots. The diffraction pattern is rotationally aligned with respect to the images. The orientation of the sample in these images is the same as Figure 3 with the original irradiated surface towards the top of the page.

Conventional TEM dark field images of the planar fault found in Figure 3b are shown in Figure 6. The fault lies close to the $(1\bar{1}0)$ habit plane; this is not the same habit plane as the regularly spaced faults reported by Banerjee et. al., which were on the (001) plane [7] with that habit plane critical to the structural relation between TiBe_{12} and $\text{Ti}_2\text{Be}_{17}$. The planar fault shown in Figure 6 is therefore not of the variety seen in [7]. The diffraction patterns either side of the fault in Figure 6 are identically aligned, so this fault is also not a grain boundary, but some other kind of planar defect. Long curved dislocations can be seen associated with the fault near the He concentration peak depth, which are strongly visible in the $g = 1\bar{1}0$ and $g = 200$ dark field images of Figure 6.

- In the 387°C sample RLB1 only one fault is imaged, running top to bottom in Figure 6 and in the precession map of Figure 5. This is weak in the $g = 1\bar{1}0$ dark field image, strong in the 110 image, weak in the 200 image, or in the notation of Table 2, x v x; none of the possible displacement vectors in the 387°C RLB1 row match this, so according to the diffraction data, this fault does not fit either of the two fault types found by Banerjee et. al. [7].

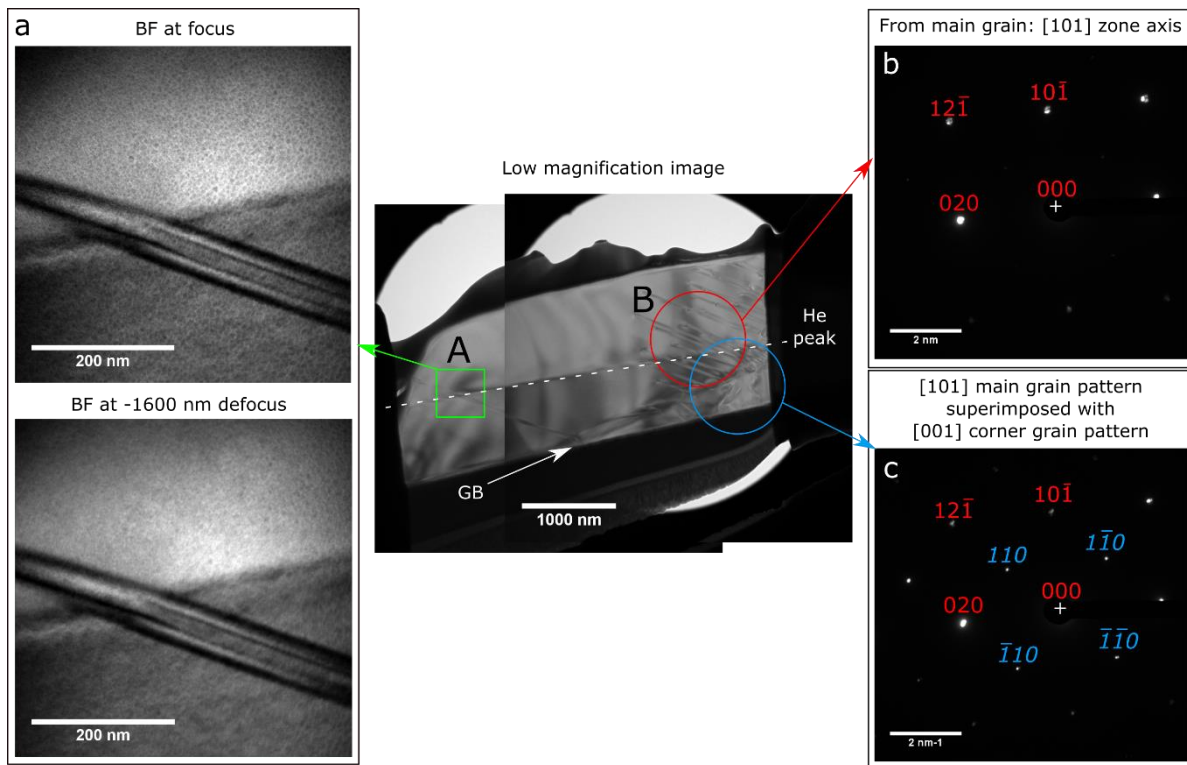
Figure 7 Low magnification bright field image montage of the 480°C irradiated TiBe₁₂ section. The lone fault that crosses the He zone is enlarged on the left at focus and -1600nm defocus. The diffraction patterns on the right were taken using selected area apertures placed at the locations circled on the image; the main grain's spots are indexed in red and normal text, the corner grain's spots are indexed in blue and italic.

A bright field low magnification montage is shown in Figure 7. The sample is on the [001] zone axis (Figure 7b) and the montage shows an isolated fault at one side of the sample (A) and multiple parallel faults at the other side (B). Images at a range of defocus values and magnifications were taken at the area where the isolated fault A intersects the He concentration peak; no bubbles are seen, though some contrast is observed from surface Cu contamination (identified by EDS mapping). The set of parallel faults B crosses a grain boundary between the larger grain that makes up most of the sample and a grain which is captured at one corner of the sample. These two grains have an orientation relationship such that zone axis [101] of the main grain is parallel to zone axis [001] of the corner grain (Figure 7c).

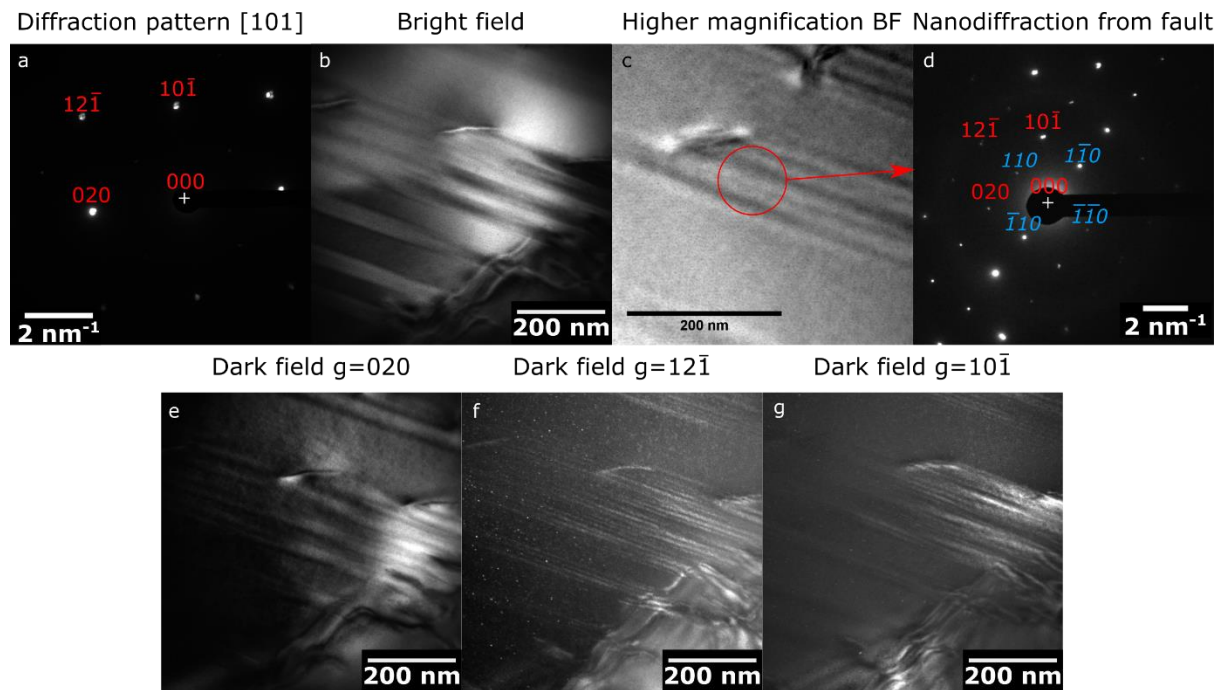
Figure 8 Image set from heavily faulted area in 480°C irradiated TiBe_{12} sample. (a) Diffraction pattern from main grain on [101] zone axis. (b) Bright field image of faults. (c) Higher magnification image of faults (actual location just out of image b to the left). (d) Nanodiffraction pattern from faults at point indicated in (c) – on the fault, the [001] zone axis is also present. (e-g) Dark field images of faults in $g=020$, $g=12\bar{1}$ and $g=10\bar{1}$ respectively.

The parallel faults are shown in bright and dark field in Figure 8, corresponding to the red circle at B in Figure 7. At the ends of the straight faults are bowed linear features, which diffract strongly to $g = 020$ (black lines) and $g = 12\bar{1}$ (white lines) and are barely visible in $g = 10\bar{1}$. The fault planes themselves can be determined from their orientation relative to the rotation-compensated diffraction pattern, and they align with the expected traces of (1 $\bar{1}$ 0) planes, the same as those in the 387°C sample.

Nanodiffraction was also performed on one of the faults in the [101] grain, well clear of the grain boundary, shown in Figure 8 c and d. The fault locally contains the zone axis [001] as well as [101], as if it is a continuation of the [001] corner grain that it protrudes from. The intersections of the faults with the grain boundary appear in Figure 8b, e, f and g to occur at steps in the grain boundary. Modelling of different fault types in this structure will take place in future work to find out what kind of defect would produce these observations.

- In the 480°C sample RLB2 a set of parallel faults was seen emerging from the corner grain in Figure 8; these are weak in the $g = 020$ dark field image, strong in $g = 12\bar{1}$ and strong in the $g = 10\bar{1}$ image, pattern x v v. This fits all of the possible displacement vectors, so these faults could be either of the fault types found in [7] or some different type.

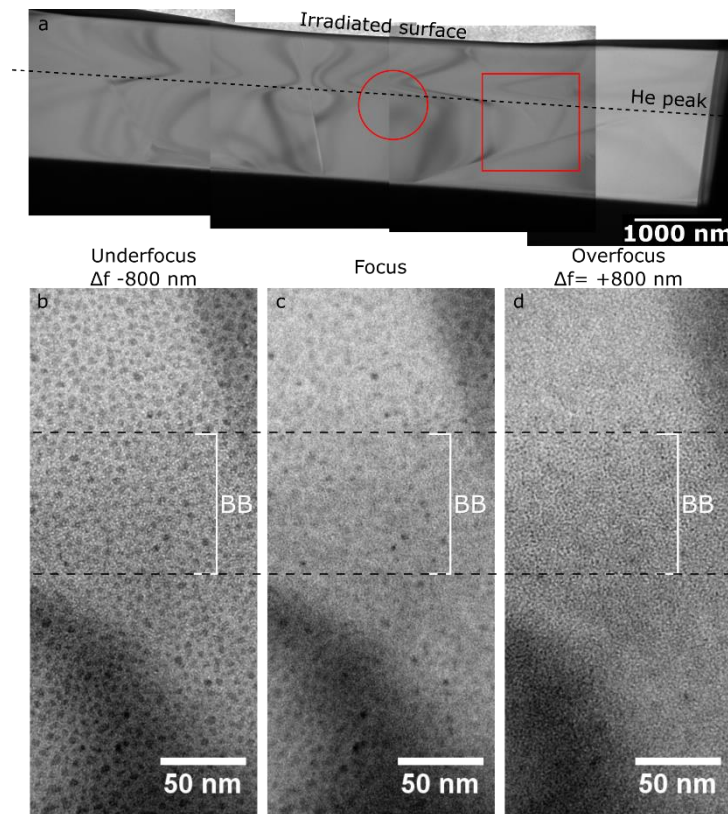
Figure 9 (a) Low magnification bright field image of 600°C irradiated TiBe_{12} specimen, not on zone. The red square shows the area where the fault complex in Figure 10 is found; the circle shows the origin of the diffraction pattern in that figure. (b)-(d) Images of the band where bubbles are most visible at the He concentration peak (annotated BB) at defocus values of -800nm (underfocus), focus, and +800nm (overfocus). The coarse dark speckle is contamination; the bubbles are the ~1nm speckles that invert contrast either side of focus indicated in the bracketed depth range.

A bright field TEM montage of this sample is shown in Figure 9, showing a strong distortion in bend contours at the implanted He concentration peak compared to the lower temperatures, indicating more internal stress around the He concentration peak to cause bending when the re-FIB sample was cut. A band of $\sim 1\text{ nm}$ scale bubbles are found at the He concentration peak by imaging either side of focus, also shown in Figure 9.

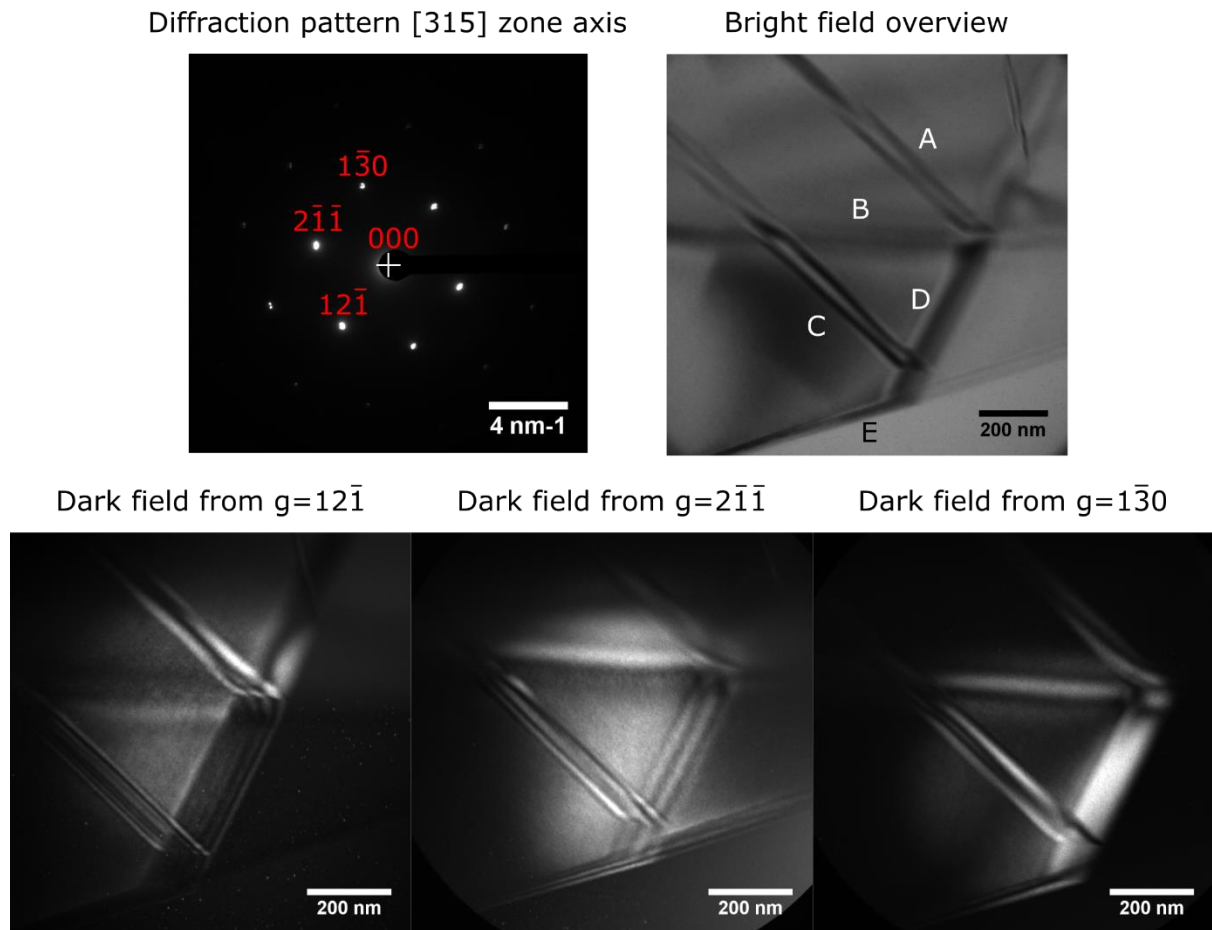
Figure 10 Set of BF/DF images from a fault complex in the 600°C irradiated TiBe_{12} sample. Letters A-E in bright field sample label individual faults in the complex for analysis in the Discussion section.

This sample too contains a number of planar faults, not parallel but an arrangement of multiple faults in the area highlighted by the red square in Figure 9a. Bright and dark field imaging was carried out on this arrangement with the sample on zone, which is the [315] zone axis, shown in Figure 10. From the angles of the faults relative to each other and the diffraction pattern, the fault planes are of type {110}, as for the TiBe_{12} samples irradiated at 387°C and 480°C.

- In the 600°C sample RLB3 the faults in the triangular arrangement of Figure 10 have different patterns of visibility in the dark field images, so must be treated as separate entities. Fault A, for example, is strong in the $g = 12\bar{1}$ dark field image, weak in $g = 2\bar{1}\bar{1}$ and strong in $g = 1\bar{3}0$, so has a visibility pattern v x v. Visibility patterns for the whole set are: A vxv, B xv v, C vvv, D vvv, E xv v. Fault A matches any of the $R = \frac{1}{2}\langle 011 \rangle$ family of faults that create a unit cell of Ti_2Be_{17} ; the remaining faults fall into two similar pairs, B/E and C/D; both pairs match neither fault family.

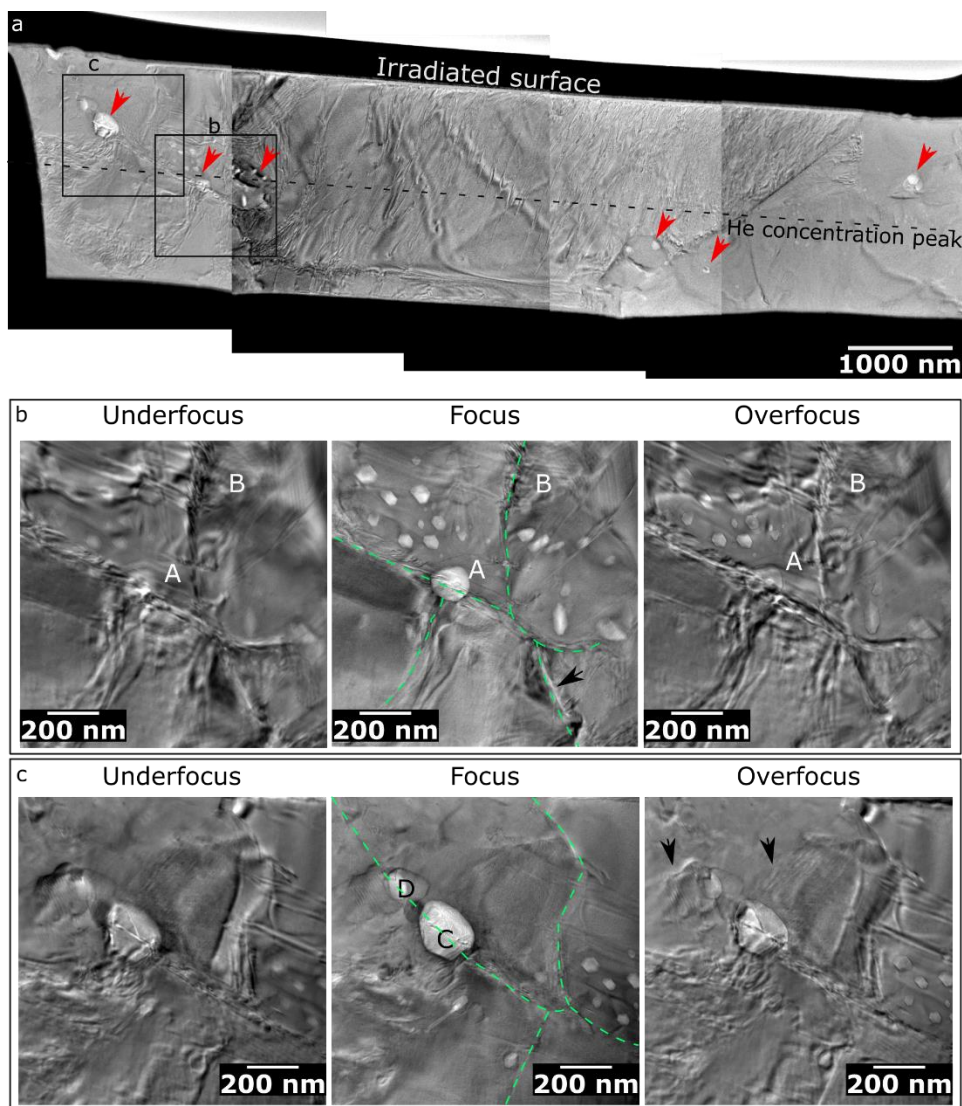
Figure 11 (a) Low magnification off-zone montage of 900°C irradiated TiBe₁₂ sample. Large bubbles are arrowed red. The dashed line marks the approximate position of the He concentration peak. (b) Bubbles on the He concentration peak. Grain boundaries are marked with green dashed lines in the focus image. Planar faults can be seen on the grain boundaries, for example at B. (c) Bubbles or voids upstream of He concentration peak. Grain boundaries are marked with green dashed lines. Overfocus and underfocus are $\pm 1600\text{nm}$ defocus.

This sample, shown in the low magnification off-zone montage in Figure 11a, shows bubbles near grain boundaries (arrowed red) and in grain interiors. The He concentration peak is marked by the dashed line. The bubbles on the He concentration peak marked by box b in Figure 11a are explored off-zone in the focus set of Figure 11b. Bubble A, fairly round with diameter ~ 200 nm, is at a grain boundary triple point (marked with green dotted lines in the focus image). The other bubbles seen here are faceted in shape and offset by 50-200 nm from the nearest grain boundary. Striped contrast from faults can also be seen at many of the grain boundaries, such as at B, and in some of the matrix.

A set of bubbles or voids upstream of the He concentration peak, marked by box c in Figure 11a, are shown in another focal set in Figure 11c. It is not certain whether these are bubbles or voids; they are away from the He concentration peak, and it was not possible in this dataset to obtain a high

enough energy resolution local electron energy loss (EELS) spectrum to determine definitively whether there is He inside. Here again there appear to be two populations: grain boundary bubbles/voids, spheroid in shape and $\sim 200\text{nm}$ in diameter, such as those labelled C and D, and smaller geometric/faceted bubbles/voids 50-200 nm from the nearest grain boundary. The other bubbles/voids (right of image) are again geometric in shape and 50-200 nm from the nearest grain boundary. Here the grain boundary bubbles/voids C and D are accompanied by attached arrays of faults, shown by arrows in the +1600nm defocus image. This does not appear to be the case for grain boundary bubble A at the He concentration peak; this could indicate these upstream objects have more defect movement associated with them, but bubble A is also on a triple junction between grain boundaries which are themselves decorated with fault arrays, so the triple point position may be a contributor to the difference in fault association. The area at the right hand side of this sample downstream of the He concentration peak where bubbles/voids are also visible follows the same pattern with two types of bubble/void in association with faults.

The faceted bubbles in the TiBe_{12} sample irradiated at 900°C (Figure 11b) have plane angles to the horizontal image axis including $9^\circ\pm 1^\circ$, $69^\circ\pm 3^\circ$ and $127^\circ\pm 3^\circ$, from a population of 16 bubbles in the focal set images. When a model in CrystalMaker is oriented to match the rotation-corrected diffraction pattern, there are no low-index planes that fall in these ranges; in particular the $\{110\}$ plane family and $\{111\}$ plane family do not make these angles in projection. Tracing out these angles on a crystal structure projection does not produce obvious lines from one atom to another to suggest any simple physical relationship between the bubble facets and the crystal structure. It is difficult to assess planes from a 2D projection, however, and future work should involve tomography (X-ray or electron depending on scale) to reconstruct 3D shapes of bubbles and measure their facet planes directly.

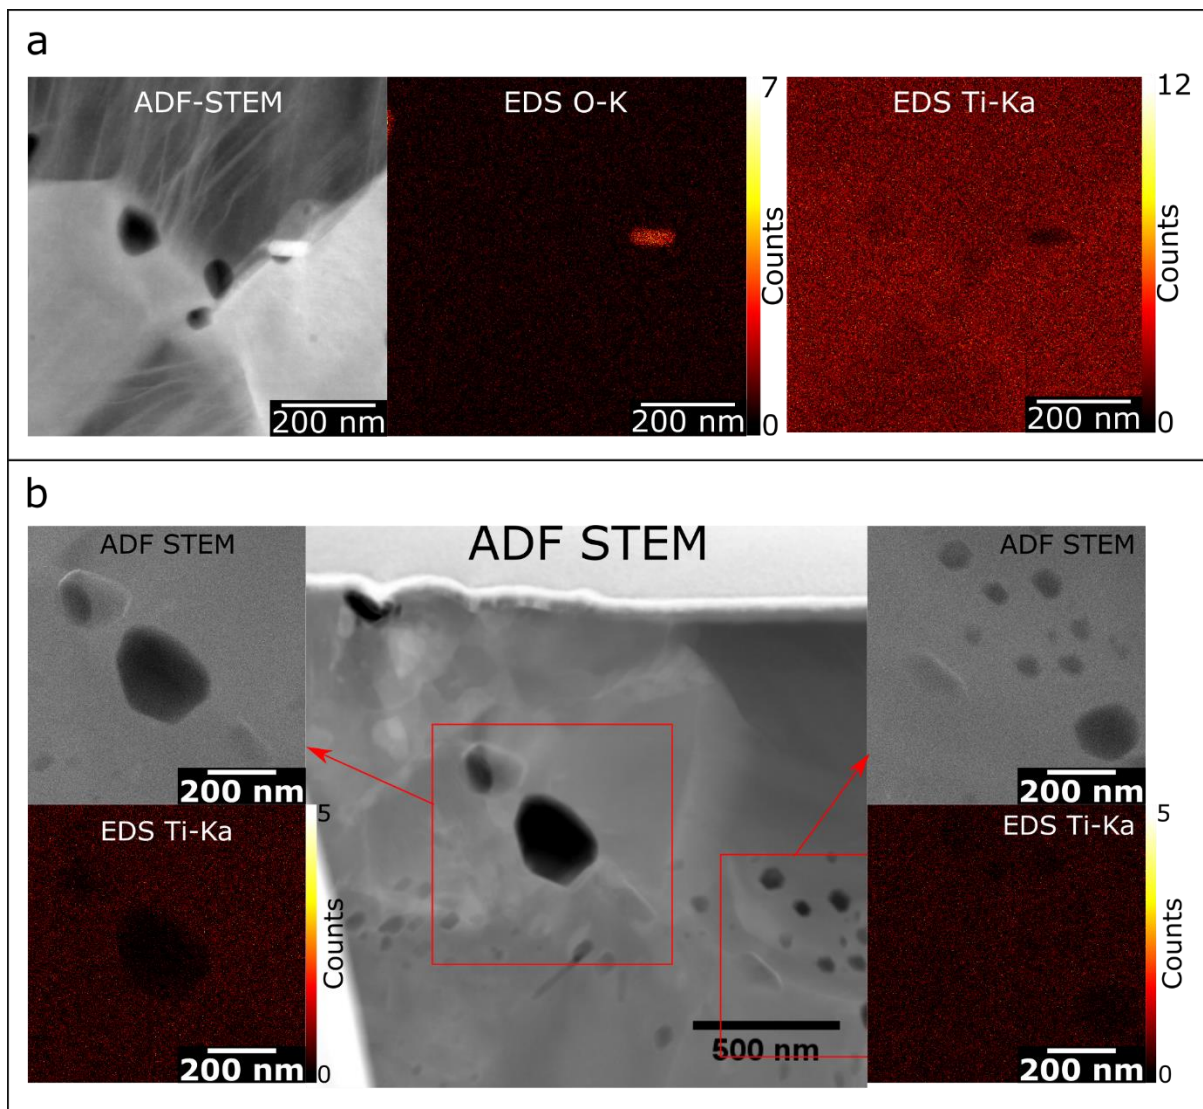
Figure 12 (a) ADF-STEM and O-K and Ti-K α EDS map from 900°C irradiated TiBe₁₂ sample, of grain boundary bubbles in unirradiated material below the He concentration peak. This region is marked 1 in Figure 15. (b) Bubbles in and upstream of the peak He concentration band. EDS maps show no Ti segregation around bubbles. This region is marked 2 in Figure 15.

Figure 12a shows STEM images and EDS maps from the region of box 1 in Figure 15, showing bubbles on the grain boundary in the unirradiated region downstream of the peak in implanted He concentration. Only the oxygen EDS map shows any contrast other than holes at the bubbles – the bright object is a grain boundary oxide precipitate on which a bubble has nucleated. The two grains that are brighter in ADF-STEM are also brighter in the Ti-K α EDS map but this is probably orientation contrast. Bubbles on the opposite side of the TEM specimen in and above the bubble-rich region around the He band are shown in Figure 12b, which is from box 2 in Figure 15. No chemical segregation was found by EDS, including Ti, in these bubbles also.

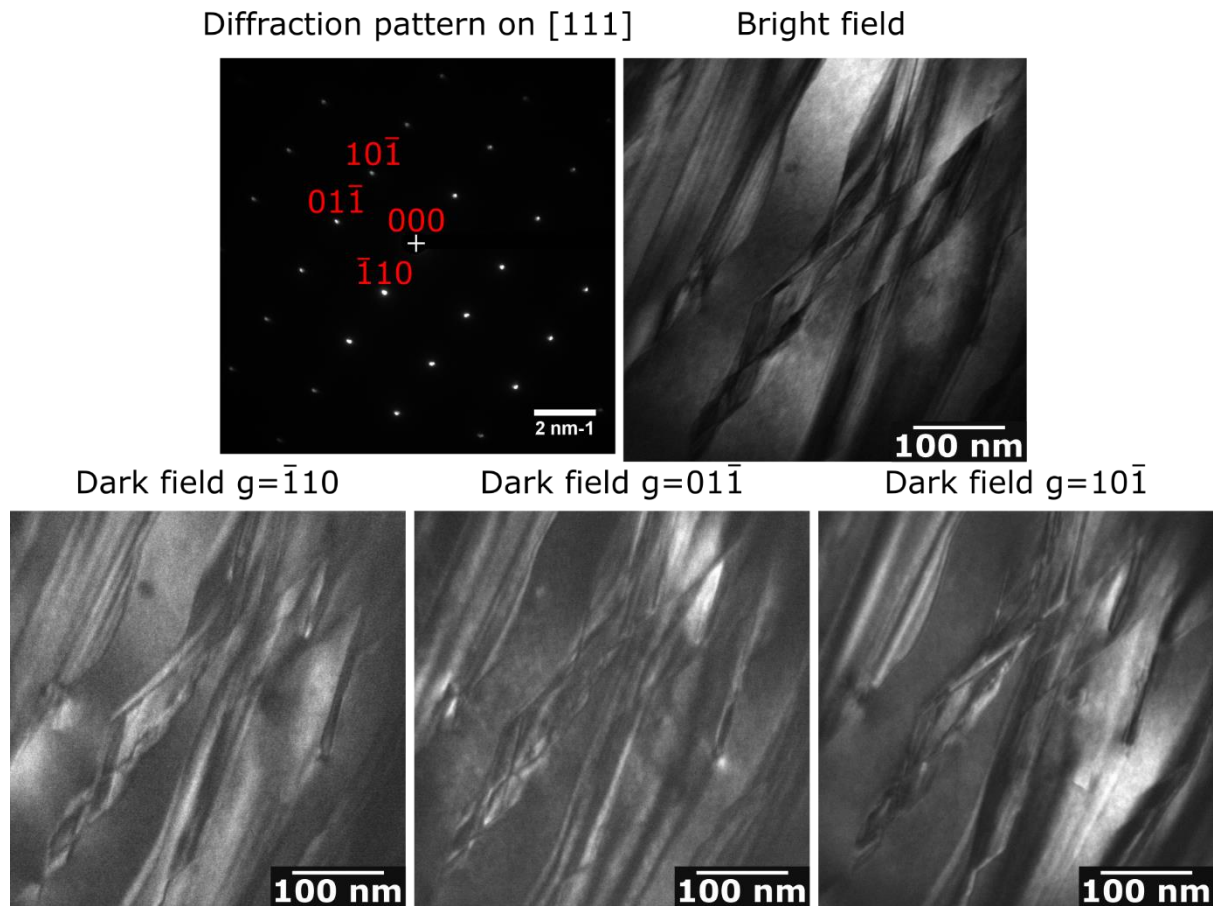
Figure 13 BF/DF image set from central heavily faulted grain of 900°C irradiated TiBe_{12} sample.

Faults in the interior of the central heavily faulted grain were imaged in bright field and dark field, shown in Figure 13. The arrangements of faults observed here follow a pattern of increasing complexity as irradiation temperature increases, though with the limitation that these specimens are small and not necessarily statistically representative of the whole. The zone axis here is [111]; the {110} type fault planes seen at lower temperatures would be either edge on or inclined at 22° to the plane of the sample and would intersect with each other at different angles seen projected onto

the zone axis. Faults on $\{111\}$ fit better the projected intersection angles seen in these images. This means the fault plane and possibly atomic arrangements at the faults have changed between 600°C and 900°C. Further analysis is ongoing to extract more information about the faults.

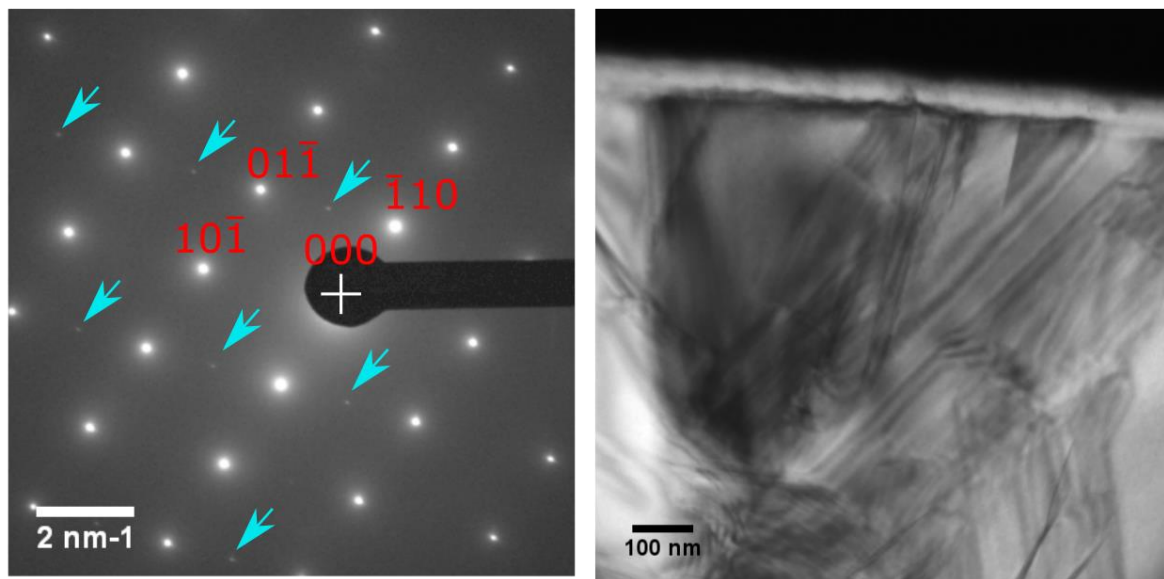
Diffraction pattern on [111]

Bright field

Figure 14 SAED from a set of faults near the irradiated surface in the central heavily faulted grain of the 900°C irradiated TiBe_{12} sample, which made superlattice spots as indexed in the text. The diffraction pattern has been enhanced by changing the gamma value to make the superlattice spots visible on this page, which are marked with blue arrows.

In the central faulted grain is one set of parallel faults which produces superlattice spots between $g = 10\bar{1}$ type spots in every alternate row that follows that reciprocal lattice direction, shown in Figure 14. The indices of these spots are non-integer, e.g. $g = \frac{3}{2}, \bar{1}, \frac{\bar{1}}{2}$.

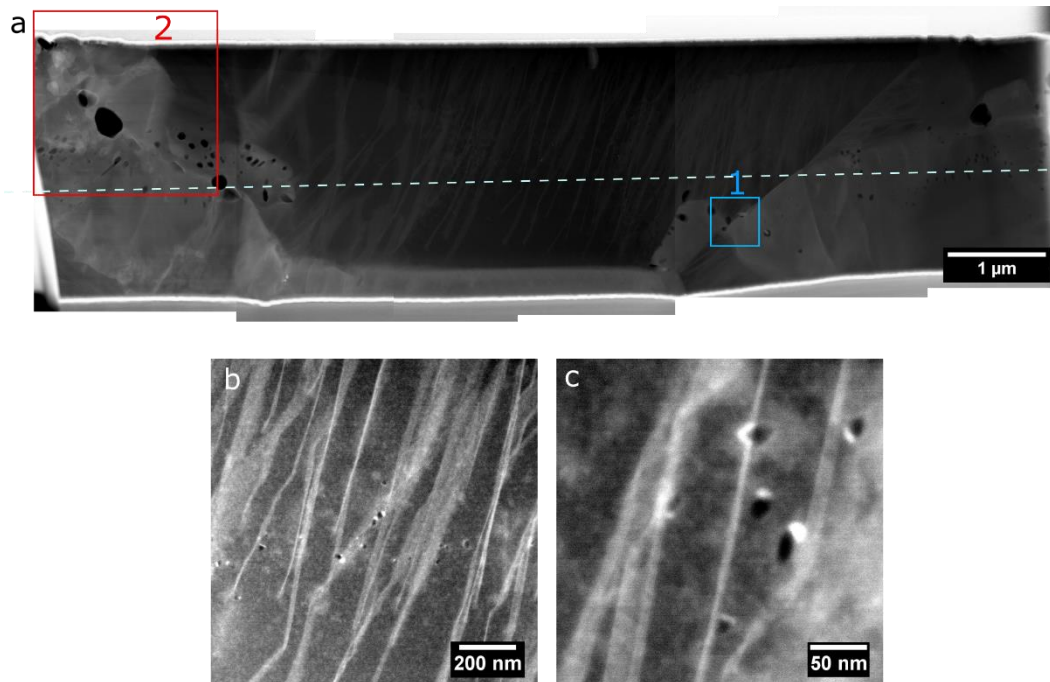
Figure 15 (a) Low magnification ADF-STEM montage of TiBe₁₂ sample irradiated at 900°C. Bubbles appear dark, faults appear bright. The dotted line marks the position of the He zone. Boxes 1 and 2 are regions of interest in Figure 12. (b) ADF-STEM image from the 900°C irradiated TiBe₁₂ sample showing small bubbles and high fault density at the He concentration peak. The small bubbles are obscured by fault contrast in conventional CTEM. (c) higher magnification image of similar area.

A low-magnification montage in ADF-STEM mode, showing some Z-contrast and some displacement contrast in which the faults are bright, is shown in Figure 15a. ADF-STEM images taken around the He concentration peak in the heavily faulted centre of the sample (Figure 15b and c) show small ($\sim 10\text{nm}$) unfaceted bubbles with very bright contrast at some edges, surrounded by bright linear fault contrast. The very bright bubble edges do not correspond to concentrations of any high-Z element in EDS. This bright contrast is likely to be localised displacement, perhaps from structure rearrangement on the bubble walls. It may also be material that has been displaced as bubbles under pressure near the walls of the FIB resection have burst through to the new surface shortly after sample preparation.

A montage of ADF-STEM images was taken on-zone to encompass the whole sample, shown in Figure 15a. Using knowledge of the fault plane being $\{111\}$, the zone axis being $[111]$, and the angles between the fault planes being 72° in the crystal structure, the sample thickness can be estimated at $\sim 150\text{ nm}$ from projected widths of faults inclined to the sample plane, assuming faults run from top to bottom of the TEM sample and do not terminate part-way through the thickness. The area of the montage image corresponding to fault contrast in a band 600 nm tall containing the bubble-dense region around the He concentration peak can be segmented visually and calculated. The known fault geometries and sample thickness then allow the volume of the sample taken up by material in the immediate neighbourhood of faults to be estimated at $12\% \pm 1.2\%$ of the volume of the 600nm band. The number of bubbles in the image montage that appear in contact with fault contrast can then be counted as a proportion of the total number of bubbles; 90% of the bubble images overlap with fault contrast. If the bubbles were randomly placed with respect to the faults, one could expect that 12% of the bubble images would overlap with fault images; 90% overlap shows that the bubbles and faults are positively associated. There is some unknown error due to the assumption that faults are through-thickness, but the faults being part-thickness would make the “random bubble locations” estimate smaller than 12%, so the result stands. Work is ongoing to determine whether

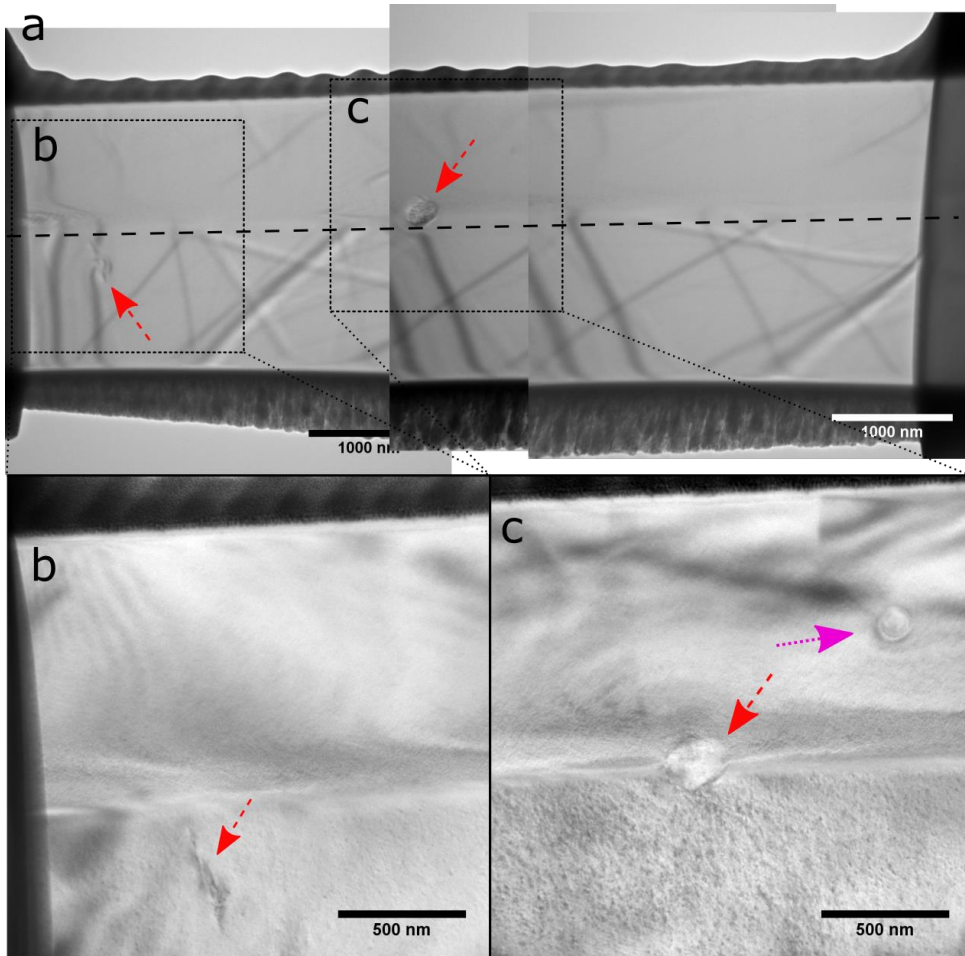
Figure 16 a) Low magnification off-axis montage of CrBe_{12} sample irradiated at 387°C . The He concentration peak is marked with a dashed line; the two features marked with red dotted arrows are a dislocation arrangement (left) and a particle (centre). Areas b and c are shown in on-zone images (b) and (c). In image (c) the particle (red/dashed arrow) is seen and another, circular object (pink/dotted arrow) which is visible only on zone.

A low magnification montage of this sample off zone is shown in Figure 16a. The unirradiated part of the specimen that He did not penetrate (towards the bottom of the image) is much more distorted than the irradiated part, shown by more bend contours. No faults are evident on this sample, but there is one particle around the He concentration peak depth. On zone, another feature can be seen on the irradiated side of the sample, shown in Figure 16c, a circular feature of diameter ~150nm. This is analysed further shortly. It can also be seen on zone that the unirradiated material under the He concentration peak (towards the top of the image) is speckled, as it was for the 387°C TiBe₁₂ sample, and the irradiated material is made of larger grains. The only defect found is an isolated dislocation structure downstream of the He band, towards the left of Figure 16, which does not appear to have bubbles attached on either side of focus.

The most accessible zone axis was $[\bar{1}33]$. Bright field/dark field images of the particle and the circular object upstream of the He concentration peak (arrowed magenta/dotted in Figure 16c) BF/DF images of the circular object are shown in Figure 18a. The contrast here is typical of a dislocation loop, especially in the $[01\bar{1}]$ dark field image where the dark/light contrast switches as an extinction contour crosses the loop. Analysis by STEM EDS, however, shows that this object contains O, as shown in Figure 18b, and matches a gap in the Cr map (not shown). It also partly contains Mo; this is probably redeposition from the grid that has adhered preferentially to this object, implying that it is on the surface. Its visibility in CTEM only on zone, and bright contrast in the $g = \bar{3}0\bar{1}$ DF images suggests it has an orientation relationship with the matrix in which an oxide diffraction spot coincides with the $\bar{3}0\bar{1}$ spot of the CrBe₁₂ matrix. The presence of dark-light linear
