Irradiation of TiBe₁₂ and CrBe₁₂ with He⁺ ions and ex-situ transmission electron microscopy to investigate ion damage as a proxy for neutron irradiation damage in nuclear fusion

Jo Sharp^{1*}, Viacheslav Kuksenko², Ramil Gaisin³, Graeme Greaves¹, Jonathan Hinks¹, Pavel Vladimirov³, Stephen Donnelly¹

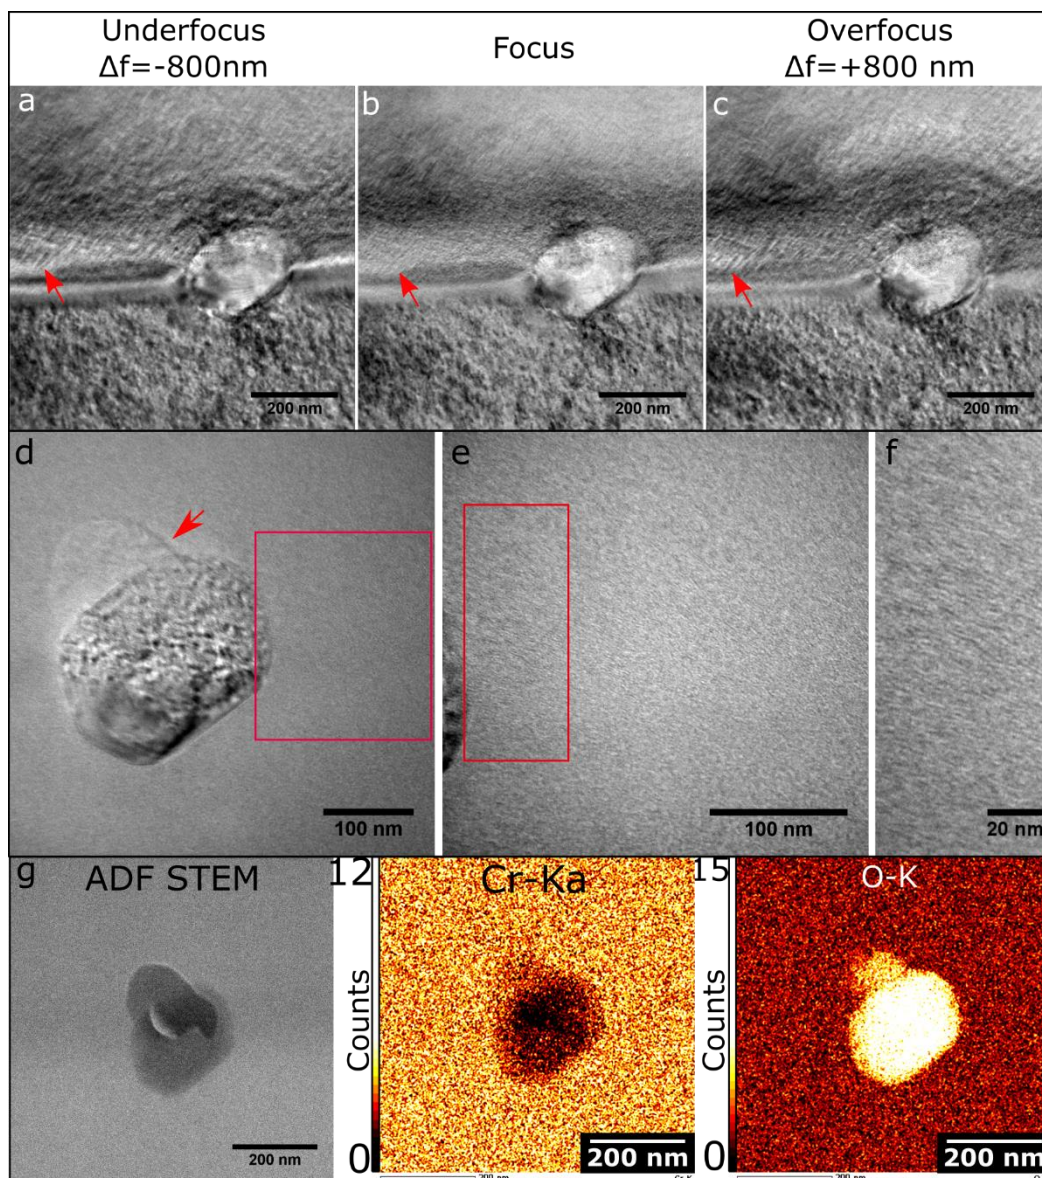
Figure 17 Images of particle at He concentration peak of CrBe₁₂ sample irradiated at 387°C. (a-c) Focal set of on-axis bright field images. The red arrows are at equivalent points on each image showing an example of the flat features which invert contrast either side of focus, possibly flat bubbles or platelets. (d) A feature is seen attached to the particle that is more obvious at defocus but does not simply contrast reverse (marked by arrow). (e) the region in the box in d; (f) the strip marked in e, showing an increase in speckling across the He band on the scale of single nm. (g) ADF STEM image and EDS maps showing a faceted oxide particle and a thinner or less densely oxidised region associated with it.

The particle at the He concentration peak depth is further analysed in Figure 17. In defocus series (a-c), long thin objects (approx. 3-4 nm wide and 30-60 nm long) are seen on the He concentration peak position, that have pale contrast at negative defocus, dark contrast at positive defocus (e.g. the feature at the end of the red arrows). These resemble long bubbles or perhaps platelets as seen in covalent compounds and some metals [18]. The long axes of their projected images mainly align closely with the $[\bar{3}\bar{2}1]^*$ reciprocal lattice direction on the diffraction pattern, which likely places their long axes or flat faces on some crystal plane of type $[\bar{n}\bar{m}1]$ where n and m are close but not necessarily equal non-zero integers. They are, however, not exactly parallel to each other. The +400nm overfocus images from the He concentration peak on the opposite side of the particle in Figure 17(d-f) show a band of smaller linear objects pointing in a different direction from the objects in (a-c). ADF STEM and EDS mapping shown in image set (g) shows the particle itself to be oxide, probably BeO given that it coincides with a hole in the Cr map. Image (d) also shows a rounded, slightly faceted object ~ 200 nm in diameter around the particle; this shows darker (less mass-thickness) in ADF STEM and partially brighter in the oxygen EDS map, indicating it contains oxide but is thinner than the main particle. It is not known at this time whether the thinner particle grew at the same time as the main particle or after irradiation and FIB sample preparation. The bright spot in the ADF STEM image is Mo, but this is probably sputtered from the support grid during FIB.

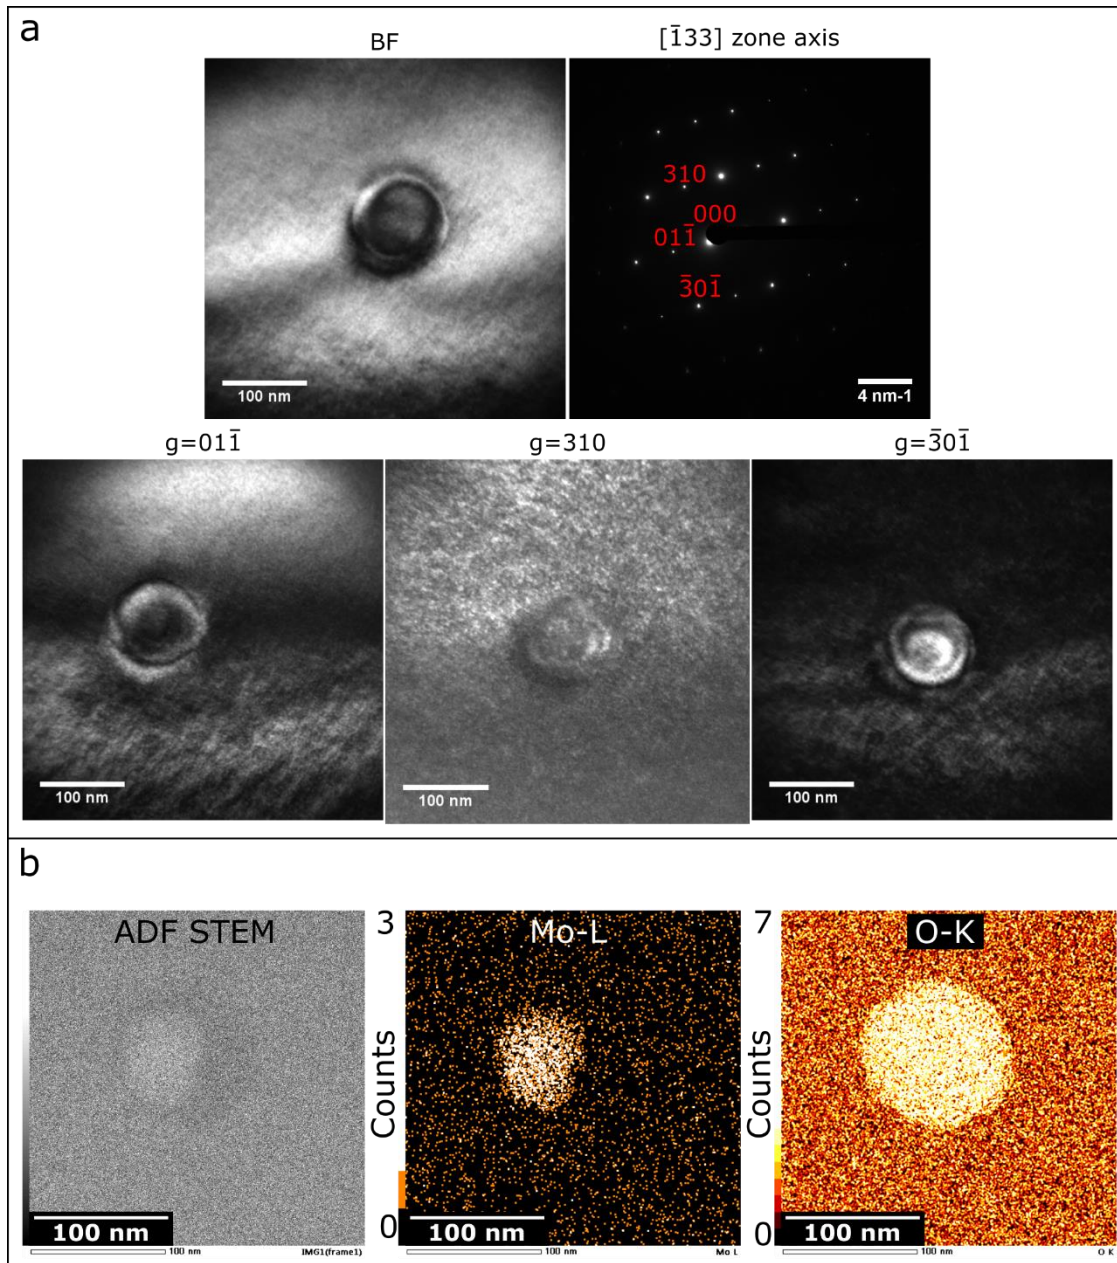
Figure 18 (a) BF/DF imaging of the circular object upstream of the He concentration peak in the 387°C irradiated CrBe_{12} sample. (b) ADF STEM and EDS mapping from the object.

The most accessible zone axis was $[\bar{1}33]$. Bright field/dark field images of the particle and the circular object upstream of the He concentration peak (arrowed magenta/dotted in Figure 16c) BF/DF images of the circular object are shown in Figure 18a. The contrast here is typical of a dislocation loop, especially in the $[01\bar{1}]$ dark field image where the dark/light contrast switches as an extinction contour crosses the loop. Analysis by STEM EDS, however, shows that this object contains O, as shown in Figure 18b, and matches a gap in the Cr map (not shown). It also partly contains Mo; this is probably redeposition from the grid that has adhered preferentially to this object, implying that it is on the surface. Its visibility in CTEM only on zone, and bright contrast in the $g = \bar{3}0\bar{1}$ DF images suggests it has an orientation relationship with the matrix in which an oxide diffraction spot coincides with the $\bar{3}0\bar{1}$ spot of the CrBe₁₂ matrix. The presence of dark-light linear

contrast around the circumference in other DF CTEM images may be due to a dislocation around the precipitate; this may be from deformation under stress from He implantation or thermal expansion mismatch, or a misfit dislocation if the interface is semi-coherent with misfit, or the precipitate acting as a point defect sink for damage at this depth further from the He concentration peak. Alternatively it may be a flat, circular bubble on the $(\bar{1}\bar{3}3)$ plane that was exposed to the air during sample preparation, gathered redeposited Mo and then oxide on exposure to air, but is no longer a bubble so does not show contrast inversion either side of focus off-zone. The structure of oxides in CrBe_{12} is not yet known so finding the structure and the character and orientation of their interfaces with the matrix is required before more can be deduced about this object.

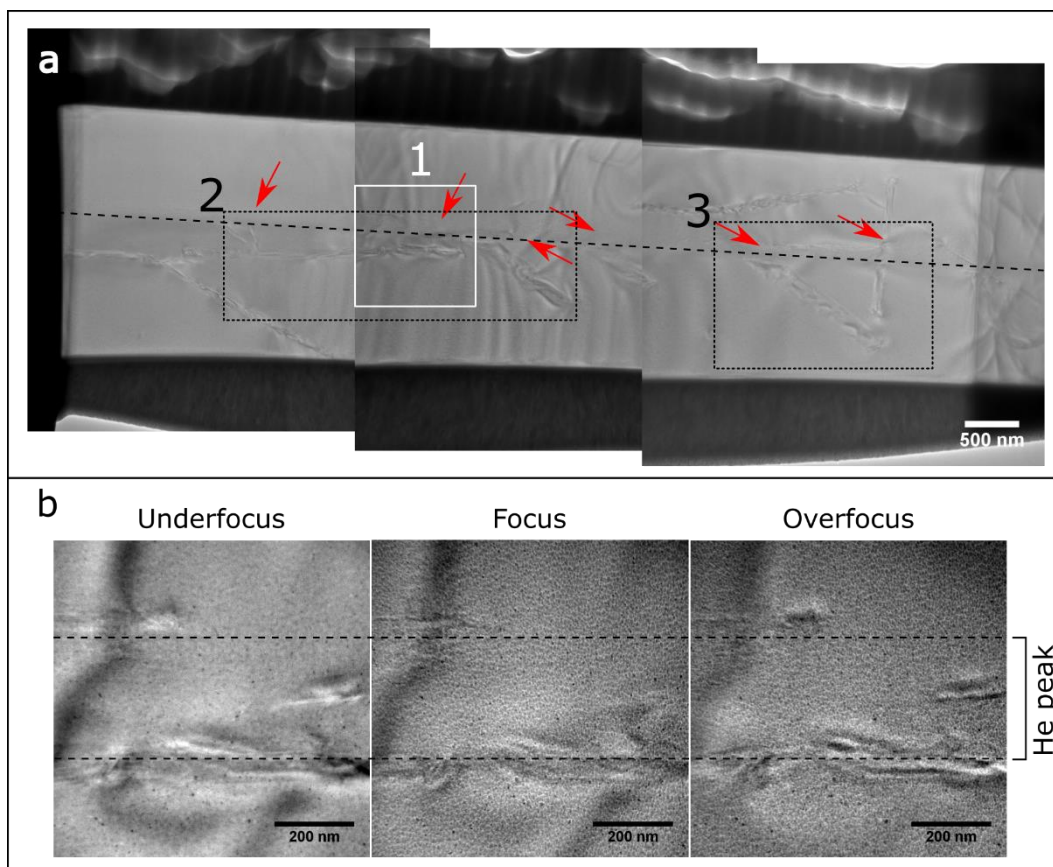
Figure 19 (a) Low magnification montage of on-zone images of CrBe₁₂ sample irradiated at 480°C. The dotted line marks the He concentration peak, red arrows mark locations where faults interact with the strain around the He concentration peak. (b) Focal set of images at the He band from box 1 in (a). Underfocus/overfocus are ± 1200 nm. The approximate location of the He band is labelled, judged from the contrast variation in (a). No evidence of bubbles was seen at these or other focus values. Images (b) are covered in fine dark speckled contrast, identified as Cu contamination using STEM EDS.

In this sample, more faults are observed which partially run along the He concentration peak, as shown in Figure 19, a montage of on-zone images. The dashed line marks the He concentration peak, the red arrows indicate faults that change direction or terminate at it. No bubbles are seen over a wide range of magnification and defocus conditions, but there is speckled contrast over the sample, identifiable in STEM-EDS as copper contamination. STEM-EDS did not reveal any precipitates in this particular FIB sample.

This sample is closest to the slightly esoteric zone axis $[\bar{1}\bar{3}7]$. Bright and dark field imaging of the faults is shown in Figure 20 for the fault arrangement in box 2 in Figure 19, and in Figure 21 for the number “4” shaped fault complex in box 3 in Figure 19. Both fault complexes are poorly visible in dark field images from $g=121$, to the extent that locating areas and assembling partial montages is impossible.

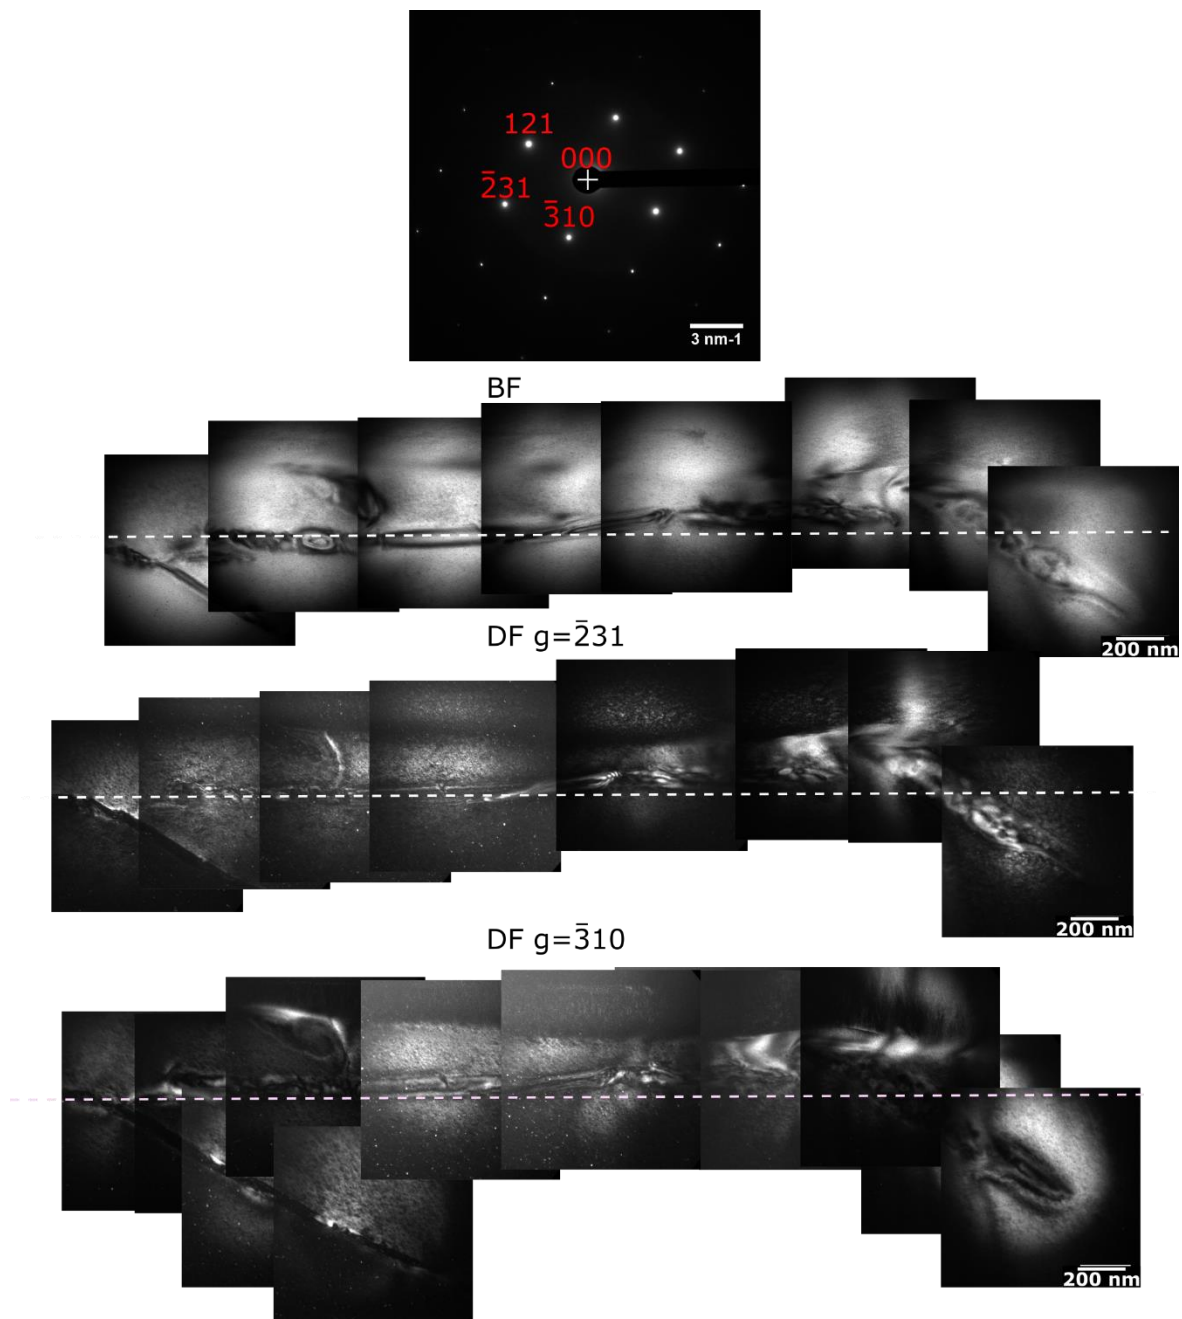
Figure 20 BF/DF imaging from CrBe_{12} sample irradiated at 480°C , showing long defect complex in box 2 in Figure 19. The structure is nearly invisible in the third DF spot $g=121$. White dashed lines show position of the He concentration peak.

Both fault plane families from the TiBe_{12} samples, $\{110\}$ and $\{111\}$, would intersect at 79° and 101° when the structure is projected on the $[13\bar{7}]$ zone axis, so would be indistinguishable from each other. The angles of intersection in the fault complexes in this sample, however, are close to 62° and 34° and do not match those angles, or projected angles that would be seen between any of the $\{110\}$ and $\{111\}$ family and Banerjee's observed fault plane of (001) [7]. This is a key difference between these faults and those found in TiBe_{12} . The dark field contrast on some of the faults seen in Figure 20 is also not striated but has a more swirled appearance; these may not be stacking faults at all but some other planar defect, perhaps microcracks.

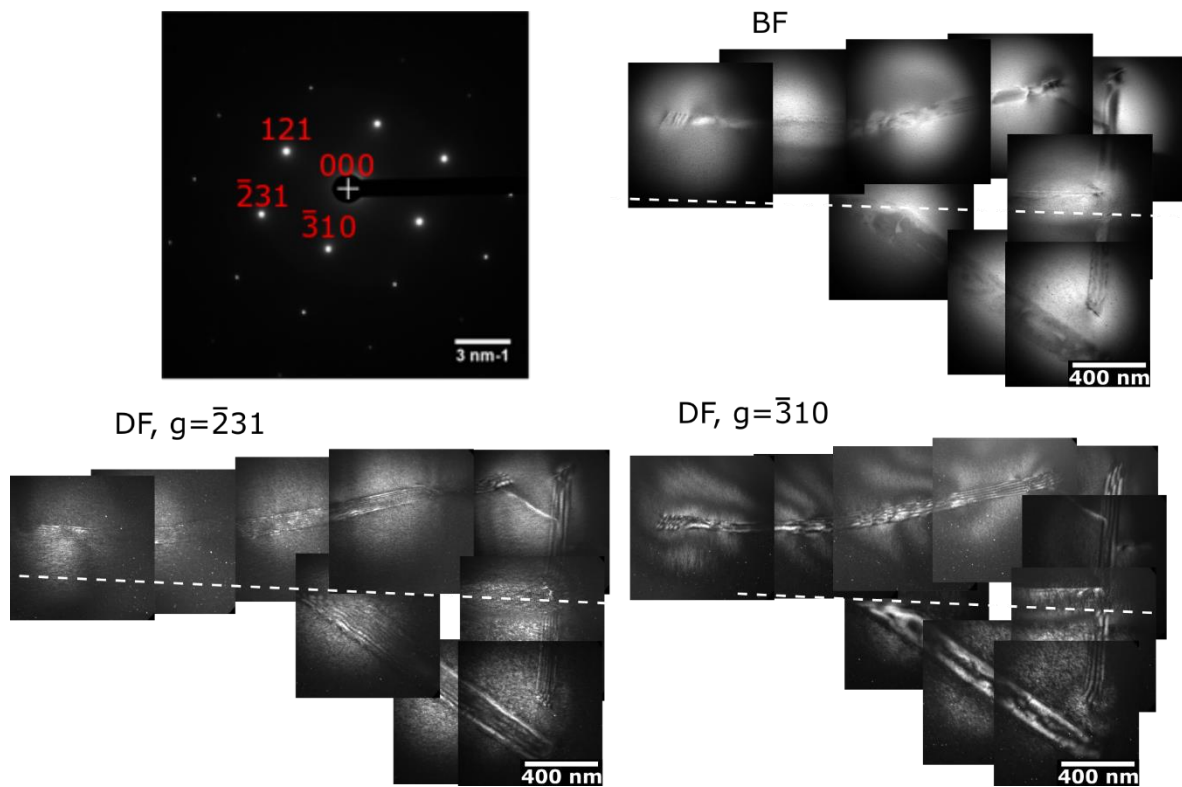
Figure 21 BF/DF imaging from CrBe_{12} sample irradiated at 480°C showing fault complex with numeral "4" shape as indicated in box 3 in Figure 19. The defects are invisible in $g=121$. White dashed lines show approximate position of He band.

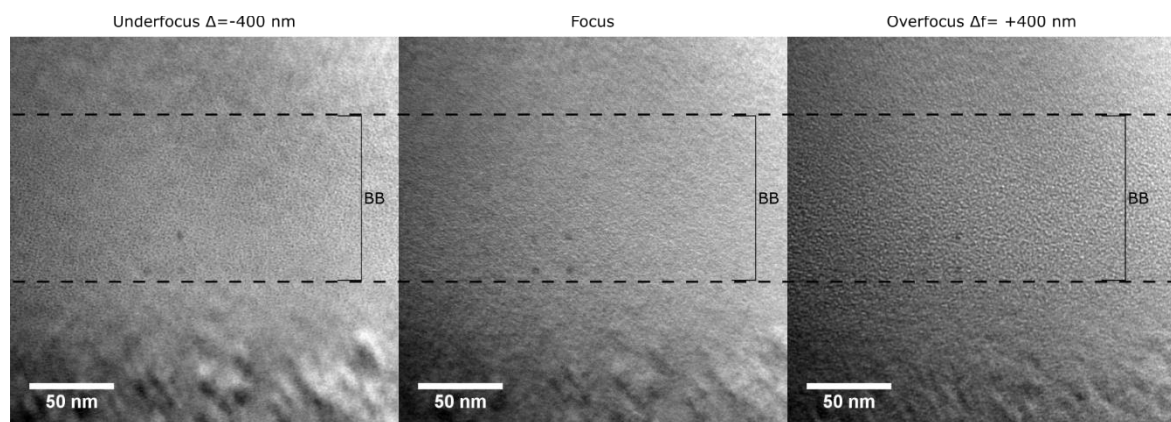
Figure 22 Focal set of images showing small bubbles in CrBe_{12} sample irradiated at 600°C . Bubble band is marked by BB.

Defocused TEM images shown in Figure 22 reveal a bubble band of small bubbles on the scale of 1 nm above the top of the speckling, at the He concentration peak. The bubble band is of comparable width to that seen in the TiBe_{12} sample irradiated at this temperature.

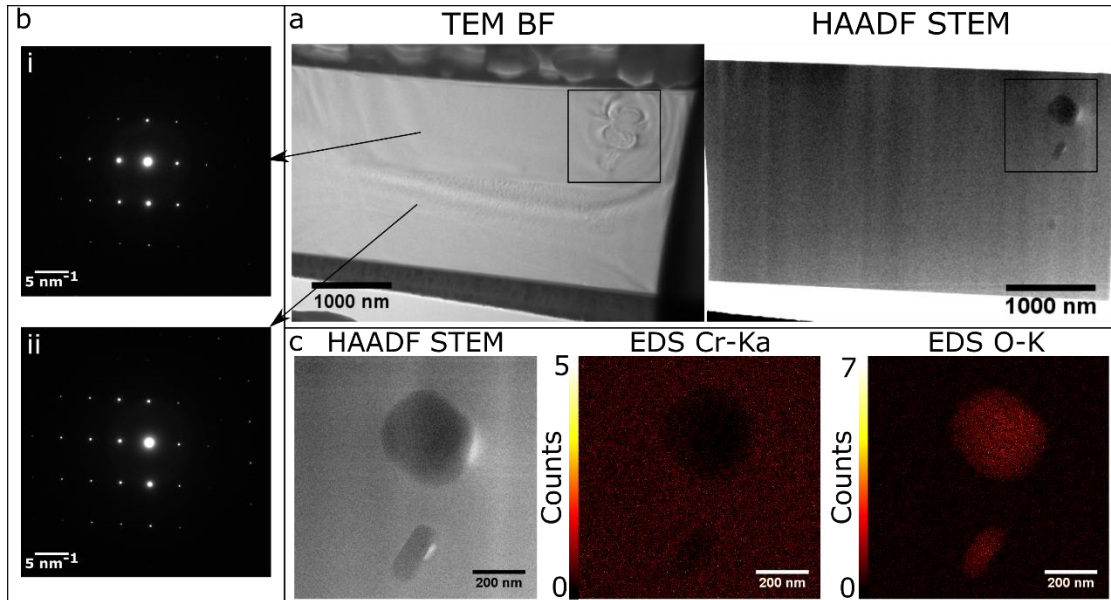
Figure 23 (a) Low magnification TEM BF and HAADF-STEM images of CrBe₁₂ irradiated at 600°C. (b) Diffraction patterns from (i) the smooth area above the bubble band, (ii) the speckled area below, both showing one main grain and diffuse contrast from surface oxide or FIB-induced surface amorphization. (c) Higher magnification HAADF-STEM and EDS maps showing oxide precipitates.

This sample, similar to the 387°C irradiated TiBe₁₂ sample, appears speckled below the irradiated area but single crystal in the irradiated part as shown in Figure 23. Diffraction patterns taken in the smooth and speckled regions are identical, both showing one strong pattern from the CrBe₁₂ grain and diffuse contrast from surface oxide and/or redeposition from the Cu FIB support grid. Be-rich oxide precipitates are seen upstream and downstream of the He concentration peak.

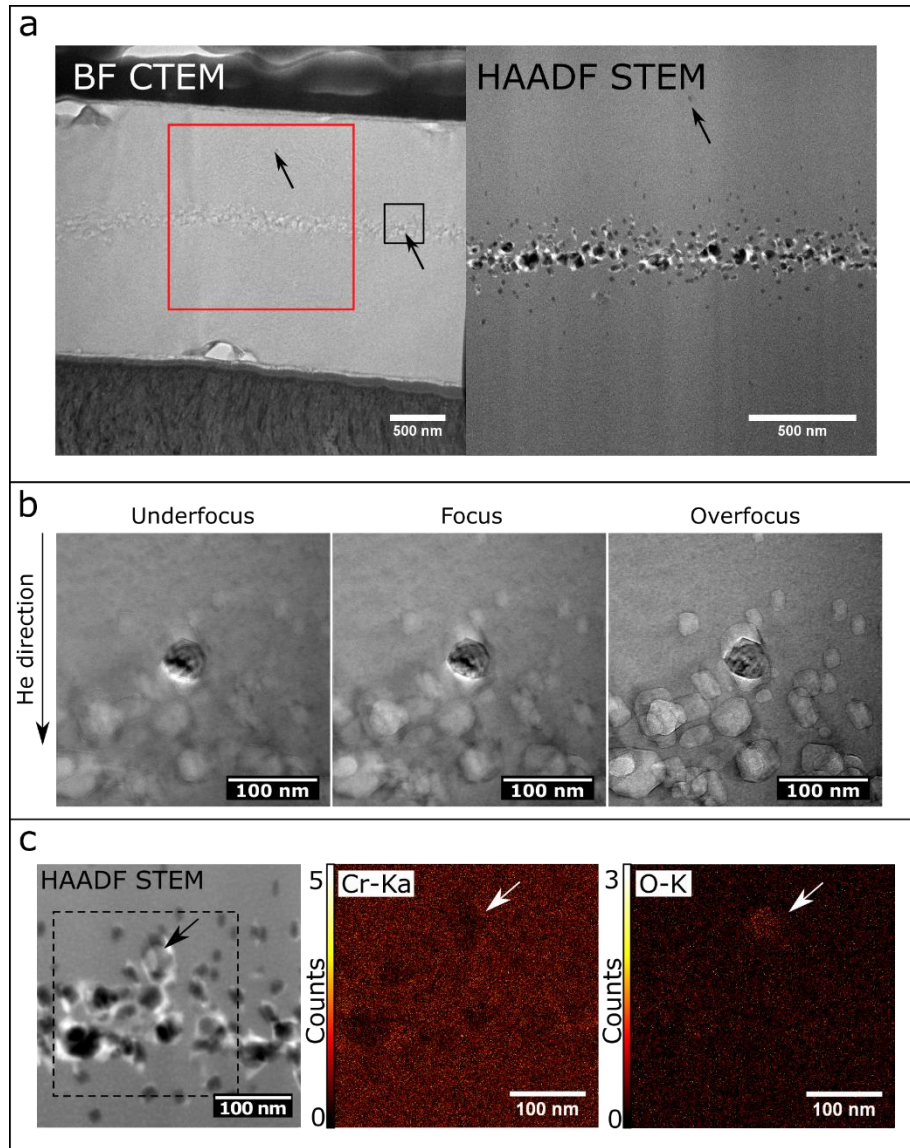
Figure 24 (a) Low magnification images of 900°C irradiated CrBe_{12} sample. A band of bubbles is clearly visible around the predicted He peak depth. The arrows show precipitates in the bubble belt and upstream of it. (b) Higher magnification off-axis TEM focal set of the precipitate in the bubble band; the ~50 nm precipitate is in a bubble that nucleated and grew around it. Underfocus/overfocus are ± 400 nm. (c) EDS mapping of the precipitate in (b) which is Be-rich oxide; there is also Cr decorating the bubble edges.

This sample was prepared with a smaller electron-transparent area because previous samples with larger thin areas bent on thinning, possibly due to higher internal stress in the slab irradiated at 900°C. Low magnification images of the thin area are shown in Figure 24a. There is a clear band of bubbles across the He concentration peak depth, unlike from the lower irradiation temperatures. Larger bubbles (up to 100 nm) are found at the He concentration peak and smaller bubbles (~20 nm) further from it. Interestingly, smaller bubbles are found not only upstream of the peak He depth but also downstream. This implies either some spread of He destination due to diffusion at this high temperature and possibly substantial vacancy diffusion to form voids; voids nucleate on He bubbles in many materials e.g. [19]. Measuring the concentration of He in bubbles using high energy resolution EELS [20], and looking for depth correlation within the cross section, would provide interesting data in future. Both sizes of bubbles are faceted rather than spherical. A higher magnification TEM focus set in Figure 24b shows a precipitate in the bubble band of diameter ~50 nm and on which a bubble has nucleated and grown. The same precipitate is analysed in EDS in

Figure 24c, which shows it is a Cr-poor (and therefore Be-rich) oxide. In the same figure, we see some of the bubble margins are enriched in Cr and some of them slightly in O, but not every hotspot on the Cr map has a counterpart in the O map. This implies there is Cr segregation to the bubble edges during irradiation which subsequently oxidises after FIB sample preparation when they are exposed to air. This is a significant difference from the TiBe_{12} specimens in which there is no elemental enrichment around the bubbles.

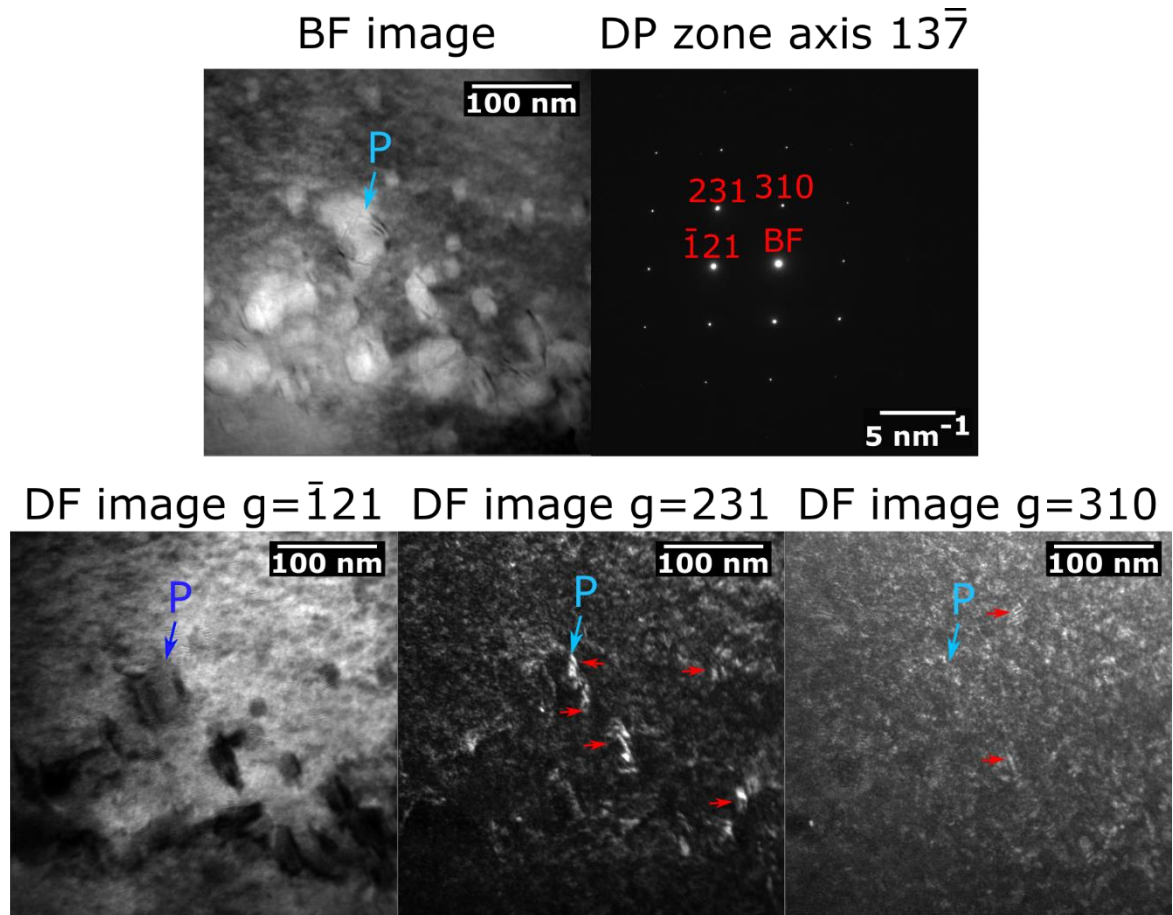
Figure 25 BF/DF images from CrBe_{12} sample irradiated at 900°C of bubble band with precipitate. Precipitate is indicated by blue arrow and letter P. Red arrows on $g=231$ and 310 dark field images show fringes around bubbles.

Imaging of the bubble band and precipitate in bright and dark field yields some interesting observations (Figure 25). Around some of the bubbles, fringes are found in the dark field image from $g=231$. The fringes in DF-CTEM coincide with the Cr decoration in EDS. This may imply some kind of orientation relationship between the Cr or Cr oxide and the CrBe_{12} and a (semi-)coherent interface is implied, containing defects which cause the fringes; further work is required to find out.
