Effects of rf breakdown on the beam in the Compact Linear Collider prototype accelerator structure

A. Palaia,^{*} M. Jacewicz, R. Ruber, and V. Ziemann

Department of Physics and Astronomy, Uppsala University, Uppsala, Sweden

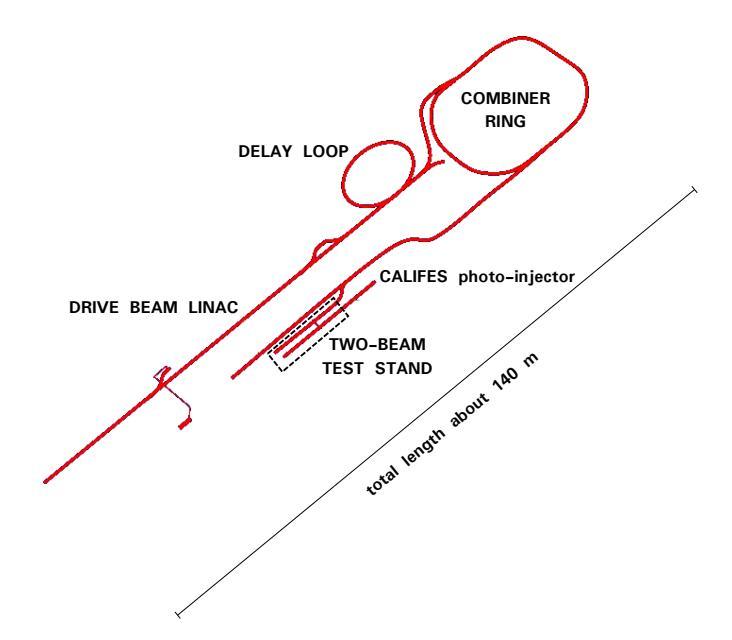
FIG. 1. Sketch of the CLIC Test Facility 3 at CERN. An electron drive beam is accelerated in a normal-conducting linac and its bunch frequency and current multiplied by means of a delay loop and a combiner ring. The beam is then sent to the Two-beam Test Stand experimental hall where the CALIFES linac is also installed to provide a second electron beam which is as well sent to the Two-beam Test Stand probe beam line for two-beam acceleration experiments.

The Two-beam Test Stand is part of the CTF3 complex sketched in Fig. 1 where a 4 A drive beam consisting of a 1.2 μs long train of electron bunches extracted from a thermionic gun at 1.5 GHz is accelerated in a normal conducting linac to an energy of about 150 MeV. Its bunch frequency and its current are multiplied up to a maximum of 12 GHz and 28 A, respectively, by means of a delay line called delay loop and a ring called combiner ring, in order to build the time structure needed to efficiently produce 12 GHz RF power in the PETS. The probe beam is generated on a photocathode in a linac called CALIFES [12] and then sent to the Two-beam Test Stand for two-beam acceleration experiments. A comparison between CLIC and CTF3 beam parameters is given in Table I. The final drive beam time structure at CTF3 is the same as the CLIC one although in CTF3 it is achieved using a different combination of delay lines and rings than in CLIC. The beam current and energy (before deceleration) are lower in CTF3 than in CLIC. The CLIC main beam and the CTF3 probe beam have a similar time structure but different energy (before acceleration) and current, the latter being limited by beam loading and space charge in the accelerator structures used in the CALIFES linac [13]. The two-beam acceleration was successfully demonstrated at CTF3 in 2010 [14] and afterwards even beyond the CLIC nominal requirements of 100 MV/m [15]. Nevertheless other experimental aspects are addressed at the Two-beam Test Stand which are connected to the acceleration technology.

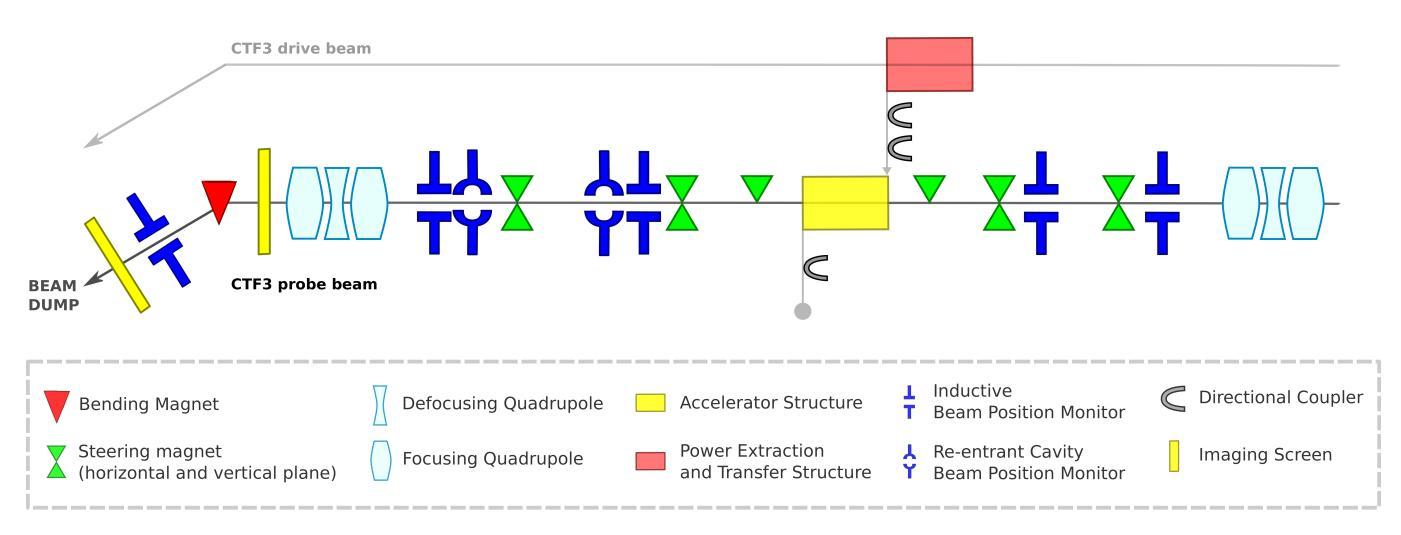
FIG. 2. Sketch of the probe beam line of the Two-beam Test Stand at the CLIC Test Facility 3. The CLIC prototype accelerator structure is fed with RF power produced in the Power Extraction and Transfer Structure installed in the drive beam line. The probe beam line is equipped with two quadrupole triplets, steering magnets, inductive and cavity Beam Position Monitors, removable imaging screens and directional couplers at the input and output ports of the accelerator structure. A spectrometer line is used to measure the beam energy just before the beam dump.

the last one being in the spectrometer line. The probe beam line sketched in Fig. 2 is also equipped with two cavity beam position monitors [17] downstream of the accelerator structure. They were recently installed to resolve fast changes in the beam position thanks to their bandwidth of 600 MHz centred at a frequency of 6 GHz which makes them insensitive to the low frequency noise visible on the inductive beam position monitor signals.

Two representative examples of beam spots measured on the screen installed before the spectrometer line (see

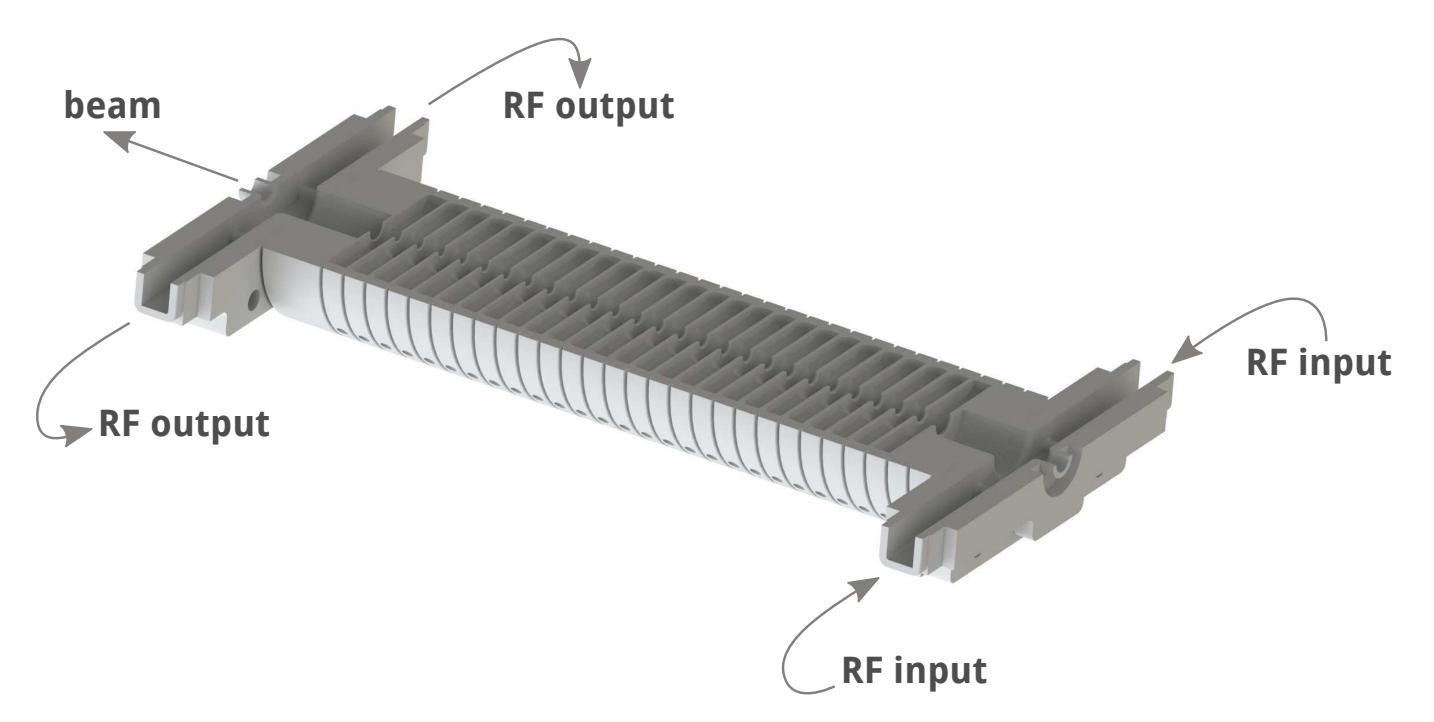
FIG. 3. Longitudinal cross section of a 3D model of the CLIC prototype accelerating structure installed in the Two-beam Test Stand in 2012.

The accelerator structure installed in the beam line is a CLIC prototype. It is a X-band travelling wave resonant structure made of copper. It consists of 24 regular cells, i.e. cells providing nominal field gradient, plus 1 input and 1 output matching cells. The phase advance per cell is $2/3 \pi$. Its total length is 22.77 cm. It has a small aperture and a strong linear tapering - group velocity varies from 1.62% in the first cell to 0.81% of the speed of light in the last cell [3]. More specifications are given in Table II and a cut-out of a 3D model of the structure is shown in Fig. 3. No high-order modes damping material are installed in this prototype. It is equipped with directional couplers at its input and output ports. Their output signals are sent to diode detectors and IQ demodulators and then calibrated for power and phase measurements.

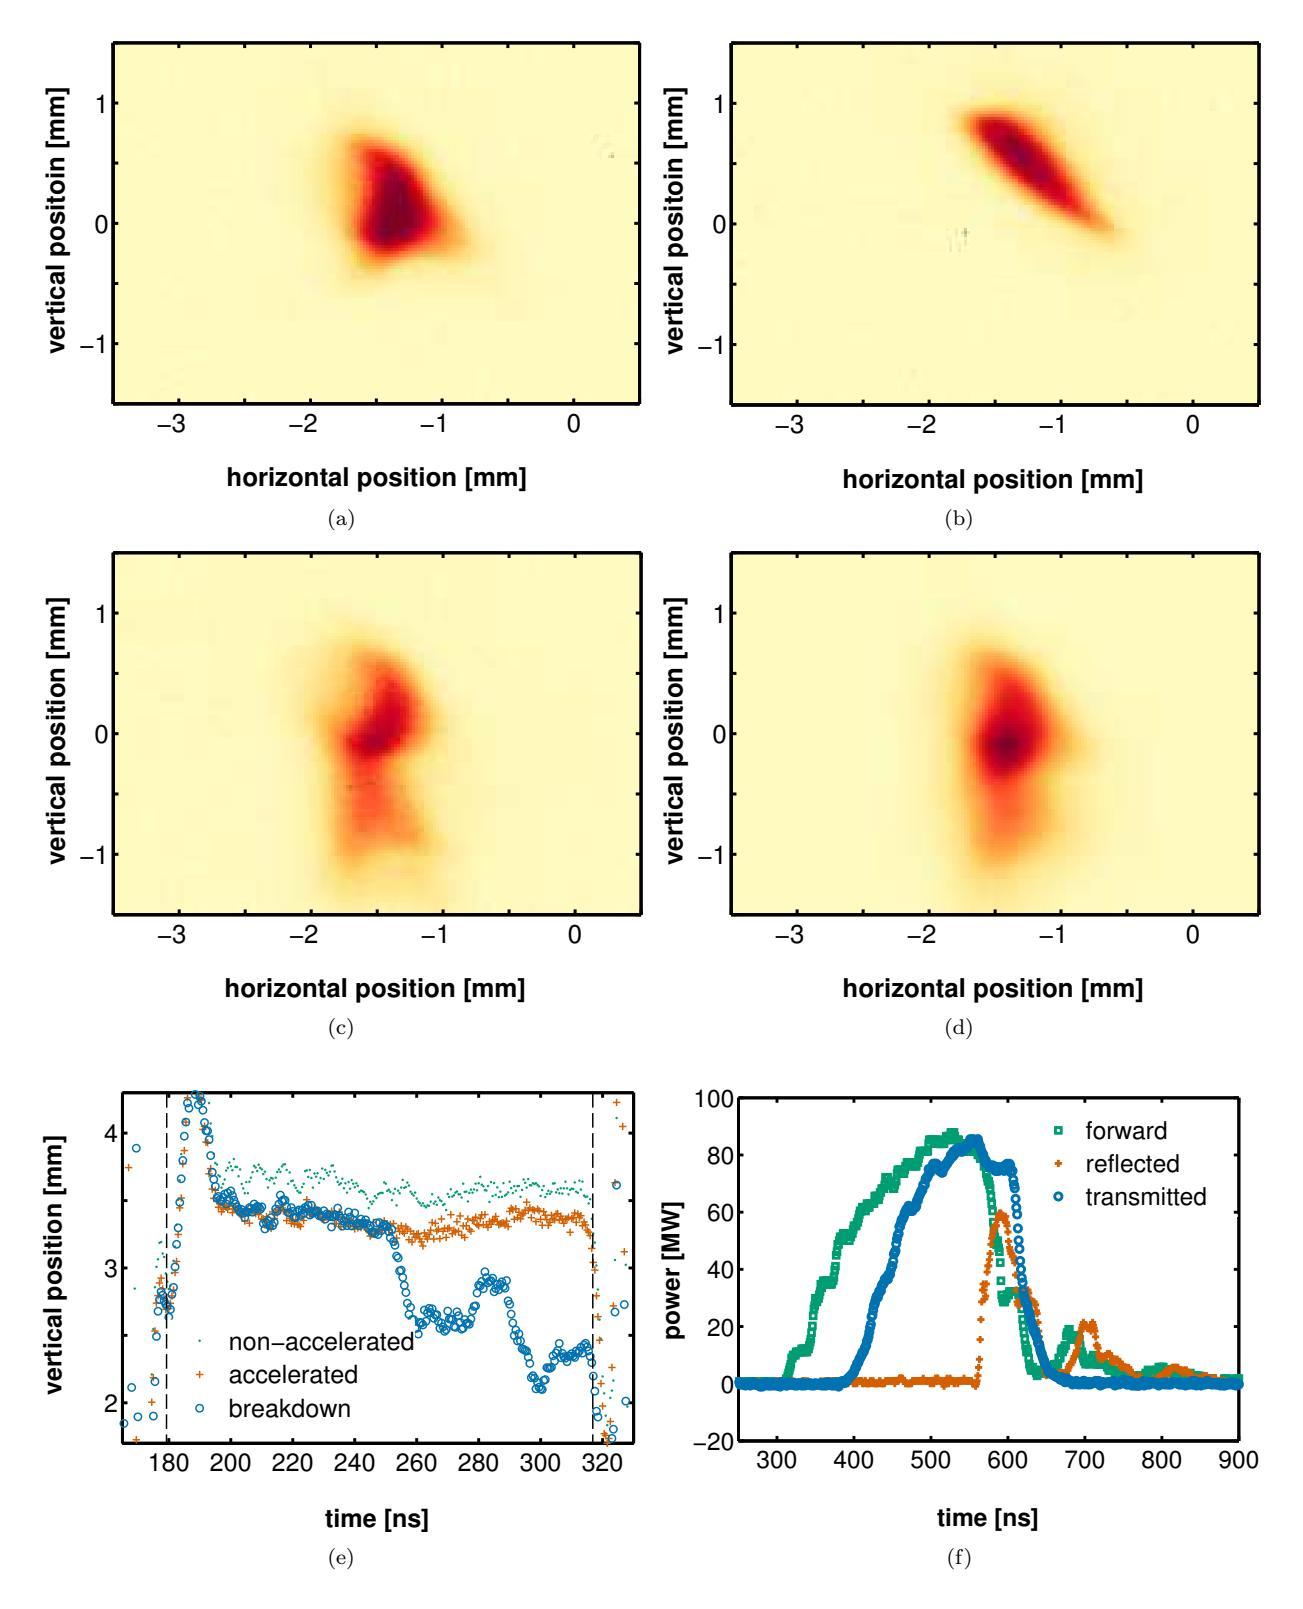
FIG. 4. Collection of measurements from three consecutive bunch-trains and prediction of the beam spot in case of RF breakdown: (a) accelerated bunch-train; (b) non-accelerated bunch-train; (c) bunch-train corresponding to a RF breakdown in the accelerator structure; (d) prediction of the beam spot in case of RF breakdown; (e) beam orbit measurements; (f) power measurements corresponding to a RF breakdown in the accelerator structure.

Fig. 2) are shown in Fig. 4(a) and Fig. 4(b). Both beam spots were measured when neither the quadrupole triplet nor the correctors between accelerator structure and screen were powered, i.e. the beam was following a ballistic trajectory after the accelerator structure. The beam spot in Fig. 4(a) stems from a bunch-train accelerated in the structure by about 23 MeV whereas the beam spot in Fig. 4(b) corresponds to a bunch-train non-accelerated. The size of the latter is determined in the CALIFES linac and is about 0.4 mm in both planes throughout this experiment. We observed that the centroids of the two beam spots have different positions and shapes. The centroid position is calculated by means of a fit of a 2D-Gaussian to the beam spot image and is found to differ by 0.40 ± 0.10 mm between the two cases. Such difference was not due to any changes in the incoming beam orbit as the beam centroid measured on the screen was stable within ± 0.13 mm from pulse to pulse. In Fig. 4(e) we show the beam position measured by the cavity beam position monitor installed just before the imaging screen. The two upper-most signals correspond to the bunch-trains whose spot is shown in Fig. 4(a) and Fig. 4(b), the accelerated one at the top and the non-accelerated one in the middle. The signal at the bottom corresponds to a breakdown and is discussed in Sec. V. The accelerated and non-accelerated positions are about 0.26 mm apart on the vertical plane whereas their shift is negligible on the horizontal plane. Given the distances of the screen and the cavity beam position monitor from the accelerator structure of 5 m and 3.4 m respectively, the different beam position measured with the beam position monitor should correspond

to a difference of $0.26 \cdot (5/3.5) = 0.37$ mm between the position of the beam centroids measured on the screen. which is in agreement with what was measured. In other words, the beam was always kicked vertically by about 0.07 mrad whenever it was accelerated. Such kick corresponds to a momentum of about 13 keV/c for a beam energy of 180 MeV. Such effect is consistent with a misalignment of the accelerator structure with respect to the rest of the beam line. Given a total energy gain of 23 MeV in the 23 cm long accelerator structure, a tilt of $0.013/23 \simeq 0.57$ mrad would correspond to a displacement of $(0.23/2) \cdot 0.57 = 66 \ \mu m$ which is consistent with the mechanical accuracy of the alignment of the structure in the beam line [19]. It is worth noting that even if the beam could be steered on an orbit which was stable irrespective whether the beam was accelerated or not, we chose to maintain the shift between accelerated and non-accelerated positions. That permits an indirect measurement of the beam energy change, even if it introduces a bias in the measurement of transverse breakdown kicks as discussed in sec. V.

Beyond the position of the centroids of the two beam spots in Fig. 4(a) and Fig. 4(b), we also observed that both their shapes and orientations are different. First of all it is worth noting that the beam spot corresponding to the non-accelerated bunch-train in Fig. 4(b) is elliptical and tilted, which indicates coupling between the horizontal and the vertical plane. This coupling is caused by the solenoids surrounding the CALIFES accelerator structures to provide transverse focusing when the beam is generated and accelerated before being sent to the Two-beam Test Stand. On the other hand, no solenoidal field is present in the Two-beam Test Stand therefore we attribute the change in size and orientation of the accelerated bunch-train to the field in the structure. If we consider that the beam size of the accelerated beam spot measured on the screen is almost doubled with respect to the non-accelerated one, such change can be accounted for by a defocusing quadrupole with a focal length of 5 m. This effect can be explained if we consider that a quadrupolar component of the fundamental accelerating mode is present in both the input and output couplers of the accelerating structure due to their symmetry which is broken by the presence of two feeding waveguides. Moreover the symmetry of all the cells in the accelerator structure is broken by the presence of wakefield damping waveguides such that there an octupolar component of the fundamental mode is introduced. The integrated strength of such additional multipolar modes were calculated for a CLIC baseline accelerator structure [20] and resulted in $17 \cdot 10^{-3}$ T integrated throughout the input and output couplers and $8 \cdot 10^5 \text{ Tm}^{-2}$ integrated throughout all regular cells of the accelerator structure. For a beam energy of 180 MeV the quadrupolar field component contributes with a focal length of about 30 m, which is not enough to explain our observation. On the other hand, the slope of octupolar field component in the regular cells at a beam offset of 200 μ m in the structure produces a quadrupolar effect with a focal length of about 5 m. Thus the effect of the octupolar mode in the regular cells of the accelerator structure can account for the observed focusing effect.

When a RF breakdown occurred in the accelerator structure while the beam was accelerated, we often observed a beam spot like the one shown in Fig. 4(c). Such spot must be compared with the two immediately preceding accelerated and non-accelerated beam spots in Fig. 4(a) and Fig. 4(b), respectively. A second spot is visible in Fig. 4(c) below the original spot, which we explain as resulting from part of the bunch-train receiving a transverse momentum in correspondence of the breakdown location in the structure, and therefore travelling on a different orbit and hitting the screen in a different position. To verify that such a secondary spot was part of the beam, we recorded images of discharge currents reaching the screen without beam. This always resulted in low intensity images of breakdown current spread over a wide portion of the screen. Therefore discharge currents could be distinguished in every case from the beam and they can be excluded as possible source of secondary spots detected in breakdown events. The explanation offered for the appearance of a second beam spot is supported by the measurements of the beam position on a nano-second time scale with the cavity beam position monitor installed just before the imaging screen,

as shown in Fig. 4(e). The position of the first part of the bunch-train - from 180 ns to 250 ns - is the same of the position of an accelerated bunch-train when no breakdown happens in the accelerator structure, i.e. it gets fully accelerated. Afterwards the position shifts in about 10 ns vertically downwards by about 0.75 mm. It oscillates for the remaining length of the bunch-train but it never shifts back to its initial position. It is worth noting that the overshoot visible at the beginning of the signal is due to the read-out electronics and that it is not related to the beam position. Moreover it is a feature observed in all the signals read-out from the cavity beam position monitors in the beam line. Therefore if we disregard the first 20 ns of such signals, we can identify two main trajectories, the first one corresponding to the fully accelerated beam and the second one corresponding to the beam affected by the breakdown. These two positions will result in two distinct spots on the imaging screen. The position of such spots is calculated as the distance between the two maxima of the sum of two 2D-Gaussian fitted to the beam image and is 1.1 mm in Fig. 4(c). Given the distance of the screen and the cavity beam position monitor from the accelerator structure, the distance between the two spots measured on the screen corresponds to the shift of the beam position measured by the beam position monitor in Fig. 4(e) and it is $1.1 \cdot (3.4/5) = 0.68$ mm.

A further indication that the rapid deviation of the beam position measured on the screen and with a beam position monitor is correlated with a RF breakdown in the accelerator structure is given by the RF measurement shown in Fig. 4(f). Such measurements, corrected for the ohmic losses in the accelerator structure and the waveguides, show that almost 100% of the power fed into the accelerator structure is reflected backwards. The time at which the reflection is measured is consistent with the time at which the beam position recorded by the beam position monitor starts changing.

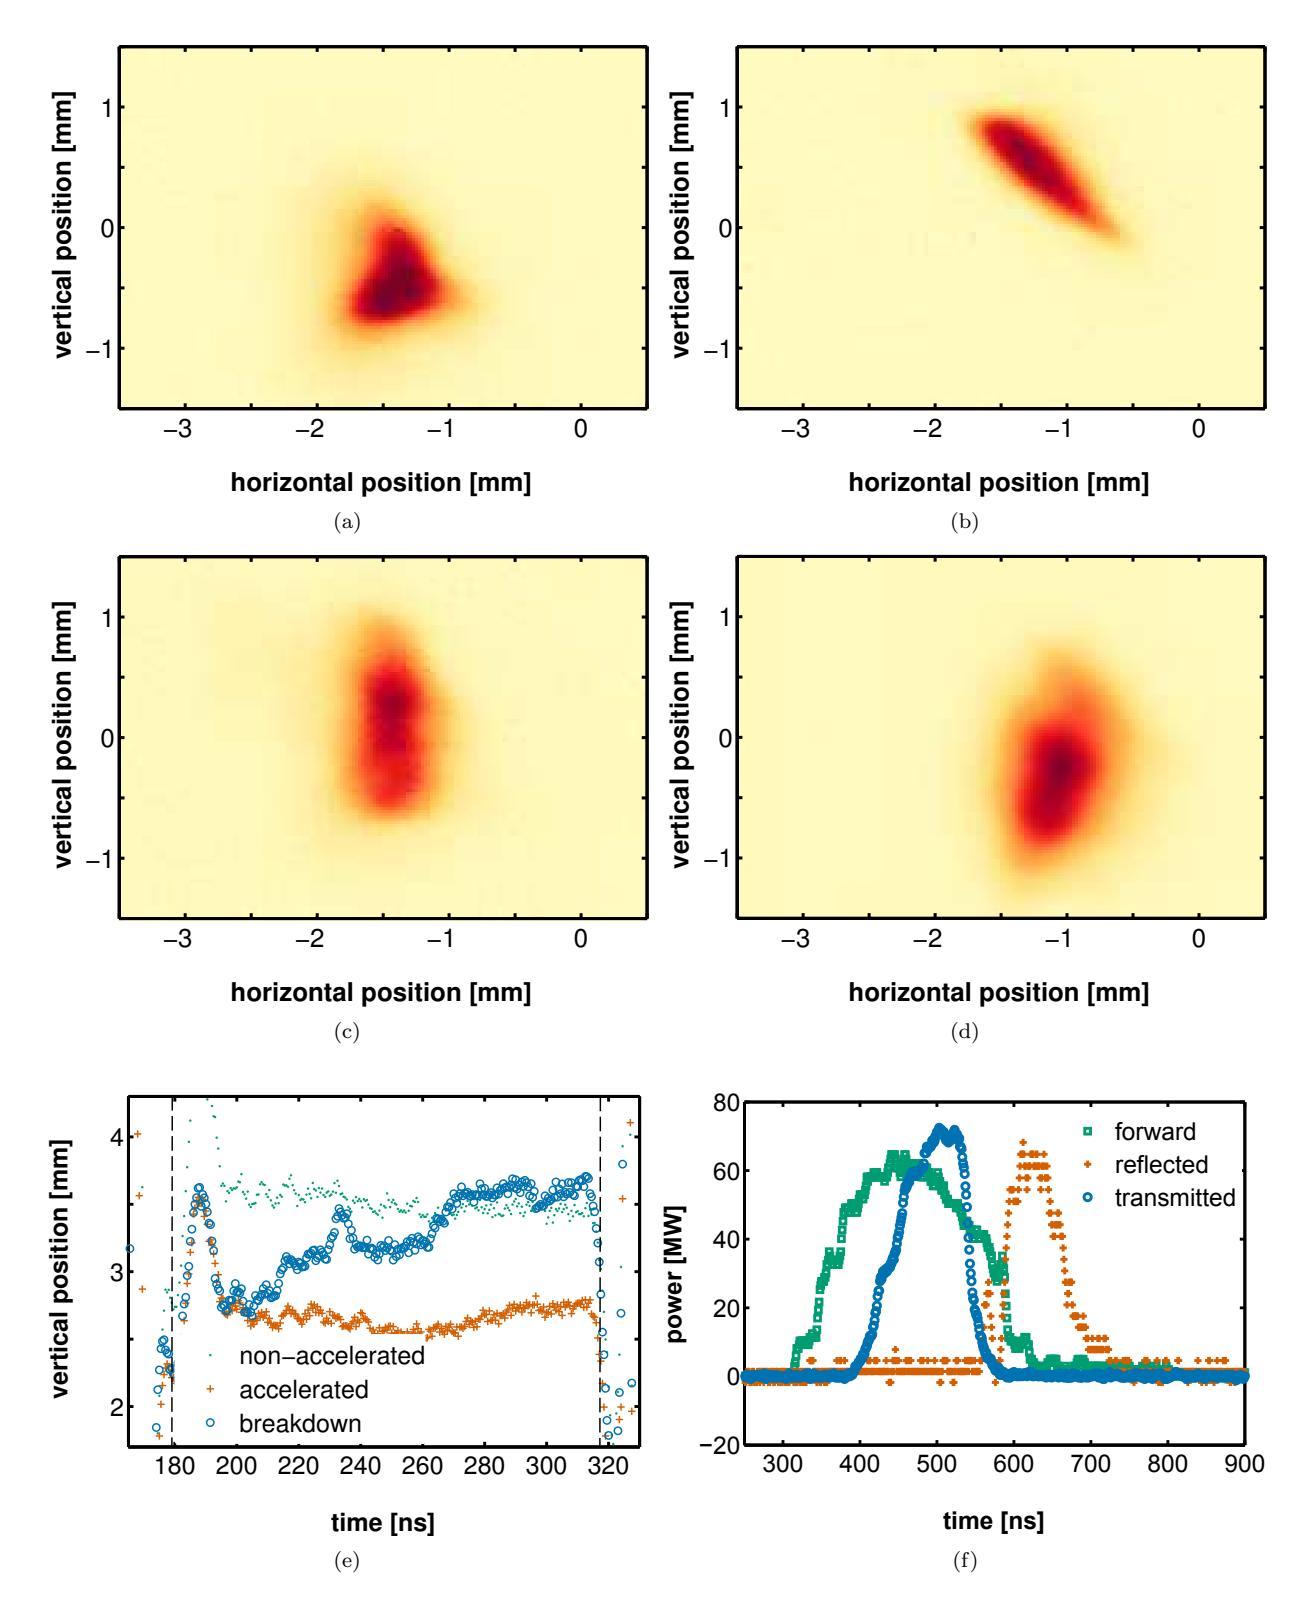
FIG. 5. Collection of measurements from three consecutive bunch-trains and prediction of the beam spot in case of RF breakdown: (a) accelerated bunch-train; (b) non-accelerated bunch-train; (c) bunch-train corresponding to a RF breakdown in the accelerator structure; (d) prediction of the beam spot in case of RF breakdown; (e) beam position measurements; (f) power measurements corresponding to a RF breakdown in the accelerator structure.

The RF breakdowns measured during this experiment have different characteristics and in addition to the breakdown in Fig. 4 discussed in sec. V, we discuss here two particular cases to illustrate other breakdown scenarios. The plot in Fig. 5(e) shows a case in which the beam is accelerated for about 20 ns until its vertical position drifts upwards over about 65 ns and finally remains consistent with the position of a non-accelerated bunchtrain. The 65 ns drift time of the accelerated position towards the non-accelerated corresponds to the filling time of the accelerator structure. This suggests the following explanation: the first 20 ns of the bunch-train are fully accelerated and then a breakdown happens close to the input port of the accelerator structure. From that moment on, most of the power fed to the structure is reflected backwards and therefore the power which fills

the accelerator structure flows towards its output port in 65 ns until the accelerator structure is left almost completely empty. The beam which in the meantime is still travelling in the accelerator structure is less and less accelerated therefore its position slowly drifts towards the position of a non-accelerated bunch-train. Because of the small group velocity in the accelerator structure - from 1.6% to 0.8% of the speed of light - we can estimate the location of the breakdown in the accelerator structure by comparing power measurements at the input and output directional couplers (see Fig. 2). For the breakdown event in Fig. 5 we estimated the breakdown to be localised in the sixth cell of the structure, therefore close to its input port. Moreover the RF measurements for this event in Fig. 5(f) show that almost 100% of the RF fed to the accelerator structure is reflected backwards and that the amount of power that leaks through the breakdown location drops in about 10 ns down to 50% of the input power, and then down to zero during the following 50 ns. Already at 50% of the input power the acceleration is reduced by a factor $\sqrt{2}$ which is consistent with the drift of the beam position from the accelerated to the non accelerated one as shown by the beam position monitor signal in Fig. 5(e).

To test the explanation that we offered to describe a breakdown in the accelerator structure and its effect on the beam orbit and energy, we try to predict how the beam spot looks like on the imaging screen for the breakdown shown in Fig. 4(c) and Fig. 5(c). According to what discussed above, we expect the breakdown beam spot to be a mixture of both the non-accelerated and the accelerated beam spots. When the bunch-train is fully accelerated in the accelerator structure its spot corresponds to an unperturbed accelerated beam spot, whereas after a breakdown we expect it to be a mixture of accelerated and non-accelerated spots according to the proximity of the beam to the accelerated or non-accelerated positions, respectively. In other words, the breakdown spot can be expressed by a linear combination of the accelerated and of the non-accelerated beam spots, whose coefficients at a given time along the bunch-train are derived from the beam position monitor measurements, according to the beam position. The results obtained are shown in Fig. 4(d) Fig. 5(d). We want to stress that the displacement of the beam position in case of a RF breakdown can be due to two different effects, the lack of power in the structure due to its reflection and the direct effect of the breakdown on the beam. When both affect the beam position in the same direction the two effects cannot be disentangled unless we use the beam position monitor in the spectrometer line, which is obscured by the screen used in our measurements.

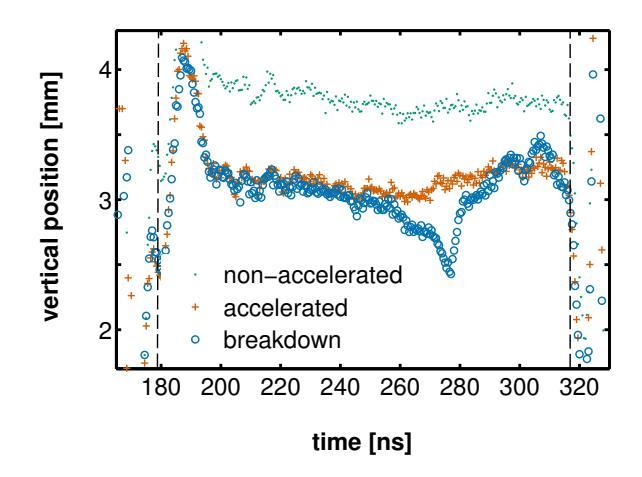
FIG. 6. Vertical beam position measurements corresponding to a non-accelerated bunch-train at the top, an accelerated one in the middle and one corresponding to a RF breakdown during the acceleration at the bottom. The bleep in the bottom signal corresponds to the effects of a short breakdown that displaces downwards the beam position.

A second breakdown scenario is shown in Fig. 6 where the beam position measured with a cavity beam position monitor has a dip in correspondence of a breakdown which lasts for about 20 ns. In this case, during the breakdown the beam is pushed away from the non-accelerated one as it was the case for the breakdown shown in Fig. 5, suggesting that little or no contribution comes from lack of accelerating gradient after the breakdown location or that the breakdown happened towards the output port of the accelerator structure. The estimation of the breakdown location based on RF measurements supports indeed the latter hypothesis, i.e. that the breakdown happened in the last cell of the accelerator structure.

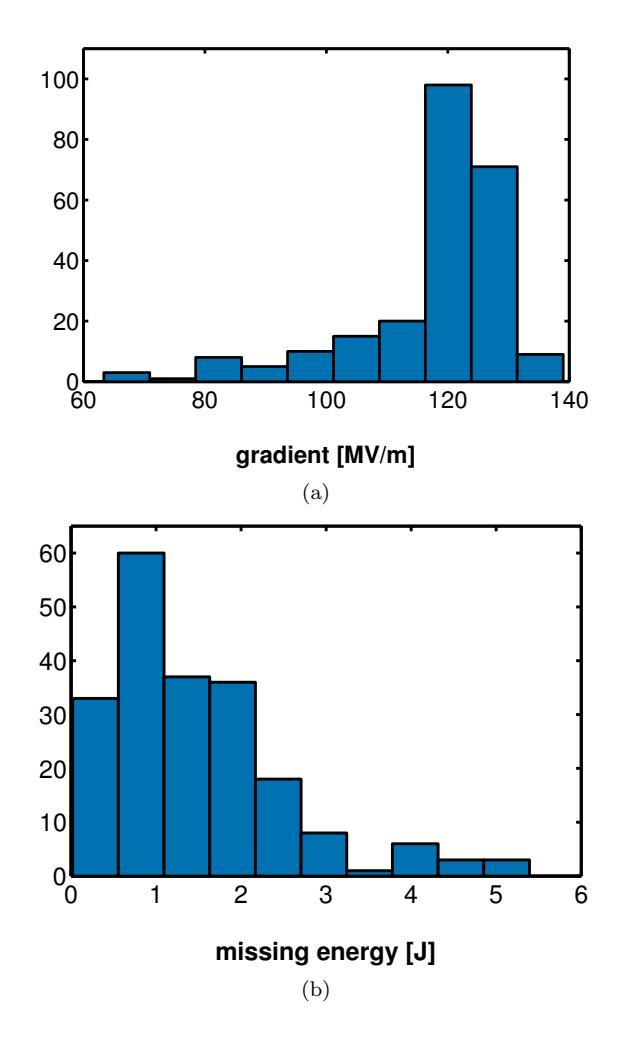
FIG. 7. Distribution of (a) accelerating gradient and (b) missing energy for the 246 breakdown events considered in our analysis.

The analysis described in sec. V and sec. VI for three selected breakdowns has been applied to a bigger data set of 246 breakdowns. Accelerating gradient and missing energy calculated for those events are shown in Fig. 7. The accelerating gradient is calculated from the measurement of RF power fed to the accelerator structure, given that the nominal power required to have an average unloaded gradient of 100 MV/m is 46.5 MW (see Table II). The energy absorbed in each breakdown is calculated as the difference between the energy fed to the structure and the energy transmitted to the structure output plus the energy reflected to the structure input. Attenuation due to ohmic losses is taken into account. The histogram in Fig. 8 shows the distribution of the total angular magnitude of transverse kicks to the beam orbit, whose average magnitude is 0.16 ± 0.08 mrad or 29 ± 14 keV/c. As discussed in sec.VI, this estimation is biased by the effect of the transverse beam acceleration due to the misalignment of the accelerator structure and the beam orbit. Nevertheless, from the analysis of only the non breakdown events we deduce that the maximum magnitude of such effect is about one third of the average magnitude of the kick distribution presented in Fig. 8. In other words the distribution in Fig. 8 represents mainly the effect of breakdown kicks, because the contribution of acceleration kicks is smaller than 30%. Finally, we looked for correlations between the magnitude of the kick angle and the location of the breakdown in the accelerator structure or the energy dissipated in the breakdown. None of these correlations is statistically significant.

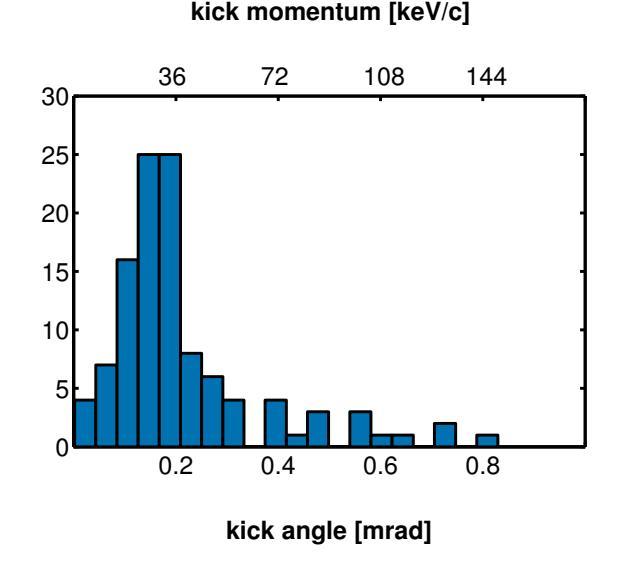
FIG. 8. Distribution of the total magnitude of RF breakdown kicks to the beam orbit.

The average magnitude of transverse kicks to the beam measured in this experiment is of 29 ± 14 keV/c in terms of transverse momentum transferred to the beam, or 0.16 ± 0.08 mrad in terms of the angle given to the 180 MeV probe beam. We consider as worst case scenario the case in which only RF breakdown contribute to the measured kicks because such kicks cannot be avoided. The worst place where a breakdown kick can happen in CLIC is at the beginning of the main linac where the beam energy is 9 GeV. For such energy a transverse kick of 29 keV/c corresponds to a kick angle of about 4 μ rad. It is worth noting that such angle is one order of magnitude bigger than the nominal CLIC beam divergence
