BEAM LOSS CONTROL FOR THE FERMILAB MAIN INJECTOR*

Bruce C. Brown[†], Fermilab, Batavia, IL 60510, USA

Abstract

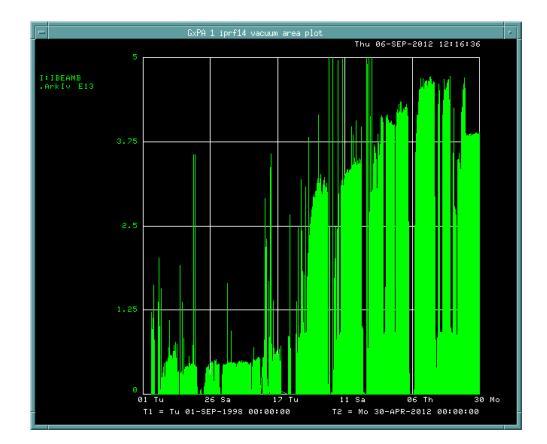
Figure 1: Sampled Intensity per cycle from September 1998 through April 2012.

Figure 1 illustrates this intensity increase using the number of protons per cycle on a periodic sample of the acceleration cycles. An injection from the Booster is termed a 'batch' with typical intensity of $4-5 \times 10^{12}$ protons and up to 84 rf buckets of beam. Machine commissioning was followed by multibatch operation for a Tevatron fixed target run. In 2001, this transitioned to a Tevatron collider run which utilized a single batch from the Booster for pbar production. Slip stacking injection of two Booster batches for pbar production was developed in 2004. Injecting two batches into buckets of different frequency allows momentum stacking when the buckets slip into alignment and the beam is recaptured in a larger rf bucket. The NuMI beamline for neutrino production was commissioned in 2005 requiring acceleration in each cycle of 5 Booster batches for NuMI in addition to a double batch for pbar production on each cycle (5 plus 2). Slip stacking for increased NuMI beam (9 plus 2) was commissioned in 2007 as was the Main Injector collimation system. At that point intensity was limited by losses in both the Main Injector and the Booster. Collimation, along with improved Booster beam quality, controlled activation and permitted Main Injector intensity per cycle to increase.

Several other features of the Fermilab HEP program are apparent in Fig. 1. Facility upgrades are accomplished using shutdown periods of several weeks. Periods of reduced intensity mark the times required to repair or replace the NuMI horn or target. When pbar production was ended neutrino target intensity limits due to thermal shock could be met by accelerating 9 batches with only three being slip stacked. Reduced per pulse intensity from September 2011 through April 2012 reflects this limitation. The spikes which report exceptionally higher intensity are instrumental. The data uses some of the instrumentation which was replaced by 2007 (see below) and spike above the trend are typically due to instrumentation or data recording errors.

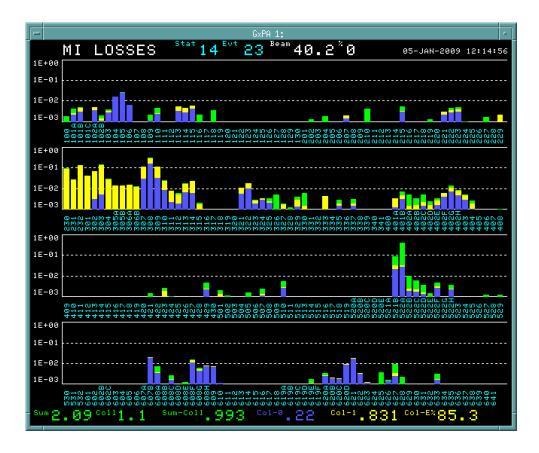
Figure 2: Beam Loss Monitor Display from Main Injector Cycle in January 2009 at an intensity of 4×10^{13} protons. Blue shows loss before acceleration, yellow after 1% acceleration, green at end of cycle. Losses in left of upper row are from injection kicker gap. Left end of second row shows collimation loss. Loss at right end of third row are at 522 extraction Lambertson; loss at left of fourth row are at 608 extraction Lambertson; loss at right of fourth row are at 620 Lambertson.

Successes in reducing loss were gratifyingly apparent with the loss display shown in Figures 2 and 4. For the last years of running, we had successfully attacked many losses, eliminating some entirely.

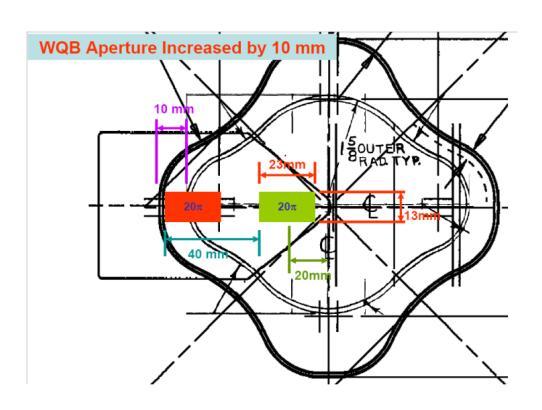
Figure 3: Aperture Improvement using WQB large aperture quadrupoles.

Unsurprisingly, improved apertures allow reduced losses. A major upgrade of the Main Injector apertures was accomplished in 2006 by installing a few quadrupoles with much improved apertures at beam transfer locations. The Lambertson-style septum magnets at injection, abort and extraction points place a septum near the center of nearby quadrupole apertures. Large aperture quadrupole magnets [7, 8] permit the circulating beam orbit to be placed in a region much further from the beam pipe but also in a region of much better magnetic field quality. Figure 3 shows the aperture now provided in one of these transfer locations. The new beam pipe is illustrated by the 'star-shaped' pipe surrounding other features. Beam apertures through the Lambertson magnets are left (circulating) and right (transferred) of center. The beam pipe for the standard quadrupole which were used previously in transfer regions is the smaller star shaped pipe. The injected beam size is shown with the new range of available positions.

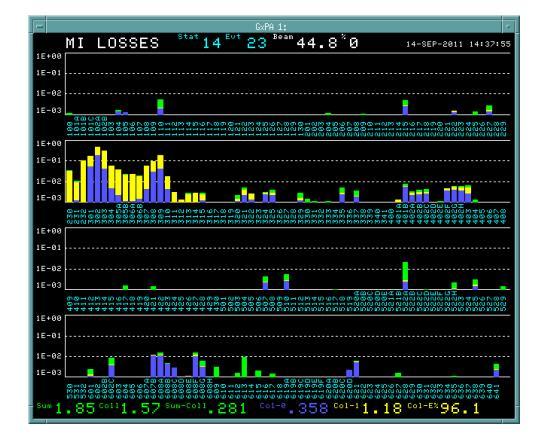
Figure 4: Beam Loss Monitor Display from September 2011 at intensity of 4.5×10^{13} protons. Loss lower everywhere except at collimators.

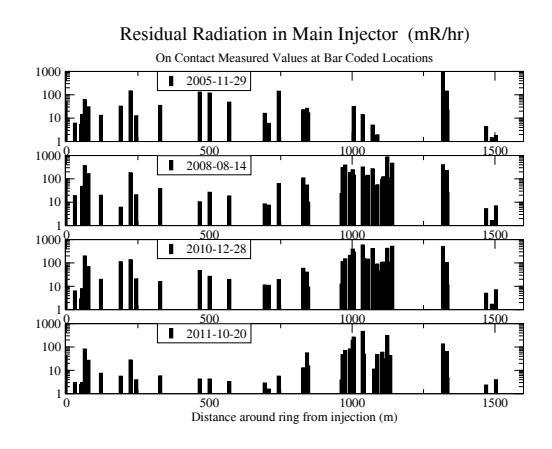
Figure 5: Residual Radiation History from Injection to Abort Region.

For each bar coded location, we have a series of more than 40 measurements from 2005 through 2012. Control console programs allow one to display these results and to fit them to the half-life-weighted BLM readings available

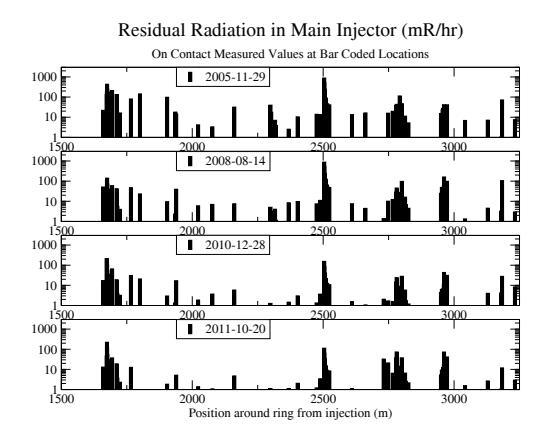
Figure 6: Residual Radiation History from Abort Region to Injection.

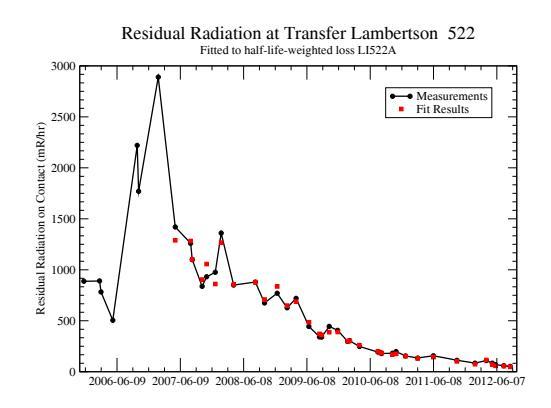
for each beam pulse[15].Figure7 shows a most atypical such plot for the residual radiation at the extraction point for antiproton production. High losses associated with commissioning of slip stacking and NuMI start-up were mitigated with collimation removal of kicker gap beam such that loss free operation was achieved for extended periods of time. Much of the remaining residual radiation is still

Figure 7: Residual Radiation History at Upstream End of Lambertson LAM522 (transfer and extraction).

from activation many years ago. For more typical locations, the radiation reduction during multiweek shutdowns are apparent. Tools to show integrated loss (see HB2010 presentation[15]) allow examination of any BLM to allow comparison of losses with any observation of new high radiation points. These tools were used for radiation exposure planning for the 2012 facility shutdown. Active monitoring of residual radiation continues.
