Crystallites in Color Glass Beads of the 19th Century and Their Influence on Fatal Deterioration of Glass

Abstract. Glass corrosion is a crucial problem in keeping and conservation of beadworks in museums. All kinds of glass beads undergo deterioration but blue-green lead-potassium glass beads of the 19th century are subjected to the destruction to the greatest extent. Blue-green lead-potassium glass beads of the 19th century obtained from exhibits kept in Russian museums were studied with the purpose to determine the causes of the observed phenomenon. For the comparison, yellow lead beads of the 19th century were also explored. Both kinds of beads contain Sb but yellow ones are stable. Using scanning electron microscopy, energy dispersive X-ray microspectrometry, electron backscatter diffraction, transmission electron microscopy and X-ray powder analysis, we have registered the presence of crystallites of orthorhombic KSbOSiO4 and cubic Pb₂Sb_{1.5}Fe_{0.5}O_{6.5} in glass matrix of blue-green and yellow beads, respectively. Both compounds form at rather high temperatures obviously during glass melting and/or melt cooling. We suppose that the crystallites generate internal tensile

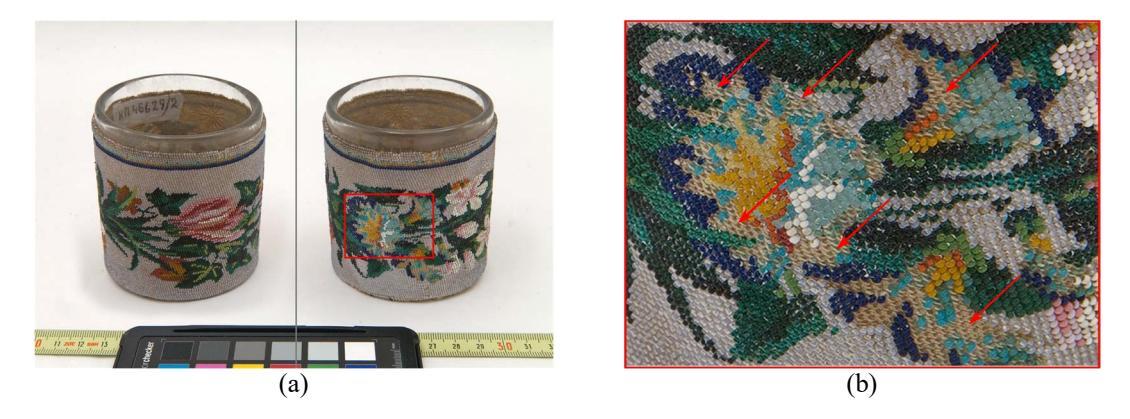
FIGURE 1. Beaded glass-holder of the 19th century from the collection of the Museum of A. S. Pushkin, Moscow (a) and its fragment (b) before restoration; numerous gaps of turquoise glass seed beads are seen in panel (b), some of them are pointed with arrows.

Glass seed bead embroideries were very popular in the 18th and 19th centuries both in Europe and in Russia.^{1,2} Beadworks depicting landscapes, portraits, flowers, battle-pieces, genre scenes, icons were widely used for housewares decoration (Fig. 1). Such handiworks are presented in many arts and historic museums of Europe, North America and Russia among collections of arts and crafts.

Samples of cloudy blue-green and yellow glass seed beads were obtained during restoration of secular beaded items of the 19^{th} century from museum collections of Russia (Fig. 1). During the study of the blue-green beads, samples with different deterioration degrees were explored (Fig. 2 (b)–(h)).

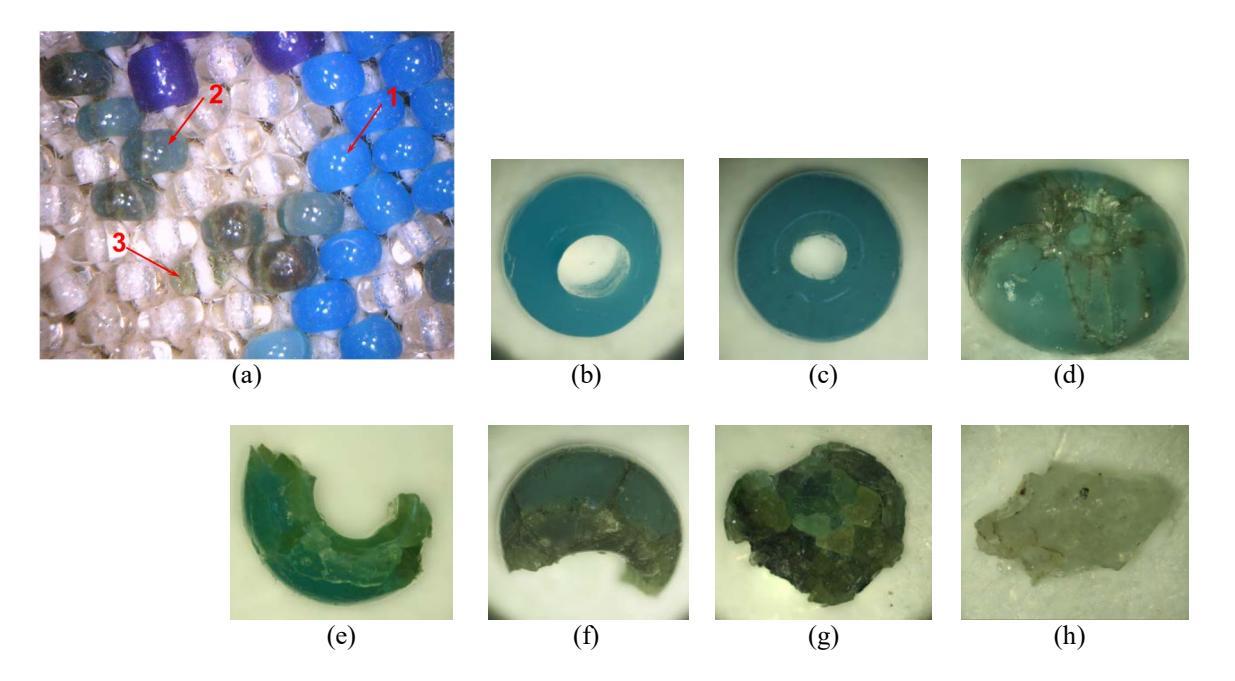
FIGURE 2. (a) Macro photograph of a damaged part of a beaded glass-holder; blue-green glass beads at different degrees of degradation (intact, severely cracked with color change and partially broken) are pointed by numbers 1, 2 and 3, respectively. (b)–(h) Micro photographs of blue-green beads at different stages of deterioration in the reflected polarized light: firstly, cracks appear in the blue beads. While cracking increases, the color starts to change into a greenish or yellowish tone. Further degradation is accompanied by bead discoloration and formation of a grainy structure. Such beads are very fragile so they eventually break into fragments.

The detailed examination of beadworks with corroded turquoise glass beads identified the following feature: there are both intact blue-green glass beads and degraded ones on the same beaded embroideries of the 19th century. Moreover, the beads at different stages of corrosion are situated side by side (Fig. 2 (a)). Being used in

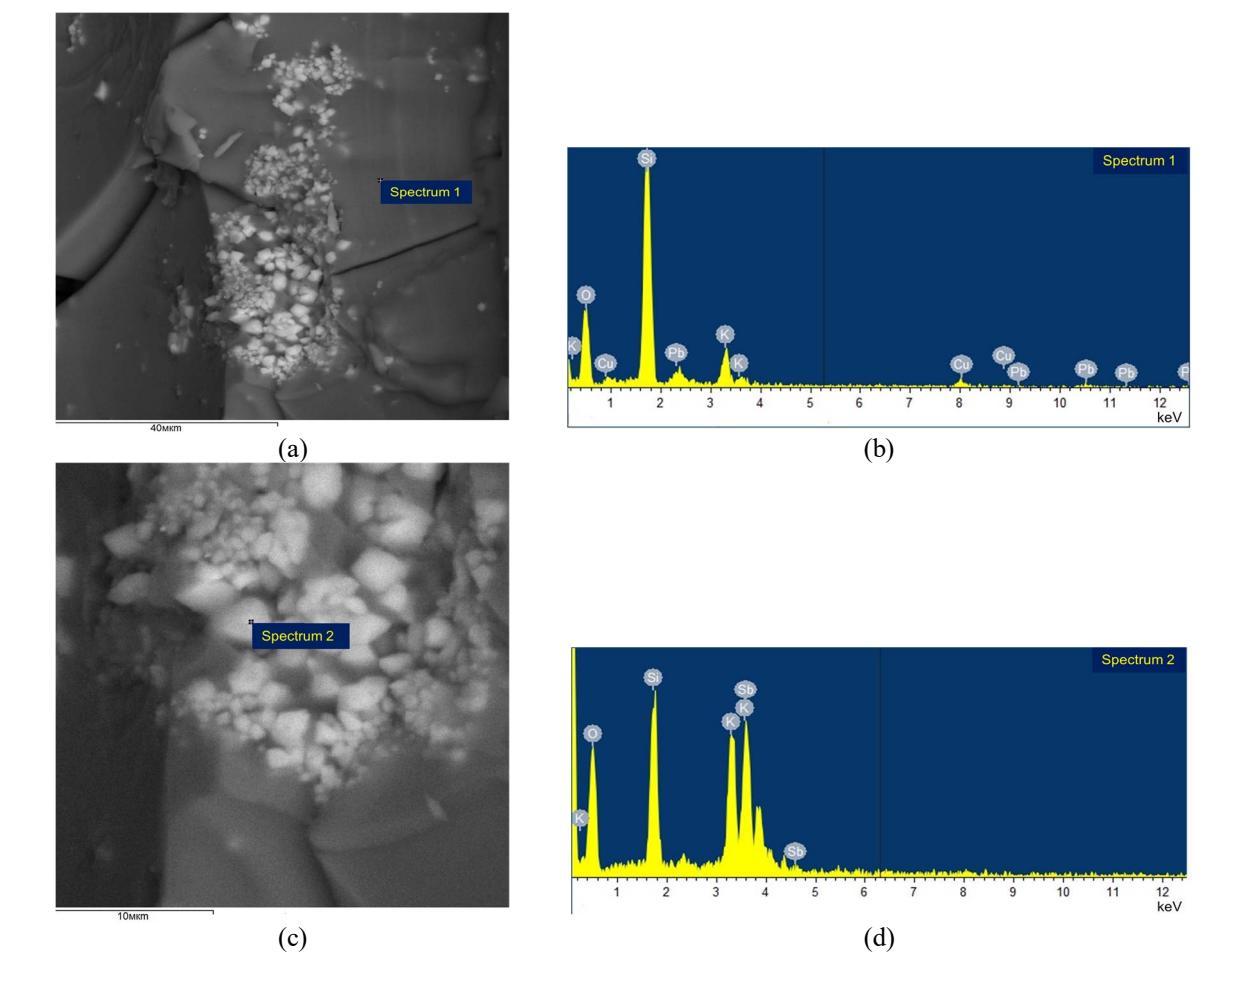
SEM images and EDX spectra are represented in Fig. 3. Numerous faceted particles were found at different points of the studied samples during the detailed analysis of glass surface around the cracks and far from them.

FIGURE 3. (a), (c) SEM BSE images of glass surface area with colonies of some crystallites (after fragmentation of turquoise bead at the final degradation stage); (b), (d) EDX spectra obtained at points indicated in panels (a) and (c) (Spectrum 1 and Spectrum 2).

The investigation of the composition of glass bulk by the use of EDX has allowed us to establish that turquoise seed beads are made of lead-potassium glass (Fig. 3, spectrum 1). Such elements as copper and aluminum were also registered.

The crystalline inclusions found in blue-green beads at different phases of corrosion—intact, slightly cracked, severely cracked and changed the color or discolored, partially or completely fragmented—contain potassium, antimony, silicon and oxygen in their composition (Fig. 3, spectrum 2).

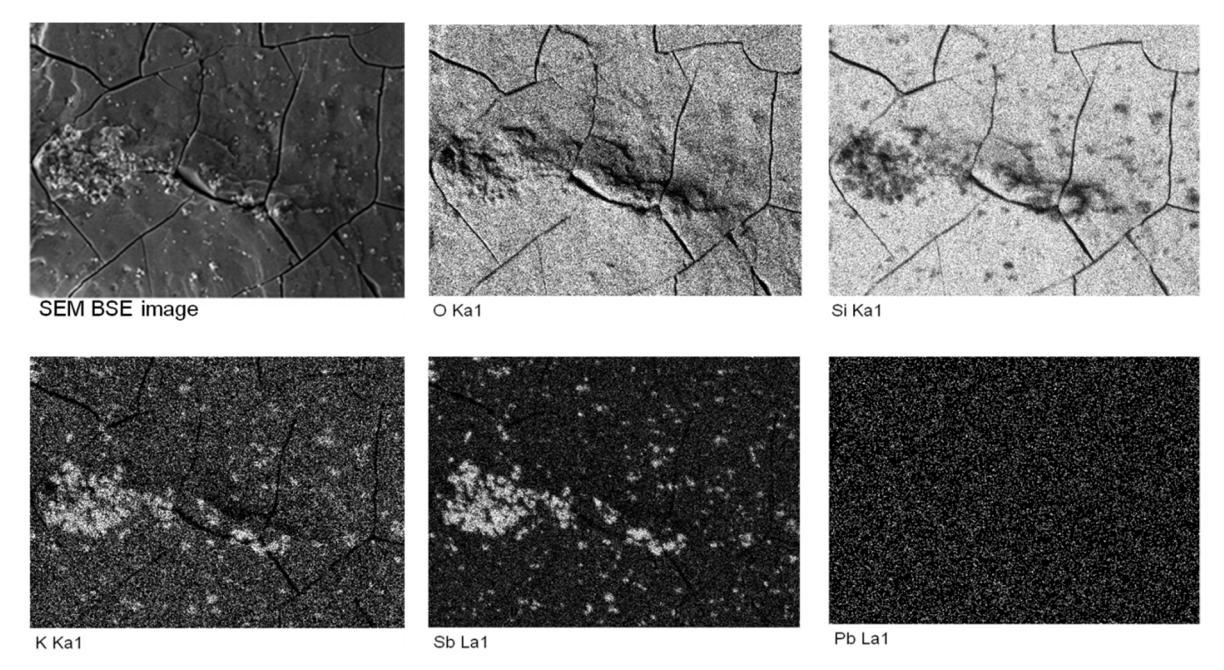
FIGURE 4. Maps of some chemical elements obtained using EDX during the investigation of a selected scanned area.

To visualize chemical elements distribution using EDX, we have plotted their spatial maps (Fig. 4).

The following features have been observed: (i) regions of decreased fraction of silicon coincide with the Sbrich precipitates; (ii) regions of increased fractions of antimony and potassium also coincide with the Sb-rich precipitates; (iii) no deviations of oxygen fraction from its mean value are observed; (iv) other elements registered in EDX spectra do not demonstrate any reliable deviations from their mean values in glass.

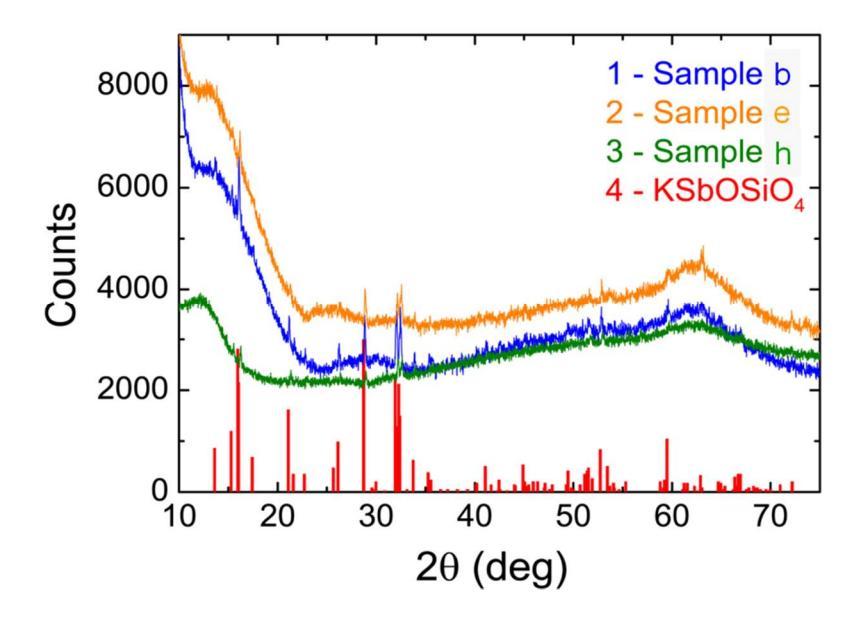
FIGURE 5. X-ray powder patterns of bead samples at different degradation stages (see panels (b), (e) and (h) in Fig. 2) demonstrating the presence of the orthorhombic KSbOSiO₄ phase.

antimony silicate KSbOSiO₄ (further KSS) was identified in all samples [symmetry *Pna*2₁ (33), PDF-2 Card # 01-080-1595] (Fig. 5).

Some reflexes detected in diffraction pattern have not been identified. We suppose that they relate to a crystalline phase of SiO_2 ; it requires further clarification, however. Nevertheless, it should be noted that the devitrification of glass under study is not observed even over the time far exceeding human lifespan. It correlates with the properties of lead oxide based glasses that are applied in optical and electronic devices and characterized by high refractivity, chemical durability, low melting point and stability against glass crystallization.⁷

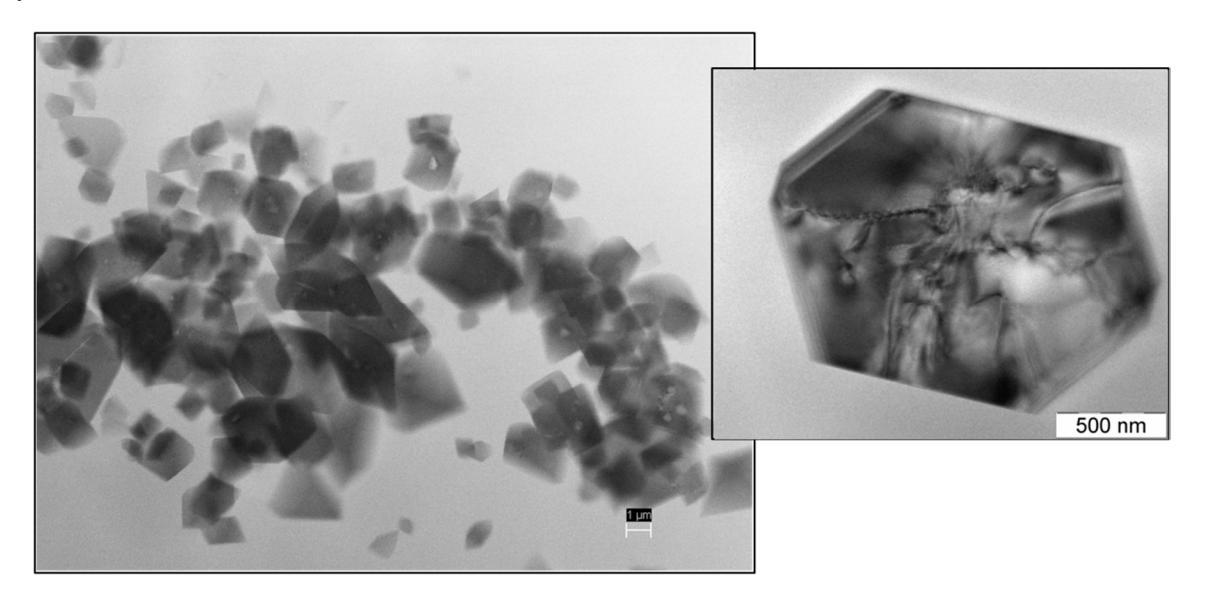
FIGURE 6. STEM image (left) of a KSS cluster and TEM image (right) of a typical KSS crystallite.

Using transmission electron microscopy, we managed to estimate the sizes of the KSS crystallites, which vary from nearly 200 nm to several tens of μ m. This compound forms whole colonies (Fig. 6).

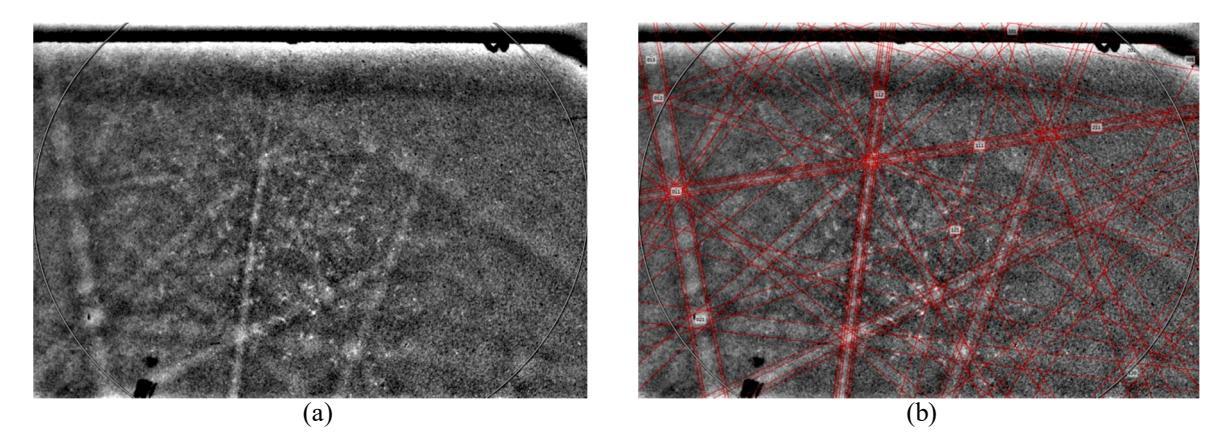
Electron backscatter diffraction enables one to explore separate crystallites in contrast to X-ray powder diffraction. Using of EBSD, we managed to confirm that namely orthorhombic KSS compose the observed crystallites in turquoise lead-potassium glass (Fig. 7).

FIGURE 7.Kikuchi patterns observed in blue-green glass beads (a) and assigned to orthorhombic KSbOSiO₄ with the analysis system (b).

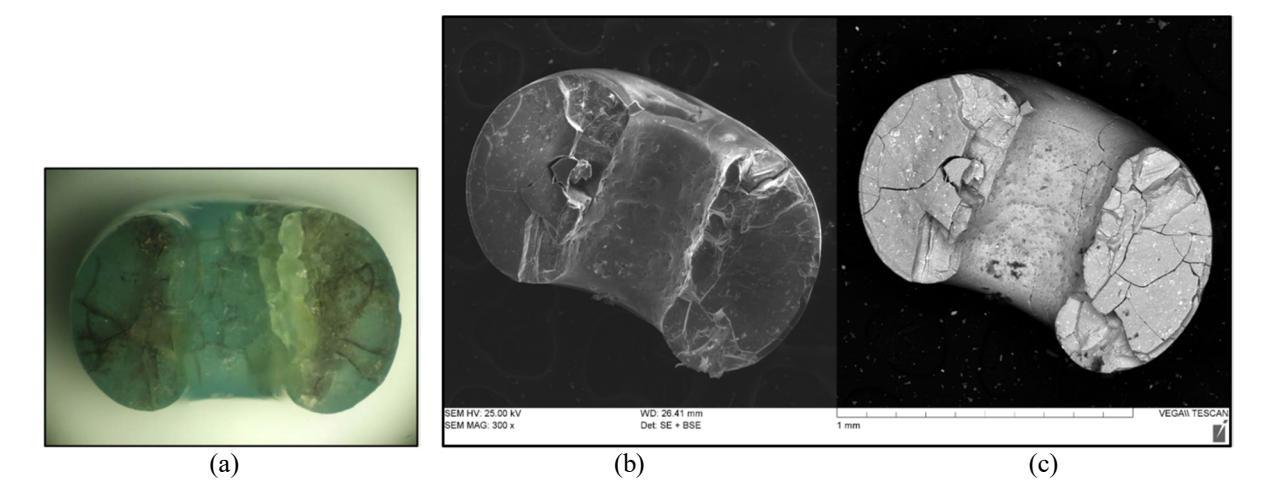
FIGURE 8. (a) Micro photograph of a degraded blue-green glass bead in the reflected polarized light, (b) SEM SE and (c) SEM BSE images of the same sample.

The effect of these crystals on glass corrosion process may be described in the following way. Once formed, the KSS crystallites generate internal tensile strain in the cooled glass because of some difference in their linear thermal expansion coefficients. It causes the formation of multiple microcracks in inner domains of beads. SEM images presented at Fig. 8 illustrate the above-mentioned statement: cracks, which look in the micro photograph as if they cover the surface of a bead hole, in reality do not reach the glass surface and are located in the bead internal domain.

The formation of multiple microcracks eventually gives rise to glass rupture and formation of heterogeneous sand grains.

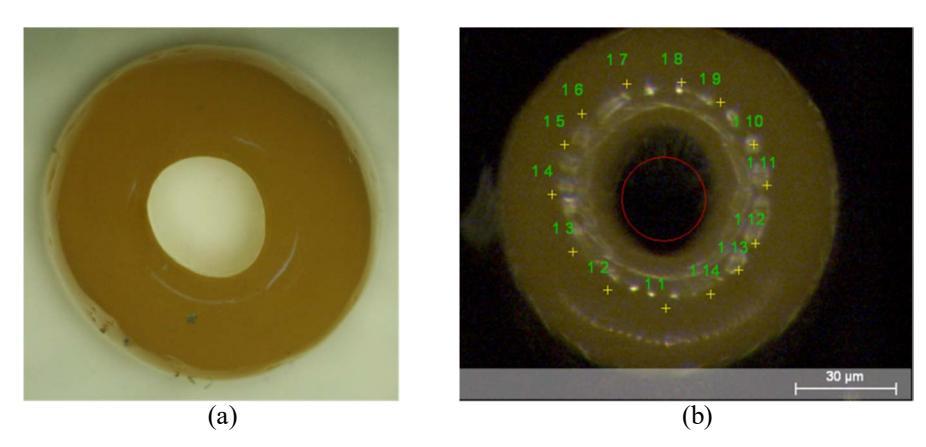
FIGURE 9. Micro photograph of yellow glass bead in the reflected polarized light (a) and an image of the sample with indication of the points at which XRF measurements were carried out.

The study by the use of X-ray fluorescence microspectrometry has shown that the yellow beads are made of lead glass (Fig. 9, Table 1). The content of lead in them is significantly higher than in blue-green lead-potassium glass. Like turquoise glass, the yellow one also contains antimony but in much less proportion. According to our previous work,⁴ like in the turquoise beads, antimony is contained only in inclusions, not in glass matrix.

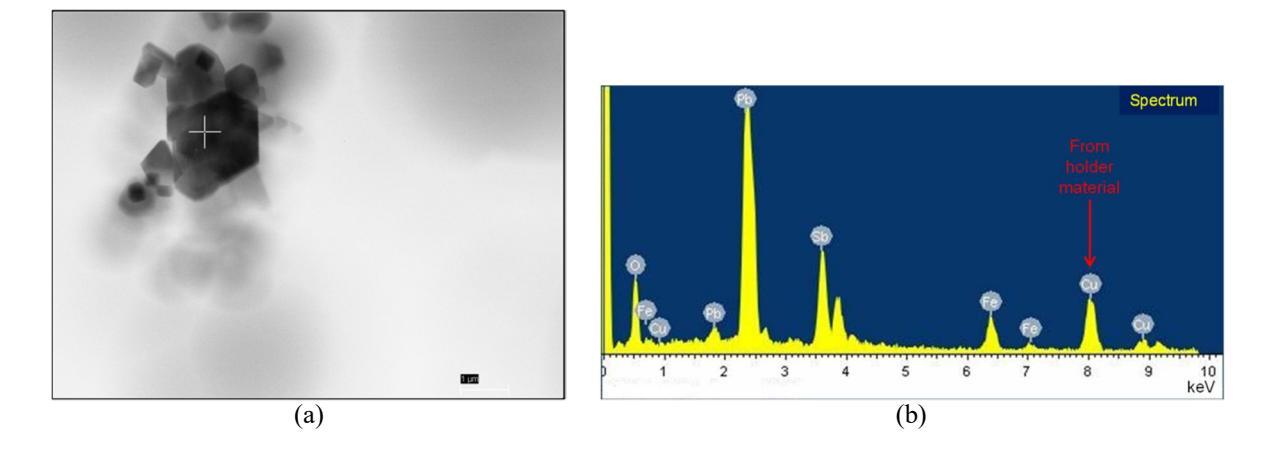
Using transmission electron microscopy, we managed to determine the composition of these inclusions and to estimate their sizes. STEM image presented at Fig. 10 (a) demonstrates that these inclusions are clusters of small crystallites. Their sizes vary from a few hundreds of nanometers to about 1 μ m. According to EDX analysis, the crystallites consist of lead, iron, antimony and oxygen (Fig. 10 (b)). The copper detected using EDX is from the sample holder material.

FIGURE 10. (a) STEM image of an inclusion in glass matrix of a yellow bead, EDX analysis point is marked by a cross; (b) EDX spectrum obtained at this point.

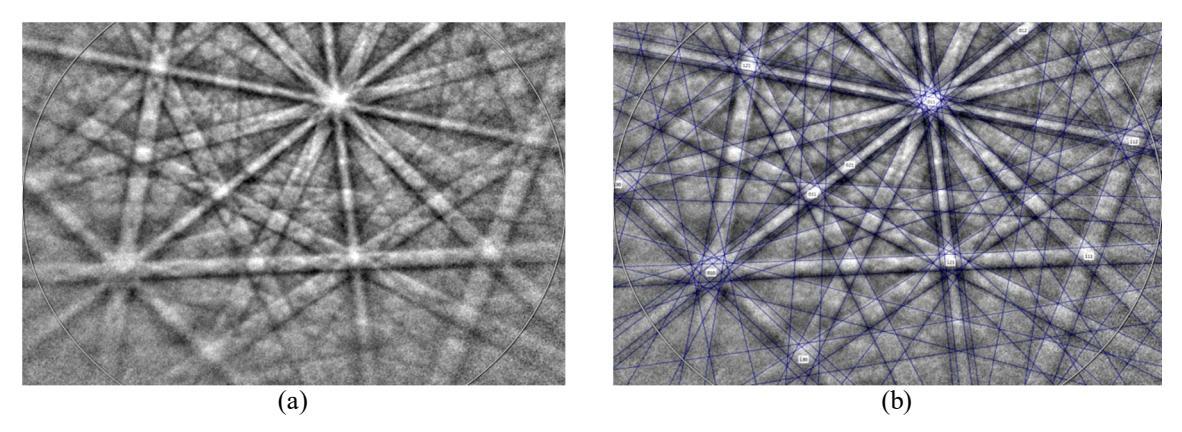
Kikuchi lines shown in Fig. 11 prove the crystallinity of the inclusions and identify them as cubic lead iron antimony oxide $Pb_2Sb_{1.5}Fe_{0.5}O_{6.5}$.

FIGURE 11. Kikuchi patterns observed in yellow glass beads (a) and assigned to cubic Pb₂Sb_{1.5}Fe_{0.5}O_{6.5} with the analysis system (b).

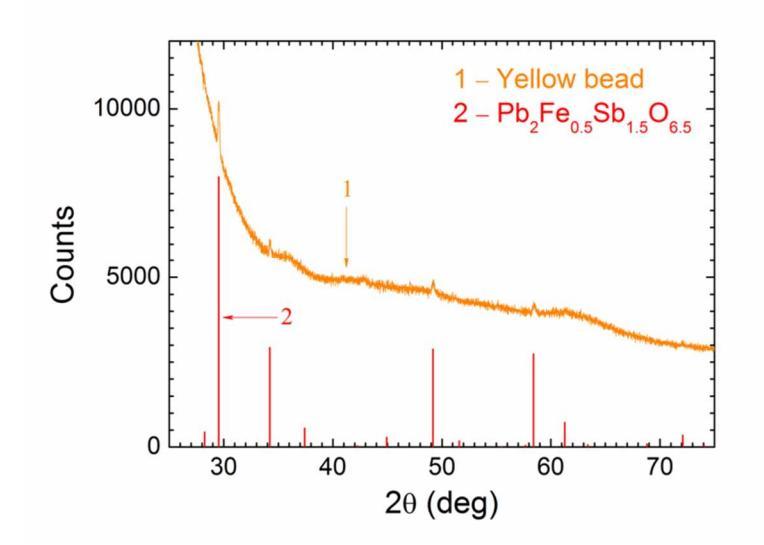
FIGURE 12. X-ray powder pattern of a yellow glass bead (Fig. 9) demonstrating the presence of the cubic Pb₂Sb_{1.5}Fe_{0.5}O_{6.5} phase in glass.

The presence of this substance was also determined by X-ray powder diffraction analysis of a yellow bead powder. The diffraction pattern (Fig. 12) corresponds to cubic $Pb_2Sb_{1.5}Fe_{0.5}O_{6.5}$ (symmetry *Fd-3m* (227), PDF-2 Card # 01-077-2454).

This compound is a derivative of Naples yellow (Sb₂O₅·nPbO) with some iron atoms replacing ones of antimony. Naples yellow is a pigment widely used in the 18th and 19th centuries in paintings.¹¹
