Estimation of fatigue life of TiN coatings using cyclic micro-impact testing

Abstract

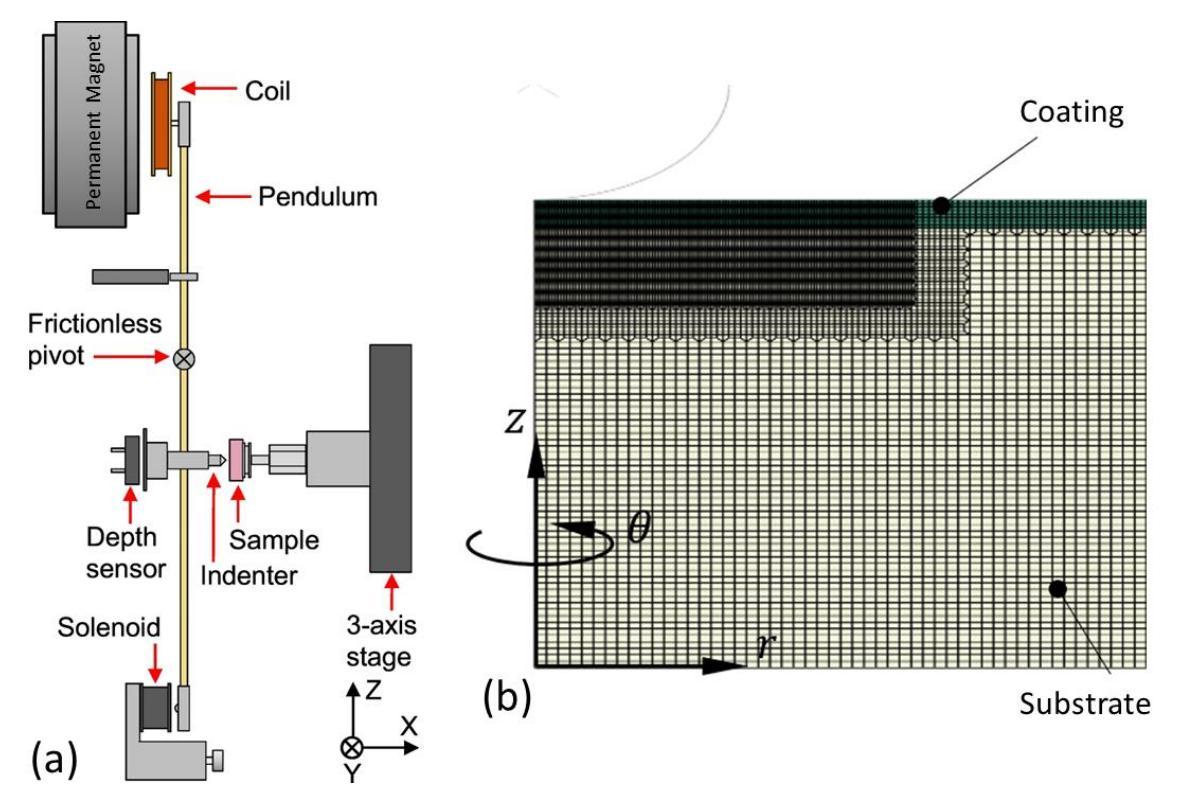
Figure 1: (a) Schematic of the Pendulum-based micro-impact testing, culled from Rueda-Ruiz et al. [15]. (b) Finite element model of indentation experiment.

In the dynamic hardness test (Figure 1a), the impact was produced by using a solenoid to raise the pendulum armature to its raised position; the solenoid was then turned off, releasing it and allowing the pendulum to accelerate towards the specimen surface with a measured acceleration to induce a specific load called the *acceleration load*. The indenter displacement along the acceleration arc and during the impact was recorded with a 10 kHz data acquisition frequency, allowing for the indenter velocity and impact instantaneous strain rate to be measured and calculated, respectively [14]. A range of incident velocities spanning nearly two orders of magnitude was achieved by varying the acceleration and the spacing between the solenoid and pendulum [15]. In addition, the maximum material penetration, residual deformation, and the ability to plastically deform the coating were calculated from the displacement and time data [16]. The dynamic hardness tests were repeated five times.

Finite element analysis (FEA) of the indentation experiment was performed using ABAQUS[®] software (version 6.6). An axisymmetric finite-element model was used (Figure 1b). The model was divided into two regions: the TiN coating and the ASP-23 tool steel substrate. The width and height of the half-space were taken as five times the indenter radius, which is essential for avoiding boundary effects. A uniformly refined element region was created beneath the indenter in the coating and substrate to control element length. 4-node bilinear axisymmetric elements (CAX4H) were used to discretise the axisymmetric conditions. It should be mentioned that a hybrid formulation was adopted to improve the convergence at large strains, where incompressible plastic deformation dominates. The mesh had 14,400 elements with a controlled element length of 0.09 μ m in the refined region, necessary to obtain an optimal solution, as confirmed by a convergence study that varied the element size over the ranges $l_e \in [0.05, 0.09, 0.20] \mu$ m.

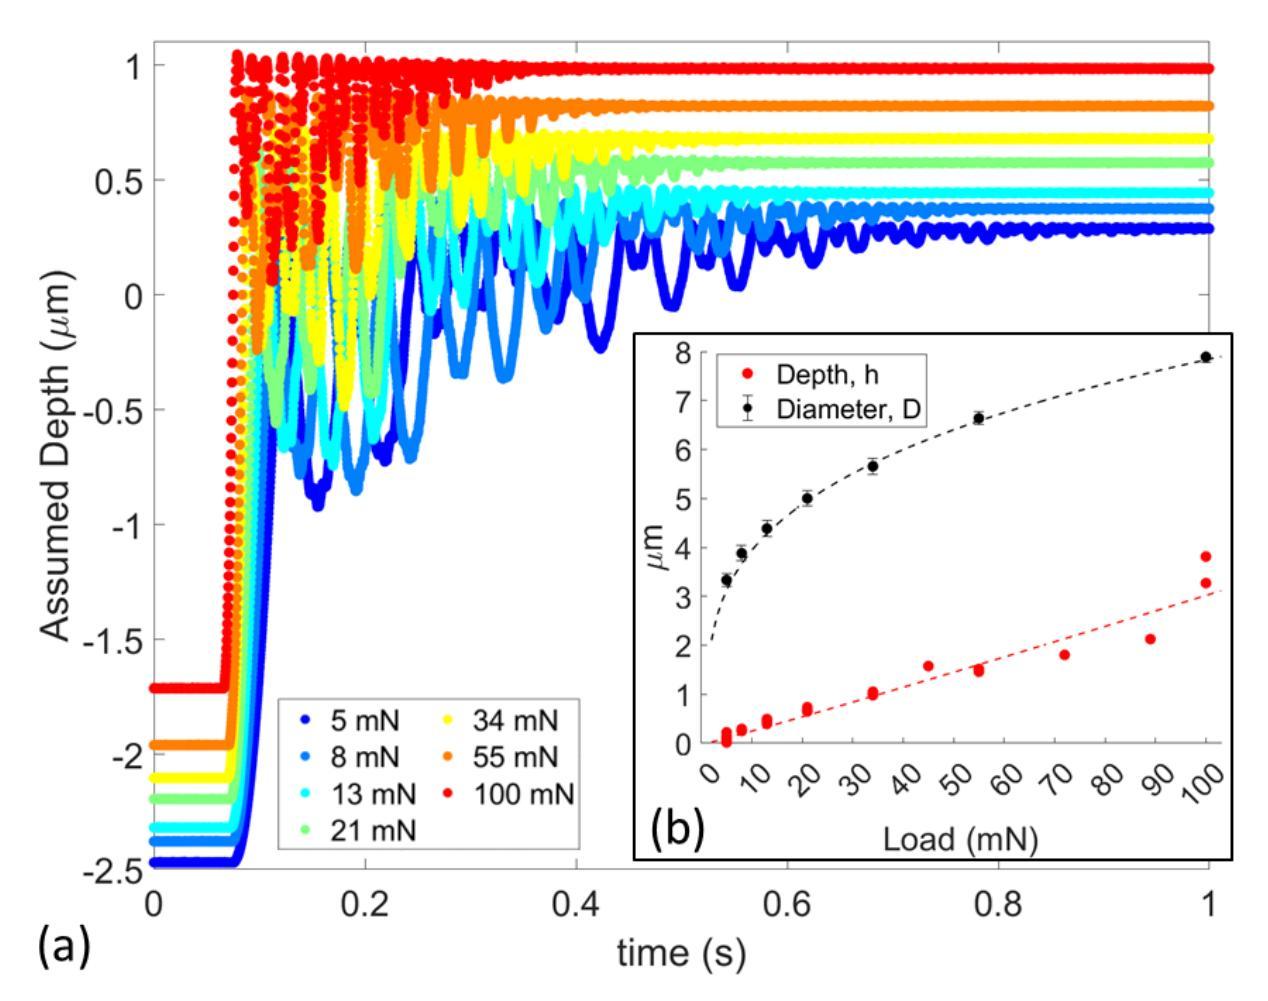
Figure 2: a) Assumed impact depth measured during the dynamic impact test for individual tests at seven acceleration loads. Plus and minus depth values describe the pendulum swinging motion, with zero being the crater's inferred depth. b) The measured depth (h) from the impact testing plotted against the impact crater's diameter was measured from SEM images of multiple tests at the seven loads.

The depth-time profile (Figure 2a) indicates that the indenter bounced off the surface of the specimen multiple times (i.e., the ringing effect) until it reached a resting position against the specimen surface under an acceleration load. However, it was previously concluded that plastic deformation only occurred during the initial impact. In contrast, the secondary indenter impacts (i.e., bounces owing to the ringing effect) did not produce plastic deformation [23].

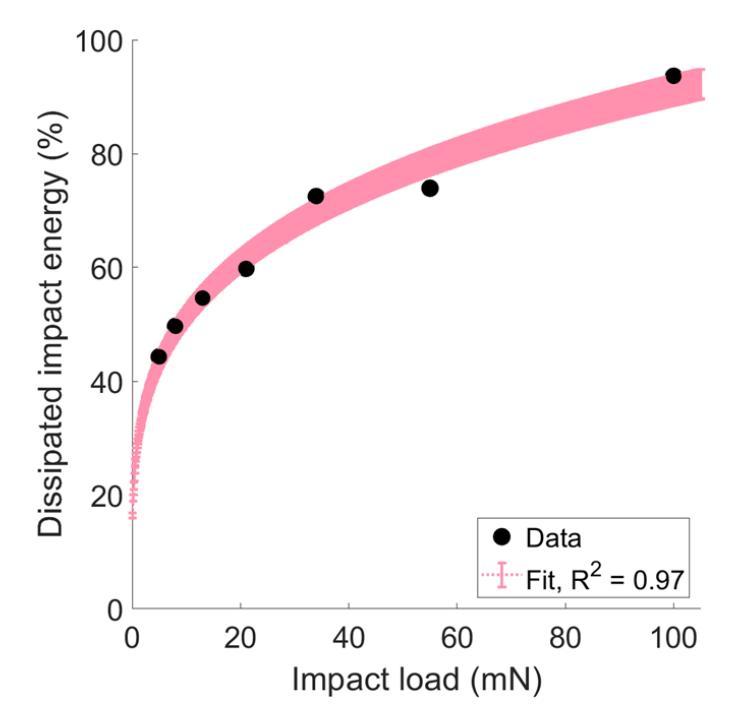
Figure 3: Energy dissipated ($E_{I,dis}$) from dynamic impact testing as a function of impact acceleration load (L). The fit is $E_{I,dis}(\%) = 29L^{0.25}$.

As shown in Figure 3, the percentage of dynamic energy change/loss increases with the accelerating load, with approximately 40% of the energy dissipated at 5 mN, which leaves an impact with a depth of approximately 500 nm. At low loads, the response was mainly due to

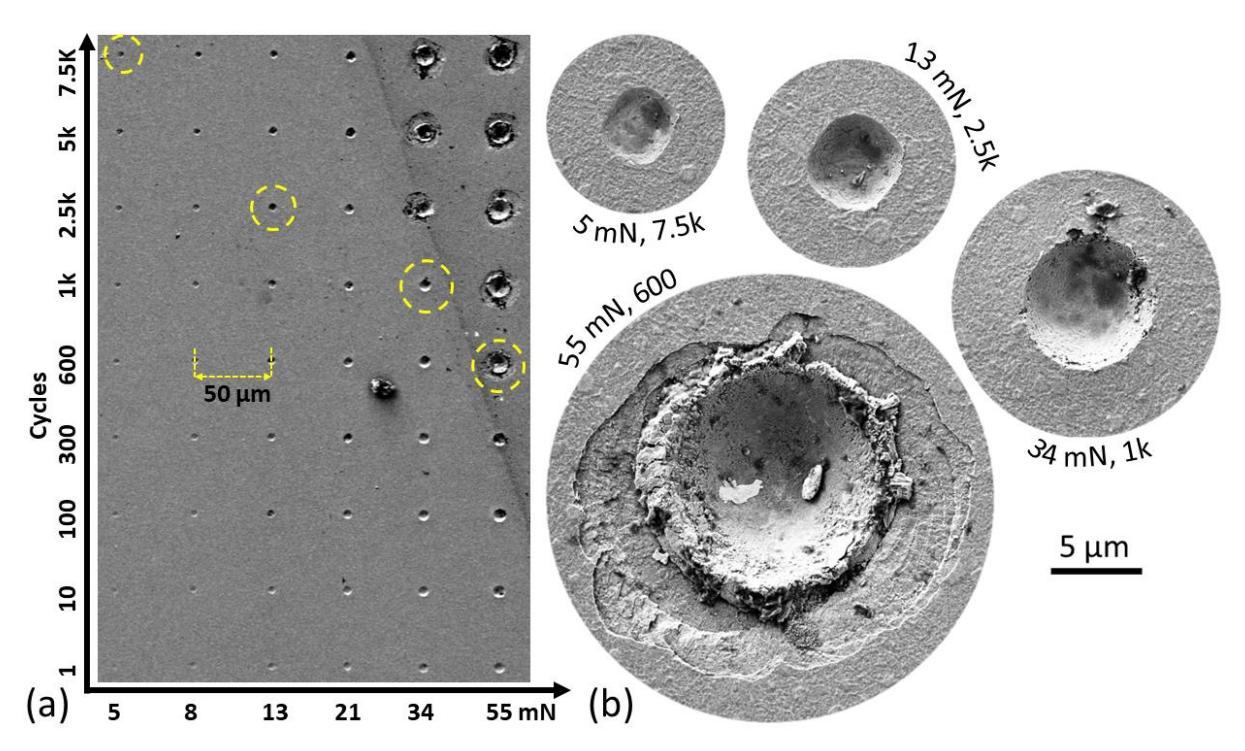
Figure 4: Low-voltage secondary electron image (SEM) of the craters of repeated impact tests on TiN coating with a diamond spherical indent for a range of cycles and acceleration load at room temperature. (b) SEM images for the impact sites' microstructures with the load (mN) and number of cycles indicated on the image correspond to locations circled in (a).

The diameter of the impact crater increased with increasing number of cycles, indicating that the coating-substrate system underwent permanent plastic deformation during each cycle (Figure 4a). This plastic deformation accumulated as cycles increased, leading to coating failure at the point of impact (Figure 5a), accompanied by coating chipping radially around the impact crater (Figure 4b). In addition, the magnitude of the increment in the diameter of the impact crater depended on the load. This indicates that the ability of the coating-substrate system to withstand cyclic loading can be load-dependent at higher loads, as it results in more significant damage to the coating-substrate system from the first impact. Thus, the relationship among the number of repeated impacts (cycles), acceleration load, and impact crater diameter can describe the mechanical behaviour of the coating-substrate system under cyclic loading.

Although TiN is known to have excellent adhesion, its fracture toughness is not very high relative to other materials [47], [48], [49]. Thus, considering the lower energy required for fracture compared to delamination, it was expected that coating failure would be cohesive, occurring because of coating cracking rather than delamination [49], as the current test setup emphasises compression (during loading) and tension (during unloading), but not delamination [50]. Nevertheless, as shown in Figure 6b, TiN coating failure was also related to the malleability of the steel substrate, as it was extruded (evidenced by the pile-up) during the cyclic impact testing (Figure 4a).

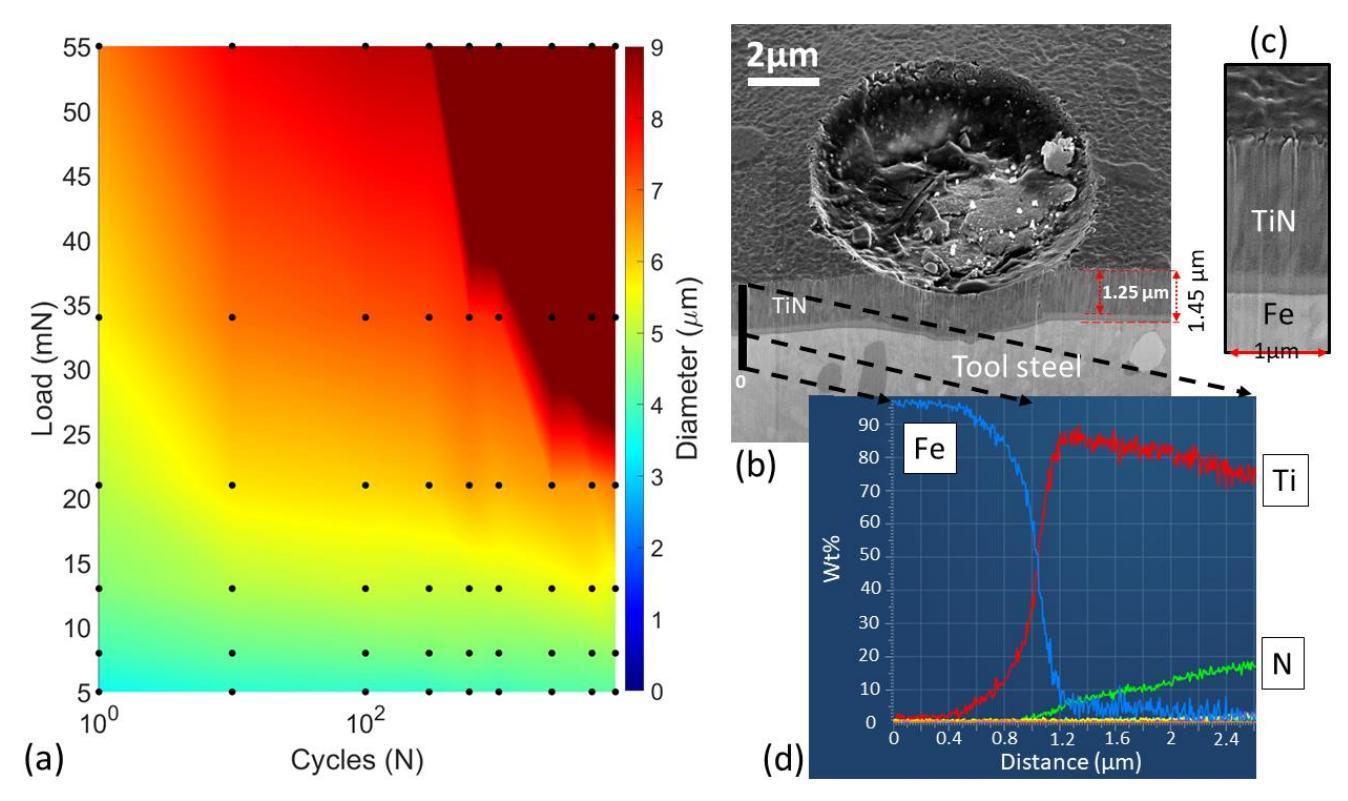
Figure 5: (a) Impact crater's diameter on the TiN surface after cyclic impact testing. The diameter was measured from high-resolution scanning electron images using ImageJ. (b) SEM image of the cross-section. (c) Higher-resolution SEM image showing a 200 \pm 50 nm interphasial layer between TiN and the tool steel substrate. (d) SEM Energy Dispersive X-Ray (EDX) line profile through the cross-section shows the thickness of the interphase between the substrate (tool steel) and coating (TiN). The approximately 200 \pm 50 nm thick interphase is a titanium and iron compound gradient with a slight nitride trace. Oxford Instruments and Aztec software were used for the EDX analysis.

The timing was adjusted to deposit a nominal $1.50 \pm 0.05 \mu m$ thick layer of TiN (Figure 5b). The temperature was maintained at 400 °C for the duration of this process. Unlike other methods, such as ARC deposition, the EB-PVD process produces a smooth finish with a more homogeneous structure.

This issue can be circumvented using a partially filled spherical tank analogy, where once the level of water depth or diameter is known, the other unknown can be calculated using equation 2, where R is the indenter radius, D is the impact crater diameter measured using SEM images and ImageJ[®] (Figure 5a), and h_{th} is the theoretical depth of the crater.

Selected impact craters were cross-sectioned, and chemical analysis for the cross-section was performed using energy-dispersive X-ray spectroscopy (EDX) at 10 kV, which showed a 200 ± 50 nm thick interlayer (interphase) between the coating and substrate. The interphase was found to be a titanium-iron compound, and the concentration of titanium increased gradually in the direction of the coating, and the iron concentration decreased, which was from when pure Ti was deposited before initially. The interphase also contained a slight nitride trace (Figure 5b-d).

The resulting impact craters exceeded the size of the indenter (4.37 µm radius as shown in Figure 5a, and 1.8 µm depth as shown in Figure 7) due to damage accumulated (Figure 4b at 5mN and after 7,500 cycles). This is because as the impact progresses, the shape of the indenter crater does not remain spherical due to the high stresses involved (see Figure 4b at 55 mN and after 600 cycles), as high stresses accumulating from cycles lead to larger impact craters and more synergic response from the coating system, i.e., the TiN coating and steel substrate. However, the initial shape and size of the indenter are critical for the start of the impact process and the subsequent deformation behaviour, as different tests may produce data with different fundamental dimensions [28], [29] and failure mechanisms [30], [31].

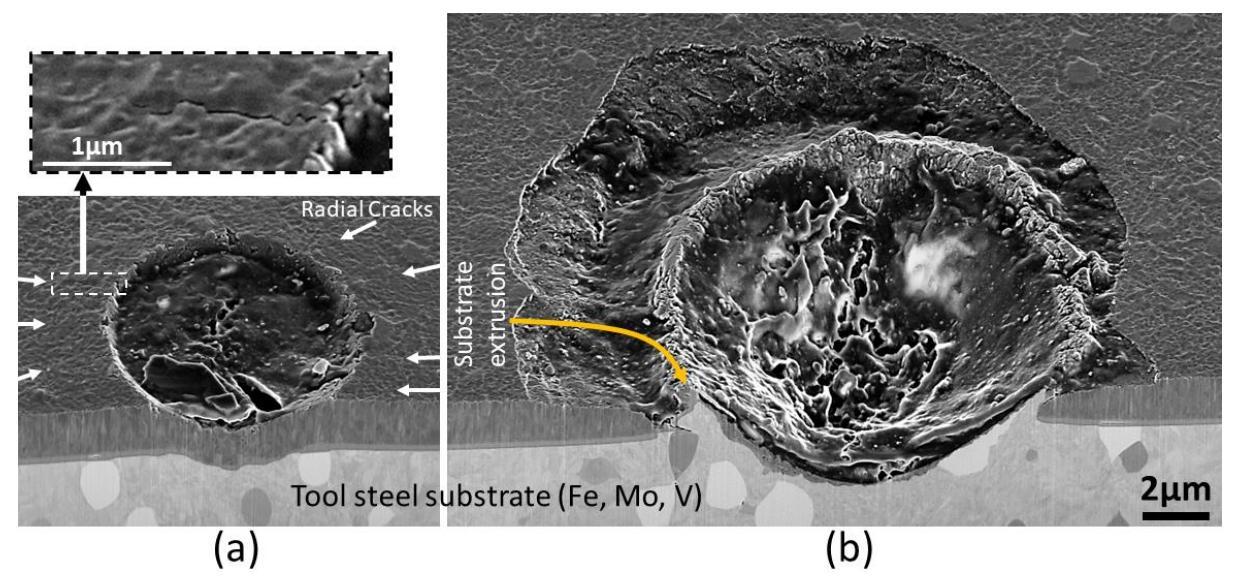
Figure 6: FIB cross-sections of repetitive impact sites. Impact craters using (a) 34 mN for 1000 cycles. (b) 55 mN for 2500 cycles. Both (a) and (b) are on the same scale. Arrows indicate the sites of radial cracks, magnified at the top of (a).

Cross-sections of the impact sites showed the degree of damage to the coatings as a function of cycles and acceleration load (Figure 6). However, the extent of plastic deformation in the substrate could not be assessed using electron backscatter diffraction because of the small grain size of the tool steel, which affects the estimation of geometrically necessary dislocations [27]. The images also indicate that the impact-induced damage led to localised radial pile-ups around the impact crater (Figure 6a) and radial cracks before the coating chipping and extrusion of the substrate, eventually leading to coating failure from repetitive impacts (Figure 6b).

The point of failure for different acceleration loads was around 2 μ m depth, larger than the coating thickness of 1.5 ± 0.5 μ m, indicating simultaneous deformation of the coating and the substrate. The plotted data shows three distinct response zones: blue at a depth of less than 0.5 μ m, green at a depth of less than 1 μ m, and amber at a depth of less than 1.5 μ m. From post-mortem imaging and cross-sectioning, the blue zone corresponds to no interaction with the substrate, with the deformation being locally sustained by the coating. Interaction with the substrate starts in the green area of Figure 7b, as shown in Figure 6a, for 1000 impacts using an acceleration load of 34 mN. The yellow-reddish area corresponds to the coating failure, as shown in Figure 6b.

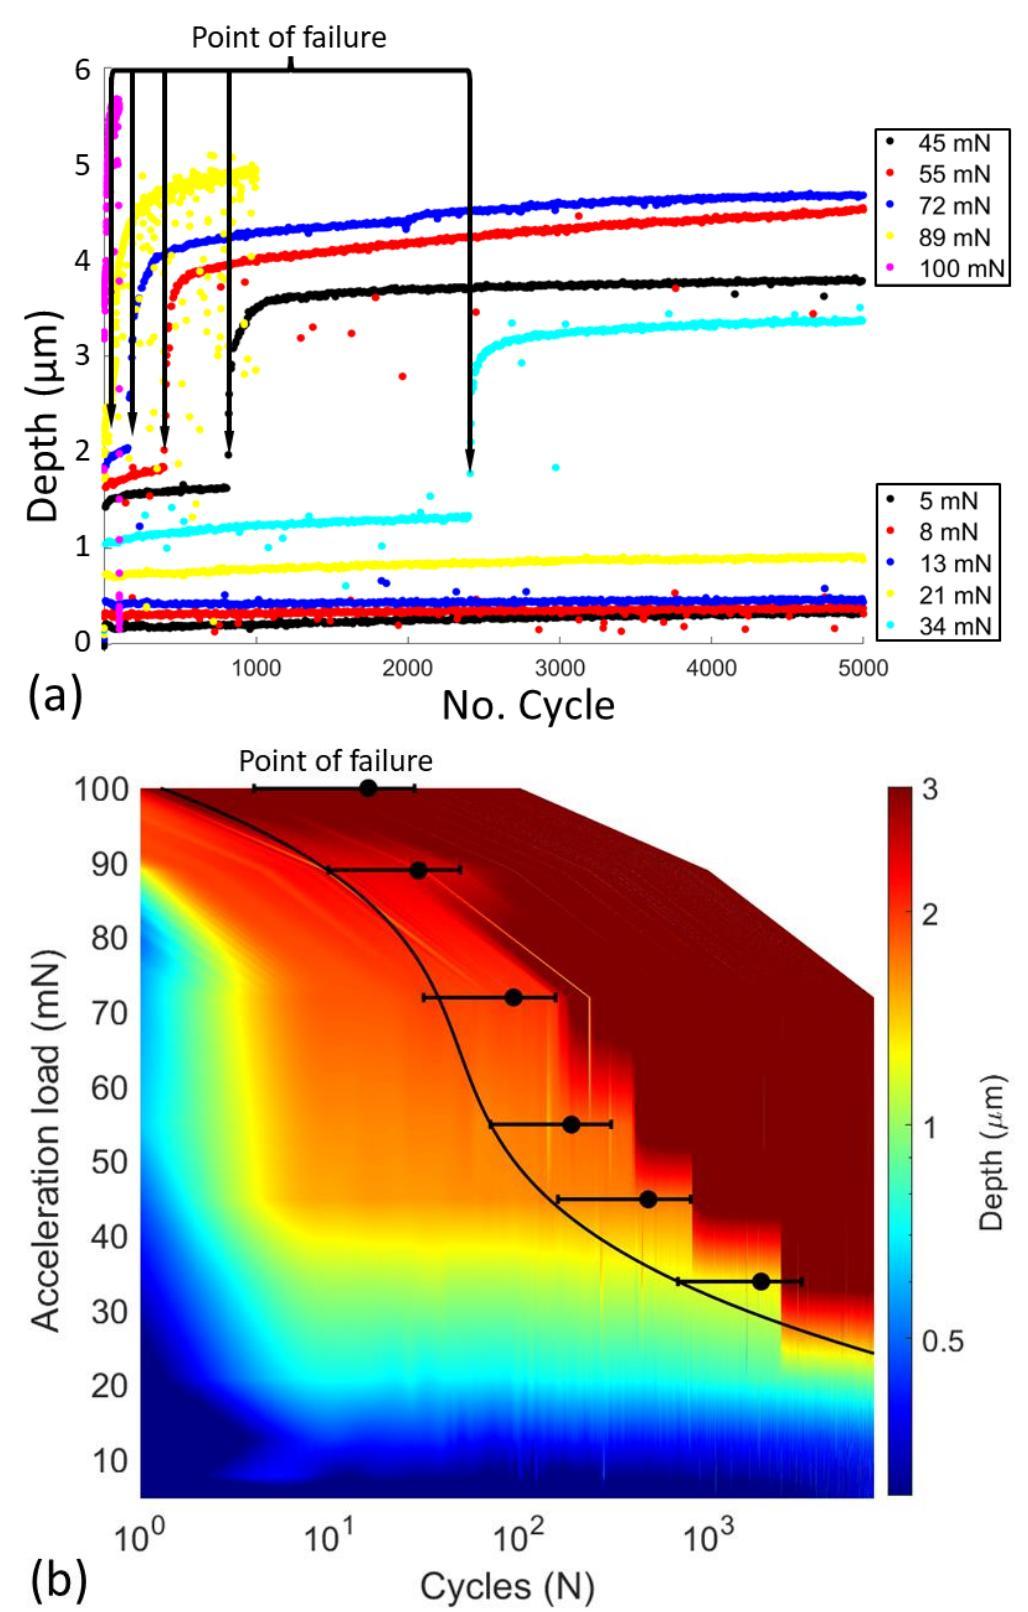
Figure 7: Impact depth data from multi-cycle micro-impact testing on TiN coating using a range of acceleration loads and up to 7500 cycles; (a) raw experimental data and (b) data interpolated into a three-dimensional map and fitted with equation 6. The test for a lower acceleration load was repeated (Figure 3) and consolidated. Depth or impact depth relates to a portion of the total length that the indent travels in and out of the sample, defined by the point at which the software decides where the zero is, which is not necessarily the original surface [23]. An abrupt depth jump during the test defined the' point of failure'.

A three-dimensional map was generated from the acceleration load, sensed depth, and number of cycles, including at which the coating failed, as shown in Figure 7a. Coating failure or 'point-of-failure' was defined as an abrupt change in measured depth during the test, such as a jump in the measured depth from approximately 1.4 μ m to 2 μ m (Figure 7), later confirmed by cross-sectioning and SEM imaging. The displacement was recorded with time (cycle at 4 s intervals) during repeated impact tests, which allowed the impact test depth to be measured as a function of cycles for each acceleration load. As shown in Figure 7, the depth increased incrementally with impact cycles. By contrast, the depth increased more significantly with the acceleration load when the number of cycles was constant.

Equation 6 (Figure 7b) includes two aspects of fatigue damage: the impact load, which determines the transition from a membrane-like failure of relatively thin coatings to plate-like failure in relatively thick coatings [33], [34], and the accumulation of damage during fatigue testing. Similar relationships between the load and depth of an indentation caused by a spherical indenter can be described mathematically using the mechanical properties of a material, such as its elastic modulus, yield strength, and plastic flow. A standard model used to describe this relationship is the Oliver-Pharr model [35]; however, this model simplifies the complex mechanical behaviour of materials under indentation and does not consider damage accumulation during repeated impact testing.

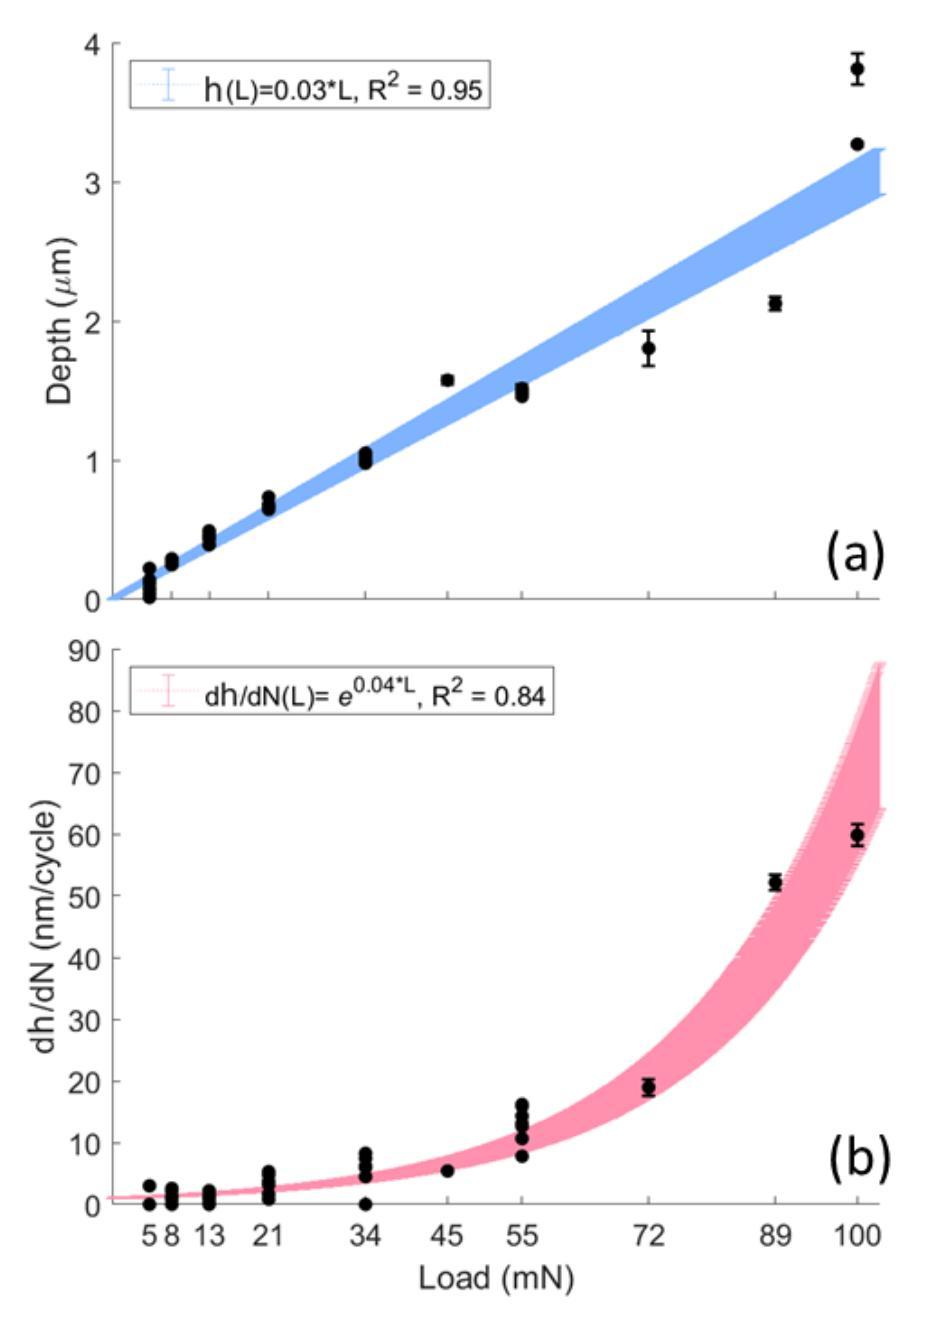
Figure 8: Fitting data from repetitive impacts on TiN coating as a function of spherical indenter acceleration load and indenter depth during the test. The experimental data and fitting for (a) the crater depth from the first impact and (b) for the depth increment or gradient $(\frac{dh}{dN})$ from repetitive impacts.

The relationship between the acceleration load and depth at the first impact showed a positive correlation, which was nearly linear ($R^2 = 0.95$, Figure 8a). The values of these fitting constants describe the coating-substrate system's combined resistance, that is, dynamic hardness and toughness, with higher loads causing deeper craters and lower loads causing shallower craters. The scatter in the data is due to the sensitivity of the depth measurement of the initial distance between the indenter and the sample surface, as discussed earlier.

The relationship between the acceleration load and depth gradient, $dh/_{dN}$, as shown in Figure 8b, can be used to understand the mechanical properties of the coating-substrate system after the first impact as a measure of damage accumulation before failure [32]. A graph plotting the acceleration load against *a* shows a non-linear relationship between the two. The intercept on the y-axis at a load equal to zero can be interpreted as the residual plasticity, which can provide information about the initial residual stress of the coatingsubstrate system, especially at low loads, where the gradient is highly sensitive to coating initial residual stress and topographies.

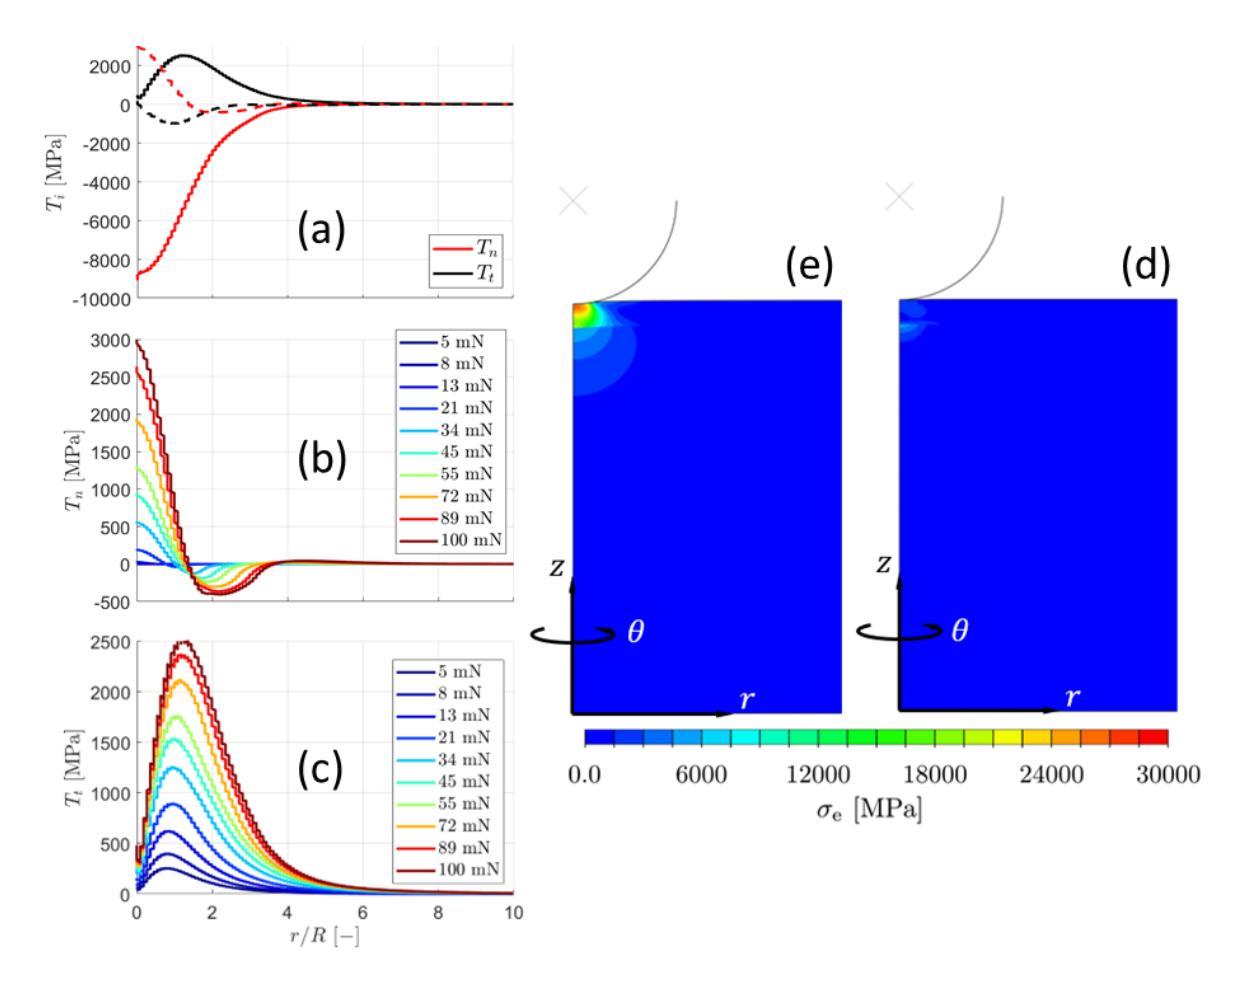
Figure 9: (a) The distribution of the normal and shear traction components, T_n and T_t along the interface at the peak of the load and after unloading, i.e., full and dashed lines, respectively, in the case of L = 100 mN. The distribution of the traction components along *r*-direction at different indentation loads: (b) the normal traction, T_n , after unloading; and (c) the shear traction, T_t , at the peak loading. Distribution of the equivalent von Mises stresses for L=100 mN and (e) at the peak of the load and (d) after unloading.

The results show that the normal traction is compressive during loading, leaving residual tensile stress after unloading (Figure 9a). Hence, the tensile component contributes to the failure of the interface with repeated impacts. It should be noted that the representative amplitude of fatigue should be equal to the traction value after unloading because compressive traction does not directly contribute to the degradation of the interface [36], [37]. A similar behaviour was observed in the case of shear traction, as it changed its direction between loading and unloading, where the maximum magnitude occurred at the loading

Figure 9b and c illustrate the distribution of the normal traction after unloading and shear traction at the peak of the loading, which is the loading responsible for coating degradation. The results showed that the traction increased with the indentation load. The position of the maximum magnitude did not change significantly with an increase in the load. It should be mentioned that the maximum values were used to examine the correlation with fatigue life. Under such circumstances, the maximum stress extends deep into the substrate. The results may be affected more significantly by the hardness and toughness of the substrate, a phenomenon that is also observed in erosion tests under harsh conditions [38].

The deformation induced on the coating can be expressed in terms of equivalent von Mises stress. Figure 9e and d show the distribution of the equivalent von Mises stress at the coating-substrate interface at the maximum loading point in the case of L = 100 mN and at the peak of loading and after unloading. The distributions imply that the maximum values occurred at peak loading, and the residual stresses yielded relatively small values. The maximum value occurs under the indenter (i.e., r = 0).

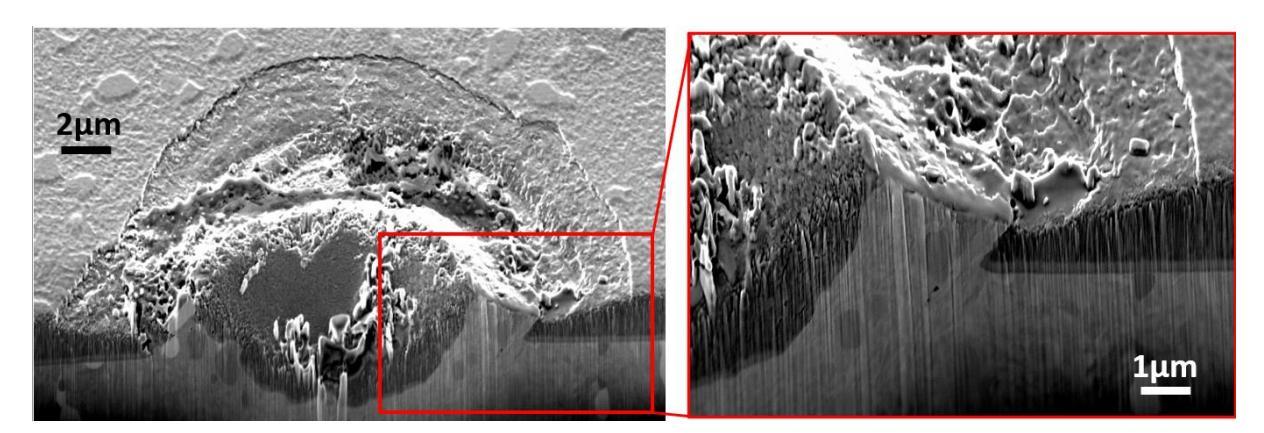
Figure 10: SEM image of a cross-section of the impact crater after 100 cycles using 100 mN acceleration load.

The findings of this study show that the fracture and cracking processes are caused by localised stress from surface impact. From the experiment and simulation, it can be inferred that repeated impacts initiated surface cracks. In contrast, forces imposed through the impact introduced a residual stress field that, in turn, caused the interface to delaminate. This led to a progressive reduction of the dynamic hardness due to the weakening of the initial coating-substrate interfacial strength and compressive stress severely localised deformation at the interface. Finally, when the combined critical limit of the maximum normal impact load and impact cycles is exceeded, the coating removal becomes dominant, which, when combined with substrate extrusion, leads to coating chipping and thinning by impact (Figure 10). Nevertheless, whether the thinning of the coating is due to localised plasticity or chipping, this thinning makes the TiN coating behave as a membrane with concentrated tensile stresses at the surface centre and interface centre, as reported in [33], [51]. The tensile stresses at the edges of the impact crater led to edge cracking, and the limited delamination that occurred owing to substrate extrusion could be attributed to exceeding the critical shear failure stress.
