Long-term usage of the off-grid photovoltaic system with lithium-ion battery-based energy storage system on high mountains: A case study in Payiun Lodge on Mt. Jade in Taiwan

Abstract: Energy supply on high mountains remains an open issue since grid connection is unavailable. In the past, diesel generators with lead-acid battery energy storage systems (ESSs) are applied in most cases. Recently, photovoltaic (PV) system with lithium-ion (Li-ion) battery ESS is an appropriate method for solving this problem in a greener way. In 2016, an off-grid PV system with Li-ion battery ESS has been installed in Paiyun Lodge on Mt. Jade (the highest lodge in Taiwan). After operation for more than 7 years, the aging problem of the whole electric power system becomes a critical issue for long-term usage. In this work, a method is established for analyzing the massive energy data (over 7 million rows) and estimating the health of the Li-ion battery system, such as daily operation patterns as well as C-rate, temperature, and accumulated energy distributions. The accomplished electric power improvement project dealing with the power system aging is reported. Based on the long-term usage experience,

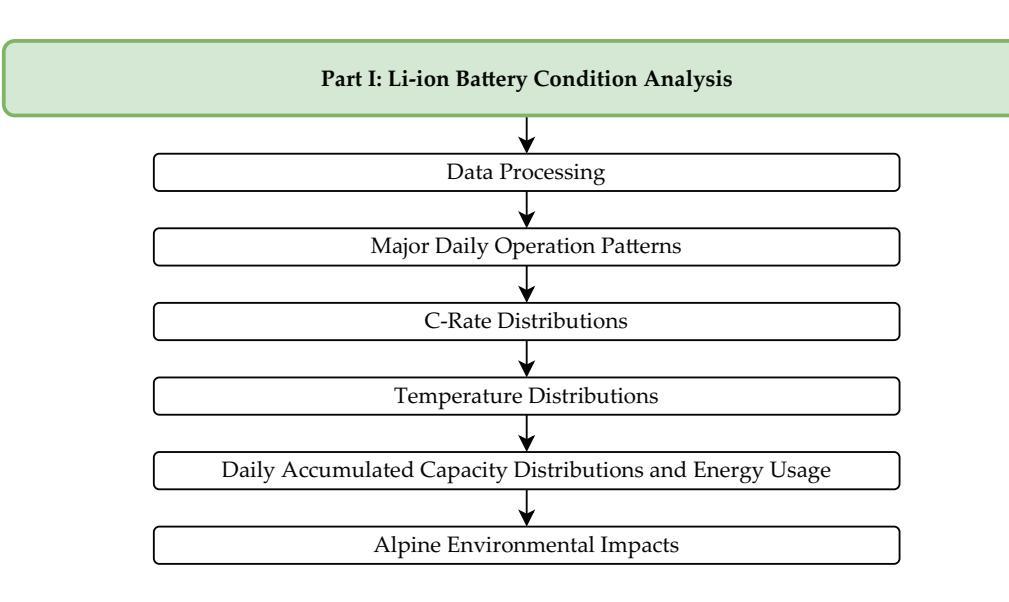
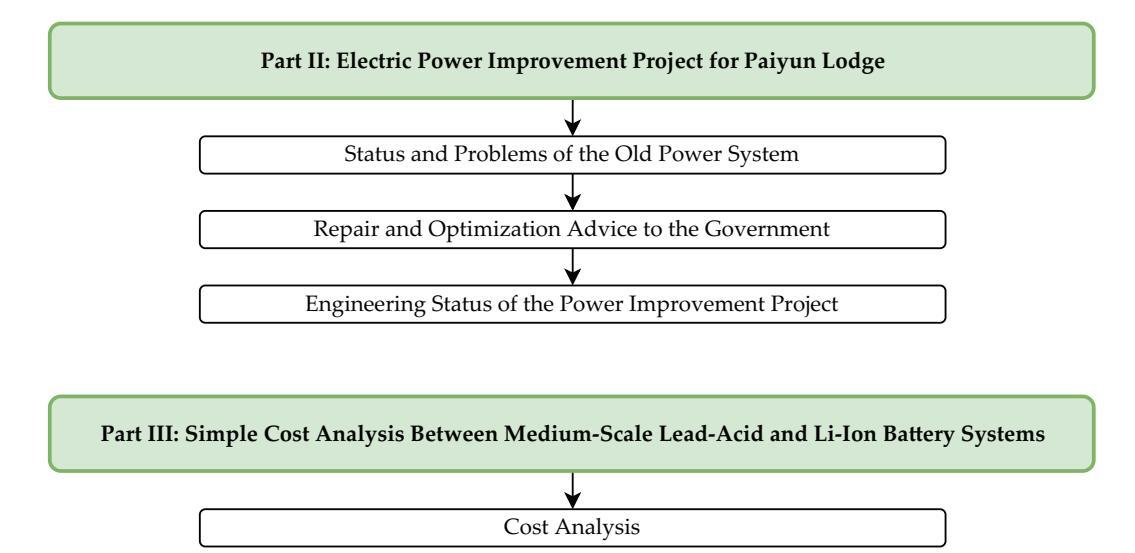
Figure 2. Methodology scheme of the work. Three parts are contained, i.e., part I: Li-ion battery condition analysis, part II: electric power improvement project for Paiyun Lodge, and part III: simple cost analysis between medium-scale lead-acid and Li-ion battery systems.

The research methodology scheme of this work including three parts is shown in Fig. 2. In the first part (Sec. 2), the energy data of the Li-ion battery system for four years is analyzed. Analysis of such massive data is not an easy task (more than 7 million rows). Especially, the data is recorded under the actual operation instead of regular data from cycle life tests in the laboratory. A method is established for analyzing the energy data during operation and estimating the health of the Li-ion battery system, including daily operation patterns as well as C-rate, temperature, and accumulated energy distributions. In the second part (Sec. 3), the status and problems of the old electric power system of Paiyun Lodge are described. The engineering status of the electric power system is reported, such as (1) reform and optimization of existing Li-ion battery cabinets, (2) PV inverter system reformation and optimization, (3) reorganization of distribution boxes and power line adjustment, (4) a self-developed cloud energy management system (EMS) is installed to

remotely monitor the off-grid PV ESS. In the third part (Sec. 4), a simple cost model is built for comparing the cost between lead-acid and Li-ion battery systems. This model reasonably explains that the expensive Li-ion batteries can compete with the cheap leadacid batteries for long-term usage on high mountains. Above all, this study gives engineers and researchers a fundamental understanding of a real case of long-term usage of off-grid PV ESSs on high mountains.

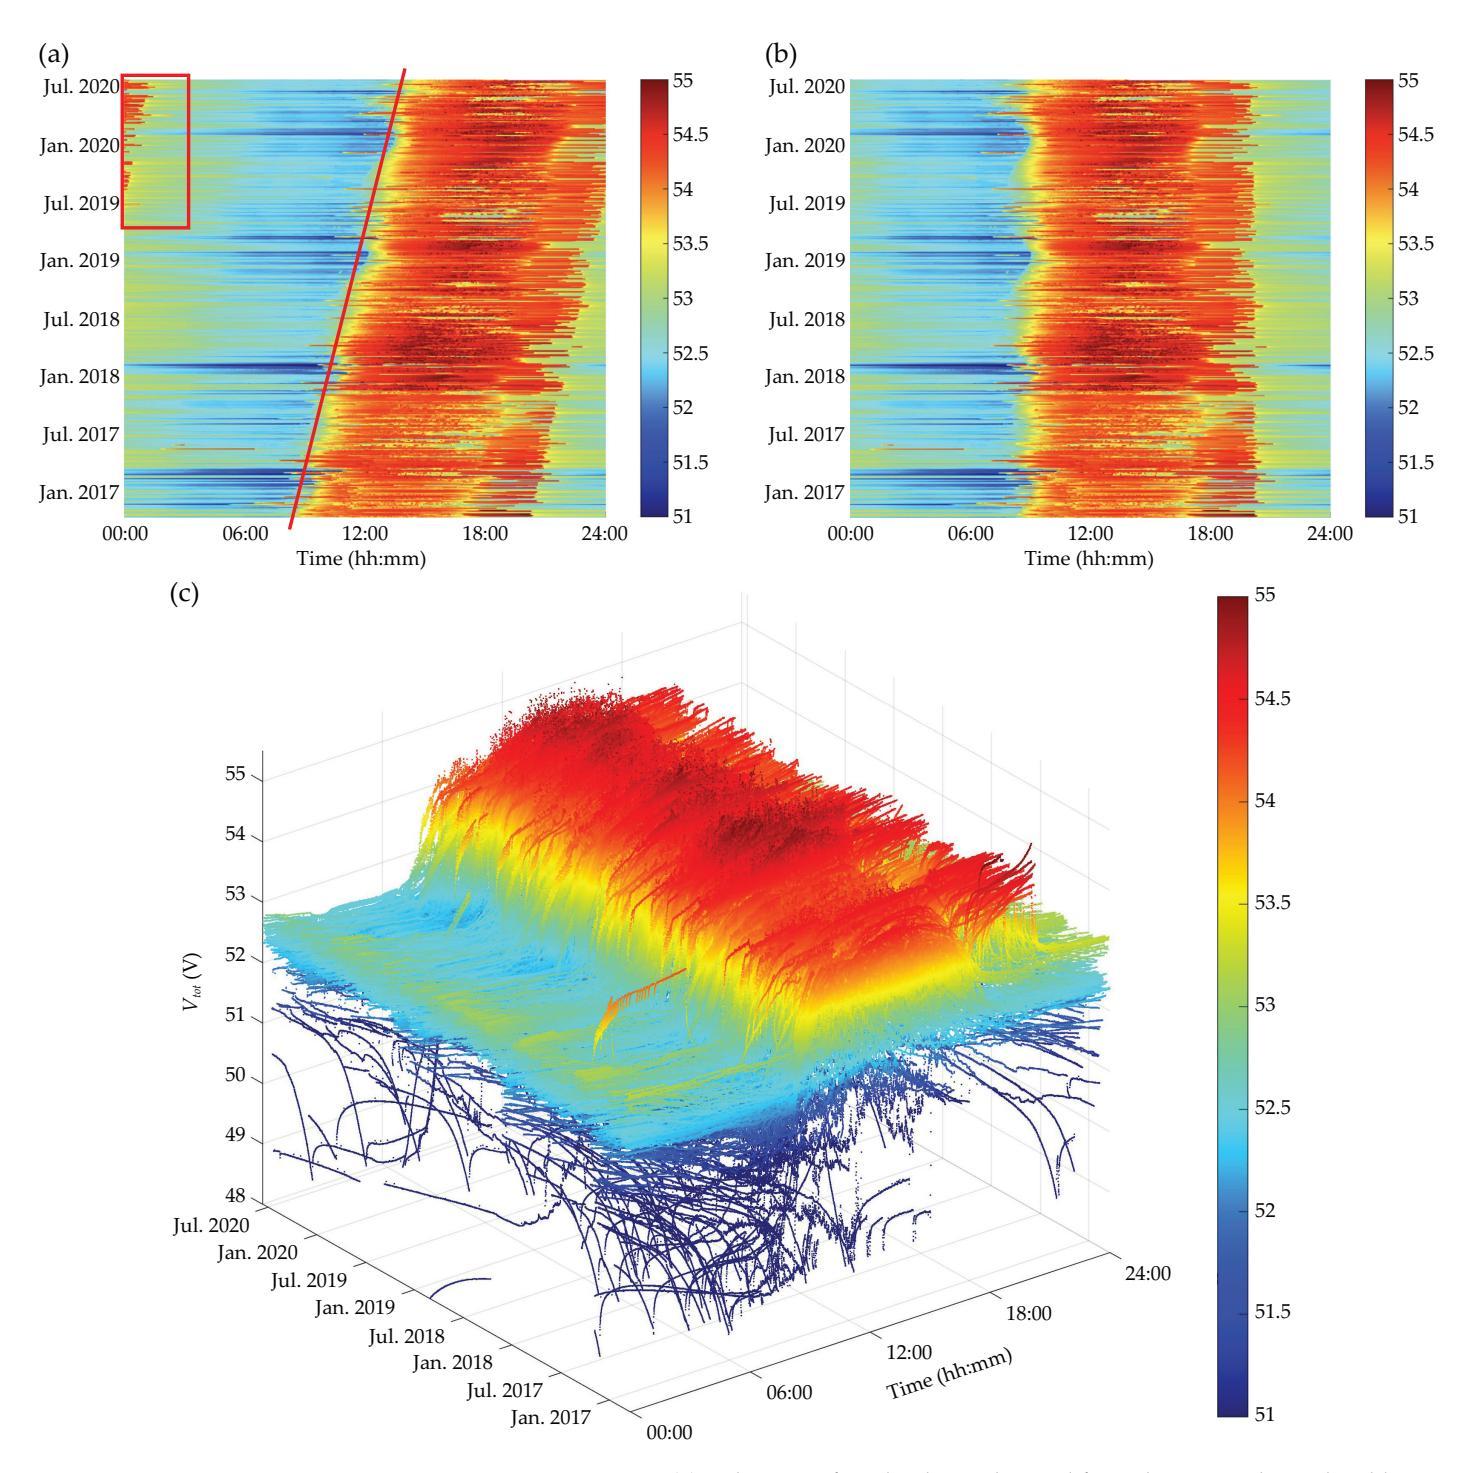
Figure 3. Data processing. (a) Colormap of total voltage obtained from the source data. The oblique red line indicates a time shift (about 15000 seconds) in the source data, causing a serious data shift. It's obvious that the data in the red rectangle should be on the right side of the figure. (b) Colormap of total voltage obtained from the time-adjusted data. After time adjustment, the data exhibits a clear daily pattern. (c) 3D plot of total voltage obtained from the time-adjusted data.

It's difficult to deal with 1400 CSV files one by one manually, e.g., using Microsoft® Excel or some lightweight scientific drawing software. In this work, MathWorks[®] MATLAB was used. The first step was to combine the data in 1400 CSV files, i.e., putting all datasets in a single database. Then, drawing a daily colormap to see the time shift condition. Because of the daily routine operation of the ESS, the data is predicted to exhibit a roughly daily pattern on a large time scale. The time shift issue can be solved by adjusting the time until the data exhibits a roughly daily pattern. As shown in Fig. 3(a), the time shift caused an obvious pattern shift of total voltage. In Jan. 2017, the red region began at about 8 o'clock, while in Jul. 2020, the red region began at about 12 o'clock. The time shift was a continuous process, exhibiting a parallelogram of red region. The red line on the left side of the parallelogram can serve as an indicator of time shift. The more sloping the red line is, the more serious the time shift is. Some data on the right side were shifted to the left side (indicated by the red rectangle). The time shift issue can be solved by linear adjustment as shown in Fig. 3(b). The red region becomes a rectangle, indicating a roughly daily pattern. A three-dimensional (3D) plot figure for showing the variation of total voltage is given in Fig. 3(c).

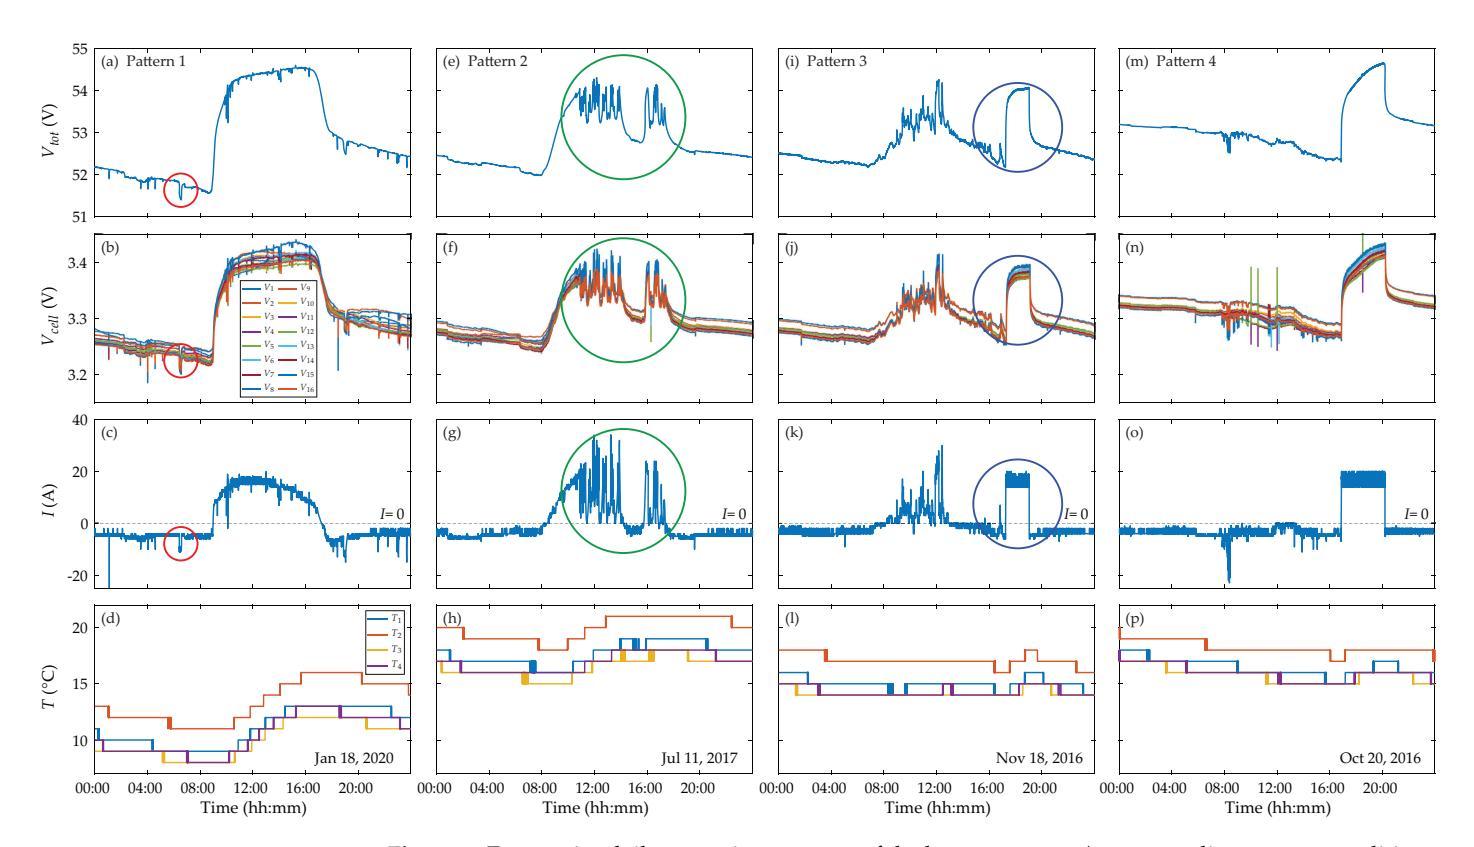
Figure 4. Four major daily operation patterns of the battery system (corresponding pattern conditions are listed in Table 1). Patterns 1, 2, 3, and 4 are shown in (a)–(d), (e)–(h), (i)–(l), (m)–(p), respectively. Each pattern contains the total voltage (V_{tot}), 16 cell voltages (V_n , $n = 1 \sim 16$), current (I), and 4 temperatures (T_n , $n = 1 \sim 4$). The level of zero current (I = 0) is denoted by dashed lines, and the charge (discharge) current is a positive (negative) value. The red circles highlight the instant voltage drop and high current of the battery system. The green circles highlight many instant voltage and current drops under the charge state of the battery system. The blue circles mark the characteristic voltage and current variations caused by the diesel generator. The date is displayed in the lower right corner of each pattern.

The massive data exhibits daily patterns. Four major daily patterns are observed during system operation (while not all conditions exhibit explicit patterns). The selected data as example cases are illustrated in Fig. 4. For pattern 1 (high solar power and generator OFF conditions), the total voltage (V_{tot}) of the battery system exhibits a smooth curve with a bump in the daytime (Fig. 4(a)). During the nighttime (about 17:00–09:00), no solar power is generated. The battery system is in the discharge state with current (I) about 5 A (Fig. 4(c)). V_{tot} and V_{cell} gradually decrease (Fig. 4(a) and (b)). During the daytime (about 09:00–17:00), the generated solar power is sufficient for the load and the battery system. The battery system is in the charge state with I of a maximum of ~20 A (Fig. 4(c)). V_{tot} and V_{cell} gradually increase to values of 54.5 V and ~3.4 V, respectively (Fig. 4(a) and (b)). V_{tot} varies under the safety operation range of about 48–56 V and V_{cell} s vary under the safe operation range of LFP battery cells about 3–3.5 V [24,25]. Some small voltage drops in V_{tot} and V_{cell} are due to instantaneous high power consumptions of the load (red circles in Fig. 4(a) and (b)), which can be verified by the large I at the corresponding time (red circle in Fig. 4(c)).

For pattern 2 (medium solar power and generator OFF conditions) as shown in Figs. 4(e)–(h), the voltage and current behaviors during the nighttime are in the discharge state and the same as those of pattern 1. During the daytime, the generated solar power is sufficient for the load, but not sufficient for the battery system. The battery system is still in the charge state, while many instant current and voltage drops are exhibited (green circles

in Figs. 4(e)–(g)), reflecting the intermittent power generation characteristics of renewable energy. For pattern 3 (medium solar power and generator ON conditions) as shown in Figs. 4(i)–(l), the voltage and current behaviors are similar to those of pattern 2. During the daytime, insufficient solar power cannot fulfill the battery system, many instant current and voltage drops are exhibited in the charge state (Figs. 4(i)–(k)). To solve the energy shortage, the backup generator is turned on with a constant charge current of about 18 A (blue circle in Fig. 4(k)), and the voltages gradually are charged to saturated values (blue circles in Figs. 4(i) and (j)).

For pattern 4 (low solar power and generator ON conditions) as shown in Figs. 4(m)–(p), the voltage and current exhibit a gradual decrease with a large bump. During the daytime, low or no solar power is generated, causing the battery system in the discharge state, i.e., the voltages gradually decrease (Figs. 4(m) and (n)) and the current is around 5 A (Fig. 4(o)). Later, the backup generator is turned on to charge the battery system. The battery system operation patterns give us a convenient way to recognize several normal operation modes of the battery system and quickly figure out abnormal conditions.

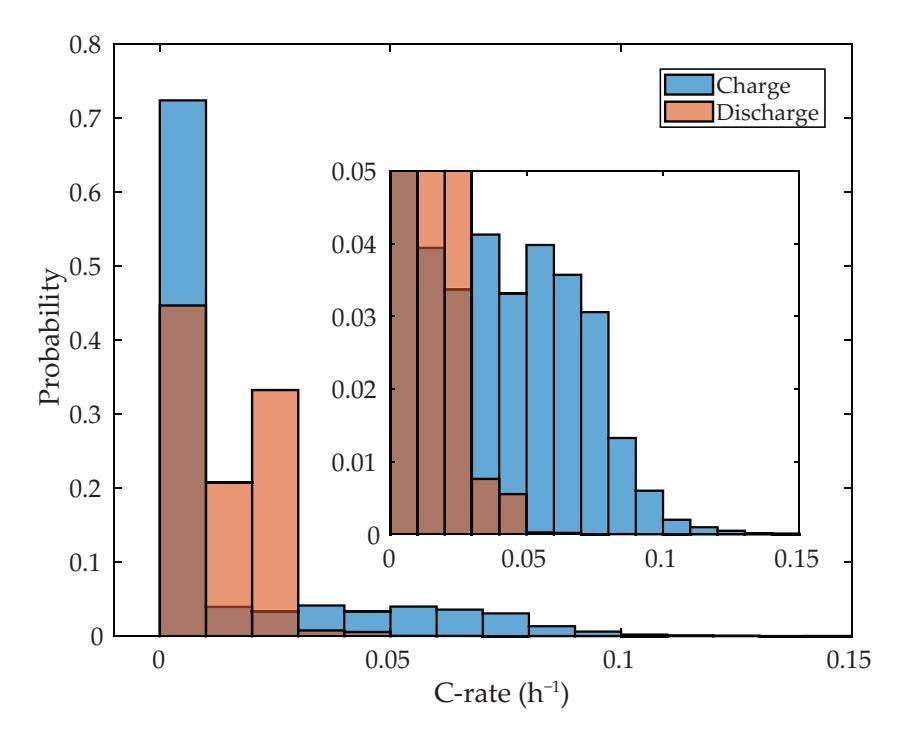
Figure 5. Time distribution of C-rate during battery system operation. The probability of charge and discharge C-rate are marked by blue and red bars, respectively. Inset shows the low-probability region. The battery system operated under a C-rate below $C_R < 0.15 \text{ h}^{-1}$, which lower than the suggested value of $C_R < 0.25 \text{ h}^{-1}$, advancing system stability and prolonging the life of the system. Time range of data: 2016-10-14~2020-07-20. (Total: 1376 days.)

Unlike power batteries used in EVs, which have instantaneous high power requirements ($C_R > 1 h^{-1}$), most battery systems in the stationary application are designed to normally operate at a low C-rate ($C_R < 0.25 h^{-1}$) with an instantaneous high-power output mode at $C_R < 1 h^{-1}$ for safety and service life extension [44–46]. For example, the grid-scale Li-ion battery (100 MW, 129 MWh from Tesla and Neoen) has been installed in Hornsdale, South Australia in 2017 [10,11]. As backup energy storage to the grid, when the Loy Yang coal-fired power plant in Victoria failed, leading to a power shortage, a power of 100 MW was input into the national electricity grid within 140 ms [12,13]. In this case, the instantaneous output C-rate was about 0.78 h⁻¹. For the discussed battery system, the time distribution of C-rate during battery system operation is shown in Fig. 5. Almost all values (over 99.9%) of C-rate during charge are under 0.1 h⁻¹, and more than 70% of the time is at $C_R < 0.01$. On the other hand, the C-rate during discharge almost distributes under 0.05 h⁻¹, and over 95% of the time is at $C_R < 0.03$. The battery system operation is under a low C-rate condition with the values of C-rate lower than the normal design C-rate, i.e., $C_R < 0.25 h^{-1}$. The low C-rate condition can avoid excessive voltage differences among

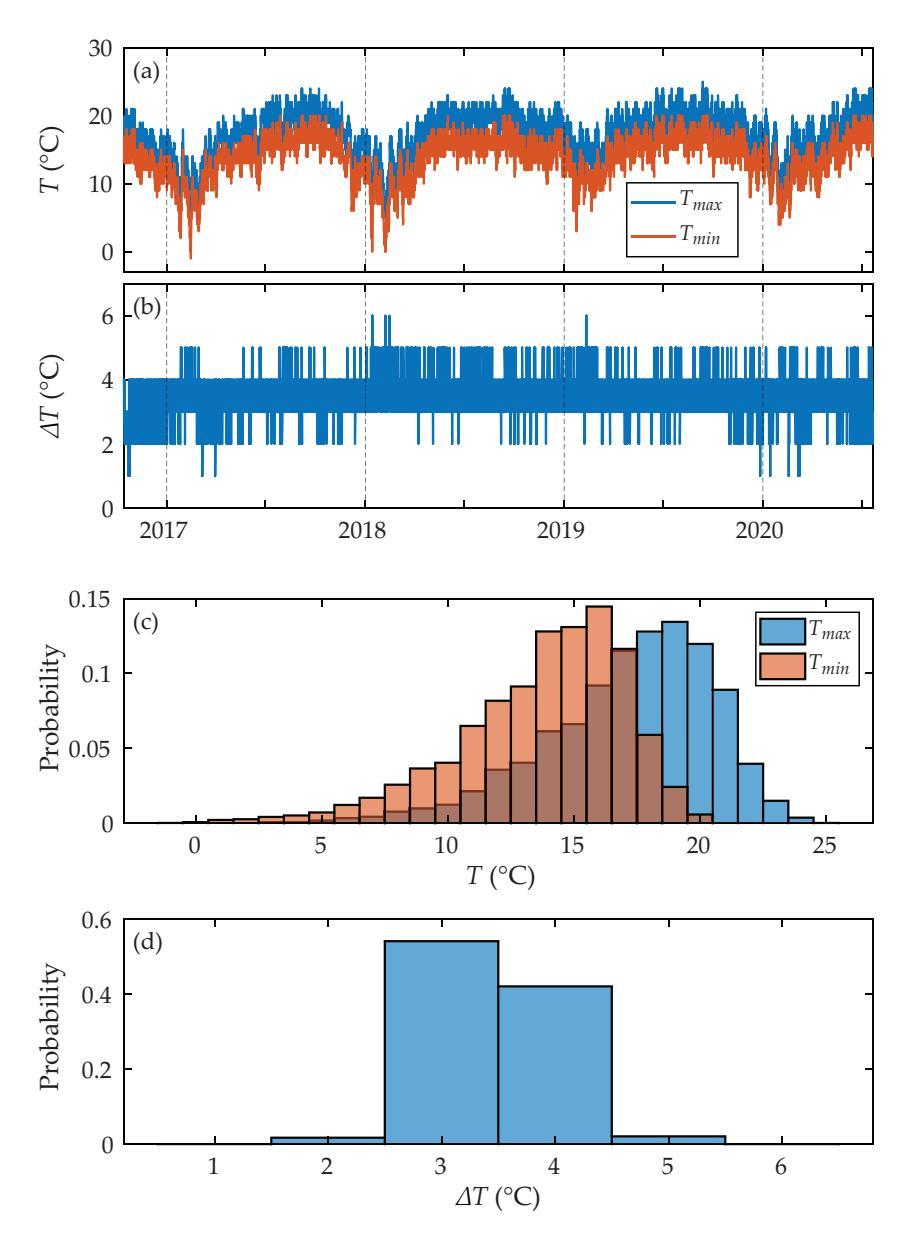
Figure 6. Temperature distribution of the battery system. (a) The variation of maximum and minimum temperatures over time, where T_{max} and T_{min} are indicated by blue and red curves, respectively. (b) The variation of temperature difference (ΔT) over time. (c) The distribution of maximum and minimum temperatures. (d) The distribution of temperature difference. Time range of data: 2016-10-14~2020-07-20. (Total: 1376 days.)

Operation temperature and temperature distribution have a large impact on the performance, lifespan, and safety of the battery system. The acceptable operating temperature for Li-ion batteries ranges from -20 to 60° C [47]. To maintain better performance, a narrow temperature range of about 15–35°C is recommended [48,49]. Temperatures outside the desired operation range will lead to fast capacity fade. Moreover, when the cell temperature exceeds the threshold of the thermal runaway point, chain electrochemical reactions might yield battery cells to burn and explode [50]. The operation temperature of the discussed battery system ranging from 0 to 25°C is shown in Fig. 6(a). The temperature variation exhibits an annual pattern, reflecting seasonal climate characteristics, i.e., high temperature in summer and low temperature in winter. More than half of the time is in the recommended range of operation temperature (Fig. 6(c)).

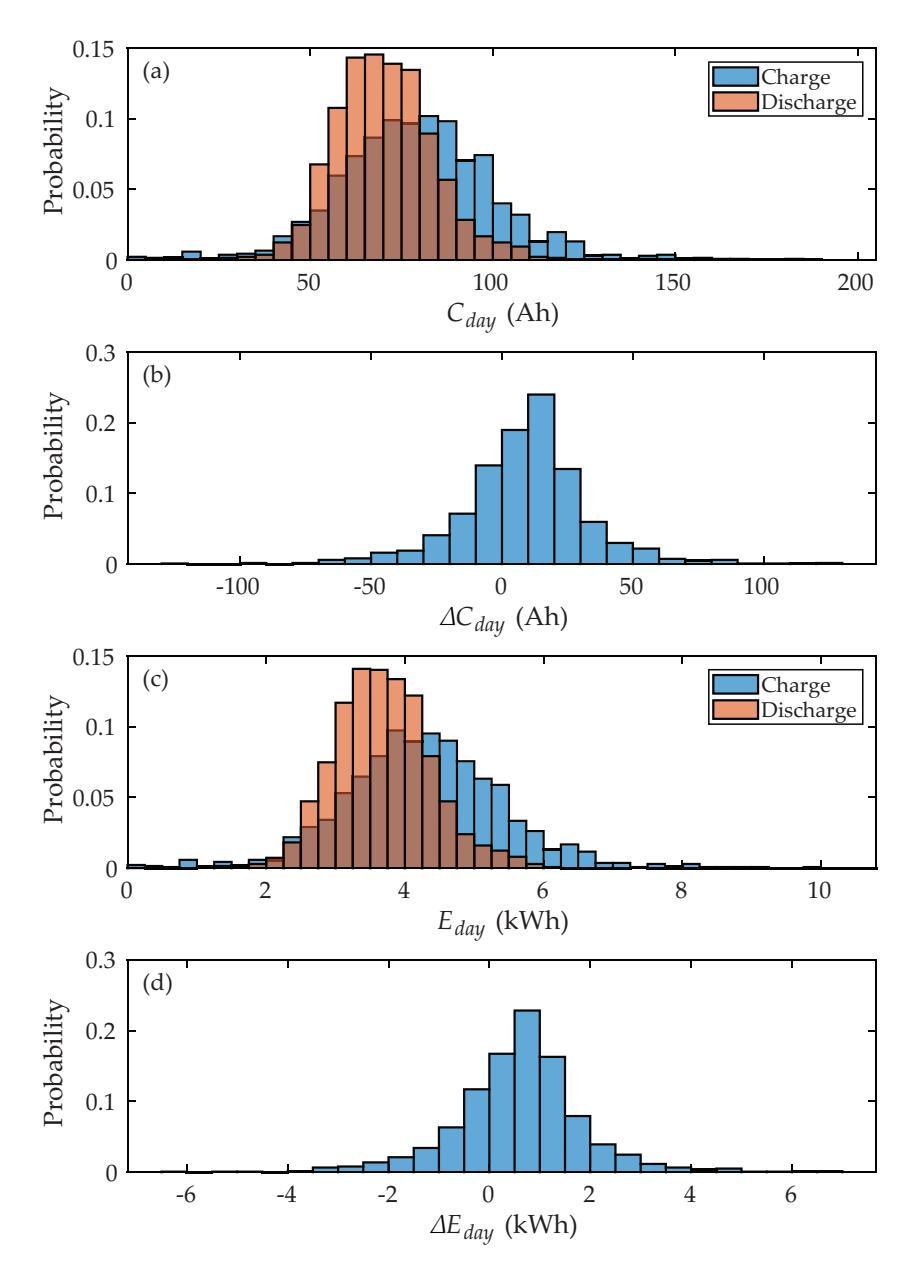
Figure 7. Daily accumulated capacity and energy distributions of the battery system. (a) The distribution of accumulated charge and discharge capacities, where the accumulated charge and discharge capacities are marked by blue and red bars, respectively. (b) The distribution of the daily accumulated capacity difference (ΔC_{day}). (c) The distribution of the daily accumulated charge and discharge energies. (d) The distribution of the daily accumulated energy difference (ΔE_{day}). Time range of data: 2016-10-14~2020-07-20. (Total: 1376 days.)

Daily accumulated capacity and energy usages calculated by Eqs. 2 and 3 are shown in Fig. 7. The major probability of the daily accumulated charge capacity (C_{day}^{chg}) distributes around 70–90 Ah, while the major probability of the daily accumulated discharge capacity (C_{day}^{dis}) is around 60–80 Ah (Fig. 7(a)). The daily accumulated charge capacity is roughly higher than the daily accumulated discharge capacity, and such a feature is more obvious when we check the daily capacity loss, i.e., the difference between the daily accumulated charge and discharge capacities, $\Delta C_{day} = C_{day}^{chg} - C_{day}^{dis}$. As shown in Fig. 7(b), ΔC_{day} exhibits a maximum probability of around 10–20 Ah. The overall distribution of ΔC_{day} is located at the positive region, indicating that the daily accumulated input energy is higher than the daily accumulated output energy, i.e., an energy loss in the battery system. The energy loss in the battery system can be explained by the equivalent circuit model (ECM), which is the most common battery model, consisting of resistance, capacitance, and inductance elements [68–70]. The effective resistance causes joule heating during charging and discharging, resulting in energy loss in the battery system.

Daily accumulated energy as a counterpart to the daily accumulated capacity is depicted in Figs. 7(c) and (d). Similar distributions are exhibited. The major probability of the daily accumulated charge energy (E_{day}^{chg}) distributes around 3.75–4.75 kWh, while the major probability of the daily accumulated discharge energy (E_{day}^{dis}) is around 3.25–4.25

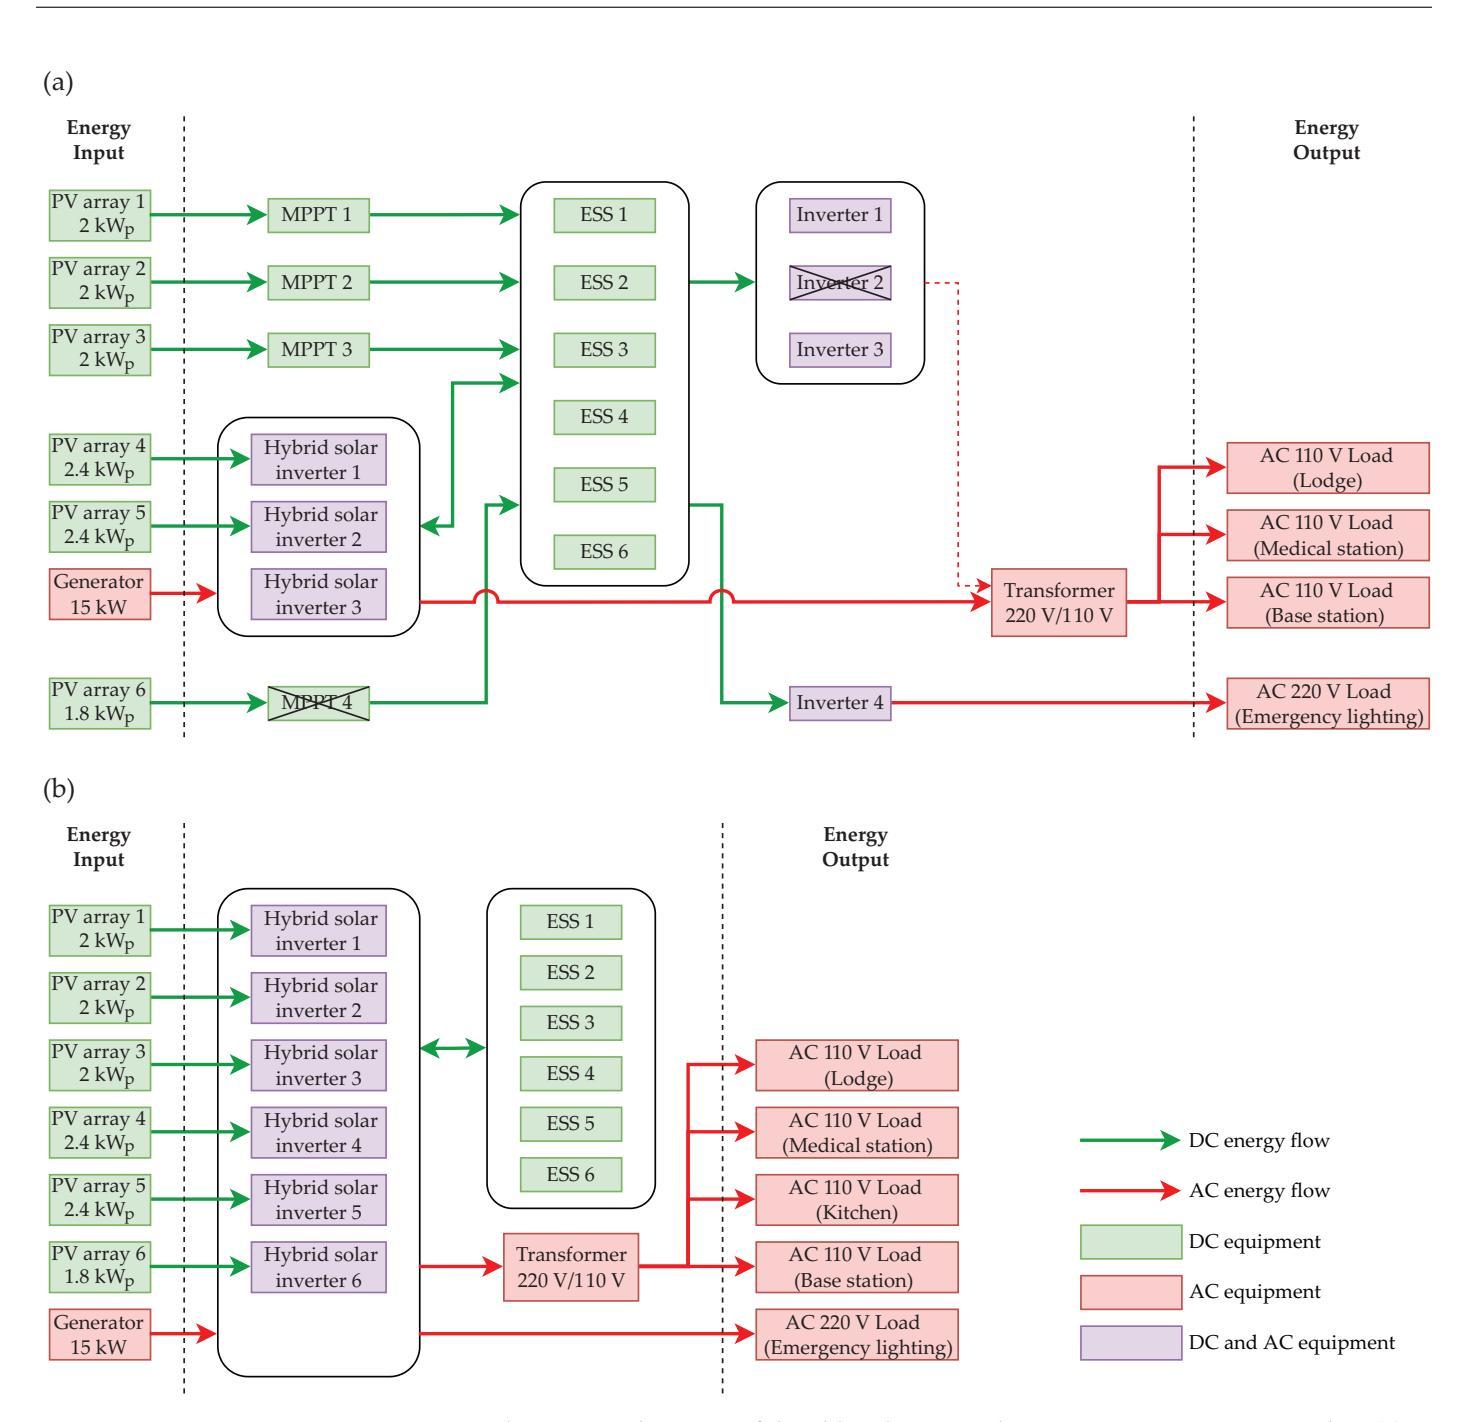
Figure 8. Electricity architecture of the old and improved power systems in Paiyun Lodge. (a) In the old power system, the DC power generated by the 1st, 2nd, 3rd, and 6th PV arrays is sent to the ESS by the 1st–4th MPPTs, and then converted to 220 V_{AC} power by the 1st–4th inverters. The transformer converts the AC power from 220 V_{AC} to 110 V_{AC} for general purposes (i.e., Paiyun Lodge, medical station, and base station). The 220 V_{AC} power for the emergency lighting is directly obtained from the 4th inverter. The rounded rectangles indicate that the equipment work in parallel. After 2016, the electricity for general purposes is provided by another power system, and the ESS is changed to Li-ion batteries from lead-acid batteries. The DC power generated by the 4th and 5th PV arrays is sent to the ESS by the 1st and 2nd hybrid solar inverters, and then converted to 220 V_{AC} power by the 1st-3rd hybrid solar inverters. The 15 kW generator serves as backup power for the system. The 2nd inverter and the 4th MPPT failed. (b) In the improved power system, the DC power generated by the 6 PV arrays is sent to the ESS by the 6 hybrid solar inverters, and the converted $220 V_{AC}$ power is sent to the load for emergency lighting directly and sent to the load for general purposes by the transformer. The electricity architecture and energy flow become simplified. The green and red arrows indicate the DC and AC energy flow, respectively. The green, red, and purple boxes indicate the DC, AC, and DC/AC equipment, respectively.

- 4. **Solar idle for older systems.** The power of the 6th PV array cannot be used due to the failure of the 4th MPPT (as shown in Fig. 8(a)), and the solar energy of 1.8 kW_p is wasted.

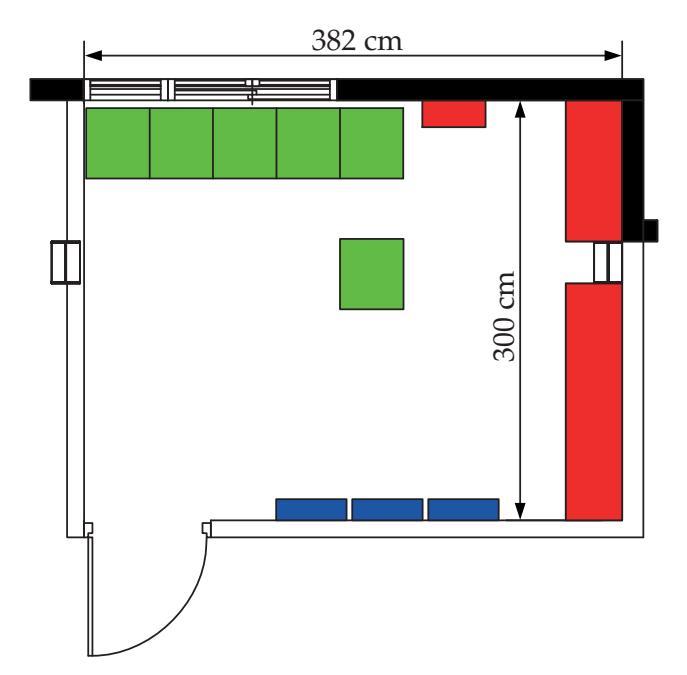
Figure 9. Map of the machine room (unit: cm). The $48V_{DC}$ Li-ion battery ESS composed of 6 Li-ion battery cabinets with a total energy of 72 kWh is indicated by green boxes. Three hybrid solar inverters on the wall with a maximum output power of 15 kW are indicated by blue boxes. Seven distribution boxes on the wall connecting energy input and output systems are indicated by red boxes.

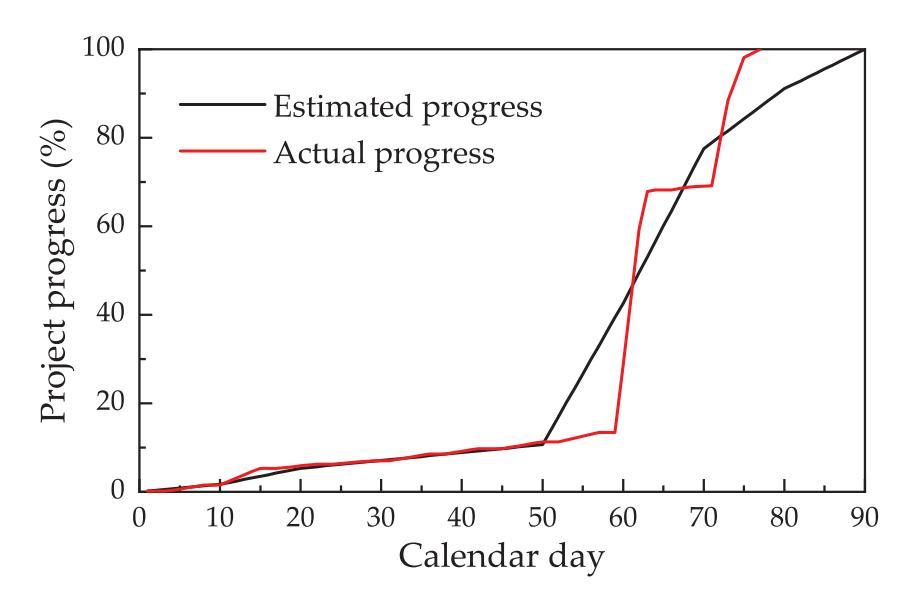
Figure 10. S-curve of the project. The estimated progress and actual progress are indicated by the black and red curves, respectively. The project was completed 13 calendar days ahead of schedule.

The engineering project started on Jul. 29th, 2022, and the scheduled completion date is Oct. 26th, 2022. The approved construction period is 90 calendar days. The project was completed on the 77th calendar day of the cumulative construction period (13 calendar days in advance) as shown in Fig. 10. The project status is described below.

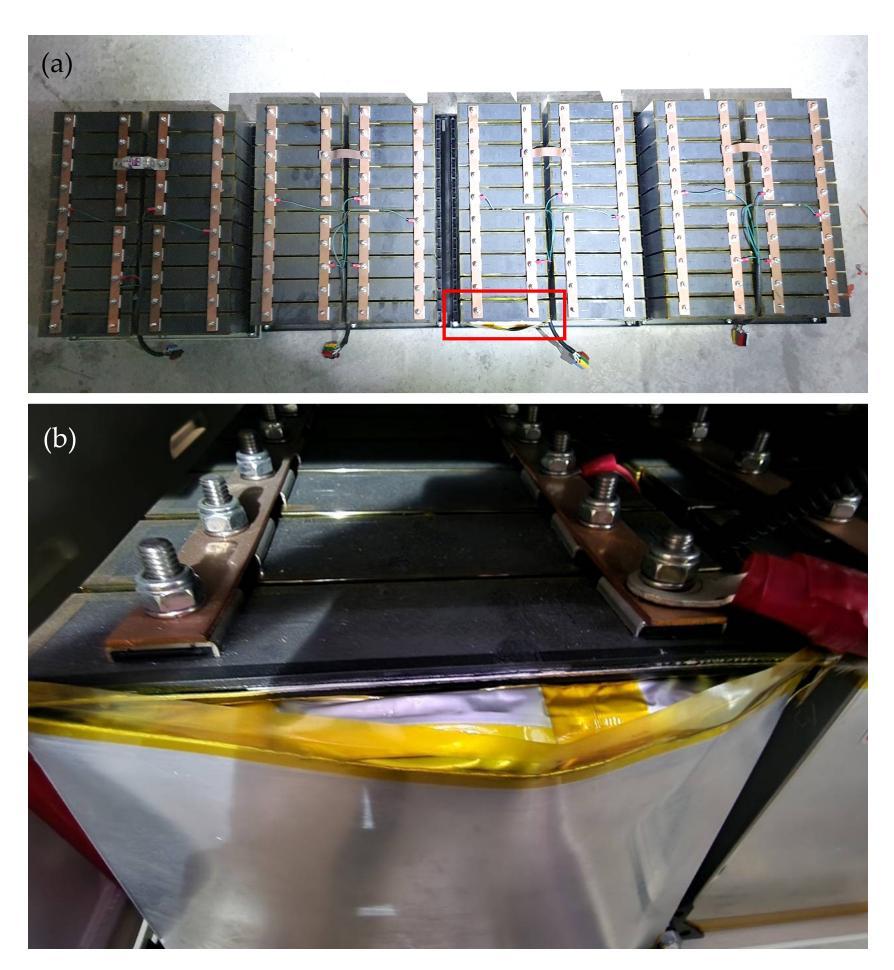
Figure 11. (a) Remove all battery modules from the battery cabinet, and check the appearance and voltages. Taking this energy storage cabinet as an example, there are 16 strings of battery cells, each string is connected in parallel with 5 battery cells, for a total of 80 battery cells. Swollen Battery Cells are marked by the red rectangle. (b) Swollen Battery Cells should be replaced.

Reform and optimization of existing Li-ion battery cabinets. Replacing of old and faulty batteries and installation of active balancers are included. In the replacement of old and faulty battery cells, if the appearance is obviously swollen or there is leakage or voltage in an abnormal range, the battery should be replaced. Each 48 V_{DC} energy storage cabinet is made by a 16S5P configuration. All battery modules were removed from the battery cabinet for checking as shown in Fig. 11. The 4th energy storage cabinet has 3 groups of battery cells that have swelled significantly and abnormal voltages of 1.000 V_{DC} and 0.967 V_{DC}. (For an LFP battery cell, the normal operation voltage is about 2.5–3.65 V [24,25].) Each group of battery cells needs to be replaced with 5 battery cells, for a total of 15 cells. The 5th energy storage cabinet has 2 groups of battery cells that are obviously swollen, and each group of battery cells needs to be replaced with 5 battery cells, for a total of 10 cells.

All replaced a total of 25 batteries. The LFP battery cell with a capacity of 50 Ah is used in the replacement, which is made by Chang Hong Energy Technology Co., Ltd., Taiwan.

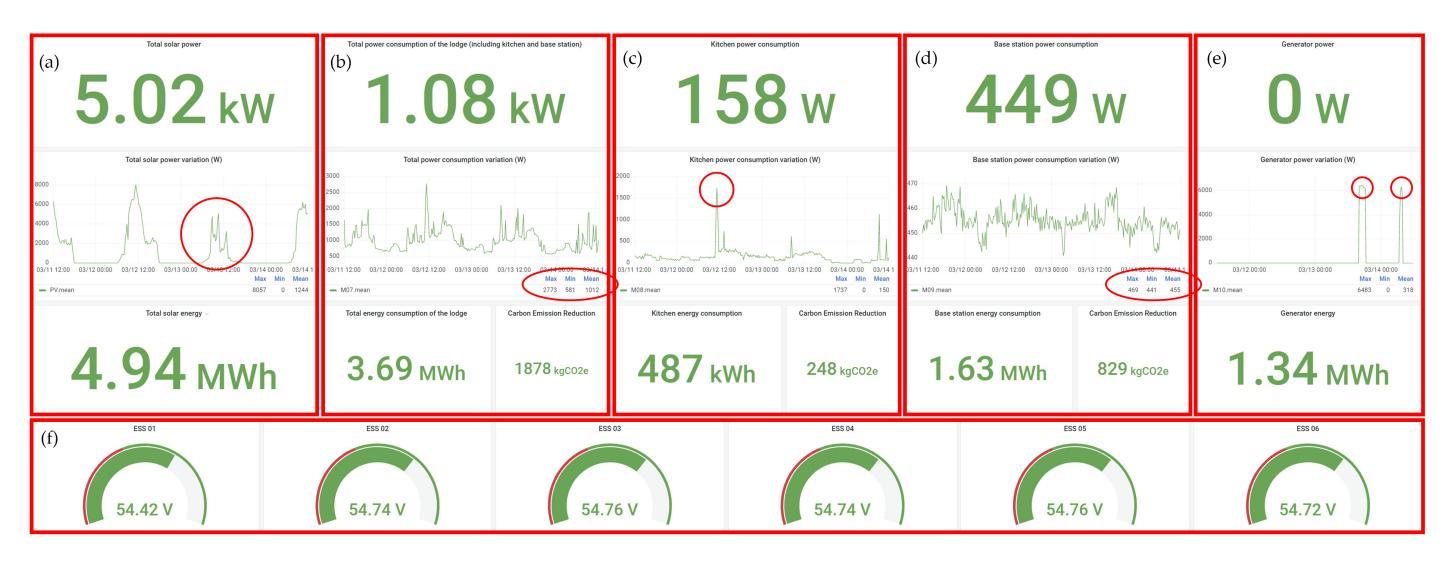
Figure 12. User monitor screen of the cloud EMS. The screen can be divided into five zones (red rectangles) for realizing the energy information. (a) Energy generation information of all PV arrays, including total solar power, total solar power variation, and total solar energy. (b)–(d) Energy consumption information of the (b) Paiyun Lodge, (c) kitchen, and (d) base station, including total power consumption of the lodge, total power consumption variation (with maximum, minimum, and mean values), total energy consumption, and carbon emission reduction. (e) Energy generation information of the diesel generator. (f) Total voltages of 6 energy storage cabinets.

Many conditions of energy usage can be read from the monitor screen (Fig. 12). The current energy input and output are listed on the top row. For example, the current PV power, power consumption of the lodge, kitchen, and base station, as well as diesel generator power are 5.02 kW, 1.08 kW, 158 W, 449 W, and 0 W, respectively. The historical energy input and output data stored in the database can provide detailed energy analysis. For example, within three days, the power variation curve of all PV arrays exhibited a non-smooth curve with many sharp power drops (circle in Fig. 12(a), reflecting the feature of fluctuations in renewable energies [20,21]. The power consumption of the lodge demonstrated a maximum value of 2773 W, a minimum value of 581 W, and a mean value of 1012 W (circle in Fig. 12(b)). The major power peaks of the lodge were contributed by the kitchen (circle in Fig. 12(c)). At the same time, it was verified that high-power appliances (about 1500 W) are used in the kitchen. The power consumption of the base station exhibited a steady value of 455 ± 14 W with an energy fluctuation of 3.1% (circle in Fig. 12(d)). Such fluctuation indicated that no explicit dependence was found. The diesel generator had been operated for a while with a peak power of about 6400 W to the ESS (circles in Fig. 12(e)).

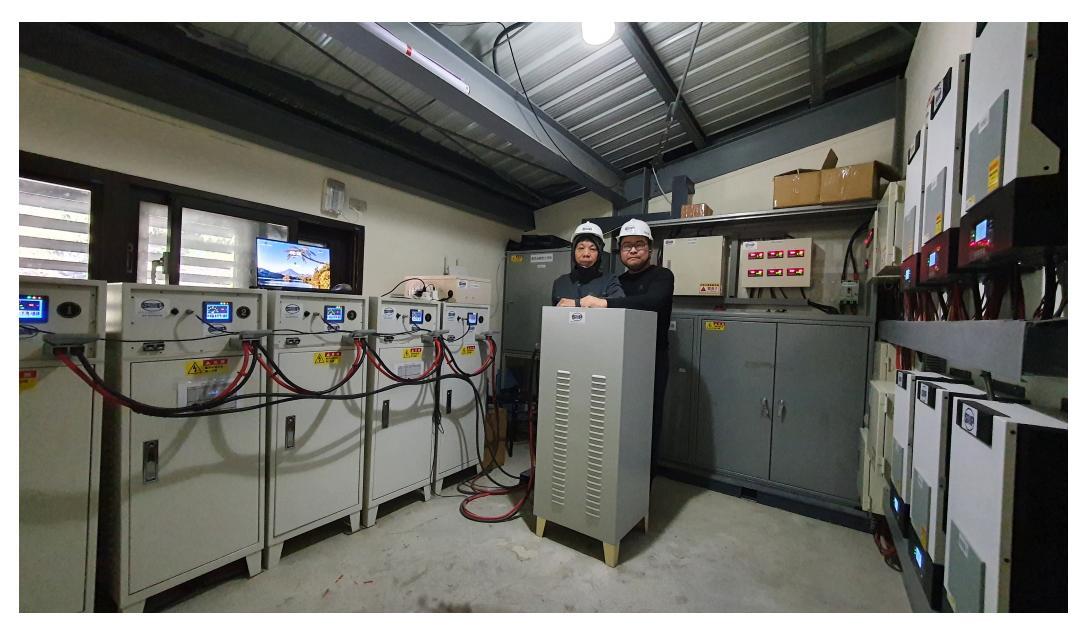
Figure 13. Site photo after the completion of the off-grid PV ESS improvement (The photo was taken on Oct. 10th, 2022). The ESS consisting of 6 energy storage cabinets is on the left side, and the hybrid solar inverters with major distribution boxes are on the right side. The people standing in the middle are Jung-Feng Jack Lin (left) and Hsien-Ching Chung (right).

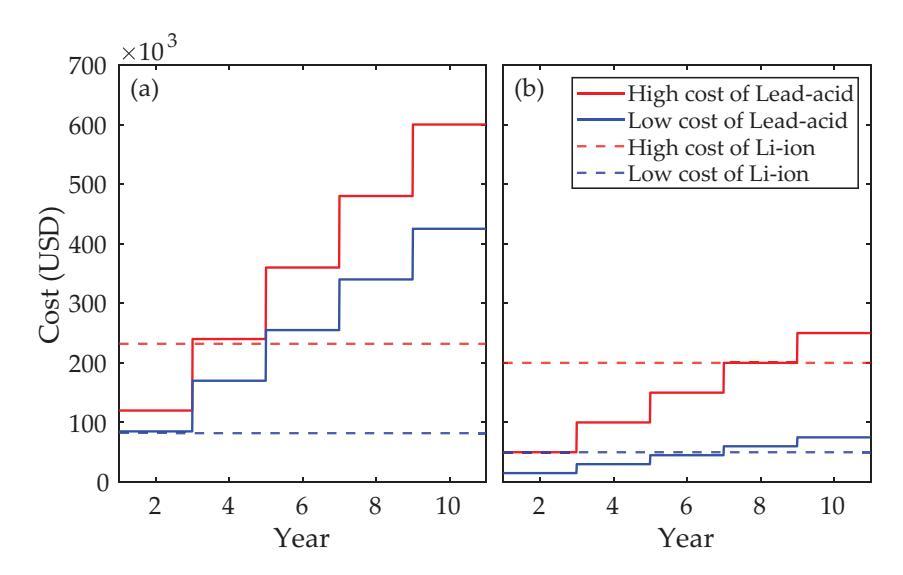
Figure 14. Cost analysis of Li-ion and lead-acid battery systems. (a) Cost analysis with the extra moving cost included. The red and blue curves indicate the high and low costs of lead-acid battery systems, respectively. The red and blue dashed lines indicate the high and low costs of Li-ion battery systems, respectively. (b) Cost analysis without extra moving costs.

More than a decade ago, the Li-ion batteries were a pricey production. The Li-ion battery packs cost 1183 USD/kWh in 2010 [127]. Nine years later, the price had decreased nearly tenfold to 156 USD/kWh in 2019, falling 87% in real terms [127]. Cost reductions in 2019 resulted from increasing order size, growth in EV sales, and the continued penetration of high-energy-density cathodes. The advance in pack designs and falling manufacturing costs will drive prices down. The prices for Li-ion battery packs across all sectors have

reached USD 151/kWh in 2022 [128]. BloombergNEF forecast that Li-ion battery costs will fall under USD 100/kWh in 2024 and hit around USD 60/kWh by 2030 [127,128]. The continued low price of Li-ion batteries will make it more likely to replace lead-acid batteries.
