An Integrated Experimental-Numerical Study of the Performance of Lime-Based Mortars in Masonry Piers Under Eccentric Loading

V. Nežerka^{a,*}, J. Antoš^a, J. Litoš^a, P. Tesárek^a, J. Zeman^a

^a Faculty of Civil Engineering, Czech Technical University in Prague, Thákurova 7, 166 29 Praha 6, Czech Republic

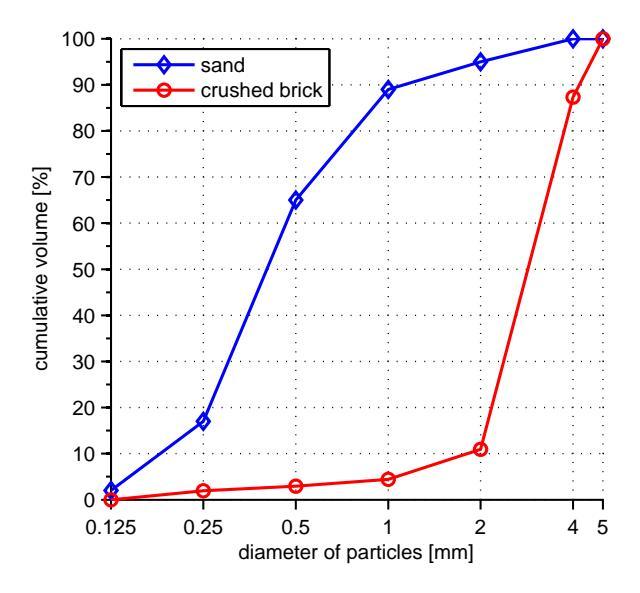
Figure 1: Grading curves of sand and crushed brick aggregates.

Beside the investigation of metakaolin and Portland cement additions on the mechanical properties of lime-based mortars, the study was also focused on the influence of aggregate composition. River sand of grain size ranging between 0 and 4 mm from Zálezlice was selected based on experience as the most suitable for the application as the bed joint mortar. The industrially produced crushed brick fragments of the grain-size 2–5 mm, from a brick plant Bratronice, the Czech Republic, were chosen based on results of previous studies [36] and experience of authors acquired by analyses of ancient mortar samples [17, 31, 37]. The grain size distribution of the sand and crushed bricks aggregates, obtained by a sieve analysis, is presented in Figure 1.

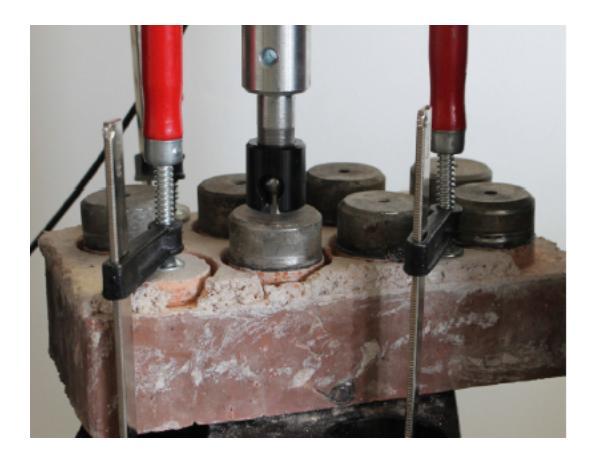
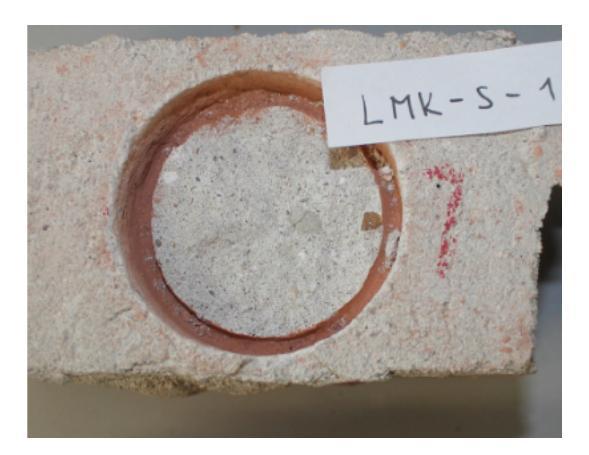
Figure 2: Interface strength pull-out testing: experiment set-up (left) and the failure plane located within the mortar layer (right).

Beside the bending and uniaxial compression tests, the dynamic Young's modulus was assessed by the resonance method on 90-day old samples, and the tensile strength of the interface between mortars and bricks was evaluated based on series of pull-out tests carried out in accordance with EN 1015-21. The tests revealed that the interface was not the weakest link in the case of all tested mortars, since the failure plane was not located at the brick boundary, Figure 2. The satisfactory interface strength is attributed to the relatively big roughness of the bricks and suitable workability of the fresh mortars.

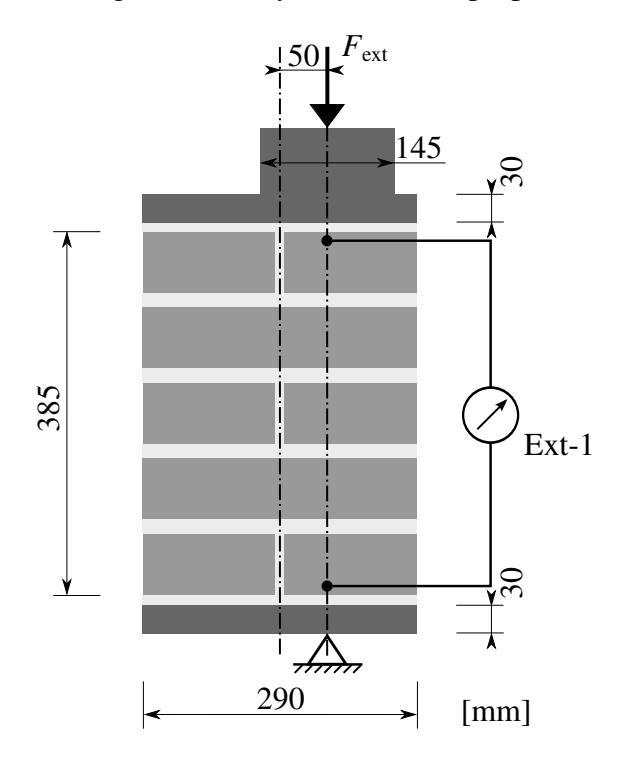
Figure 3: Loading of the tested piers and placement of virtual extensometers.

The geometry of the tested masonry piers of a square cross-section is described in the scheme provided in Figure 3. The piers were subjected to a displacement controlled quasi-static compression with an eccentricity to introduce a combination of bending and compression. The geometry, loading, boundary conditions, and material of the masonry blocks (clay bricks) were the same for all tested piers, because the study was focused on the influence of the bed joint mortar. The bed joint thickness was equal to 15 mm, while the vertical joints were 10 mm thick, and the bricks were arranged in five layers to make a proper bond.

The geometry of the 3D FE model was following the geometry of the experimentally tested masonry piers, as described in Figure 3; the FE mesh is presented in Figure 11. The interface between bricks and surrounding mortar was not explicitly defined and modeled using interface elements, because the interface was not the weakest link in tension, recall Section 3.1.

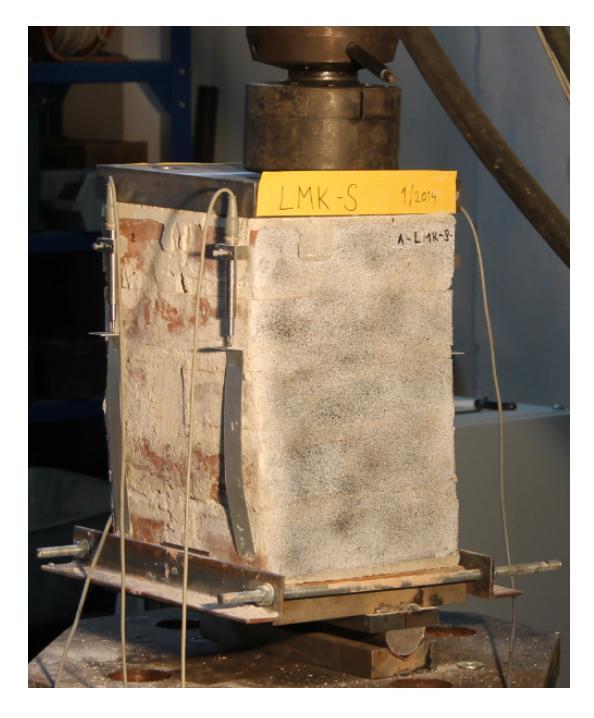
Figure 4: Tested masonry pier subjected to the combination of compression and bending, introduced via eccentric loading and supporting.

The loading of the piers was accomplished using a steel loading frame with a hydraulic actuator of 1 MN loading capacity. The steel slabs ensured a uniform distribution of stresses from the loading and a joint assembly allowed a rotation of the pier ends in all directions. The test was displacement-controlled with a loading rate of 1 mm/min in order to capture the descending part of the force-displacement diagram after the loss of pier integrity.

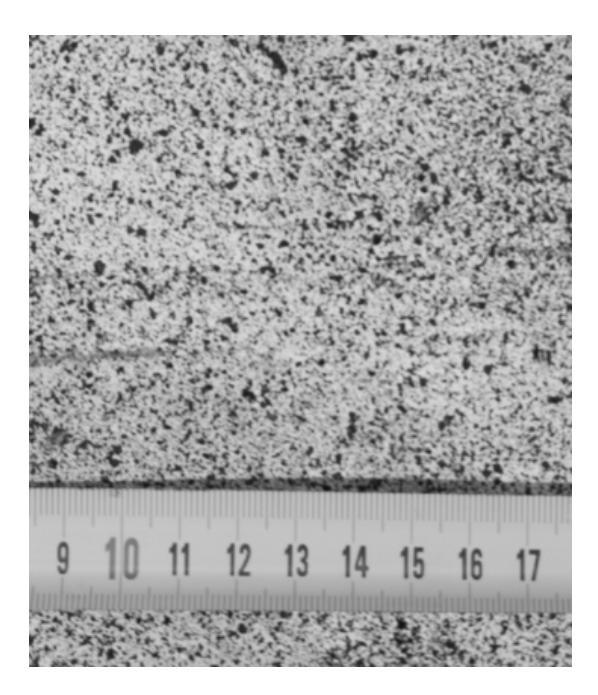
Figure 5: Black and white stochastic pattern applied onto the pier surface for the purposes of DIC; the main scale units represent centimeters.

The optical monitoring of masonry piers was accomplished using high-definition Canon 70D camera taking pictures at 5-seconds time intervals, set equally for all tested piers, to yield on average 210 images documenting the deformation of a single pier until its complete failure. The light sensitivity ISO parameter was manually set to 100, since a powerful artificial lighting was available, Figure 4. The perfect illumination allowed the short exposure time (1/125 sec) and the low aperture number set to f/8, which was kept constant for all images in the series. In order to minimize the effect of lens distortion [44], the distance between the camera and the observed surface was approximately 1 m, and the focal length (zoom) was set to 55 mm. The resulting DIC real scale resolution equal to 0.202 mm/pixel was computationally feasible while preserving the required precision.

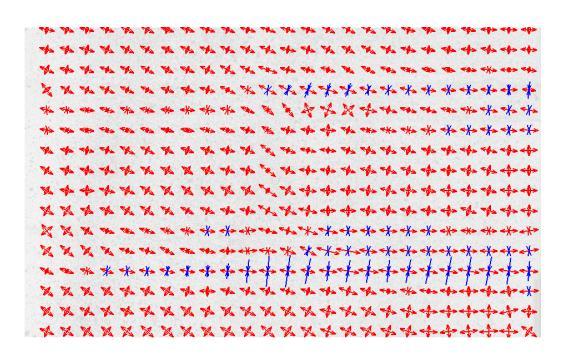
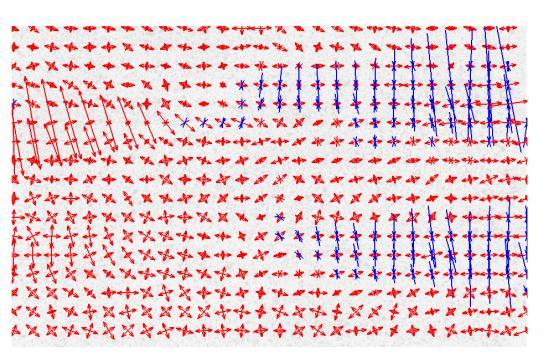
Figure 6: Direction and relative magnitude of principal strains on the surface of masonry piers: stiff LMK-SCB mortar joints (left) and compliant L-SCB joints (right); red and blue arrows indicate principal tension and compression, respectively.

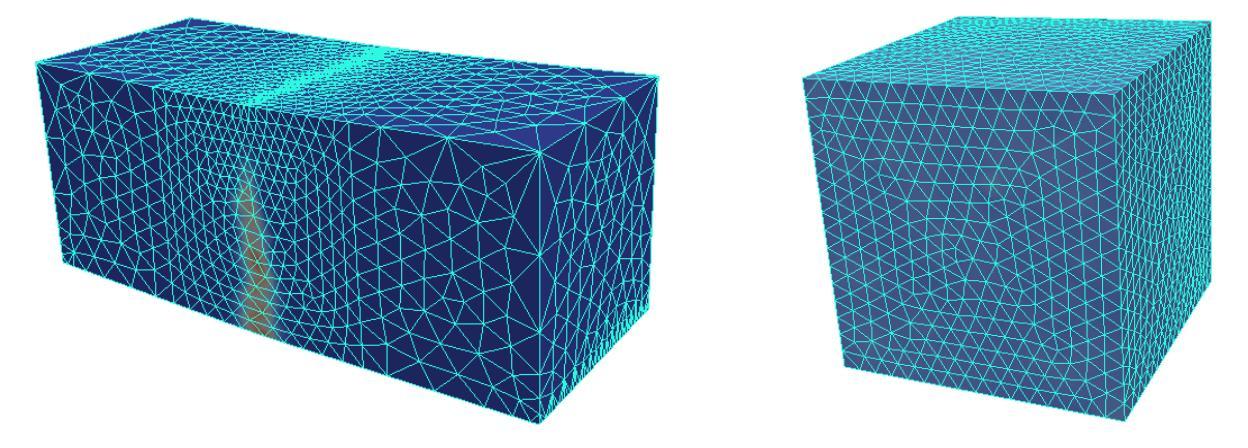
Figure 7: FE model of specimens for three-point bending (left) and uniaxial compression (right) tests.

The independent material model parameters to represent individual mortars and clay bricks were adjusted through an inverse analysis by reproducing the experimentally obtained data. First, the Young's modulus, E, and parameters to influence the flexural strength (tensile strength, f_t , and fracture energy, G_f) were adjusted to reproduce the results of the three-point bending tests, Figure 7.

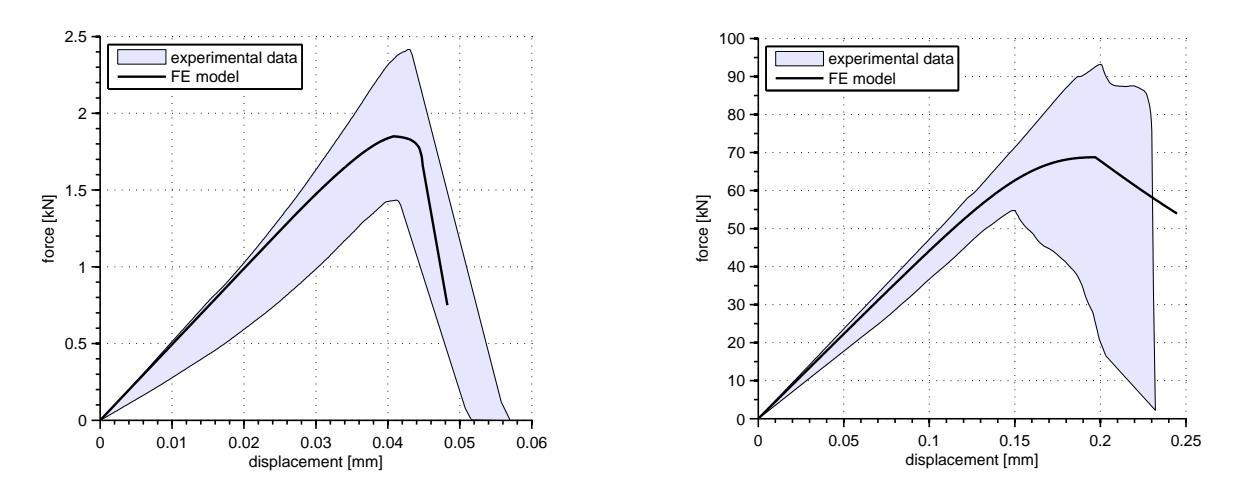
Figure 8: Fit of the material model input parameters representing bricks to reproduce the results of three-point bending (left) and uniaxial compression (right) tests.

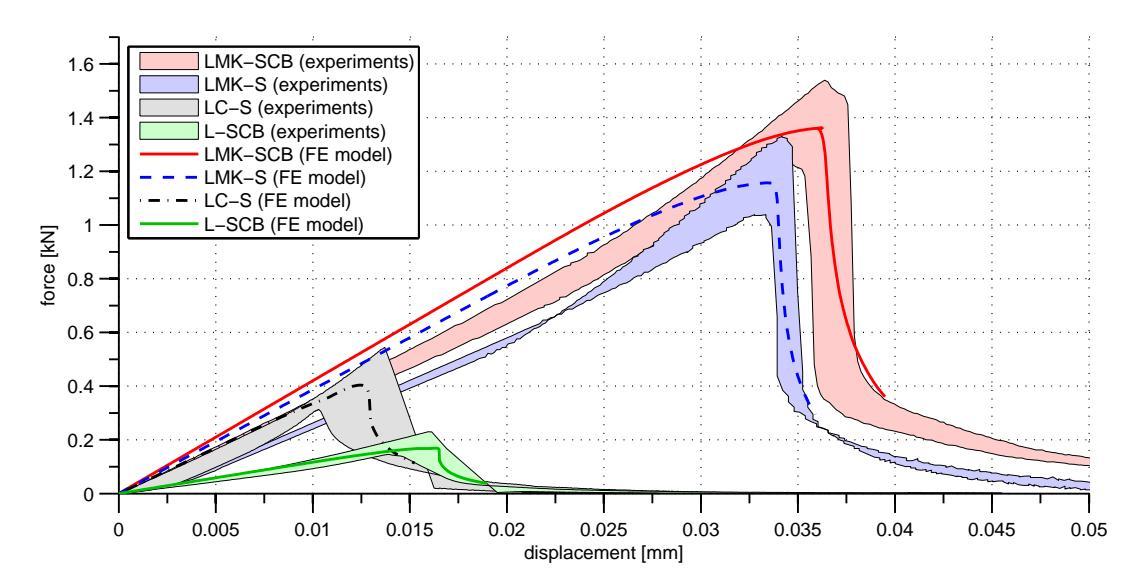
Figure 9: Fit of the material model input parameters representing the individual tested mortars to reproduce the results of three-point bending tests.

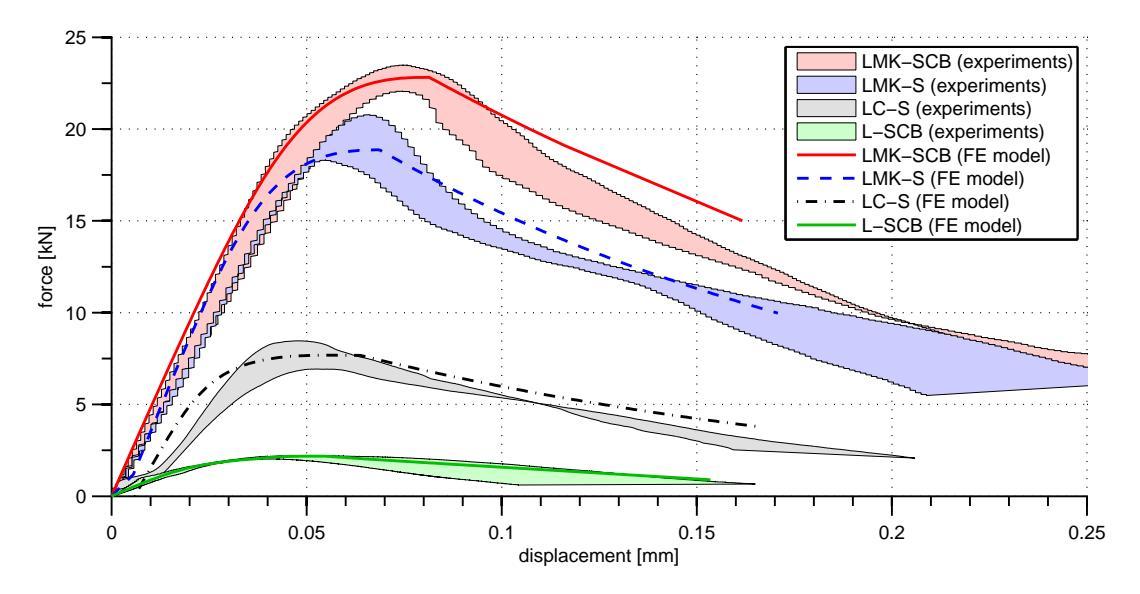
Figure 10: Fit of the material model input parameters representing the individual tested mortars to reproduce the results of uniaxial compression tests.

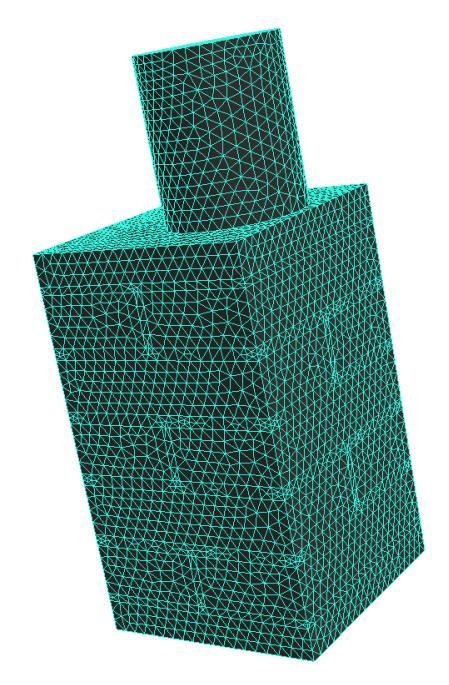
Figure 11: FE mesh of the investigated masonry piers.

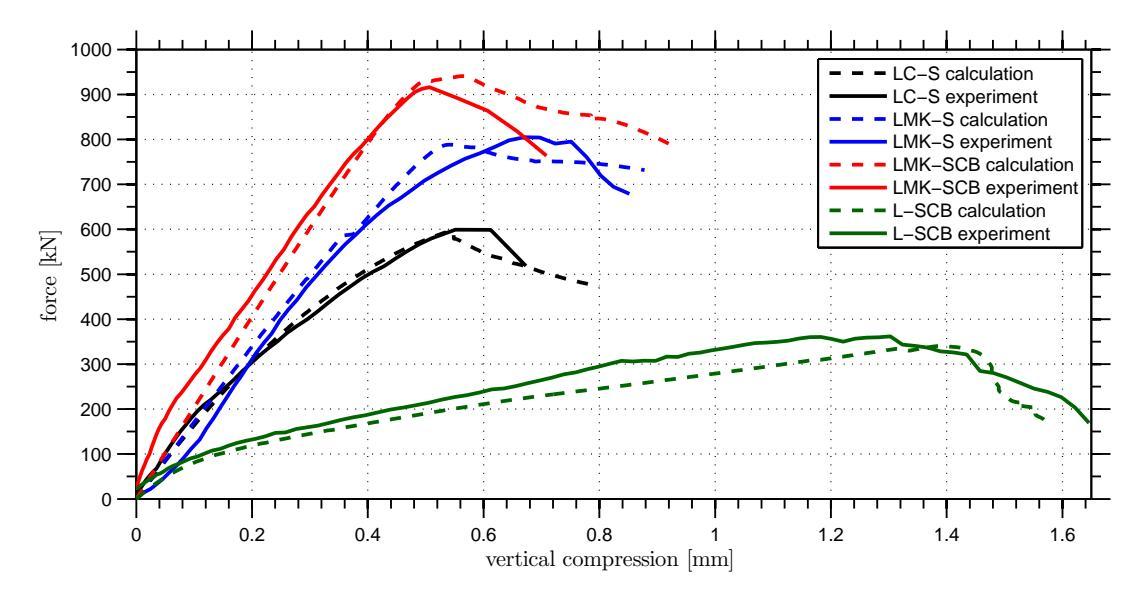
Figure 12: Comparison between the numerically and experimentally obtained loaddisplacement diagrams, describing the response of the tested masonry piers to the imposed vertical displacement at the crest of the loading cell.

The FE model was at first validated by comparing the predicted and measured load-displacement diagrams, as presented in Figure 12. Both, the reactions in a load cell and the displacements obtained from DIC by placing virtual extensometers at the top and bottom of the tested piers, were in a good agreement with the numerically obtained predictions, Figure 3. The agreement between the predicted cracking patterns (reflected in the field of damage distribution) and the observed development of cracks (visualized as a map of maximum principal strains obtained from DIC) is not perfect for all tested piers. However, considering the non-homogeneous microstructure of the tested materials, the FE analysis results cab be considered satisfactory.

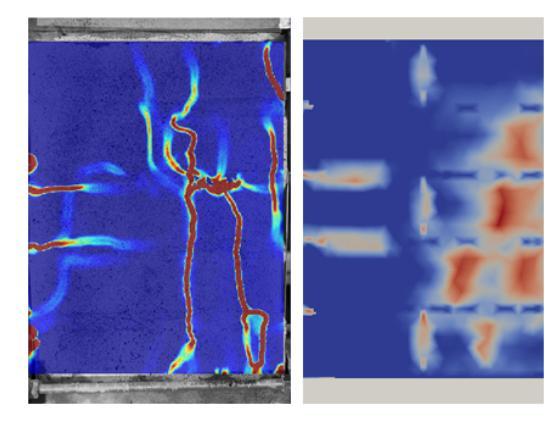
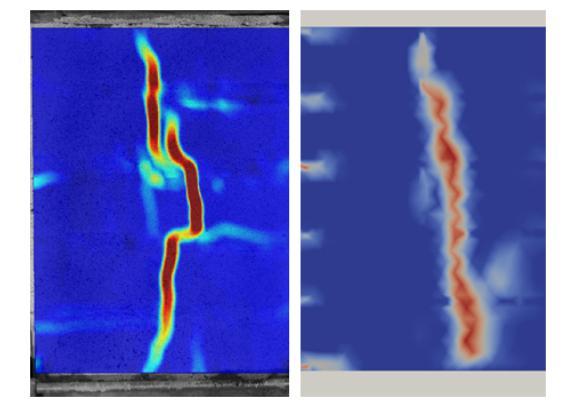
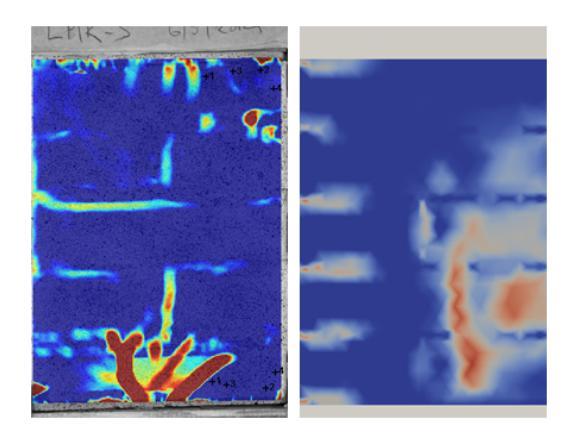
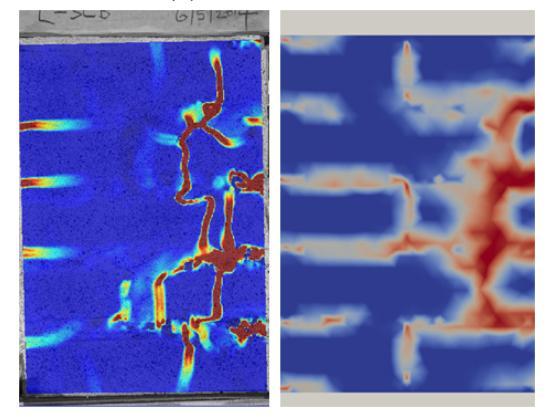
(a) LC-S mortar.

(c) LMK-SCB mortar.

(b) LMK-S mortar.

(d) L-SCB mortar.

Figure 13: Field of maximum principal strain obtained by DIC (left within the couples) and FE model damage predictions (right) on the face of the tested piers after reaching the peak load. The images provide a qualitative comparison between the predicted cracking patterns and experimental observations using DIC; the red areas represent the localized cracks.

In the case of piers with lime-cement mortar LC-S (Figure 13a), the model correctly predicted the formation of multiple cracks at the compressed side of the tested piers and the formation of two major cracks at the opposite side due to tensile stresses from the pier bending. The DIC results in the case of lime-metakaolin mortar LMK-S (Figure 13b) were influenced by a spalling of pier surface at the bottom, but the major crack formation in the middle of the tested pier can be identified in both, model predictions and DIC results. On the other hand, the formation of the major splitting crack in the case of mortar LMK-SCB (Figure 13c), containing metakaolin and crushed bricks, was perfectly predicted by the FE simulation, as well as the distributed cracking at the compressed pier edge in the case of the weak mortar L-SCB (Figure 13d).

In conclusion, the strategy to model the masonry units and mortar separately allowed us to capture the failure mode quite realistically (see Figure 13), enabling to study the relationship between the mechanical resistance of the masonry piers and bed-joint mortar properties.

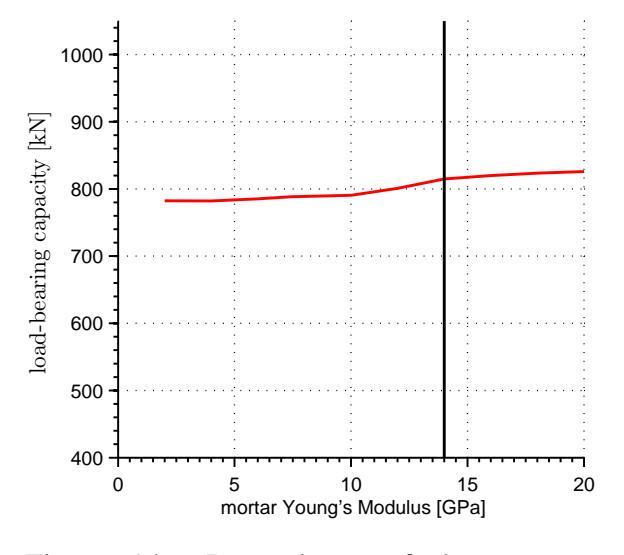
Figure 14: Dependence of the masonry pier maximum load-bearing capacity on mortar stiffness; black line represents the brick Young's modulus $E^{(b)} = 14$ GPa.

The plot in Figure 14 clearly demonstrates that the value of the mortar Young's modulus has just a minor impact on the load-bearing capacity of the studied masonry pier, and that there is no abrupt change when the mortar stiffness becomes superior to the stiffness of masonry units. However, the failure mode changes quite significantly. The use of a compliant mortar results in a multiple cracking of bricks at the more loaded side due to poor supporting, while a major crack passing through the entire column in the middle forms if the bed joints are stiff, see Figure 15.

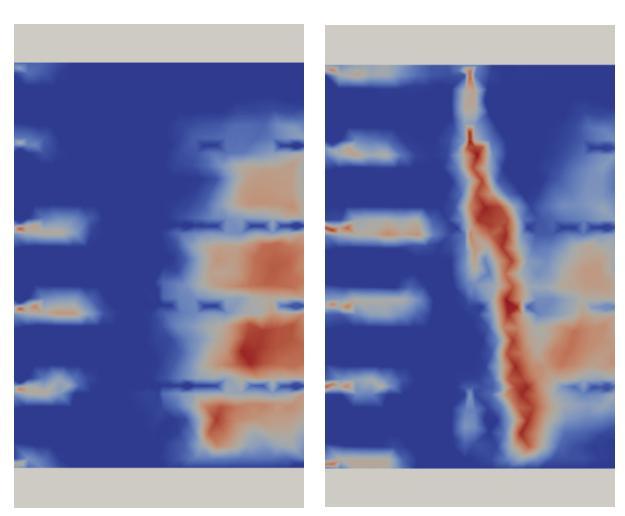
Figure 15: Crack patterns on masonry piers containing compliant ($E^{(m)} = 2$ GPa, left) and stiff ($E^{(m)} = 20$ GPa, right) mortar.

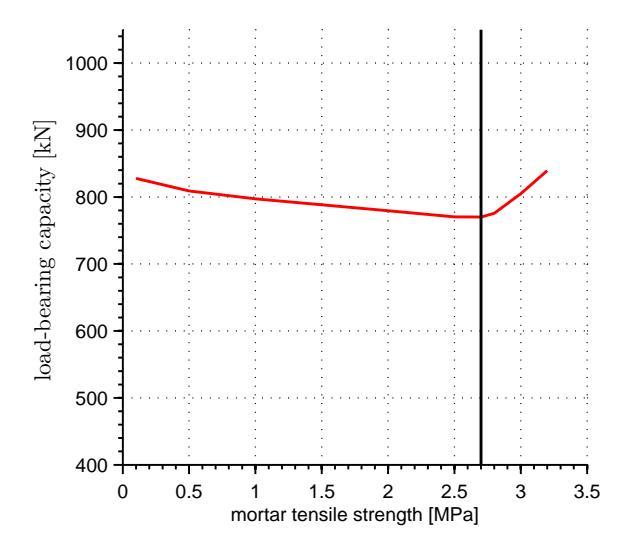
Figure 16: Dependence of the masonry pier maximum load-bearing capacity on mortar tensile strength; black line represents the brick tensile strength $f_t^{(b)} = 2.7$ MPa.

According to our numerical simulations, the confinement imposed by the strong mortars resulted in the cracking of the bricks and eventually the formation of the wedge-like failure as opposed to the vertical splitting of the pier containing a very weak mortar as indicated in Figure 17.

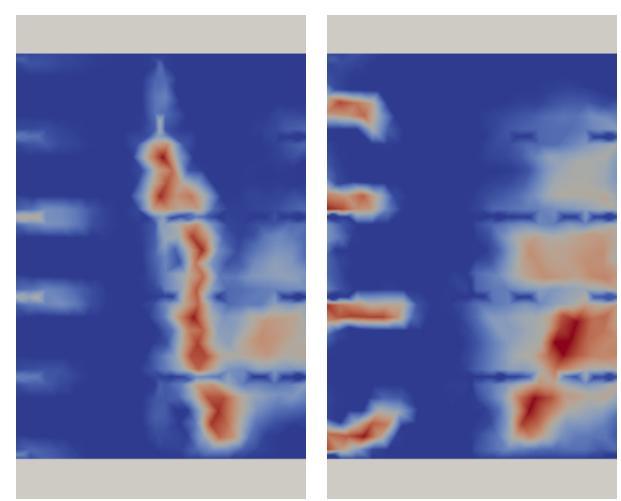
Figure 17: Crack patterns on masonry piers containing weak ($f_t = 0.1$ MPa, left) and strong ($f_t = 3.2$ MPa, right) mortar in tension.

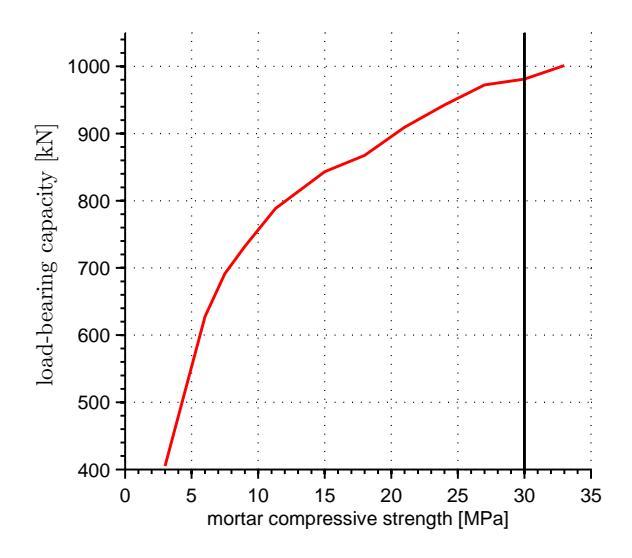
Figure 18: Dependence of the masonry pier maximum load-bearing capacity on mortar compressive strength; black line represents the brick compressive strength $f_c^{(b)} = 30$ MPa.

The bed-joint mortar compressive strength appears to be the crucial parameter with respect to the load-bearing capacity of masonry subjected to a combination of compression and bending. Mortars of a low compressive strength suffer an irreversible deformation at relatively low levels of external load, and masonry units are consequently subjected to uneven distribution of stresses due to imperfect supporting and excessive deformation of the bed joints.

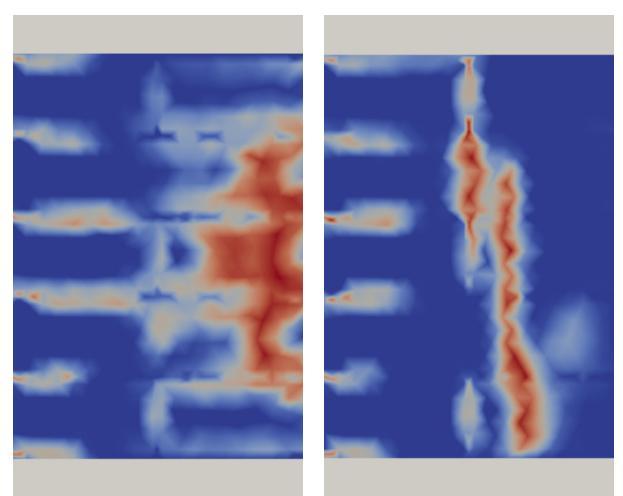
Figure 19: Crack patterns on masonry piers containing weak ($f_c = 3$ MPa, left) and strong ($f_c = 33$ MPa, right) mortar in compression.

In the case of the modeled masonry piers, the early crushing of the weak bed-joint mortar resulted in cracking of bricks at the more loaded pier periphery, Figure 19. This phenomenon limited the load-bearing capacity of the tested pier rather significantly, especially in the case of very poor mortars ($f_c^{(m)} < 10$ MPa), see Figure 18. The bed joints containing mortars of a high compressive strength did not suffer the inelastic deformation before the major splitting vertical crack appeared due to transversal expansion, resulting in a high load-bearing capacity. Therefore, the mortars with superior compressive strength should be used especially if a bed joint reinforcement is introduced so that the high strength can be efficiently exploited.
