Influence of grain size and grain boundary misorientation on the fatigue crack initiation mechanisms of textured AZ31 Mg alloy

Scripta Materialia, accepted for publication.

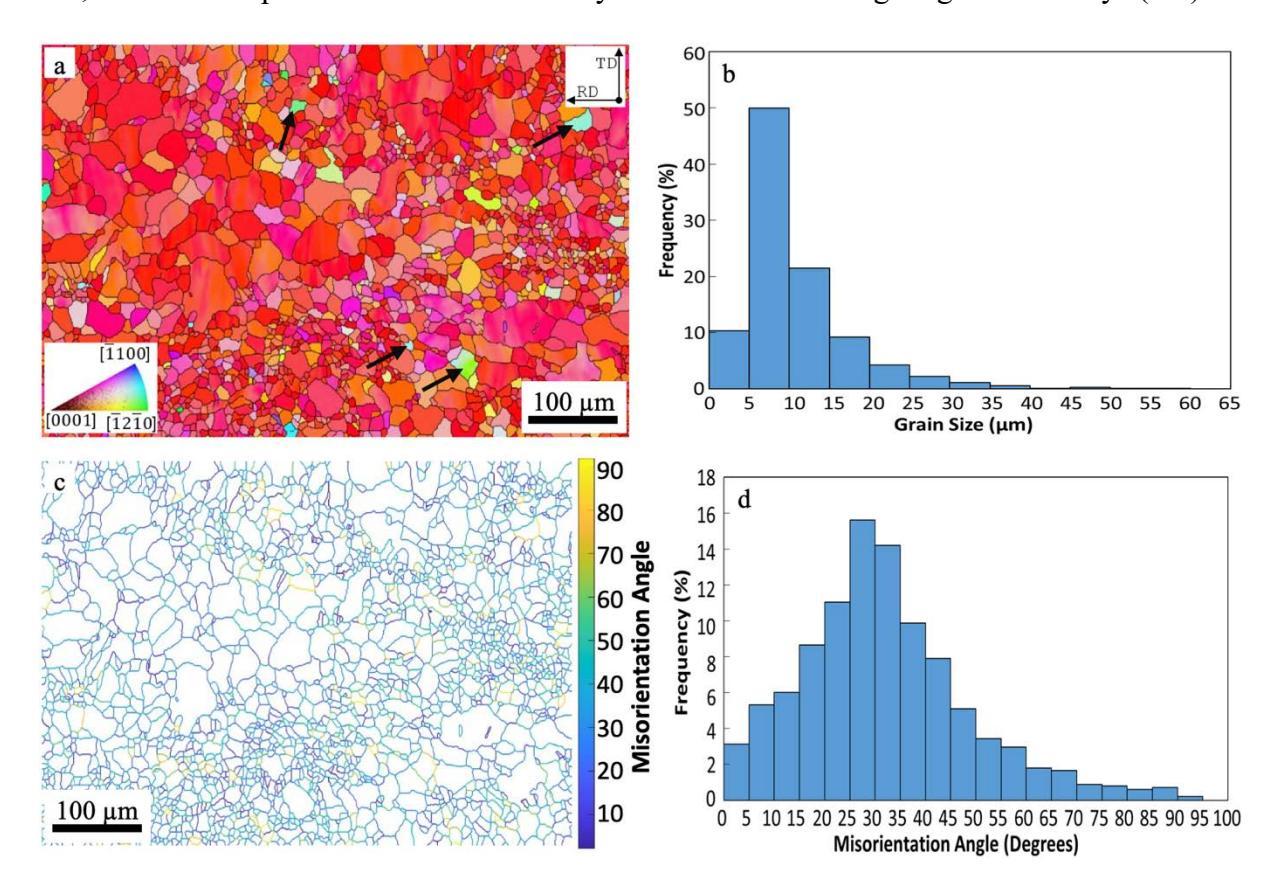
Fig. 1. (a) EBSD image showing the orientation of the grains in RD-TD plane. Twinned grains (as indicated by the orientation and the grain boundary misorientation angle) are marked with arrows) (b) Grain size distribution in the RD-TD plane. It should be noted that a few grains in the range 50 to 60 μ m were found in the microstructure. (c) Map of the grain boundary misorientation angle. (d) Grain boundary misorientation angle distribution.

Fatigue tests were carried out under strain control under fully reversed deformation at a cyclic strain semi-amplitude of $\Delta \varepsilon/2 = 2.0\%$ in a servo-hydraulic Instron 8802 mechanical testing machine. This strain was selected because it led to large number of microcracks on the specimen surface after 50 cycles, which allowed to relate the crack initiation sites with the microstructural features. Strain was controlled with an extensioneter attached to the sample, the test frequency was 0.5 Hz and load and deformation were monitored during the test through a computer-controlled data acquisition system. Specimens were initially deformed in compression in all cases. Three tests were carried out until failure while two tests were stopped after 5 and 50 cycles at the minimum (compression) strain. They were removed from the machine and the sample surfaces were observed in the SEM using EBSD and secondary electron detectors to assess the deformation mechanisms and the fatigue crack initiation sites. The microstructure of the rolled AZ31B-O alloy in the RD-TD plane is shown in the Fig.1a. It shows a very strong basal texture with the basal plane of most grains parallel to the RD-TD plane. The analysis of the grain boundary misorientation distribution showed the presence of very few twinned grains (Fig.1c, d), which showed different orientation and that are marked with black arrows in Fig. 1a. The grain size distribution is plotted in Fig. 1b and the average grain size was $14.4 \pm 8.8 \mu$ m. Approximately 80% of the grains were < 20 µm but the 20% remaining were much larger, reaching up to 60 µm. The average aspect ratio was 1.7 \pm 0.8 and the grains (particularly the large ones) were slightly elongated along RD. The grain boundary misorientation is plotted in Fig. 1d. Most of the grain boundaries (\approx 75%) have a misorientation angle <40°. About 2% of the grain boundaries have a misorientation angle between 80° and 90°, which corresponds to the twin boundary misorientation in Mg magnesium alloys (86°).

µm in the material (Fig. 1b), pyramidal slip and twinning occur more easily in these large grains, leading to localization of the deformation and to the nucleation of large fatigue cracks that encompass the whole grain width. As a result, these transgranular cracks nucleated at the largest grains may become the critical ones that control the fatigue life. This result is in agreement with experimental results of the negative effect of abnormal grain growth on the fatigue endurance of Mg alloys [25] and supports previous predictions of the fatigue life of Mg alloys based on fatigue indicator parameters associated with the shear strain accumulated by plastic slip [17] or with twinning/de-twinning [11] in each fatigue cycle.

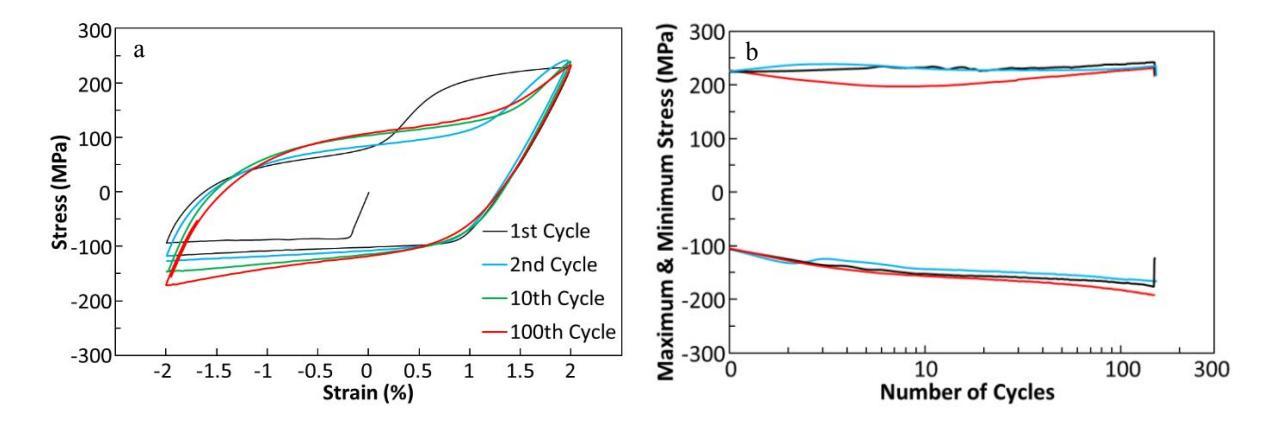
Fig. 2. (a) Cyclic stress-strain curves along the RD specimen after 1, 2, 10 and 100 fatigue cycles. The applied cyclic strain semi-amplitude was $\Delta\epsilon/2 = 2.0\%$. (b) Evolution of the maximum and minimum stress in each cycle as a function of the number of cycles.

The cyclic stress-strain curves of one sample after 1, 2, 10 and 100 fatigue cycles are plotted in Fig. 2a and they are typical of rolled Mg alloys with strong texture. Plastic deformation in the first compression cycle occurs at a constant stress due to twinning and reversed deformation leads to a curve with sigmoidal shape due to the activation de-twinning followed by pyramidal slip. In addition, basal slip is also assumed to develop during the tensile and compressive parts of the fatigue cycle due to the low CRSS necessary to activate this mechanism [5,6,12-15]. The shape of the cyclic stress-strain curves becomes stable after the first cycle, leading to large differences between the maximum stress in tension (controlled by pyramidal slip) and the minimum stress in compression (controlled by twinning). The evolution of the maximum and minimum stresses in the three samples that were deformed until failure is plotted in Fig. 2b. The maximum tensile stress remained constant during the whole fatigue life while continuous hardening was observed in the case of the minimum stress. The three samples failed at approximately 150 cycles. Cyclic hardening in compression was attributed to the presence of residual twins [6,12,19] that are obstacles to dislocation slip while the cyclic hardening in tension due to dislocation accumulation is balanced by the development of 100 µm damage, as shown below.

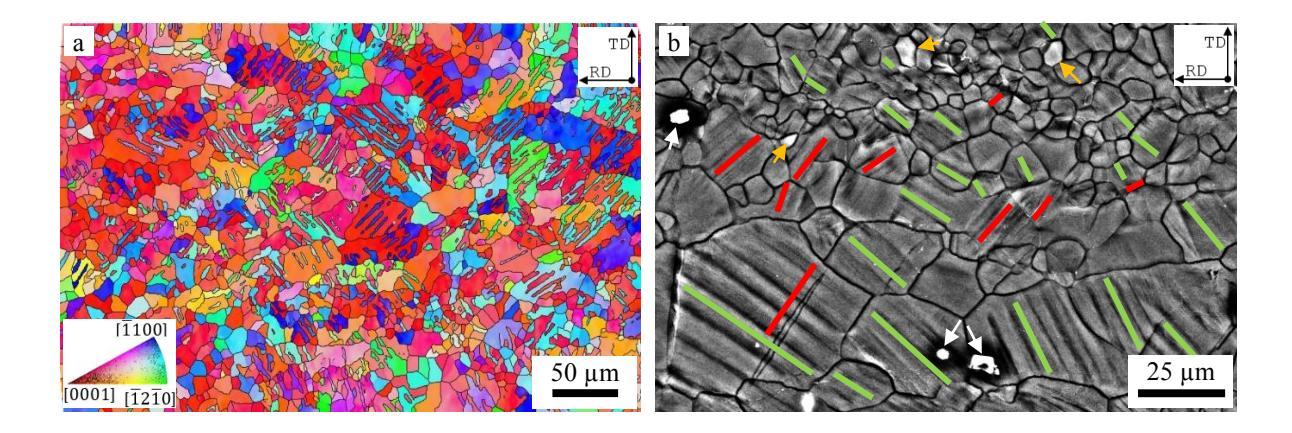
Fig. 3. Microstructure of the AZ31B-O sample after 50 fatigue cycles at $\Delta \varepsilon/2 = 2.0\%$. (a) EBSD map showing the orientation of the grains and the twins within the grains. (b) Secondary electron image showing deformation bands within the grains. Following slip/twin trace analysis, those parallel to the green lines were identified as pyramidal slip bands and those parallel to the red lines are twins. Intermetallic particles are marked with white arrows and fully twinned small grains with orange arrows.

The surface of the specimen deformed during 5 cycles was analyzed in the SEM and cracks were not found, although deformation bands were present in many grains. The EBSD map of the sample after 50 cycles is plotted in Fig. 3a. The test was stopped at the minimum strain and the inverse pole figure map shows that the *c* axis of several grains was reoriented nearly 90° from ND towards RD and the $<11\overline{2}0>$ or $<10\overline{1}0>$ axes were parallel to ND. This

The deformation mechanisms after 50 fatigue cycles were analyzed from secondary electron images at higher magnification in 2100 grains (Fig. 3b). Distinct deformation features could be identified in 538 grains, which were identified as pyramidal slip bands or tension twins. Most grains contained one set of long and straight slip lines parallel to each other. Slip trace analysis from the grain orientation, following the methodology presented in [22-23], showed that they were parallel to one of the pyramidal slip systems (normally the one with highest Schmid factor). They are indicated by green lines in Fig. 3b. Another set of deformation bands were parallel to one of the tension twin planes - as indicated by the twin trace analysisand they are identified by the red lines in Fig. 3b. In addition, some small grains appeared brighter in the secondary electron images (marked with orange arrows in Fig. 3b) and they were identified as fully twinned grains by checking with the EBSD map after deformation. The brighter appearance in the secondary electron images results because they were slightly elevated above the sample surface to accommodate the eigenstrain associated with tension twinning. It should be noted that only 11 small grains (with a grain size below 20 µm) out of approximately 2000 grains were fully twinned. Thus, twinning occurred preferentially in large grains and fully-twinned small grains were very rare. Twinning of small grains was very likely triggered by the large local stresses induced by the surrounding grains on these small grains. Finally, basal slip traces were only found in one grain. They were much thinner that the pyramidal slip bands and more difficult to identify. The fraction of each type of features found in the 538 grains is reported in Table 1. It should be noted that only one deformation mechanism (either pyramidal slip or tensile twinning) was found in > 90% of the grains with distinct deformation features and a combination of both of them was reported in 9.1%. Overall, the deformation mechanisms were in agreement with the shape of the stress-strain curves in Fig. 2 and with those reported by other investigations in extruded Mg alloys [5,6,12-17]. The lack of evidence for basal slip in the surfaces does not rule out that this mechanism is also active because the basal slip plane is parallel to the RD-TD plane in most grains and basal slip leaves no traces on this surface.

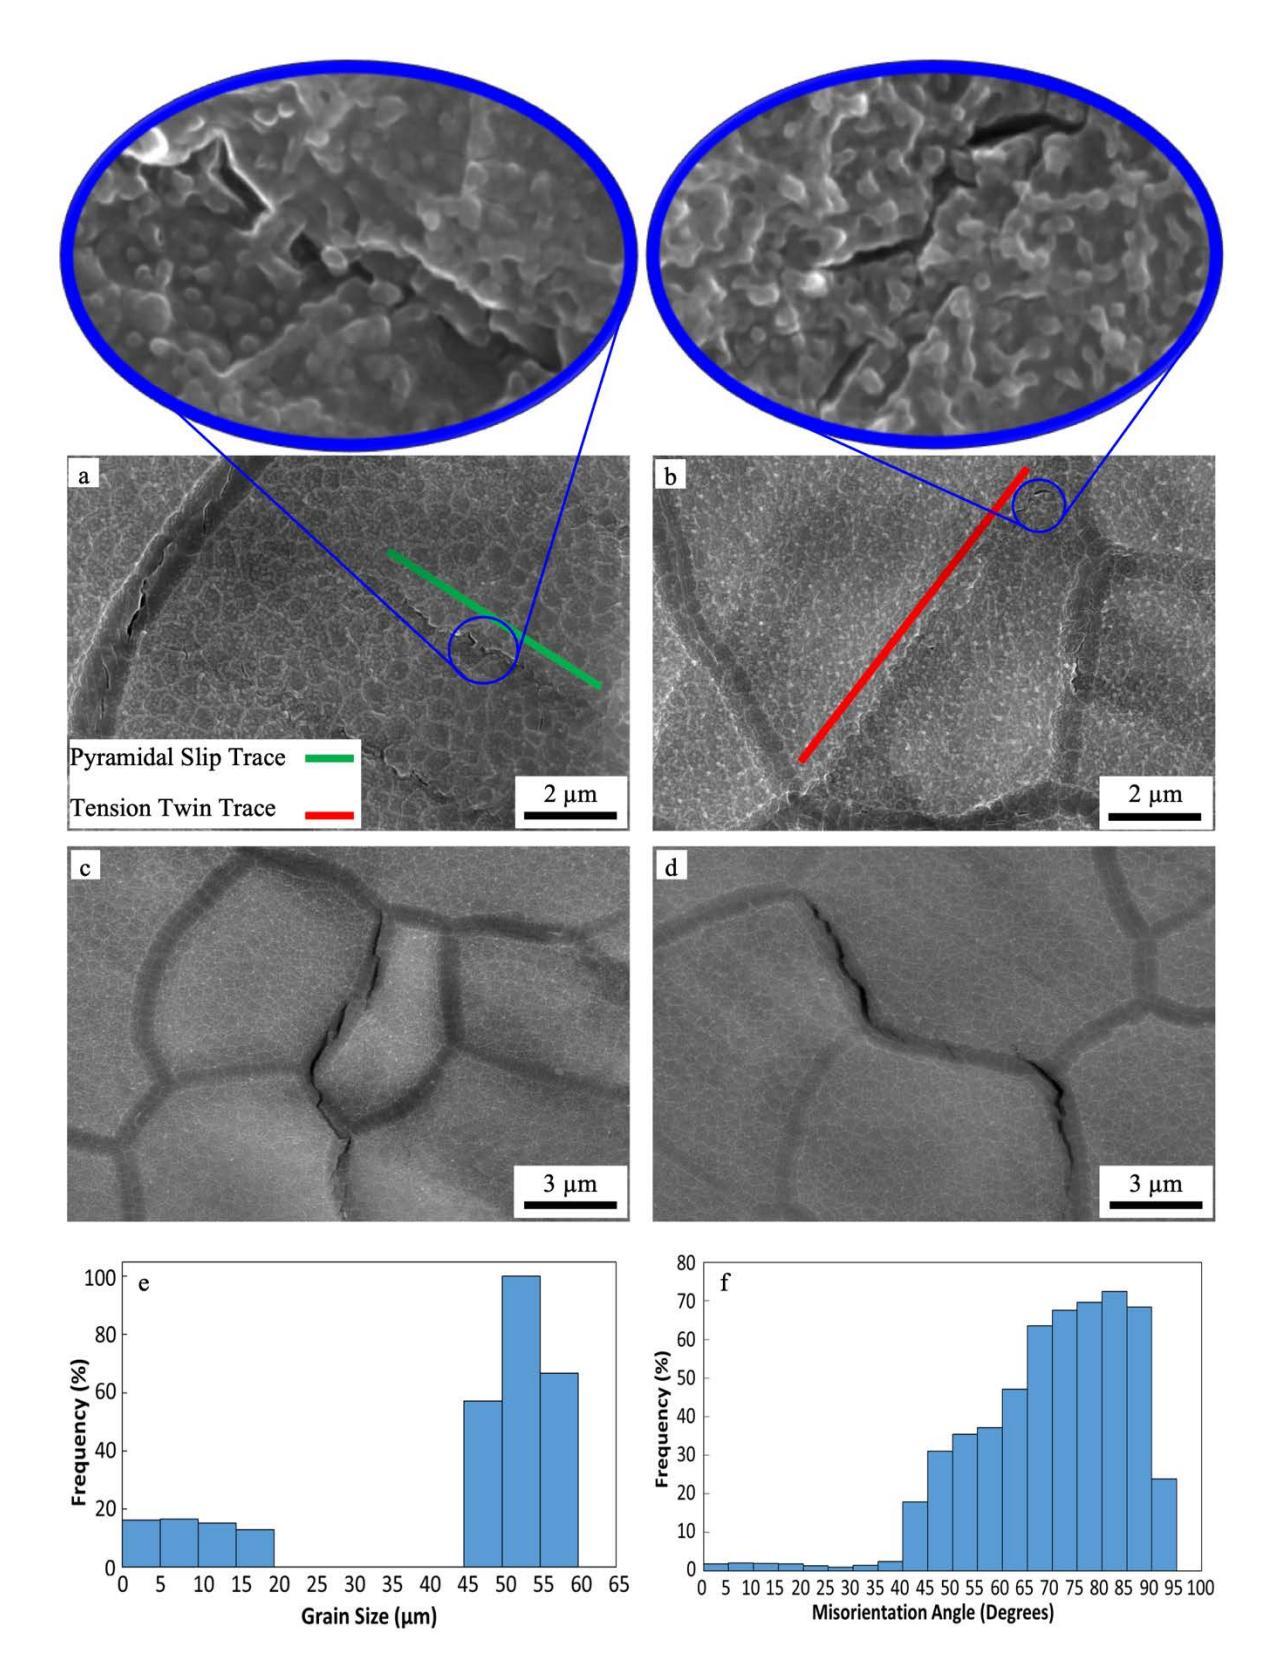
Fig. 4. Fatigue crack initiation sites in the extruded AZ31B-O sample after 50 fatigue cycles at $\Delta \varepsilon/2 = 2.0\%$. (a) Transgranular cracks parallel to pyramidal slip bands. (b) Transgranular crack parallel to tensile twin. (c) Intergranular crack around a fully twinned grain. (d) Intergranular crack. (e) Fraction of crack initiation sites as a function of the grain size. Fatigue cracks in grains $\geq 50 \ \mu m$ were transgranular, either associated with pyramidal slip

bands or twin boundaries. Fatigue cracks in grains $< 25 \ \mu m$ were either intergranular or transgranular. (f) Fraction of cracked grain boundaries as a function of the misorientation angle.

Intergranular and transgranular cracks were found in approximately 15 % of the grains < 20 µm (Fig. 4e) but grain boundary cracking was dominant for small grains. Two different types of grain boundary cracks were found. The first one was associated with small, fully twinned grains (Fig. 4c) and the grain boundary cracks appeared due to the stress concentration induced by the twinning eigenstrain. However, this mechanism was only observed in 11 grains. Most of the grain boundary cracks were not associated with twinning neither with the interaction of slip bands or twins with the grain boundary but with large values of the grain boundary misorientation angle, as shown in Fig. 4f. In fact, the fraction of grain boundaries that nucleate fatigue cracks rises sharply when the grain boundary misorientations is $> 40^{\circ}$ and 70% of the grain boundaries with a misorientation angle between 65° and 90° were cracked. On the contrary, only about 3% of the grain boundaries with the misorientation angle of $< 40^{\circ}$ were cracked. These cracks in grain boundaries with high misorientation are probably created due to the incompatibility of deformation between adjacent grains, which is more likely to occur in small grains because the critical stress to nucleate twins or promote slip increases as the grain size decreases. As a result, higher stresses are attained at the grain boundaries, promoting grain boundary cracking.
