Tensile material properties of human rib cortical bone under quasi-static and dynamic failure loading and influence of the bone microstructure on failure characteristics

Damien Subit^{a,*}, Eduardo del Pozo de Dios^b, Juan Velázquez-Ameijide^c, Carlos Arregui-Dalmases^{a,d}, Jeff Crandall^a

^a*University of Virginia, Center for Applied Biomechanics, 4040 Lewis and Clark drive, Charlottesville, VA 22902, USA*

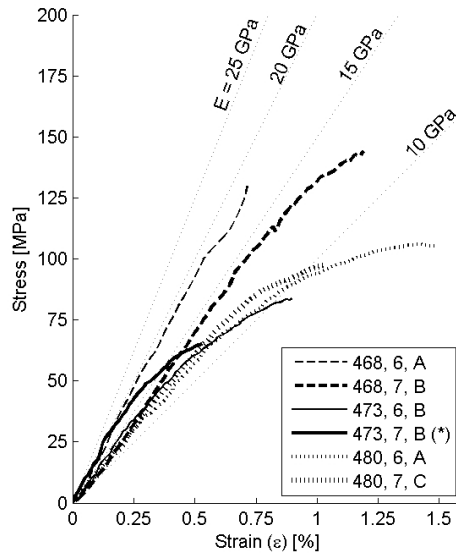
Figure 7: Strain-stress curves for the quasi-static tests. *: sample fractured in the clamp.

Strain-stress curves were plotted for all the quasi-static tests (figure 7). The material properties were determined by assuming a linear elastic model between 0 and 0.5 % of tensile strain (table 3). Young's modulus ranged from 11.4 to 18.5 GPa, failure stress from 83.4 to 143.9 MPa, and failure strain from 0.71 to 1.49 % in quasi-static, and failure stress ranged from 94.7 to 155.9 MPa in dynamic.
