# MECHANICAL DESIGN OF CERAMIC BEAM TUBE BRAZE JOINTS FOR NOVA KICKER MAGNETS\*

Fermi National Accelerator Laboratory, Batavia, IL 60510, USA

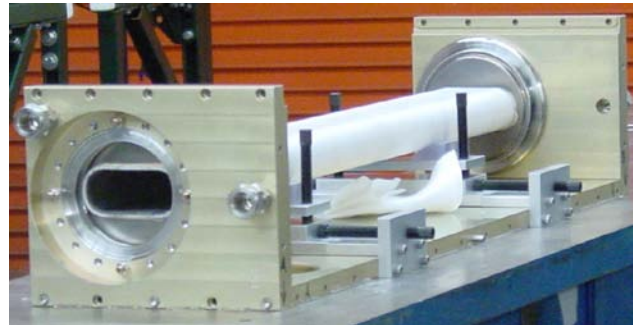
An elliptical shaped tube is used in order to give the proper beam aperture and also adequate strength for the internal vacuum pressure (Figure 1). The wall thickness used is approximately 4.8 mm, although for other projects the wall thickness has been thinner.

Figure 1: Brazed ceramic beam pipe during the welding process to end bellows.

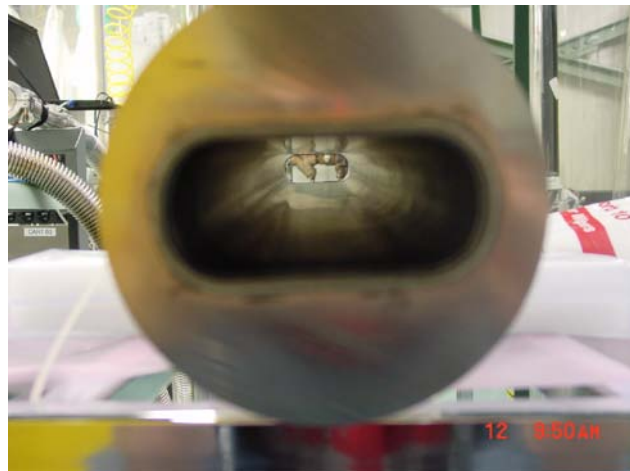
The kovar disc on the tube is typically dished in order to take the radial expansion and contraction forces of the flange on the tube during the brazing process. This design works well with metallization. However, it was found that a flat kovar flange configuration needs to be used with the active brazing process because it requires a flatter surface in order to make better surface contact (Figure 2).

Figure 2: End view of a flat kovar flange brazed on a ceramic tube.

The flange is made with an inner diameter about 6.35 mm too small so that there will be about 3.2 mm lip all

around the inner diameter of the tube. This provides some tolerance if the tube moves during the brazing process and also more surface area for the braze material. This inner lip is ground down after brazing in order to match the inner diameter of the ceramic tube.

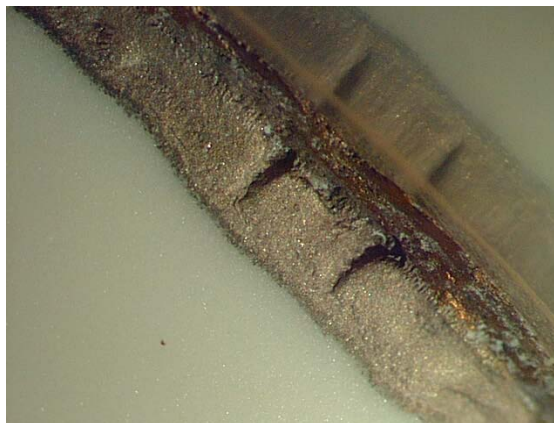
During the brazing process and subsequent cool-down to room temperature, residual stresses are generated due to the differential thermal contractions of the alumina, silver braze and kovar flanges [4]. As the joint is cooled from the brazing temperature to ambient temperature, the interface microstructure changes and residual stresses develop. Sometimes these braze joints subsequently will crack and will not be leak tight (Figure 3).

Figure 3: Active braze joint between the ceramic tube and kovar flange which has cracked.

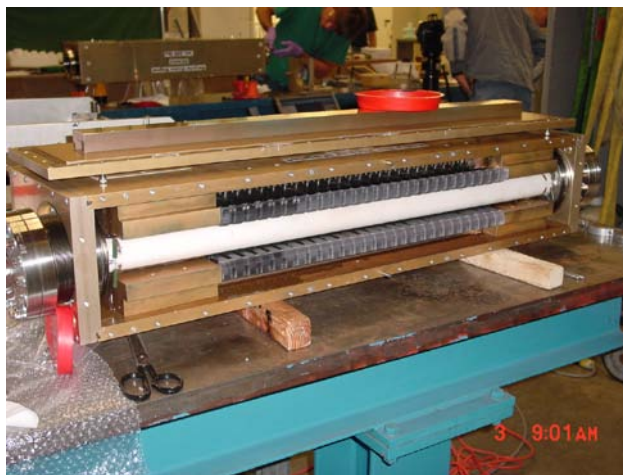
Seven shorter Recycler Gap Clearing Kicker magnets were installed last year (Figure 4). A purchase requisition for the brazing of twelve 1219 mm long tubes has been written and approved. Six tubes will be brazed by one vendor and the other six by another. The magnet design has been completed and the plan is that seven Recycler Extraction, Main Injection, and Beam Abort kickers will be ready for installation in early 2012.

Figure 4: Ceramic tube installed in kicker magnet with one of the side plates removed.
