The 4 K outer cryostat for the CUORE experiment: construction and quality control

The external shell of the CUORE cryostat is a large cryogen-free system designed to host the dilution refrigerator and the bolometers of the CUORE experiment in a low radioactivity environment. The three vessels that form the outer shell were produced and delivered to the Gran Sasso underground Laboratories in July 2012. In this paper, we describe the production techniques and the validation tests done at the production site in 2012.

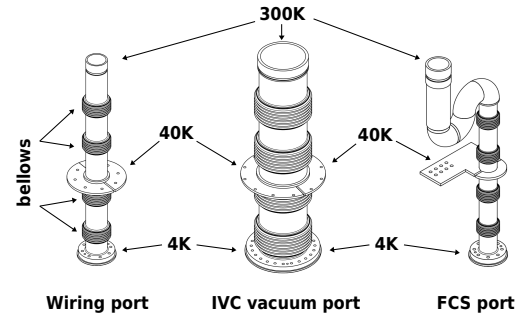
Figure 4: The wiring port, the IVC vacuum pumping port and the Fast Cooling System port.

age. This design allows the system to withstand seismic events with a peak ground acceleration as large as about 0.08g. Finally, several feedthroughs will be employed in CUORE for pumping, fast cooling with cold He and for the electrical leads of the detector (Fig. 4). During the tests at the production site we mounted only a few of them: the vacuum ports for the IVC and OVC, the two ports of the fast cooling and one wiring port. Fig. 5 shows the 300 K and 4 K plates connected by the A-bars with the above-mentioned ports before closing the chambers (see Sec. 5).

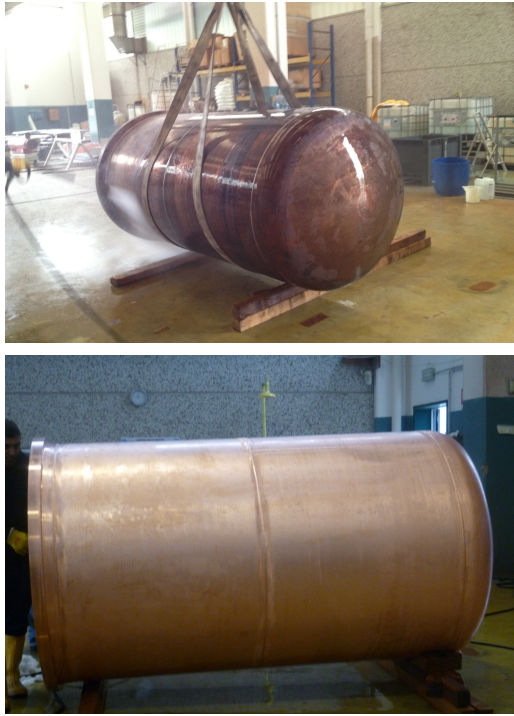
Figure 7: The 4 K vessel at the beginning and at the end of the cleaning procedure.

The surface contamination of the vessels was mainly due to machine oil deposited during calendaring (Fig.7). In most cases, pre-processing was necessary to remove the bulk of the machine oil. Such pre-processing was done with degreaser (10% weight), nitric acid ($\sim 1\%$ weight) in hot ($\sim 40^\circ\text{C}$) unpurified water solution. All gilded parts were protected by a peelable rubber coating (Green Maskant), which was removed before the installation at the production site (see Sec. 5). The 300 K plate, which is made from AISI 304L steel, was cleaned by INFN personnel at the production site. In this case, only the degreasing cycles and the final flushing with Grade 2 water were performed (Fig.8).

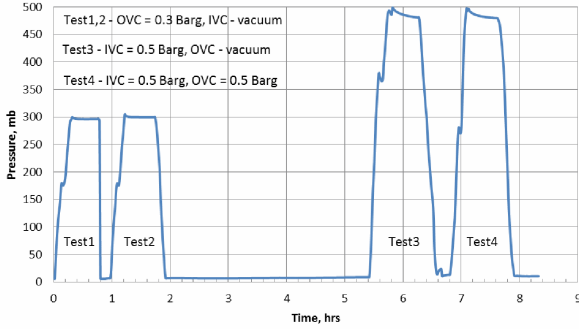
Figure 10: Pressure versus time in the IVC and OVC.

Overpressure was obtained injecting a He (50%) -Ar (50%) gas mixture in the IVC (OVC) port, while pumping the OVC (IVC). For greater safety, the test was performed filling a buffer bottle from a high pressure reservoir. The pressure of the buffer bottle (p_b) was chosen so that the expansion of the gas into the IVC (or OVC) was enough to bring the IVC to the sought-for pressure ($p_{IVC} = p_b V_b / V_{IVC}$, V_b and V_{IVC} being the volume of the buffer bottle and IVC respectively). In this way, there is no risk of accidental overpressure in the vessels even in case of a malfunction of the pressure reducer at the reservoir. During the expansion, the pressure at IVC/OVC was monitored by a digital pressure gauge and recorded by the DAQ system. The overpressure was kept for ~ 30 min in each cycle and every cycle was repeated twice (see Fig. 10).

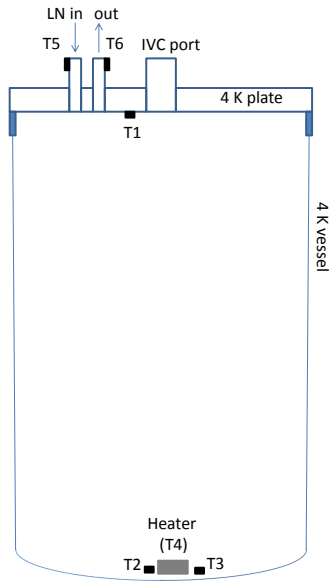
Figure 11: Position of the thermometers T1-T6.

As anticipated in Sec. 5, cooling was achieved circulating LN₂ from the input port of the FCS. The Nitrogen was extracted by the dewar at a pressure of 2 bar at the entrance of the cryovalve. The opening of the cryovalve was driven by four PT100 thermometers (T1, T2, T5, T7 in Fig. 11). T1 and T2 were located at the bottom and top of the 4 K vessel, respectively. T5 and T7 at the end and at the beginning of the line connecting the cryovalve to the FCS port. The cryovalve was opened/closed through a relay by a Lake Shore model 218 Temperature Monitor. The valve was open when the following conditions were fulfilled: $T_2 > 80$ K (no LN₂ accumulating in the bottom of the vessel), $T_1 - T_2 < 30$ K (temperature gradient along the height of the vessel < 30 K), $T_5 - T_7 < 200$ K (a safety condition to test the integrity of the transfer line). In addition, the temperature of the Nitrogen vapor at the exit of the vessel, i.e. at the output port of the FCS, was monitored (T6). A 60 W heater was also installed at the bottom of the vessel to speed up the warming. The regulation system, however, operated smoothly down to the target temperature ($T_1 = 82$ K) and the heater was not used in any phase of the cycle. Finally, T3 and T4 were employed as spare for T2 and as T monitor in the proximity of the heater, respectively.

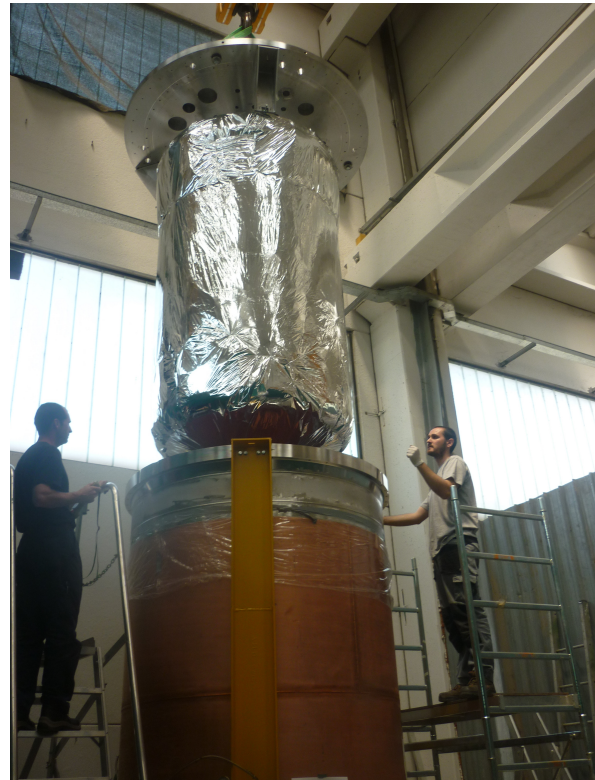
Figure 12: Insertion of the IVC into the 300 K vessel before the cold tests. The 4 K vessel and plate is wrapped with superinsulation.

Before the cold test, the 4 K vessel and plate were wrapped with a 10 layer aluminized superinsulation blanket (Ruag Space GmbH, model COOLCAT II, see Fig. 12). During cooldown, the IVC port was equipped with a rupture disk with burst pressure 0.45 ± 0.05 bar, a drop-off plate (300 mbar) and connected to the pressure gauge used during the tests of Sec. 6.2. Along this line, a pressure switch set at 200 mbar was connected in parallel to the relay driving the cryovalve. Hence, the maximum overpressure causing a stop of the cooling was set to 200 mbar while exhaust through the IVC port was granted at 300 mbar. The OVC port was used to connect the turbo pump to the OVC and record the pressure with a high-vacuum pressure gauge. The wire port was employed for the readout of the thermometers and to drive the heater with a 24V/3A DC current generator.

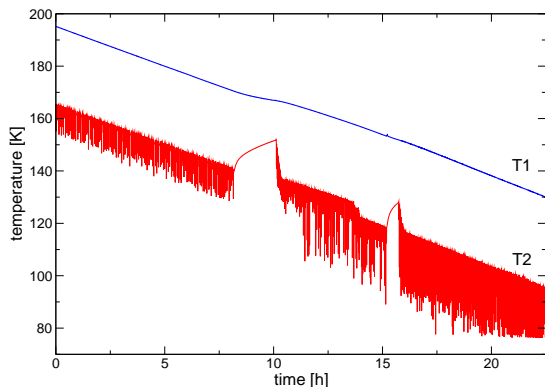
Figure 13: Temperature at T1 (4 K plate) and T2 (bottom of the 4 K vessel) during cooldown. The temperature jumps at T2 occurred after 8 and 15 hours from the beginning were caused by failure of the silicon tube section in the LN₂ transfer line.

Cooldown started with a pressure in the OVC of $p_{OVC} = 3.8 \times 10^{-5}$ and 1.8×10^{-5} mbar in the first and second cycle, respectively. During cooldown it reached a minimum value of $p_{OVC} = 5 \times 10^{-8}$ mbar. The cooldown rate was stable (see Fig. 13) at about

3 K/h and the opening of the cryovalve was driven by the $T1-T2 < 30$ K condition until $T1 \approx 110$ K, i.e. when the temperature at T2 was close to LN_2 temperature. Then, cool-down was mostly driven by the $T1 > 80$ K condition. The temperature reached at the end of the cooling was 82.5 K (84 K) at T1 and 77 K (77 K) at T2 during the first (second) cycle. The LN_2 consumption per cycle was about 1800 l, the total mass to be cooled being 2012 kg. As expected, LN_2 consumption was ~ 2 times larger than for an ideal cooling system that uses only the latent heat of vaporization (900 l [14]). Warm-up was purely passive (no use of heaters) in both cycles. While keeping high vacuum in the OVC ($p_{OVC} = 5 \times 10^{-3}$ mbar with the turbo pump off) the warming rate was about 3 K/h and it reached 4 K/h when p_{OVC} was brought to 1 mbar. In the final phase of the warm-up ($T1 \approx 260$ K), in order to increase the heat exchange and maintain a warming rate of 4 K/h, p_{OVC} was brought to 50 mbar.
