# Breakdown voltage of metal-oxide resistors in liquid argon

ABSTRACT: We characterized a sample of metal-oxide resistors and measured their breakdown voltage in liquid argon by applying high voltage (HV) pulses over a 3 second period. This test mimics the situation in a HV-divider chain when a breakdown occurs and the voltage across resistors rapidly rise from the static value to much higher values. All resistors had higher breakdown voltages in liquid argon than their vendor ratings in air at room temperature. Failure modes range from full destruction to coating damage. In cases where breakdown was not catastrophic, subsequent breakdown voltages were lower in subsequent measuring runs. One resistor type withstands 131 kV pulses, the limit of the test setup.

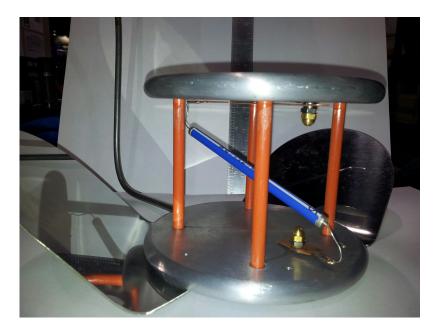
Figure 2. A photo of the test apparatus that held the resistors under test.

The test apparatus holds the resistors under test and allows the application of the voltage. It is made of two 14.5 cm diameter, 1 cm thick aluminium disks connected by four G10 rods making a total height of 11.5 cm. A hole in each disk aided the mounting of the resistors and provided good electrical contact. The grounded bottom plate had three mirror-finish stainless steel wings attached that were angled so that the resistor under test could be viewed from above. A picture of the test apparatus can be seen in Figure 2. Here one of the wings is removed.

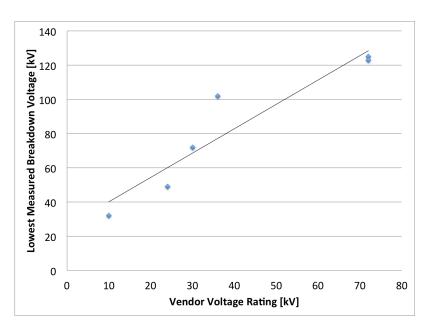
**Figure 3.** Vendor voltage rating in air versus lowest measured breakdown voltage for all failed resistors (i.e. not including the Metallux 969.23).

resistors and at various resistances. In Figure 4 we show the breakdown voltage distribution for one hundred resistors of one resistor type. In Figure 3, we show the voltage rating by the vendor in air versus the lowest measured breakdown voltage, the dependance of all devices follows a linear fit, the offset can be attributed to the vendors safety factor, which is not known to the authors.

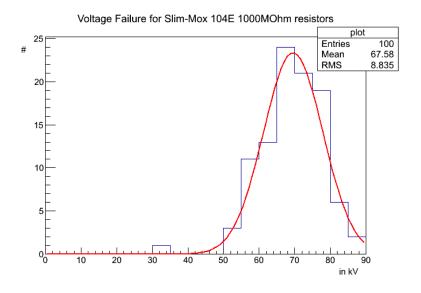
**Figure 4.** Breakdown voltage of the Slim-Mox 104E resistors in a 3 s voltage pulse.

A high statistics sample of Ohmite Slim-Mox 104E resistors was tested to establish a reliable lower breakdown voltage for this device. Their power rating suggests a failure at a pulse of about 60 kV, yet lower values were observed. In a sample of 100 resistors, the lowest observed breakdown occurred at 32 kV, with a Gaussian distribution around a mean value of 67.5 kV. This measurement, as shown in Figure 4, suggests that some outliers can occur, but gives confidence that this type of resistor is able to achieve its nominal 10 kV (in air) rating when used in liquid argon.

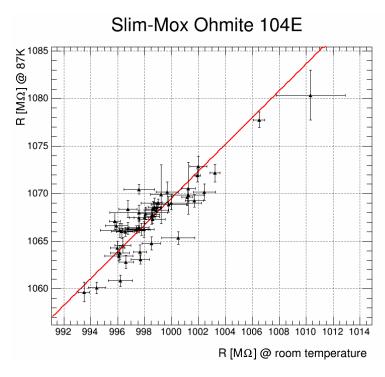
**Figure 5.** Resistance of Ohmite Slim-Mox 104E (1000 M $\Omega$ ) resistors measured at room temperature versus at liquid argon temperature of 87 K. The fit parameters are:  $\chi^2$ /ndf: 99.09/48, slope: 1.41  $\pm$  0.01 and intercept:  $-340.7 \pm 12.2$ .

It was found that the resistances in liquid argon are higher than the values measured at room temperature. The resistances at room temperature and at 87 K are correlated as shown in Figure 5 and 7. The measurement uncertainties are due to resolution of the current measurement, with currents in the  $0.1~\mu A$  range for  $G\Omega$  resistors.

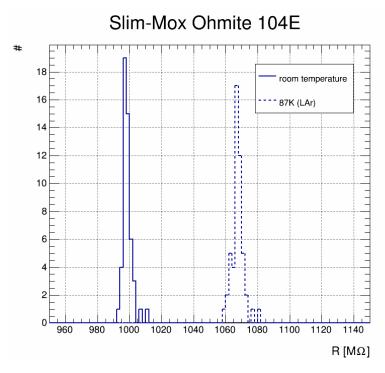
**Figure 6.** Resistance of Ohmite Slim-Mox 104E (1000 M $\Omega$ ) resistors measured at room temperature (998.7  $\pm$  2.7 M $\Omega$ ) and liquid argon temperature of 87 K (1067.6  $\pm$  3.7 M $\Omega$ ).

The mean resistance for the Metallux 969.23 at room temperature is  $507.4 \pm 25.6$  M $\Omega$ ; for the Slim-Mox Ohmite 104E it is  $998.7 \pm 2.7$  M $\Omega$  (see Figures 6 and 8). The smaller spread of the Slim-Mox Ohmite 104E reflects that these resistors were rated with a tolerance of 1%, while the Metallux 969.23 only have a tolerance of 10%.

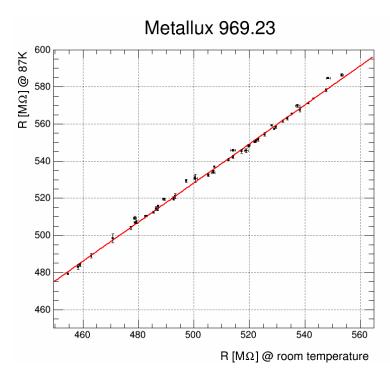
**Figure 7.** Resistance of Metallux 969.23 (500 M $\Omega$ ) resistors measured at room temperature versus at liquid argon temperature of 87 K. The fit parameters are:  $\chi^2$ /ndf: 199.3/48, slope: 1.053 ± 0.004, and intercept: 1.714 ± 1.831.

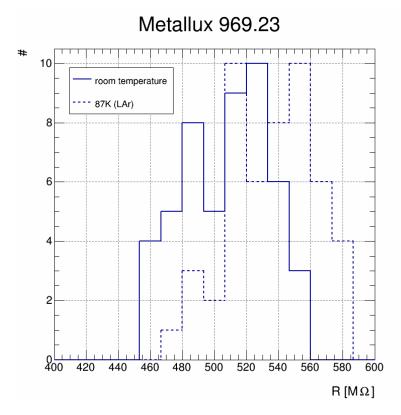
**Figure 8.** Resistance of Metallux 969.23 (500 M $\Omega$ ) resistors measured at room temperature (507.4  $\pm$  25.6 M $\Omega$ ) and at liquid argon temperature of 87 K (536.2  $\pm$  27 M $\Omega$ ).
