Plasma cleaning of ITER first mirrors in magnetic field

Lucas Moser^{a,*}, Roland Steiner^a, Frank Leipold^b, Roger Reichle^b, Laurent Marot^a, Ernst Meyer^a

^aDepartment of Physics, University of Basel, Klingelbergstrasse 82, CH-4056, Basel, Switzerland ^bITER Organization, Route de Vinon-sur-Verdon, 13115 St Paul-lez-Durance, France

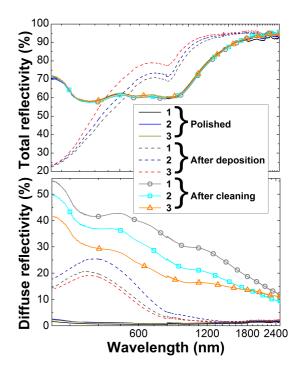
Figure 2: Total and diffuse reflectivity measurements of Mo polished mirror, after deposition of an Al/Al_{oxide} film and after plasma cleaning. The measurements were done on position 1,2 and 3 from Fig. 3 (a)).

The polished mirror A was deposited with a 260 nm thick Al / Al_2O_3 film. The total reflectivity of this mirror decreased drastically in the UV range compared to the polished one (Fig. 2). To remove the deposited film, four cleaning cycles (Ar, 0.5 Pa) were necessary. Two with a self-bias of 200 V for 20 and 42

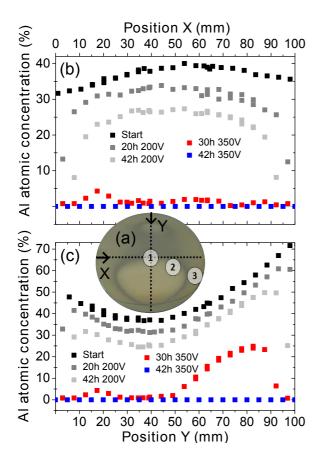
Figure 3: (a) Picture of the Mo mirror after the third cleaning cycle. 1,2 and 3 are the positions for the reflectivity measurements. The X and Y axis on the mirror are used for the EDX measurements. (b) and (c) EDX measurements where the Al atomic concentration are normalised by the measured Mo and Al values $\left(Al(\%) = \frac{Al(\%)}{Al(\%) + Mo(\%)}\right)$

hours, and two with a self-bias of 350 V for 30 and 42 hours. The EDX measurements carried out after each cleaning cycle (Fig. 3) clearly showed a homogeneous cleaning over the whole surface, i.e. the fraction of Al decreased with the same speed along the X and Y axis, except at the edge of the mirror. No electrical shielding of the mirror i.e. no metallic surrounding at ground potential was used for the cleaning: more ions were collected at the edge thus increasing the cleaning rates. The last EDX measurement showed a total removal of all Al from the mirror surface. This can also be seen by the recovering of the total reflectivity (Fig. 2). On the other hand, the diffuse reflectivity increased from a few percent up to 55% after 130 hours of cleaning. Ar ions bombardment (especially 72 hours at 350 eV) on poly-crystalline mirror is known to lead to a high roughness causing an increase in the diffuse reflectivity as reported by Voitsenya et al. [12]. The high diffuse reflectivity may exclude poly-crystalline Mo mirrors for systems which require mirror cleaning.

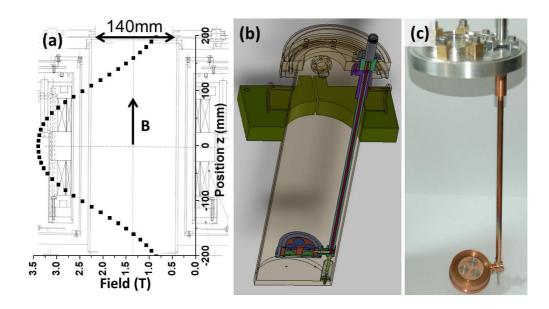
Figure 6: (a) Schematic of the superconducting magnet including the magnetic field intensity profile. (b) Cross section of the vacuum chamber and electrode used for the plasma cleaning experiments. (c) Illustration of the electrode (Cu) with 3 mounted mirrors (Mo).

To validate the cleaning procedure in a higher magnetic field, a new vacuum chamber was designed and will be installed in a superconducting magnet used to operate a gyrotron located at the CRPP Lausanne (Fig. 6) [13]. Depending on the depth on where the chamber will be inserted in the superconducting magnet, the magnetic field will vary between 1 and 3.5 T. The rotatable electrode provides the possibility to perform experiments for various angles α . This project is ongoing and first results will be presented soon.
