# Improving a pavement-watering method on the basis of pavement surface temperature measurements

Martin HENDEL<sup>1,2,3\*</sup>, Morgane COLOMBERT<sup>2</sup>, Youssef DIAB<sup>2,4</sup>, Laurent ROYON<sup>3</sup>

<sup>1</sup>Paris City Hall, Water and Sanitation Department, F-75014, Paris, France

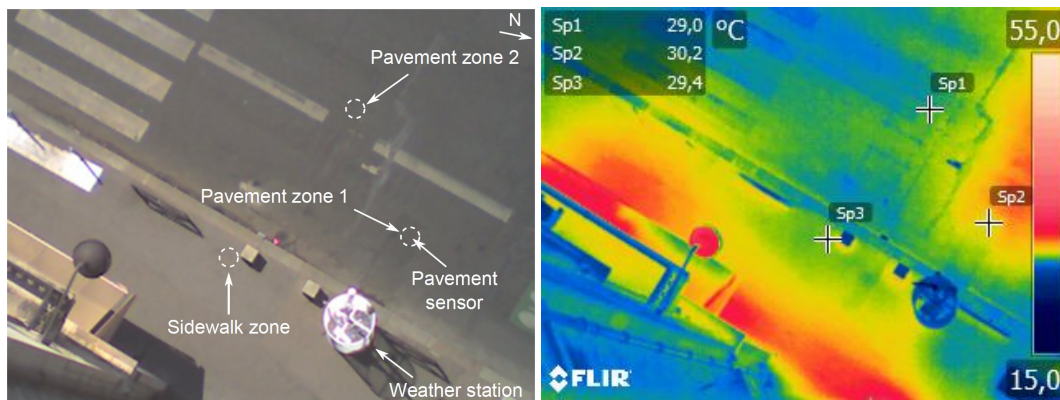
The surface temperatures of three street areas were surveyed as illustrated in Figure 2 (left): pavement zone 1, located above the pavement sensor used in the parent analysis [3], pavement zone 2, located further towards the street's center and a sidewalk zone. All three had an emissivity of 0.97 despite different surface composition and texture. No change in emissivity was applied for the wet pavement. It is assumed that the wet pavement has the emissivity of a water film, i.e. 0.98.

The studied zones were selected according to the presence of thermal disturbance sources, detected via a nighttime infrared photograph of the area provided in Figure 2 (right). The use of a nighttime rather than daytime infrared image prevents interpretation errors due to differences in insolation or shading. Thermally disturbed areas are either significantly warmer or colder than their surroundings, once differences in emissivity have been accounted for.

Figure 2: Surface temperature measurement zones (left) and corresponding nighttime corrected infrared photograph on July 22<sup>nd</sup> at 03:20 (right). Temperature scale is in degrees Celsius. Sp2: pavement zone 1; Sp1: pavement zone 2; Sp3: sidewalk zone.

The main disturbance is caused by a district heating main, which runs below the sidewalk along the edge of the building and crosses the street perpendicularly below the weather station. It is most easily recognized in its sidewalk portion in the form of a distinct red band running from left to right from the awning to the bottom edge of the false-color infrared image. It then runs perpendicularly, from bottom to top, underneath the weather station where it is not as visible and continues until the other side of the street, reappearing with rough contours just after pavement zone 1 (Sp2).

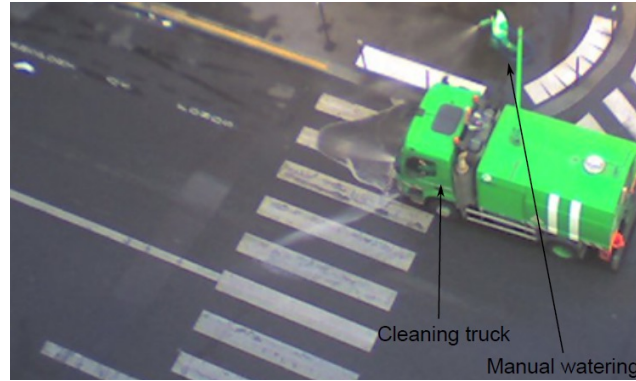
Figure 3: Pavement- and sidewalk-watering on July 8<sup>th</sup> by a cleaning truck and its operators. Watering is taking place across the street from the weather station visible in Figure 2.

Cleaning trucks assisted by manual operators sprinkled approximately 1 mm every hour from 06:30 to 11:30 and every 30 minutes from 14:00 until 18:30 on the sidewalk and pavement. This amount of water is considered to be the maximum water-holding capacity of the road surface in Paris by the Roads and Traffic Division. Exact watering times were reported by truck drivers, cross-checked against visible images taken by the rooftop camera when available. Resulting watering time precision is estimated to be no better than 5 minutes. A picture of pavement-watering underway across the street from the studied street surfaces (the same pedestrian crosswalk is visible) is presented in Figure 3. Each watering cycle required two passes by the cleaning truck to water both halves of the street.

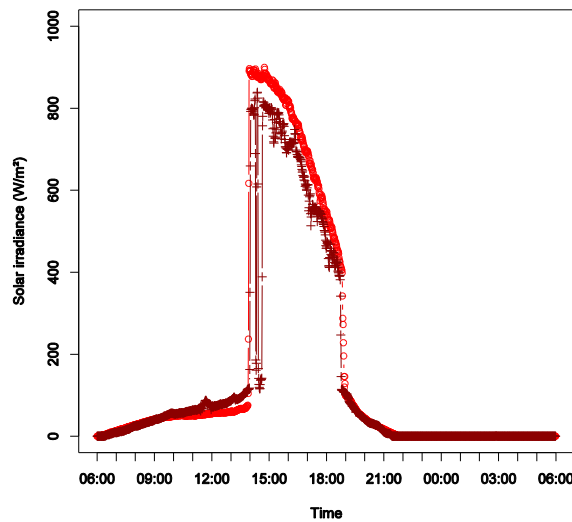
Figure 4: Solar irradiance measured on July 8<sup>th</sup> and 22<sup>nd</sup>.

approximately 25 minutes shorter than on July 8<sup>th</sup>, while solar zenith is reduced by less than 2°. The magnitude of these changes can be seen in Figure 4 which illustrates solar irradiance as measured by the weather station on July 8<sup>th</sup> and 22<sup>nd</sup> for comparison. Daily shading conditions were checked and were found to be unmodified for the studied surfaces between July 8<sup>th</sup> and July 21<sup>st</sup>. For the purpose of this discussion, we therefore consider the changes in sun trajectory to be negligible.

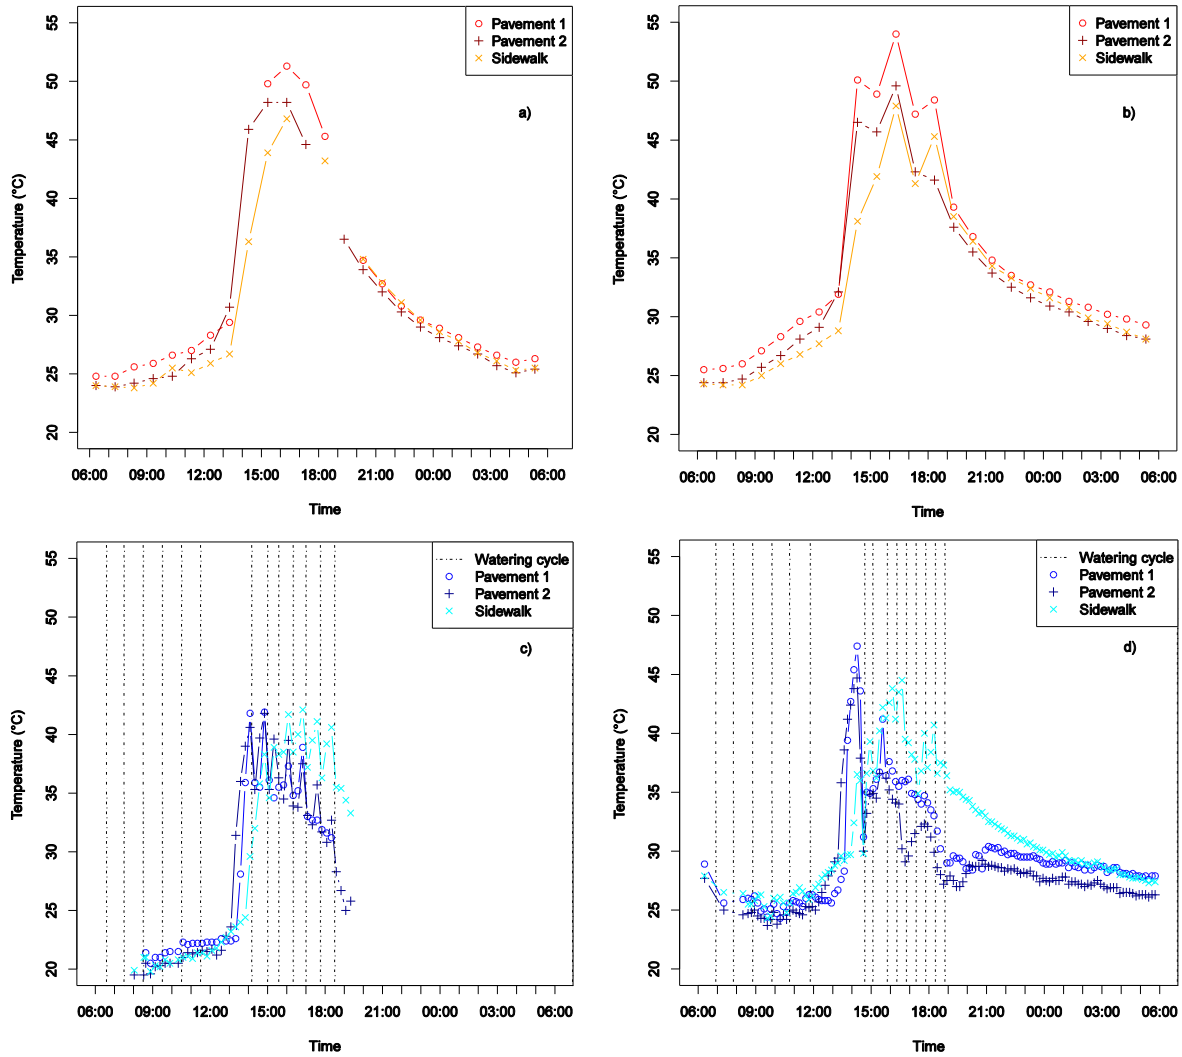
Figure 5: Pavement Directional Radiometric Temperature on control days: a) July 20<sup>th</sup> and b) July 21<sup>st</sup>; and on watered days: c) July 8<sup>th</sup> and d) July 22<sup>nd</sup>

Figure 5 presents directional radiometric temperature for the three defined areas of the street: the (o) series represents pavement zone 1; the (+) series represents pavement zone 2; the (x) series represents the sidewalk. Some data points are missing due to passing or parked vehicles over the measurement areas. Vertical dot-dashed lines indicate watering cycles for July 8<sup>th</sup> and 22<sup>nd</sup>. It should be noted that afternoon watering on July 8<sup>th</sup> occurred about every 45 minutes, while it was every 30 minutes on July 22<sup>nd</sup>.

On July 20<sup>th</sup> and 21<sup>st</sup>, surface temperatures reach a low of 24°C between 06:00 and 07:00 and a high of 50-54°C at 16:00. All three surfaces follow a very similar approximately bell-shaped curve. Morning temperatures increase slowly until they spike when the pavement becomes insolated around 13:30. Pavement shading causes an exponentially-shaped decrease in temperatures starting between 18:00 and 19:00. Pavement zone 1 is generally the warmest, followed by pavement zone 2 and the sidewalk, with nocturnal temperatures being the most similar with differences smaller than 2°C. Temperature differences are more pronounced during the day, particularly during insolation. It should be noted that the temperature fluctuations which occur on July 21<sup>st</sup> are due to the passing of isolated clouds.

On July 22<sup>nd</sup>, the daily low was about 25°C, but this temperature was maintained from 07:30 until 12:00. A maximum temperature of about 47°C was reached just before afternoon pavement-watering began. The bell-shape of the temperature curves is greatly affected by watering. Morning increases are slower, insolated surface temperatures are several degrees lower and nighttime temperatures follow a more linear decrease, except for the sidewalk zone. After watering begins, the temperature of all surfaces remains below 45°C. Furthermore, unlike on control days, the sidewalk becomes the warmest area after afternoon watering begins and remains so until late in the night. Similar temperatures and trends are observed in available data from July 8<sup>th</sup>.

A dip in the temperature of pavement zone 2 and that of the sidewalk should be noted on July 22<sup>nd</sup>. It occurs due to shade caused by the buildings across the street at approximately 17:00 and 18:00, respectively. This shade event did not occur before this date.

In addition to these changes, the presence of several temperature spikes during and just before afternoon watering is noted on both July 8<sup>th</sup> and 22<sup>nd</sup>. For pavement zones 1 and 2, these are mainly found on July 8<sup>th</sup>, with nearly all occurring during afternoon watering. On July 8<sup>th</sup>, the detected spikes are up to two 15-minute measurements wide. On July 22<sup>nd</sup>, when watering occurs more frequently, only two spikes are visible, excluding the temperature dip due to building shading: one before and one during afternoon watering. The latter spike follows a 50-minute interruption in pavement-watering and is only detected by one measurement. For the sidewalk, spikes are found on both watered days. The amplitude of these local maxima is in the order of 5°C on July 8<sup>th</sup> for all three zones. On July 22<sup>nd</sup>, the amplitude of the sidewalk maxima is reduced to about 2-3°C while temperatures are comparable. In the morning of July 22<sup>nd</sup>, small temperature spikes may occur for the sidewalk zone, but these are of low amplitude and are hard to distinguish.

Spikes just before afternoon watering begins occur for the pavement zones only. This is because the studied areas are not insolated simultaneously and pavement-watering began before the sidewalk was insolated, but not before the pavement zones were.
