Preliminary corrosion studies of IN-RAFM steel with stagnant Lead Lithium at 550 C

A.Sarada Sree, Hemang S.Agravat, Jignesh Chauhan and E.Rajendrakumar

Institute for Plasma Research, Bhat, Gandhinagar-382428.

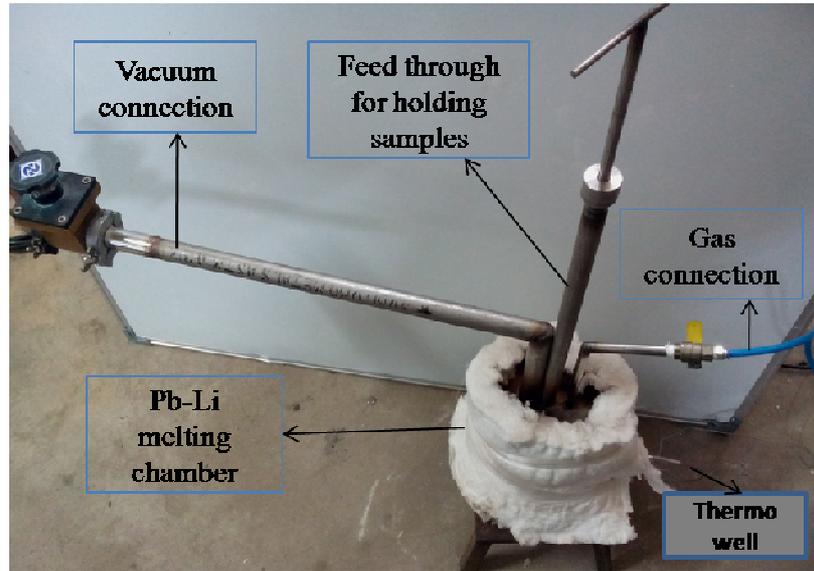
Experimental set up is shown in figure 1. Lead Lithium chunks are loaded in a cylindrical chamber made of SS316 L. A thermo well was fixed on the side of the chamber. A 'K' type thermocouple was introduced into the thermo well, which extends up to the center of the chamber. A 3 KW heater coil was wound over the circumference of the chamber to melt the Lead-Lithium chunks.

Fig.1. Experimental setup for studying corrosion of IN-RAFMS with static Pb-Li at 550 C.

Top flange of the chamber has the provision for the following.

- a. to evacuate the chamber
- b. to introduce Argon gas into the chamber to maintain positive pressure over liquid metal melt.
- c. a movable feed through arrangement to hold the samples.

IN-RAFMS flat and tensile samples were fixed to a sample holder, attached at the end of the feed through. Chemical composition of IN-RAFMS material is given in table 1. Initially samples were held above the Pb-Li chunks. The chamber is evacuated upto 10^{-3} m.bar, raising the temperature of the chunks upto 200 C. Then the vacuum system was isolated and Argon gas was introduced into the chamber. Then the temperature was further raised up to 550 C. Once all the chunks were melted and maintained at a temperature of 550 C, the sample holder was lowered with the feed through arrangement to dip the samples in the liquid metal melt. A positive pressure of 1.5 bar is maintained over the liquid melt throughout the experiment.

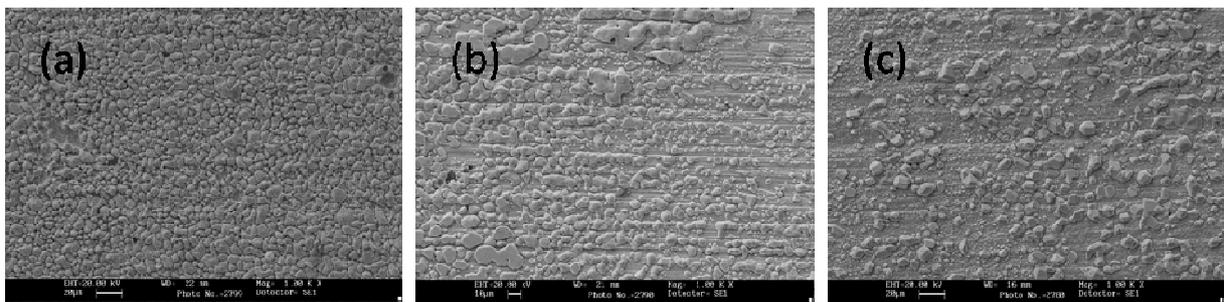
After exposure to liquid metal, the samples lost their metallic luster and the surface became dull. Surface micrographs of exposed samples for 2500, 5000 and 9000 hours were shown in figure 2(a), (b) and (c) respectively. Surface got deteriorated with increasing exposure time.

Fig.2. SEM surface micrographs of samples exposed to static Pb-Li at 550 C. Exposure time: (a) 2500 hours , (b) 5000 hours, (c) 9000 hours.

In all the exposed samples, pebble like structure can be seen. Similar type of surface morphology was observed by V.Tsisar et al., [30] when EP-823 steels were exposed to Nitrogen added Lithium maintained at 600 C. This type of structure is due to dislodging of grains/ sub grains from the surface. Initially, when the surface of the structural material is exposed to Lead-Lithium eutectic at 550 C, corrosion occurs on the surface and the bonding between grains / sub grains become weak. Slowly the grains/ sub grains get detached from the surface and go into the eutectic, giving rise to pebble like structure.

From the surface micrographs, pebble like structures were seen on the surface. When the surface of the structural material is in contact with Pb-Li eutectic, corrosion occurs on the surface and the bonding between the grains/sub grains becomes weak, leading to detachment of some grains/sub grains from the surface which pass into the eutectic.

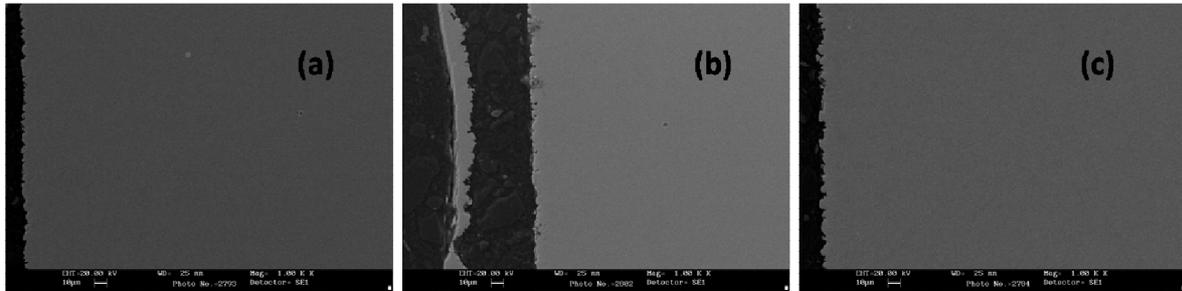
SEM cross section micrographs after exposure of the samples to static liquid metal at 550 C are shown in figure 3(a), (b) and (c) for the case of 2500, 5000 and 9000 hours respectively.

Groove like structure was observed in all the three cases, showing internal corrosion of the material. After 5000 hours, a detached layer was observed. Chemical composition, measured in the detached layer revealed that it is part of the matrix and contained mainly iron and chromium.

Fig.3. SEM cross section micrographs after exposure to static Pb-Li at 550 C. Exposure time: (a) 2500 hours, (b) 5000 hours and (c) 9000 hours.

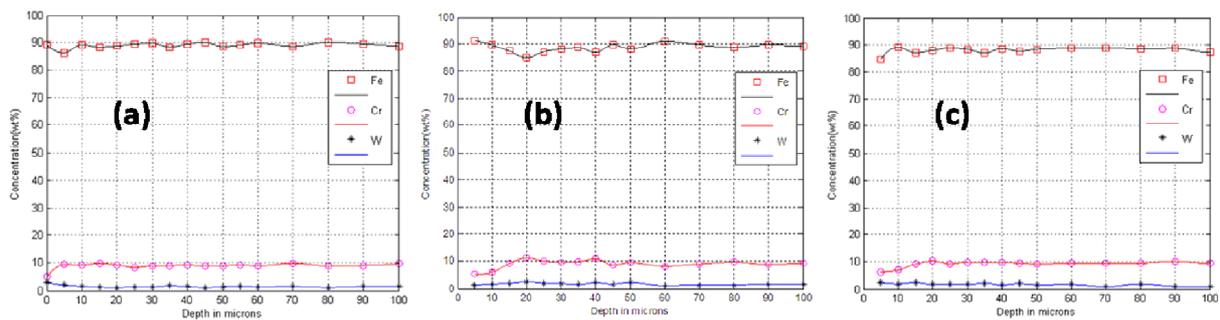
SEM EDX was carried out on the cross section of the samples exposed for 2500, 5000 and 9000 hours. Chemical composition was measured depth wise and shown in figure 4(a), (b) and (c) for the above mentioned three exposure times. In all the three cases, chromium is found leaching from the near surface regions and tungsten is found slightly high near the surface. In case of 5000 and 9000 hours exposure, chromium is found leaching from a greater depth $\sim 20 \mu\text{m}$ as compared to $\sim 5 \mu\text{m}$ in case of 2500 hours.

Fig.4. EDX line scan on cross section of IN-RAFMS after exposure to static Pb-Li at 550 C. Exposure time: (a) 2500 hours, (b) 5000 hours and (c) 9000 hours.

Dissolution of the alloying elements seems to be the main corrosion mechanism. From SEM/EDX measurements on the cross section of the samples, chromium was found selectively getting leached out from the near surface regions, ~15 microns from the surface. Chromium content reduced from 9% to (5-6)% after exposure to liquid metal. Tungsten was found high near the surface. This could be due to less solubility of tungsten in the liquid metal.

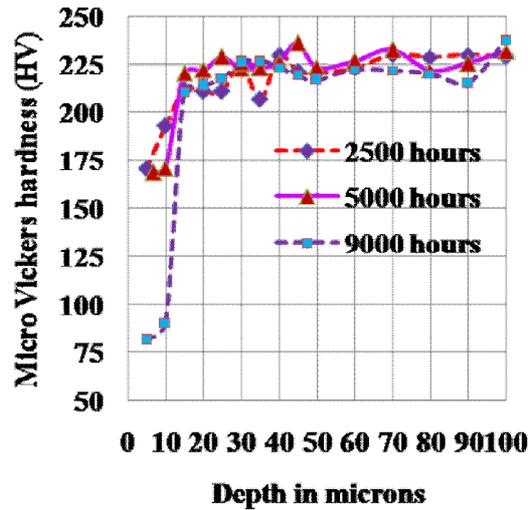
Micro Vickers hardness was measured on the cross section of the samples up to a depth of 100 μm and shown in figure 5 for all the three exposure times.

Fig.5. Depth profiles of Micro Vickers hardness of exposed IN-RAFMS samples to static Pb-Li at 550 C. Exposure time: (a) 2500 hours, (b) 5000 hours and (c) 9000 hours.

It is observed that hardness decreased in the near surface regions up to a depth of 15 μm in all the three cases. After 2500 and 5000 hours exposure to liquid metal, hardness decreased up to ~ 170 HV. After 9000 hours exposure, surface hardness decreased drastically up to 80 HV. Decrease in surface hardness was also observed for 9Cr-ODS steels exposed to static Li and Pb-Li at 600 $^{\circ}$ C for 250 hours by Y.Li et al.,[22] and for JLF-1 steel exposed to Li by Qi Xu et al.,[31].

From the Micro Vickers hardness measurements it was observed that the surface hardness decreased up to a depth of 15 μm for all the exposure times. Surface hardness decreased up to 170 HV after 2500 and 5000 hours exposure and up to 80 HV after 9000 hours exposure to liquid metal. From weight loss measurements, estimated corrosion rate was $\sim 40 \mu\text{m}/\text{year}$. Thus weight loss and decrease in surface hardness could be due to the dissolution of chromium in the liquid metal. Tensile strength of exposed samples to liquid metal remained almost same as that of fresh IN-RAFMS samples. It can be said that reduction of hardness in the near surface layers did not affect the tensile strength of the material.
