# Advanced Methods for the Optical Quality Assurance of Silicon Sensors

We describe a setup for optical quality assurance of silicon microstrip sensors. Pattern recognition algorithms were developed to analyze microscopic scans of the sensors for defects. It is shown that the software has a recognition and classification rate of  $> 90\%$  for defects like scratches, shorts, broken metal lines etc. We have demonstrated that advanced image processing based on neural network techniques is able to further improve the recognition and defect classification rate.

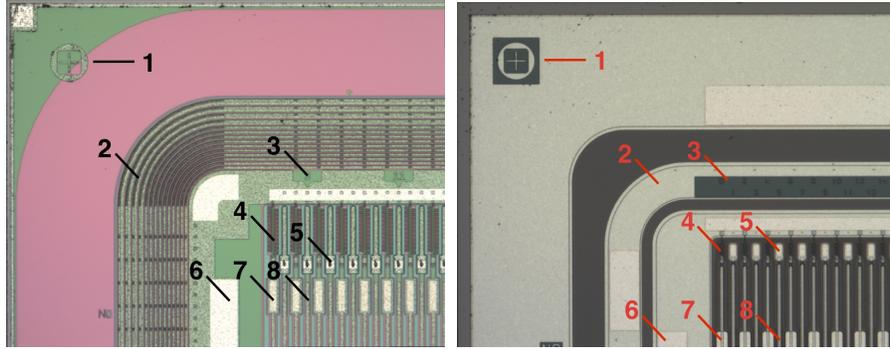
Figure 1: Layout of the silicon sensors from CiS (left panel) and Hamamatsu (right panel) in the corner region, n side. Legend: 1) Alignment mark 2) Guard ring 3) Strip numbering panel 4) Polysilicon bias resistor 5) DC pad 6) Bias ring pad 7) AC pad 8) Aluminum read-out strip.

To meet these requirements, it is necessary to restrict the material budget in the acceptance to an absolute minimum. The basic building block of the STS is a module, which consists of a double-sided silicon microstrip sensor and a multi-layer microcable which connects the sensor to the front-end electronics (FEE). The sensor sizes used in the setup are  $6.2 \times 2.2 \text{ cm}^2$ ,  $6.2 \times 4.2 \text{ cm}^2$ ,  $6.2 \times 6.2 \text{ cm}^2$  and  $6.2 \times 12.4 \text{ cm}^2$ . The wafer material is of n-type. The sensors are segmented into 1024 strips per side at a strip pitch of  $58 \text{ }\mu\text{m}$ . The strips are read out through integrated AC coupling. The p-strips are arranged under a stereo angle of  $7.5^\circ$  with respect to the n-strips. The short corner strips are interconnected using a second metal layer in order to enable full readout of the p-side from one sensor edge only, like with the simpler topology of the n-side. To degrade the field towards edge, the sensor has multiple and single guards ring on the n-and p-side, respectively.

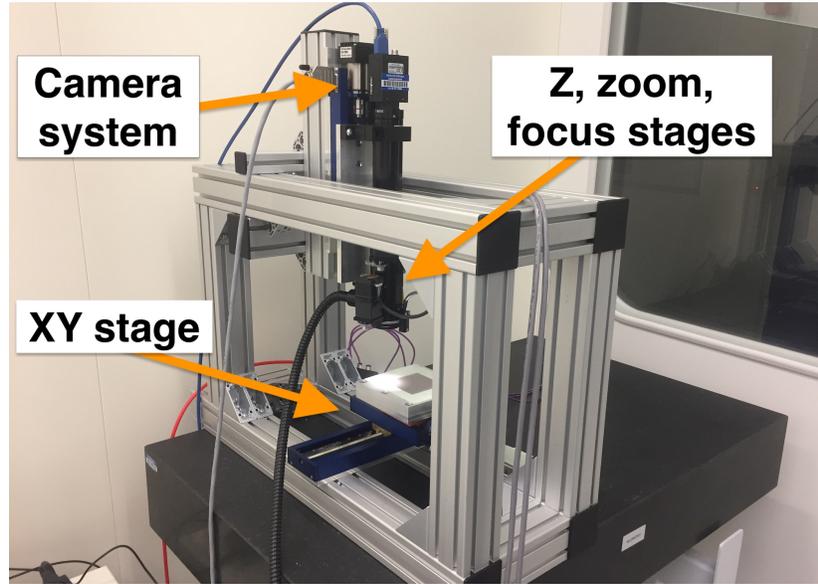
Figure 2: Setup for optical QA.

The basic components of the optical inspection setup (cf. Fig. 2) are the camera system mounted on a stable support frame on a massive granite table and an XY-linear stage to move the object under inspection with respect to the camera. A motorized Z-linear stage, the focus and the zoom stages give the setup the flexibility to inspect the object under different focal conditions. The XY-linear table based on Faulhaber/Movtec<sup>®</sup> SMC-300 servo motors provides

a movement range of 200 mm and 70 mm in X and Y directions, respectively, with a precision of about 0.3  $\mu\text{m}$ . This allows to mount and inspect sensors up to 124 mm long.

A custom-made 3-zone vacuum chuck allows to mechanically adjust the suction area and underpressure. It is attached to the XY stage to hold the different sensor variants in place during the scanning. A Becker<sup>®</sup> 150 mbar vacuum pump supplies the vacuum to the chuck. A vacuum pump bypass channel is controlled by an electromagnetic relay, allowing to release the sensors from the vacuum suction.

The Z-motor stage allows the vertical movement of the optical assembly within a range of 70 mm with a precision of about 0.3  $\mu\text{m}$ . The optical assembly consists of a motorized 12 $\times$  zoom (0.58 $\times$  - 7 $\times$ ) and a motorized 3 mm fine focus tube from Navitar<sup>®</sup>. The optical tube allows the direct coaxial inline light illumination by a  $\varnothing$ 15 mm flexible light guide connected to a 590 lm, 5700 K model Roma LED3 direct light source from Starlight<sup>®</sup> company. Use of a ring light source was investigated and phased out due to mirror-like surface of the

sensors and not satisfactory image quality. A 5 megapixel microscope camera from Motic is attached to the optical tube with a C-ring connection. The camera has a sensor size of 1/2.5 with a 4:3 aspect ratio and characteristic pixel size of  $2.2 \times 2.2 \mu\text{m}^2$ .

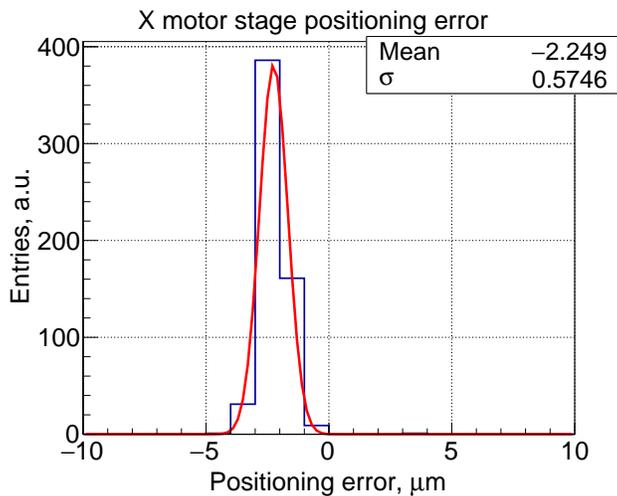
Figure 3: Estimate of the motor stage positioning precision by measuring repeatedly the residuum of actual and targeted position.

The linear motors use closed-loop feedback correction. In order to estimate the uncalibrated motor positioning precision and repeatability, a set of repetitive positioning measurements were carried out. An example of the deviation of the actual position from the target position value is shown in Figure 3 for the X direction. Here, the actual position was measured immediately upon arrival. This results in a biased distribution, because motor driver reports end of movement before the closed-loop corrections are carried out. The positioning error is further influenced by the jitter of about 0.5 - 1  $\mu\text{m}$  for all three axes.

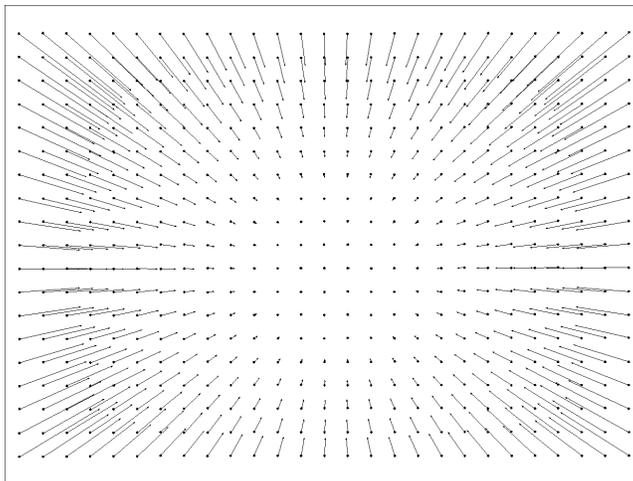
Figure 4: Correction for the barrel distortions of the image. The errors are scaled by a factor of 450 for demonstration purposes. The dimensions of the field are 2.4 by 2.0 mm<sup>2</sup>.

Geometrical barrel distortions are corrected with the help of a dot calibration array. The optimal array dot size and spacing for the present optical system is estimated based on the field-of-view calculations [9, 10]. The individual dots should be visible and detectable at lowest magnification and as many as possible should be visible at highest magnification. Accordingly, a 50  $\mu\text{m}$  dot size and a 100  $\mu\text{m}$  dot spacing has been chosen.

The barrel distortion correction is done using the NI Vision software package [11]. The dots of the calibration plate are recognized by the detection algorithms, their centers and spacings are taken into account. Then, using a polynomial distortion model based on the Brown-Conrady model [12, 13], the corrected positions are calculated. The residuals from this normalization are represented as the vectors pointing into the direction of the corrected position as shown in Fig. 4. The vector sizes are scaled by a factor of 450. The maximal value of the correction is 2.1  $\mu\text{m}$ .

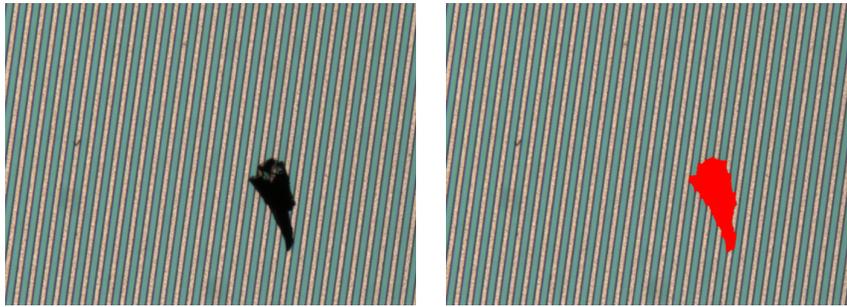
Figure 5: Detection of a dust particle covering 4 strips of a prototype sensor. The left panel shows the source image, the right panel shows the identified defect.

Figure 5 shows an example of dust detection. The left panel presents the source image and the right panel shows the detected defect overlaid onto the source image. Here the luminance plane was extracted and the image was thresholded using a metric auto-threshold. Then, small background objects were removed with the morphology tools. The particle size was measured by the *Particle Analysis tool* and estimated to be  $6330 \mu\text{m}^2$ . The size of the particles allows to quantify the defect severity.

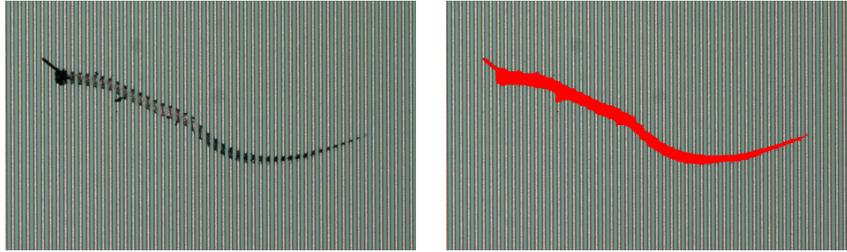
Figure 6: Detection example of a scratch traversing many strips on an n side of a prototype sensor. The left panel shows the source image. The right panel shows the scratch defect detected.

Figure 6 shows an example of a scratch detection. The left panel shows the source image and the right panel shows the detected scratch overlaid onto the original image. In this example, the luminance plane of the image was extracted and thresholded manually to extract only the dark objects with brightness values lower than 70 out of 255. The thresholded binary image was then cleaned from small background objects and the interstrip gaps were closed. The resulting single object was analyzed, its total area was measured to be  $30130 \mu\text{m}^2$ . The analysis tool also indicates a big elongation factor of around 9, which make this defect clearly distinguishable from a typically smaller and more round dust grains. Other metrics of this tool include center of mass, compactness, circularity, perimeter to area ratio, etc. This illustrates how the *Particle Analysis tool* can be used for an offline defect analysis and classification.

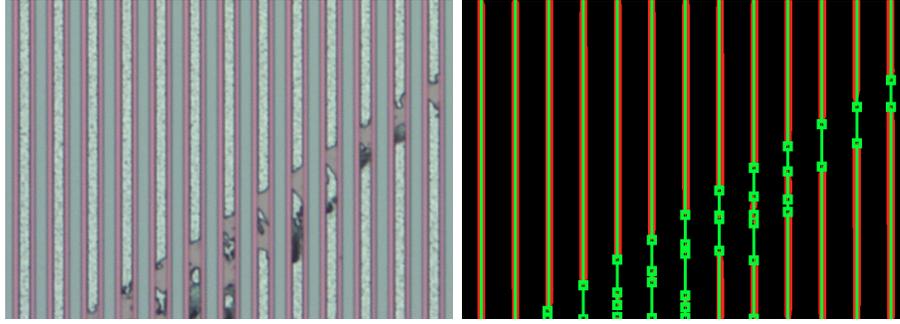
Figure 7: Detection example of a metal break region on a prototype sensor. The left panel shows the source image, the right panel shows the processed image with edges detected, edge numbering is suppressed.

Strip and implant defects are defects on the strip level, i.e., broken aluminum or implant strips. Figure 7 shows an example of the detection of defective strips which, like scratches, result in faulty readout channels. This defect, however,

occurred during the manufacturing process. Here, the luminance plane was extracted and the image was then thresholded with a background correction criterium, where the interstrip gap was selected as a background element. The resulting binary image was additionally cleaned up from small objects and the strips were filled with a convex hull morphology algorithm. Then a set of edge detection lines were applied to the strips. For the first two non-defective strips, there are zero edges detected as expected. The defective strips show at least one edge detected, which indicates the defect.

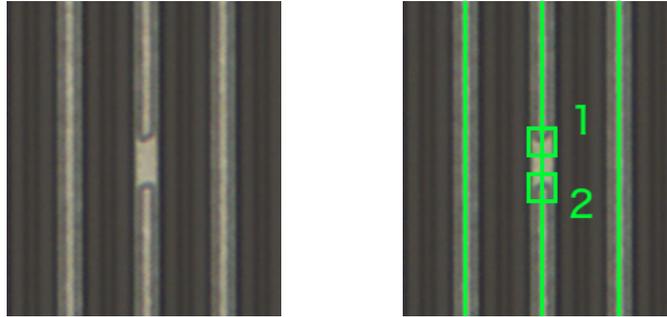
Figure 8: Detection example of an implant strip break. The left panel shows the source image, the right panel shows the detected defect.

The fact that the widths of the implant and aluminum strips differ it is possible to inspect the implant strip underneath the Al strip due to the layer topology. Here, the amount of light reflected into the camera shows the edges of this complex 3D structure. Figure 8 shows a detection example of the implant break defect type. The left-hand side panel shows the source image. The right-hand side panel shows the implant strip break detected. The detection is done by recognizing the strips with pattern matching and using the edge detection algorithms over the detected strips. The fact that edges are detected indicates a defect along the green edge detection line.

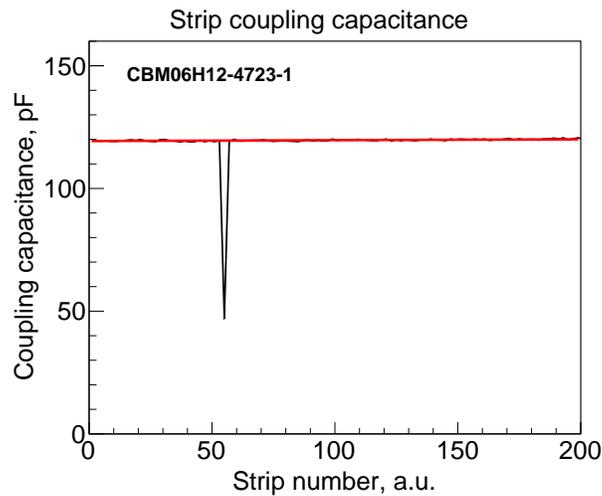
Figure 9: Strip coupling capacitance measured during the electrical inspection. Low value measured for the strip 58 indicates the defect.

capacitance. Fig. 9 shows the strip coupling capacitance measured for the prototype sensor. The lower capacitance of the strip 58, compared to the neighbors, verifies the defect observed during optical inspection.

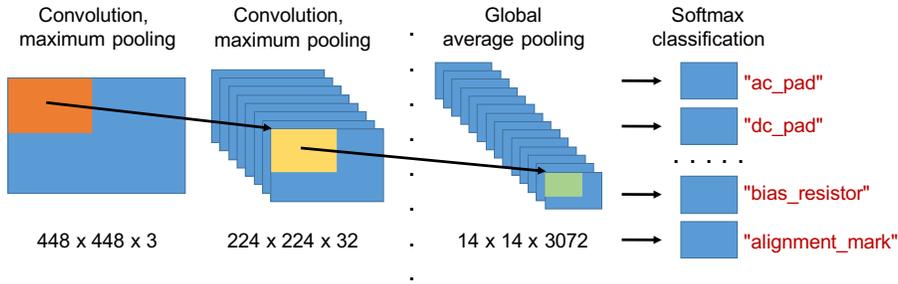
Figure 10: A simplified sketch of the neural network architectures used in this work.

Figure 10 shows a simplified sketch of the deep convolutional neural networks used in this work, the full network architecture is provided in [8]. It features many convolutional layers, which apply image convolution operations with certain amount of filters with different convolution kernels. The convoluted images retain their size but the depth of the feature maps is modified according to the amount of filters applied. Each convolution layer is activated with an activation function which governs the propagation of the information to the next layers of the network. Examples of these functions are sigmoid, hyperbolic tangent, rectified linear unit and parametrized rectified linear unit functions [23]. In this work, we use parametrized rectified linear unit functions which, for deep neural networks, provides better classification accuracy compared to the others [23].

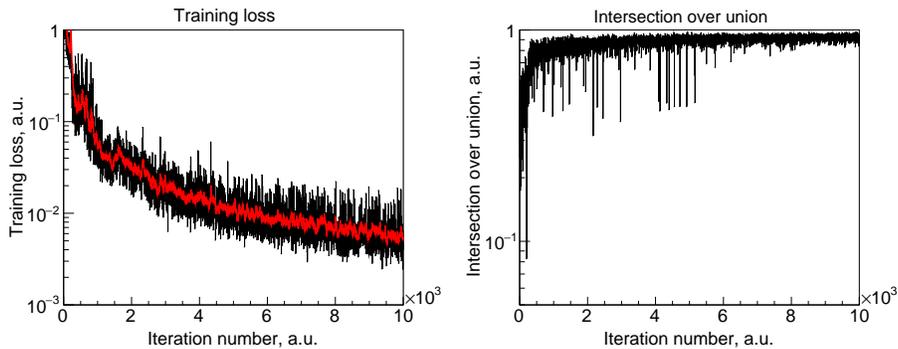
Figure 11: Training progress illustrated in terms of training loss (left panel) and intersection over union (right panel).

Figure 11 illustrates the progress of the training of the neural network for defects detection. The iterations represent a full training data set processing step. The training loss (left panel, black curve) represents the sum of errors made for each prediction and is the minimization parameter, the evolution of the average training loss is depicted with a red curve. The *IOU* metric evolution is depicted on the right panel. In a well trained network, this metric should tend to be equal to unity.

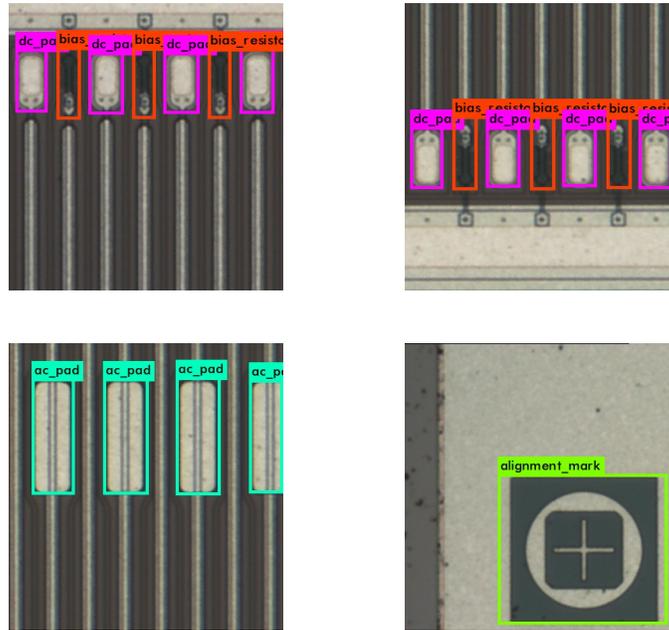
Figure 12: Different contexts of the sensor identified with a neural network.

Figure 12 shows the output of the trained context detection neural network. It allows to identify the electrical elements and other features of the sensor.

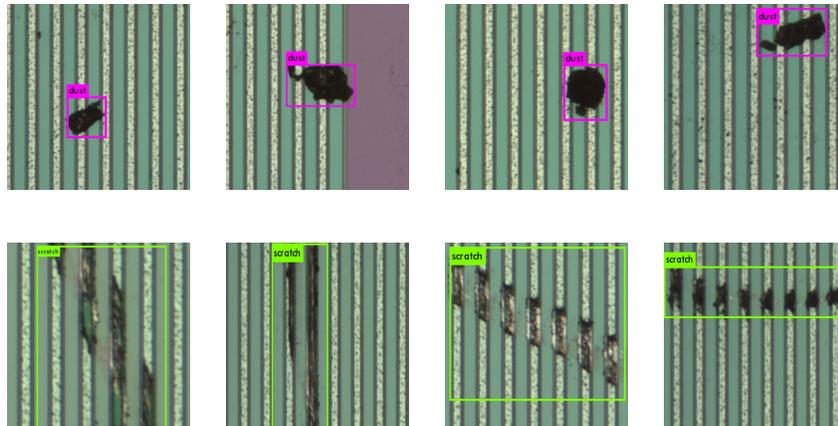
Figure 13: The dust particles and scratches identified with a neural network.

Fig. 13. Here the dust particles and scratches are detected. The associated regions where the defects are found are extracted as well.
